# ACETYLENE GAS SAFETY SEMINAR 2010 MALAYSIA

# Learning from Acetylene Incidents

# DA Incidents

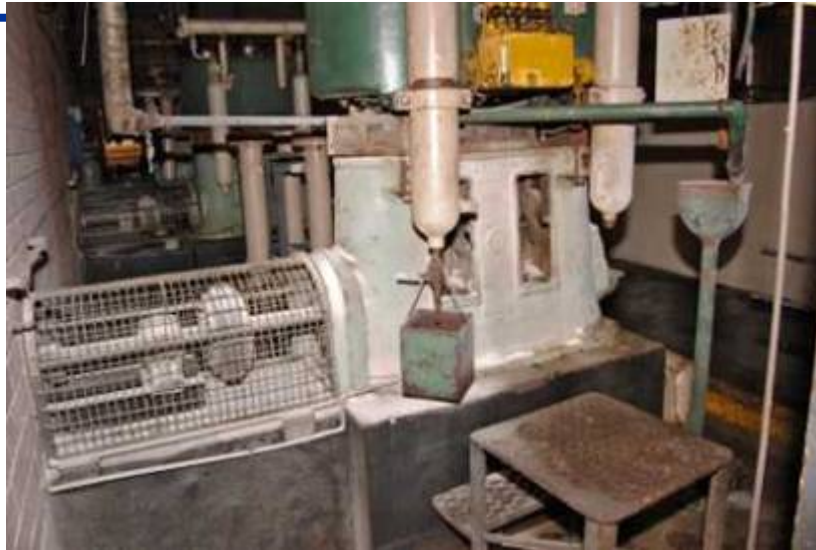
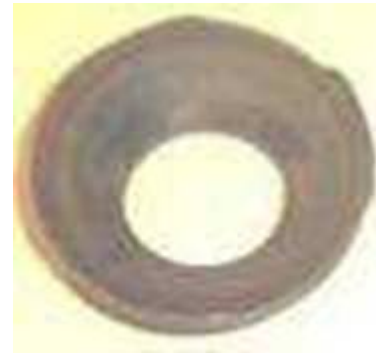
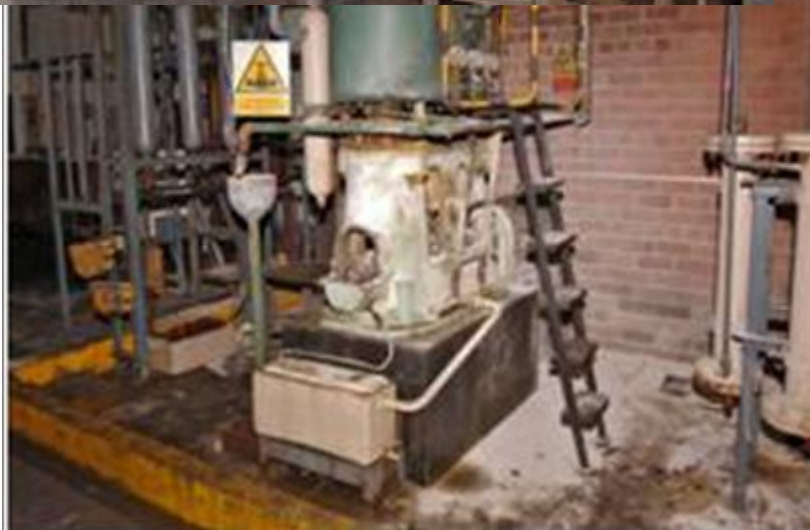
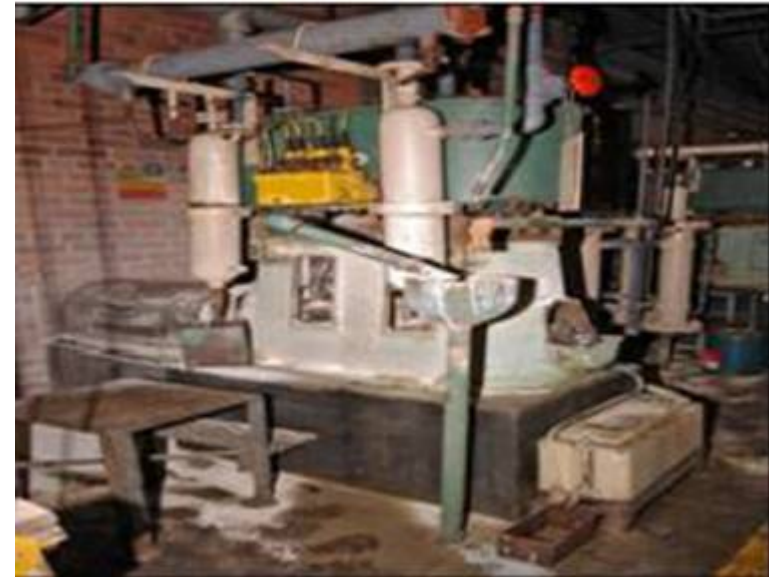
# 1. Compressor explosion

- In the afternoon, an explosion and fire occurred in the crank case of Seager acetylene compressor #1.
- The crank case inspection doors were blown off the machine by the force of the explosion.
- The acetylene supply was isolated by activating the plant emergency stop button and by closing the compressor suction valve.
- The fire was then extinguished by plant personnel with dry powder fire extinguishers.
- Nobody was injured in the incident.
- No permanent damage to the plant occurred.
- The plant was shut down for a full investigation until it was deemed safe to restart.

- Flammable atmosphere in the crankcase created by high leakage of acetylene past the worn compressor piston rods and gland packing.
- Source of ignition (suspected to be friction from loss of oil to the piston rod and gland packing, as evidenced by scuff marks on the piston rods and wear on the packing rings).

- The guards fitted to the compressors prevent adequate dispersion of gas between the bath and crank case.
- The guards also hinder condition monitoring.
- Reason for loss of lubrication unknown – either due to lack of oil top-up or to loss of prime in the lubricator.

- Compressor guarding was inappropriate, as it hindered condition monitoring and also prevented adequate ventilation of acetylene escaping past the piston rods.
- Compressor oil lubricators were not overhauled, since the sight glasses were found very dirty which prevented oil level monitoring.
- Routine condition monitoring and preventative maintenance plans are essential to ensuring equipment is in good operating order.

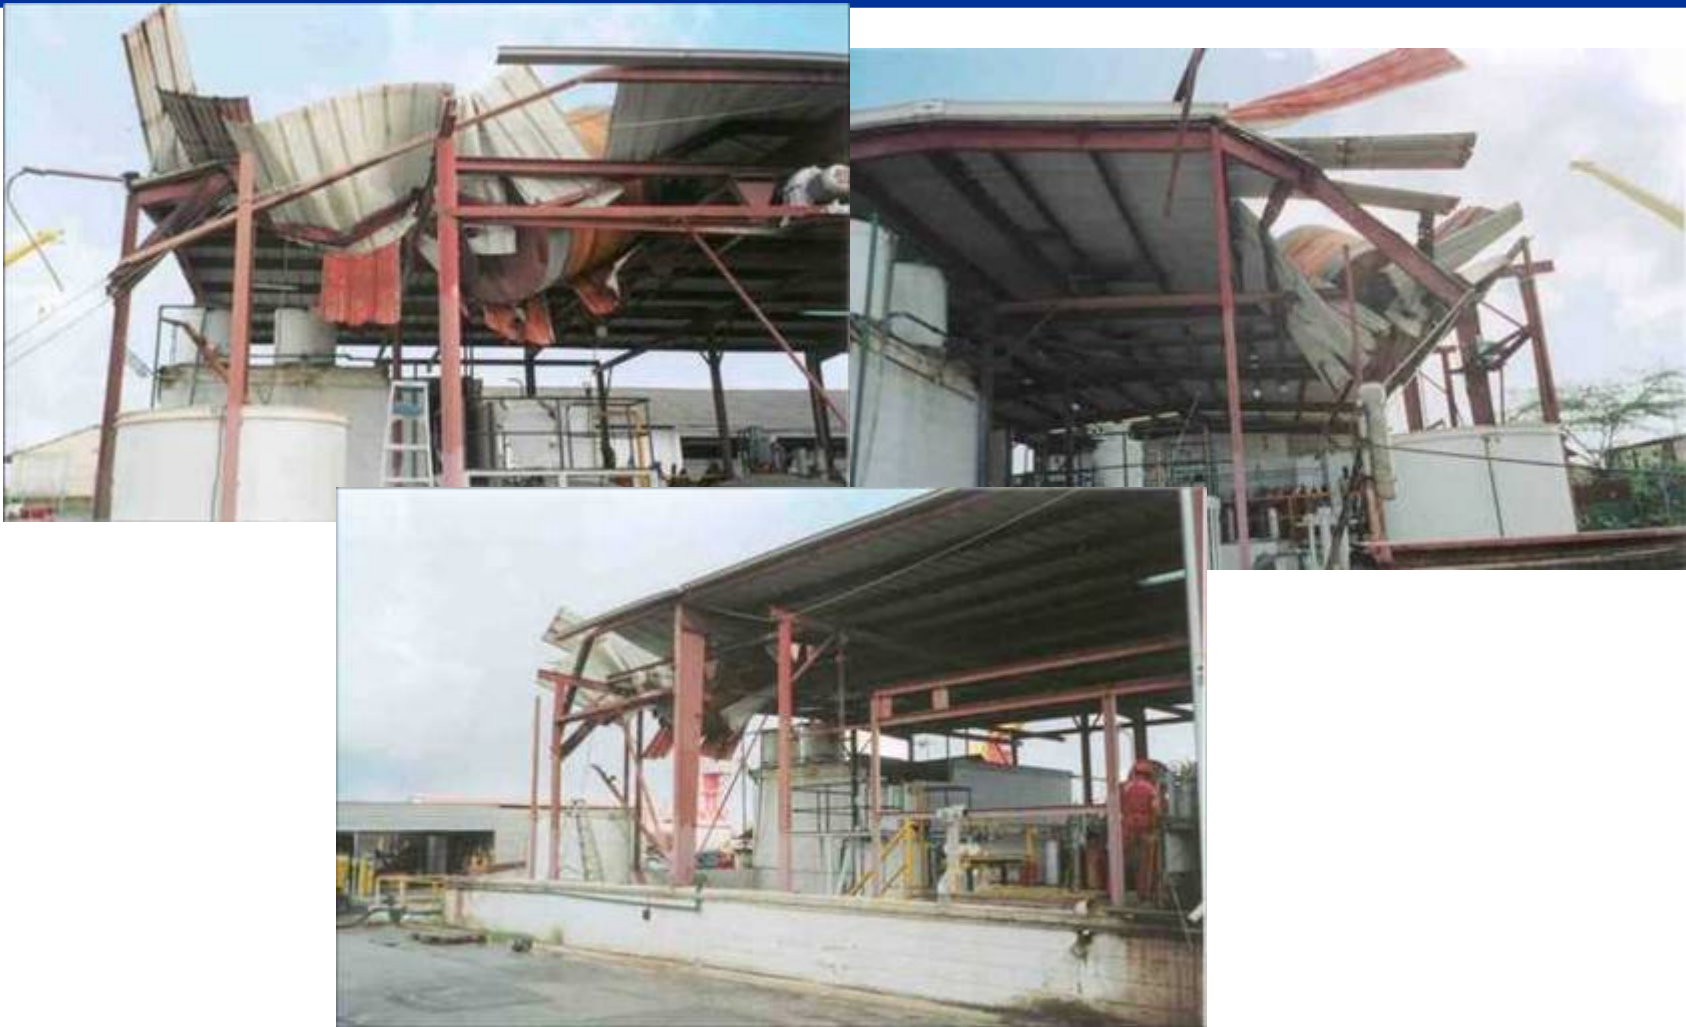
## 2. Acetylene Gas Holder Explosion

- Broken support bracket on gasholder dome required repairing.
- Plant shut down, system purged with nitrogen for 4 days.
- Permit to Work issued after testing for acetylene in the gasholder.
- Welding started - there was an instant explosion.
- The gasholder dome shot up in to the air.
- The welder fell from his ladder - not hurt.

- Pellistor sensors require the presence of air and acetylene in order to function.
- They cannot detect acetylene in nitrogen.
- Acetylene dissolves in the water in gasholders.
- The acetylene may be released if the temperature rises or the pressure drops.

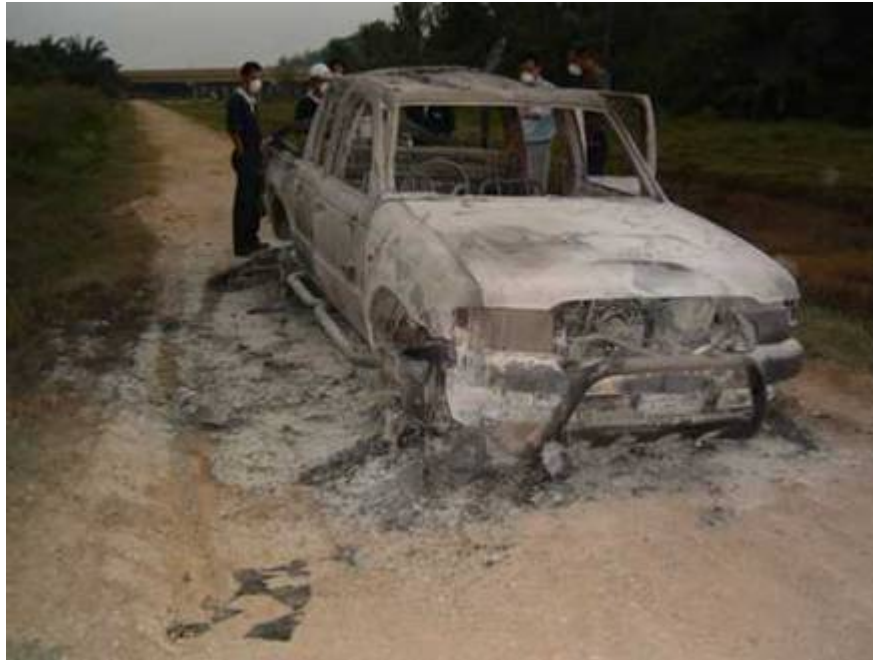
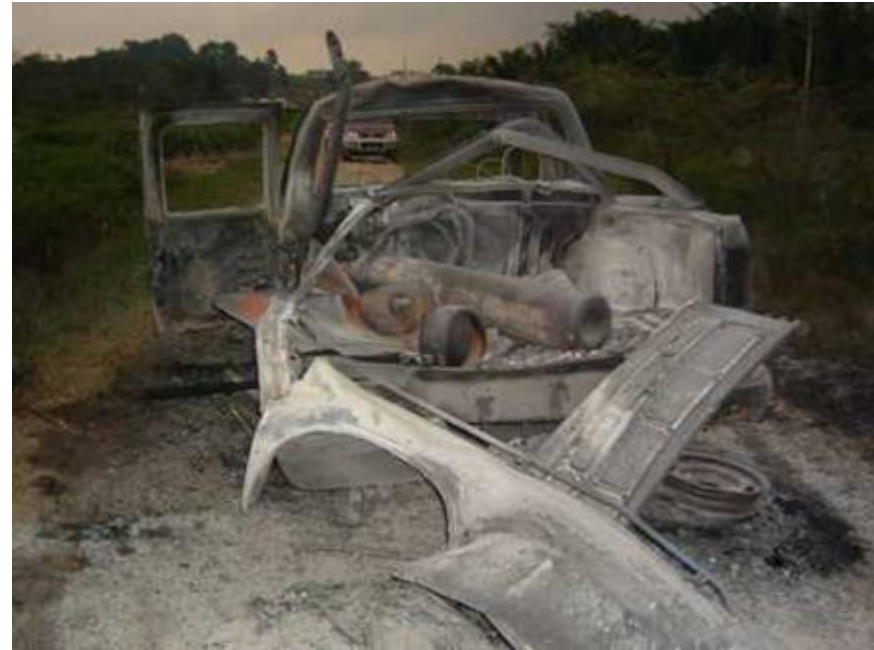
### 3. DA cylinder exploded while in transit on customer pick-up truck

The cylinders were transported on a pick-up truck. The two cylinders were lying diagonally on the pickup bed tied with nylon string. The size of the pickup bed was just sufficient to allow the taller O2 cylinders to be laid in this diagonal position. (Friction between nylon string and cylinders may cause electrostatic charges)

The road from the pump house to the main site is very bumpy which could have aggravated the movement of cylinders causing them hitting each other (cylinders hitting each other potential for spark)

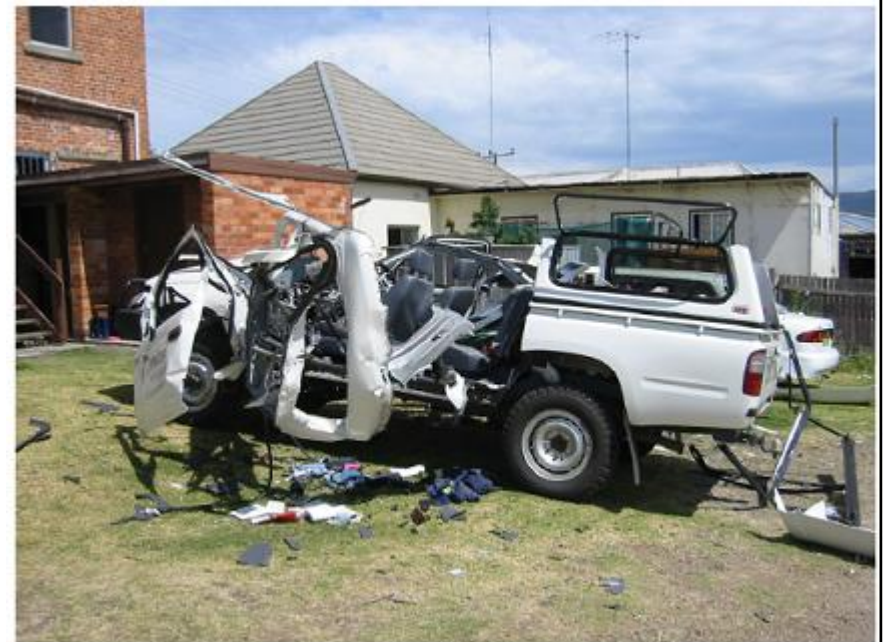
## 4. Leak of Acetylene

DA cylinder left on the back seat over the week end.

Acetylene cylinder valve was not fully closed and a leak occurred.

Acetylene accumulated in the van.

On Monday morning, as soon as the fitter opened the door, a large explosion took place.

Ignition may have been caused by either :

- Internal light circulatory
- Automatic door control
- Mobile phone which was on the front seat
- Lighting a cigarette (The fitter was a smoker)

The fitter has damage to his ear drums & injuries on the face.

The cab was badly damaged.

Never store cylinders in an enclosed vehicle or area.

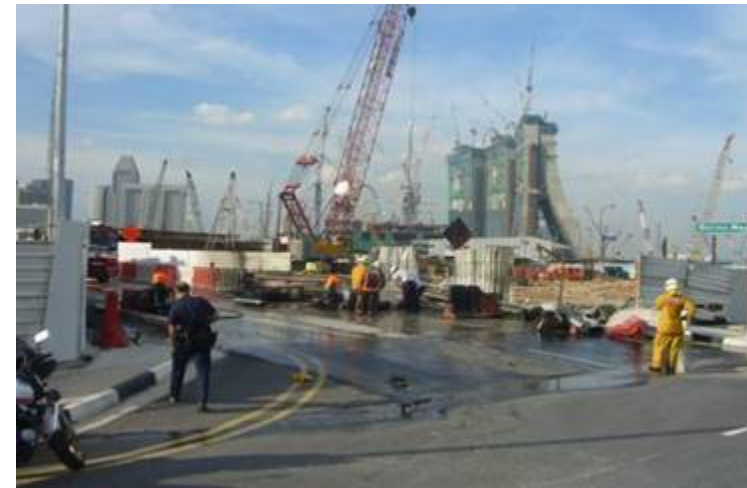
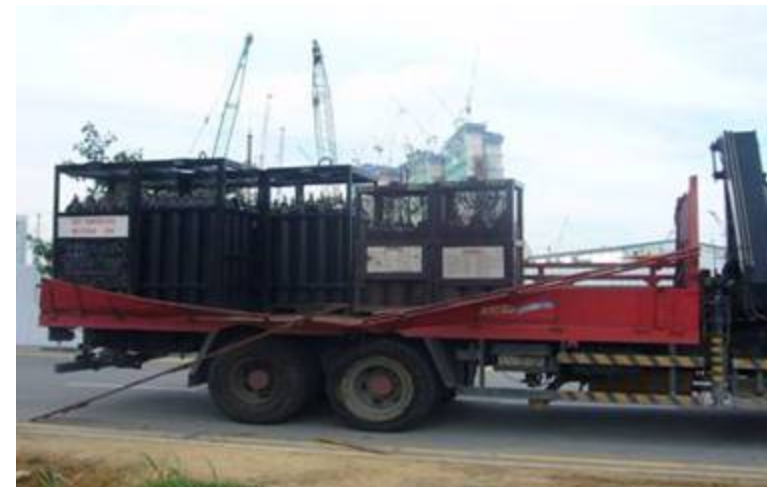
## 5. Acetylene pallet transport incident (Fire & Explosion - 2009)

- A contracted cylinder delivery truck carrying 5 oxygen cylinder pallets and 5 Acetylene cylinder pallets was making a delivery to a construction site.
- It negotiated a sharp corner near the site [unplanned route] as the usual road was closed on that day.
- 3 acetylene pallets fell off the truck.

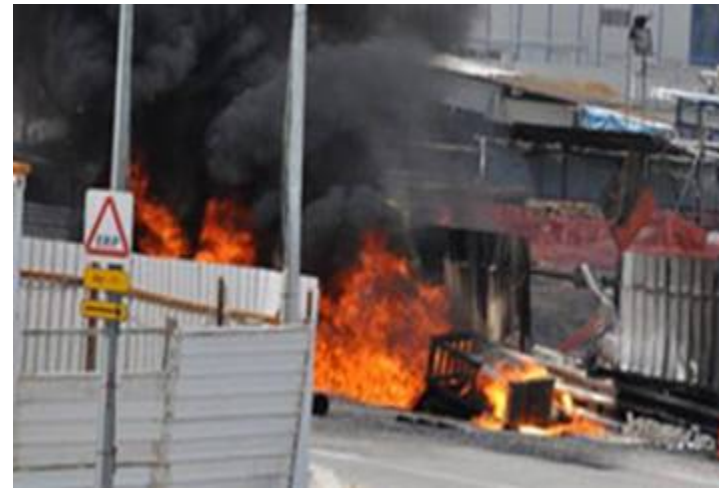
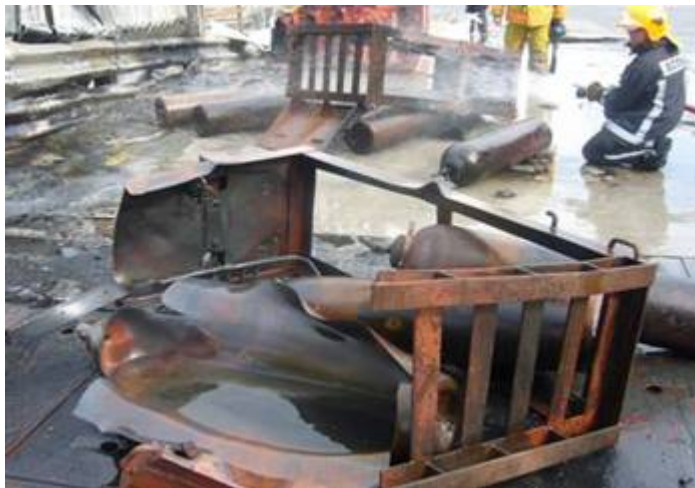
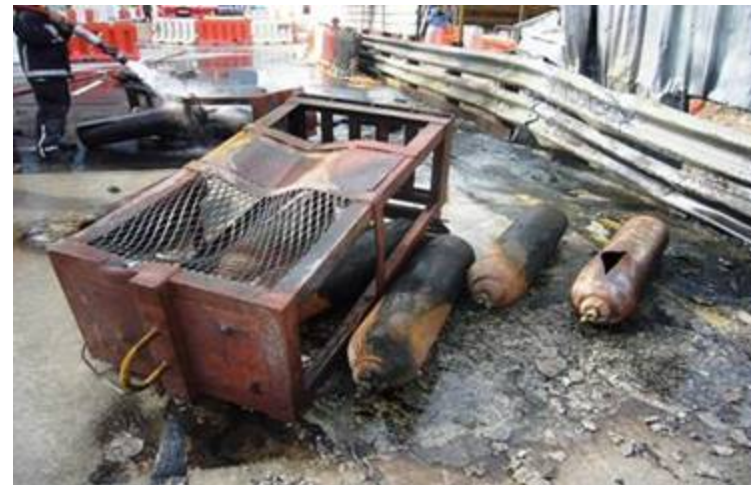
## 5. Sequence of events

- The 3 Acetylene pallets that fell out of the truck immediately ignited. Each pallet has 6 cylinders.
- Acetylene gas was released and burned rapidly in the pallets.
- 3 cylinders were ejected skyward from the pallets and landed some 100 metres away
- All 18 cylinders (3 x 6) were completely destroyed, with the valves detached from the cylinders or burned.

- Truck was going around the corner too fast.
- Pallets were not properly secured on the truck. Wooden sideboard on the truck was not strong and high enough to prevent pallets from tipping over.

- Cylinders were connected with a flexible hoses to a manifold with a main isolation valve.
- All the cylinder valves were opened to the manifold from the production site, relying on the main outlet valve on the pallet as the stop valve.
- Cylinders were loosely packed in the pallets.

- The cylinders hit the top of the pallets, causing the valves to be damaged.
- Cylinders fell out of the pallet frames.
- Acetylene gas would be released if any of the above occurred.
- Acetylene released in air ignited. Cylinders on fire could be propelled in different directions.

- All cylinder trucks that carry pallets to have strapping or lashing to secure the cargo during the transportation.
- Sideboards on truck have to be strengthened and height raised.
- Review is required on pallet design and operation:
  - Cylinders are filled individually and placed in the pallet. Cylinders need to be locked in place in the pallet to prevent movement.
  - All cylinder valves should be closed during transportation.

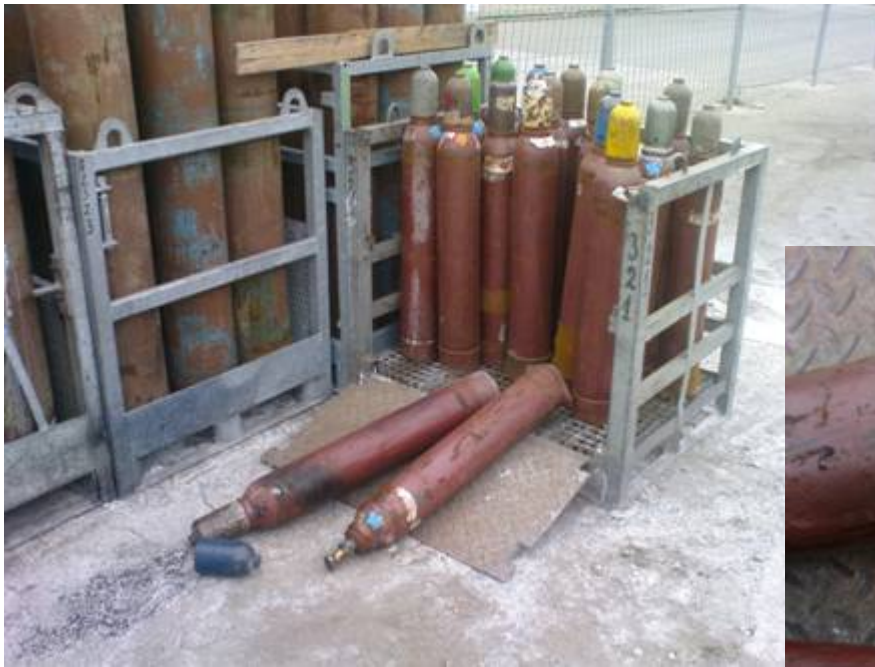
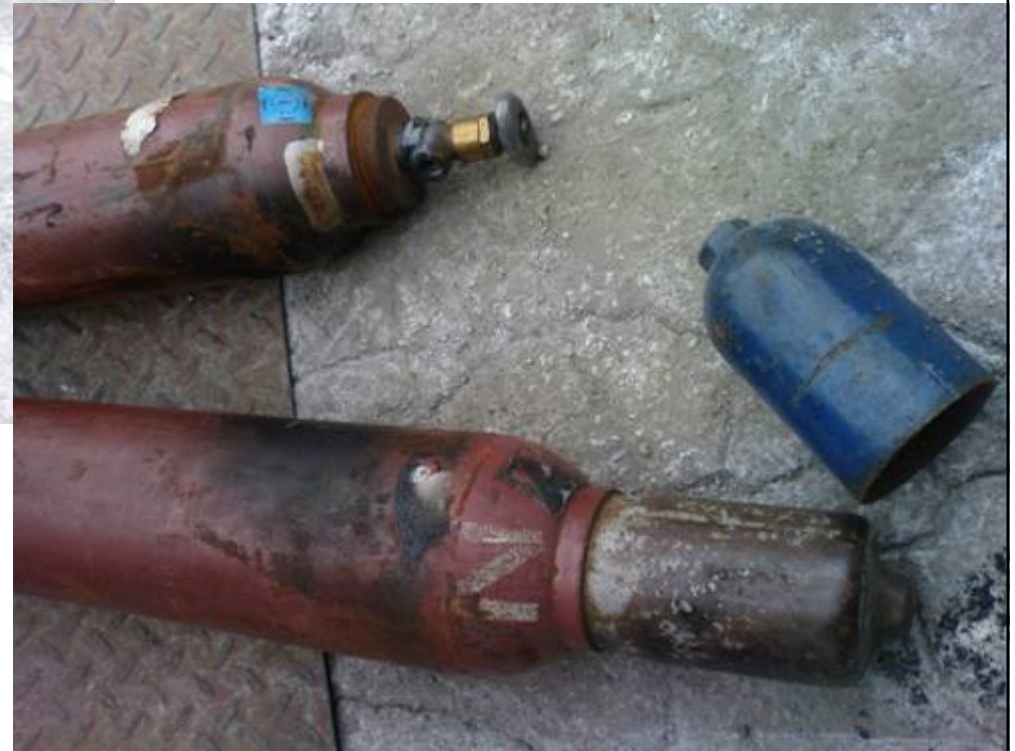
## 6. Fire from fallen acetylene cylinders

- At a cylinder filling site, while unloading a pallet of acetylene cylinders in the yard, two cylinders fell to the ground.
- The first cylinder valve hit the ground and caused a leakage of acetylene from the valve.
- When the second cylinder fell it caused a spark and ignited the leaking acetylene.
- Local personnel extinguished the fire quickly and the situation was made safe by cooling the cylinders.
- Nobody was injured.

- Flammable atmosphere due to acetylene leaking from damaged valve.
- Ignition source – falling cylinder generated a spark on impact.

- Cylinders not properly secured.
- Cylinder caps not fitted securely.
- Lack of procedures for forklift driver to check the load and move cylinders in pallets.

- Cylinders and cylinder caps are to be checked to make sure they are secure before moving them.
- Because acetylene has the widest flammability range (2.5%-82% in air), leaking acetylene can form a flammable atmosphere.
- Leaking acetylene can be readily ignited, e.g. from impact sparks.

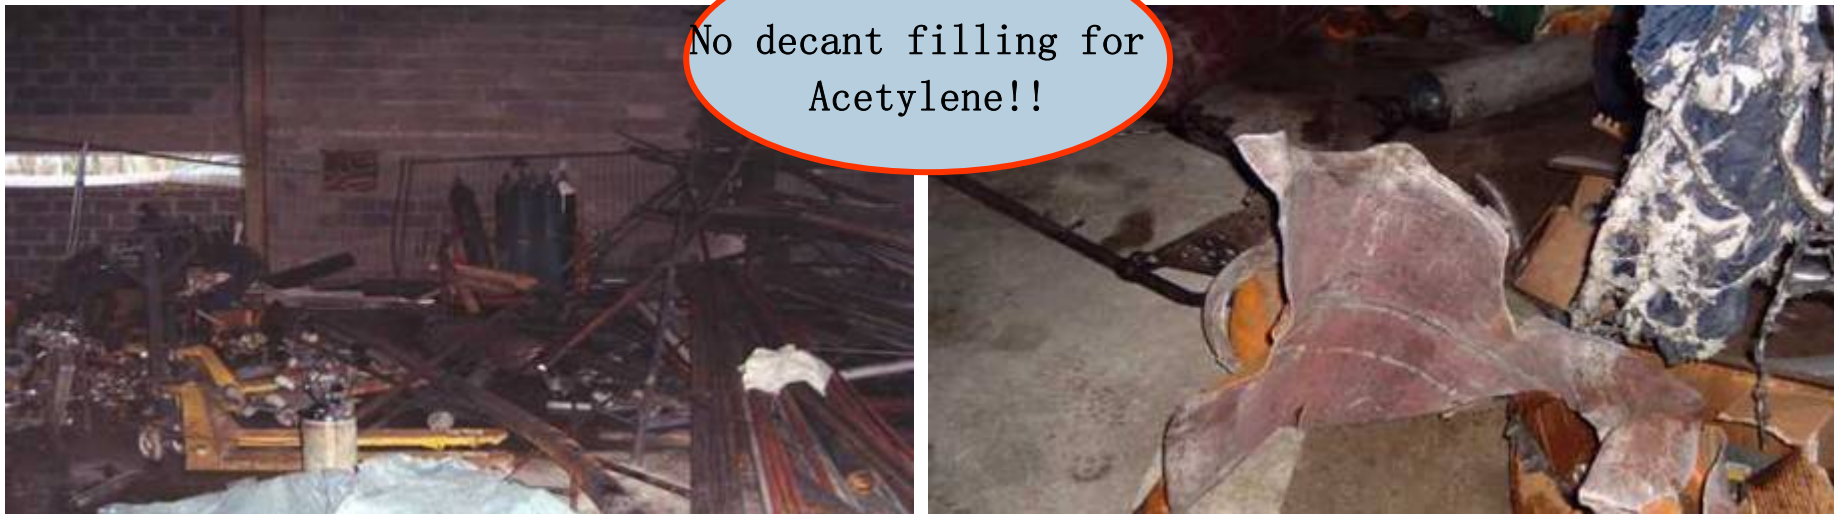
## 7. Cylinder Explosion

A contractor was reported to have been trying to decant acetylene into a beer gas cylinder.

At this stage it appears that there was a **backfire into the cylinder** with associated **contamination** from the beer gas cylinder, resulting in an **explosion**.

One fatality and two minor injuries were suffered, as well as substantial damage to the building.
