TAP WATER CORROSION OF COMPOSITES WITH AA 6061 LINERS

AIGA 073/11

Asia Industrial Gases Association

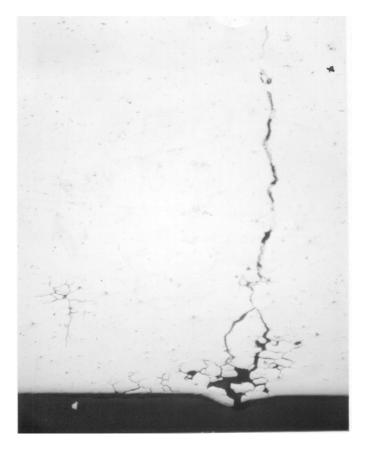
It is clear that a mechanism related to corrosion is in progress. Clear signs of intergranular corrosion were visible at the crack initiation sites for failed cylinders which have been metallographically examined, see Fig 1.

The above would indicate that the intergranular corrosion created by the contaminants contained in the tap water introduced local stress raisers which led to premature cyclic loading failures. This intergranular corrosion promotes very high stresses during test pressure cyclic testing which effectively reduced the fatigue initiation process that usually provides the majority of the cycle life for aluminium alloys. The above can be explained by the following:-

- a) Residual chemicals, notably the chloride content, in the tap water, have created some pre-existing corrosion related defects due to the alloy's susceptibility, albeit small, to intergranular corrosion.
- b) The very much thinner wall thickness in a H-W composite AA6061 cylinder, compared to its seamless counterpart, means that the stress takes a lot less time to propagate the cracks to failure which have been initiated in a) above.

Figure 1 – HW Cylinders (AA 6061)
Fatigue crack initiated from a corrosion pit.
Magnification X 125

Manufacturers are investigating ways by which the internal surfaces of H-W AA6061 cylinders can be treated in order to overcome the reduction in their overall life. Techniques including internal coatings, sand-blasting etc are being evaluated.

It is strongly recommended that companies who use such H-W AA6061 cylinders ensure that there is no ingress of tap/ordinary water either within their factories e.g. at the time of retest or whilst in service e.g. from a customer's process through backfeed, from rainwater etc.

THIS WILL MEAN THAT EXISTING H-W and F-W AA6061 CYLINDERS WILL NEED TO BE RETESTED AT THE TIME OF PERIODIC INSPECTION USING SPECIALLY TREATED WATER, EG. USE OF INHIBITORS, REMOVAL OF CHLORIDE ETC AND USING THE SHORTEST POSSIBLE TIME OF EXPOSURE TO THIS WATER DO NOT LEAVE CYLINDERS FILLED WITH TAP WATER FOR MORE THAN 2 HOURS.

Until this problem has been fully resolved, use of a positive pressure, non-return valve with such cylinders is highly recommended, as it will considerably reduce the risks involved during service.

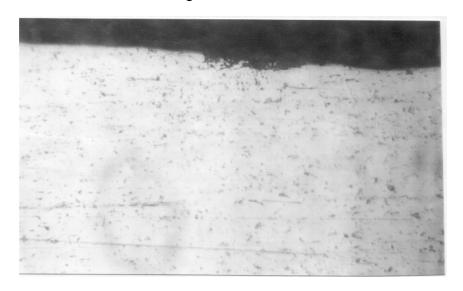
Figure 2 - AA 7060 Cylinder

Unlike aluminium alloy cylinders manufactured from say alloys 5283, 7060 etc which are totally resistant to intercrystalline corrosion (according to testing to EN 1975), see fig. 2, cylinders from alloy 6061 pass the test but exhibit some susceptibility to intercrystalline corrosion see fig 3.

Metallographic examination according to the intercrystalline test as per EN 1975.

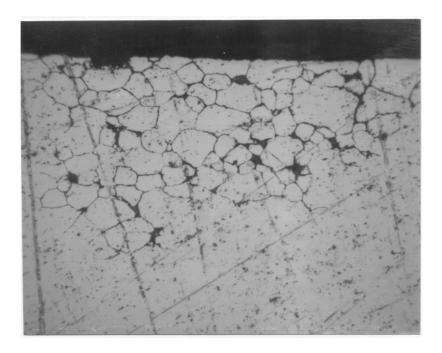
Figure 3 - HW AA 6061 Cylinder

Metallographic examination according to the intercrystalline test as per EN 1975.
