## TAP WATER CORROSION OF COMPOSITES WITH AA 6061 LINERS

### AIGA 073/11

Asia Industrial Gases Association

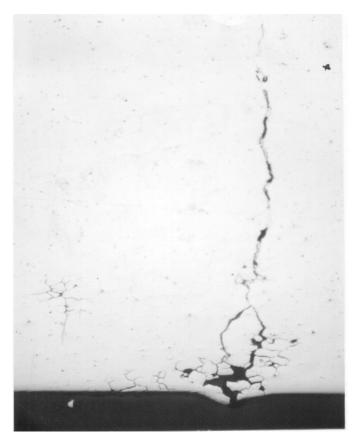
It is clear that a mechanism related to corrosion is in progress. Clear signs of intergranular corrosion were visible at the crack initiation sites for failed cylinders which have been metallographically examined, see Fig 1.

The above would indicate that the intergranular corrosion created by the contaminants contained in the tap water introduced local stress raisers which led to premature cyclic loading failures. This intergranular corrosion promotes very high stresses during test pressure cyclic testing which effectively reduced the fatigue initiation process that usually provides the majority of the cycle life for aluminium alloys. The above can be explained by the following:-

a) Residual chemicals, notably the chloride content, in the tap water, have created some pre-existing corrosion related defects due to the alloy's susceptibility, albeit small, to intergranular corrosion.

b) The very much thinner wall thickness in a H-W composite AA6061 cylinder, compared to its seamless counterpart, means that the stress takes a lot less time to propagate the cracks to failure which have been initiated in a) above.

**Figure 1 – HW Cylinders (AA 6061)** Fatigue crack initiated from a corrosion pit. Magnification X 125

Manufacturers are investigating ways by which the internal surfaces of H-W AA6061 cylinders can be treated in order to overcome the reduction in their overall life. Techniques including internal coatings, sand-blasting etc are being evaluated.

It is strongly recommended that companies who use such H-W AA6061 cylinders ensure that there is no ingress of tap/ordinary water either within their factories e.g. at the time of retest or whilst in service e.g. from a customer's process through backfeed, from rainwater etc.

THIS WILL MEAN THAT EXISTING H-W and F-W AA6061 CYLINDERS WILL NEED TO BE RETESTED AT THE TIME OF PERIODIC INSPECTION USING SPECIALLY TREATED WATER, EG. USE OF INHIBITORS, REMOVAL OF CHLORIDE ETC AND USING THE SHORTEST POSSIBLE TIME OF EXPOSURE TO THIS WATER DO NOT LEAVE CYLINDERS FILLED WITH TAP WATER FOR MORE THAN 2 HOURS.

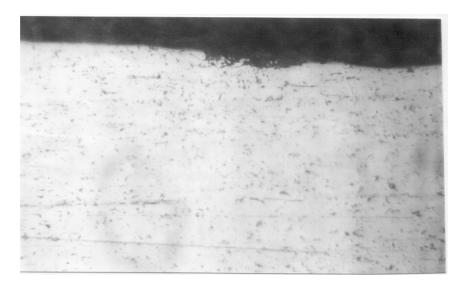
Unlike aluminium alloy cylinders manufactured from say alloys 5283, 7060 etc which are totally resistant to intercrystalline corrosion (according to testing to EN 1975), see fig. 2, cylinders from alloy 6061 pass the test but exhibit some susceptibility to intercrystalline corrosion see fig 3.

Figure 2 - AA 7060 Cylinder Metallographic examination according to the intercrystalline test as per EN 1975. Magnification X 300

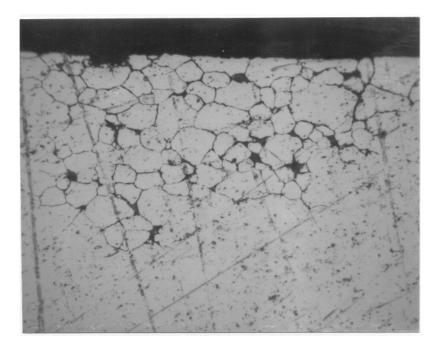
**Figure 3 - HW AA 6061 Cylinder** Metallographic examination according to the intercrystalline test as per EN 1975. Magnification X 300
