**Training Package**  
**TP 08/11**

# **Recent Incidents in the Gases Industry in Asia**

***Asia Industrial Gases Association***

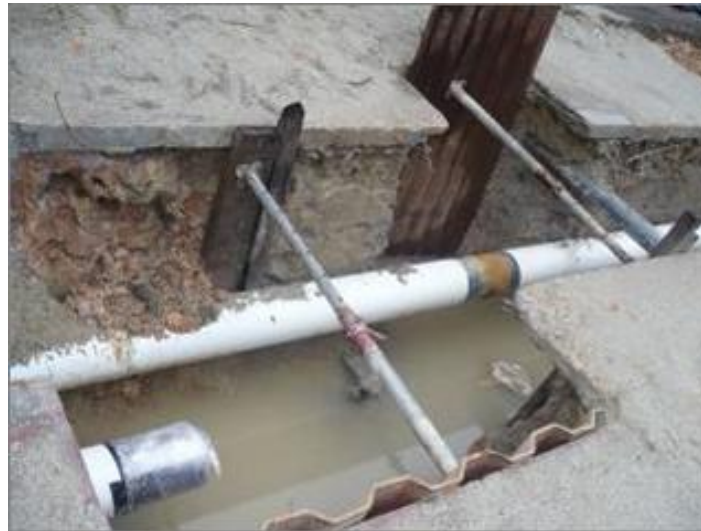
**N2 pipeline cap  
and O2 pipeline**

The blank cap used to blind off the open-end of the pipeline uses a compressed rubber ring fitting design that is supposed to hold a pressure of up to 3 bar(g).

When the incident occurred the N2 pressure had probably risen to 7 bar (g) due to a malfunction of the pressure regulator used to regulate the pressure from the source.

- **Blank cap design pressure exceeded**  
The blank cap used to seal off the open-end of the pipeline under construction was specified as *'to be able to hold a pressure of 3 bar'*. The pressure in the line was supposed to be maintained at 1 bar(g). Failure probably occurred when the pressure reached 7 bar (g).
- **Failure of pressure regulator**  
The upstream pressure before the regulator was in excess of 20 bar (g). The regulator's malfunction resulted in a much higher pressure in the pipeline section.
- **No protection for over-pressure in the pipeline**  
No pressure relief protection was installed to prevent the pipeline from exceeding the intended pressure.

- Work Permit procedure – Was this well understood and correctly administered ?
- Management of Change – Was a risk assessment done for use of high pressure nitrogen regulated down to low pressure ?
- Necessity to inert pipeline?  
Was there a need to inert pipelines under construction and was there a need to have a pressure in the pipeline?

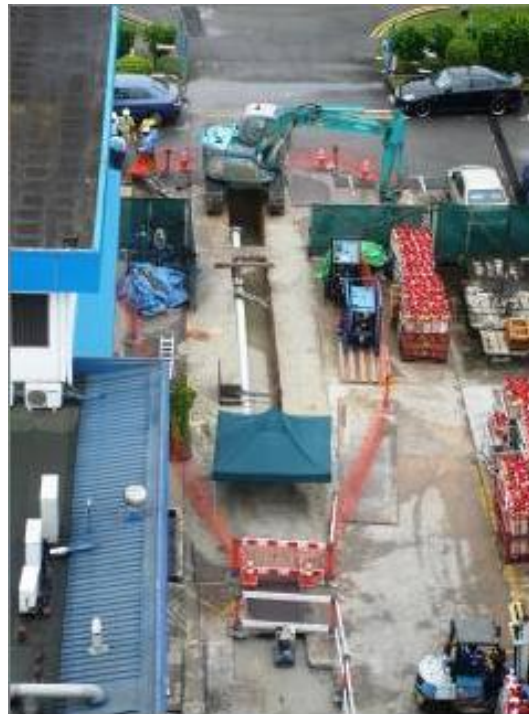
**Location of  
the accident**

- Underground O2 & N2 pipelines construction work was in progress on site from February 2011.
- To protect the pipelines under construction against ingress of humid air outside of working hours and during rainy periods, it was decided to plug the open ends with mechanical caps and inert the pipelines with nitrogen at 1 bar (g). The pipelines would be de-pressurized before work resumed.
- On 9 March 2011 after rain had stopped at around 5.30 pm two workers from the subcontractor company were in the trench doing housekeeping when the cap on the N2 pipeline suddenly came off. The ejected cap struck one of the workers in the trench and he was thrown off some 14 metres away.  
He suffered multiple injuries and died three hours later at the hospital.
- The other worker suffered slight injury on his back.

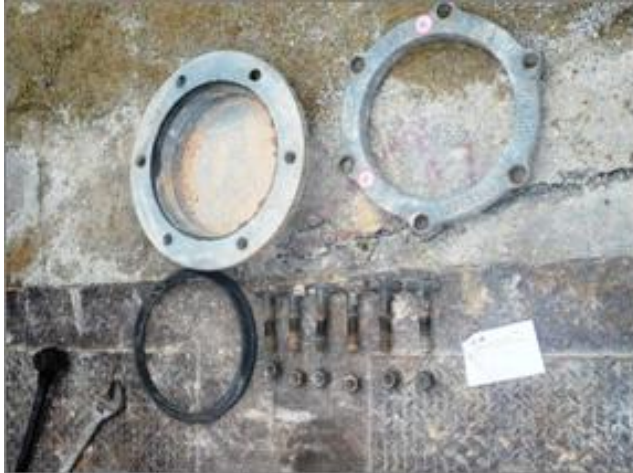
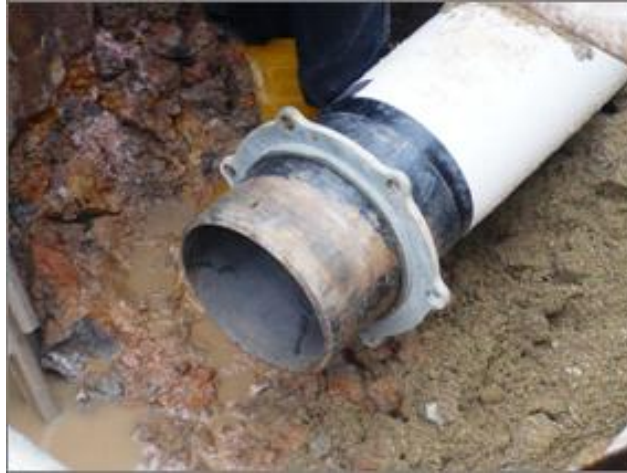
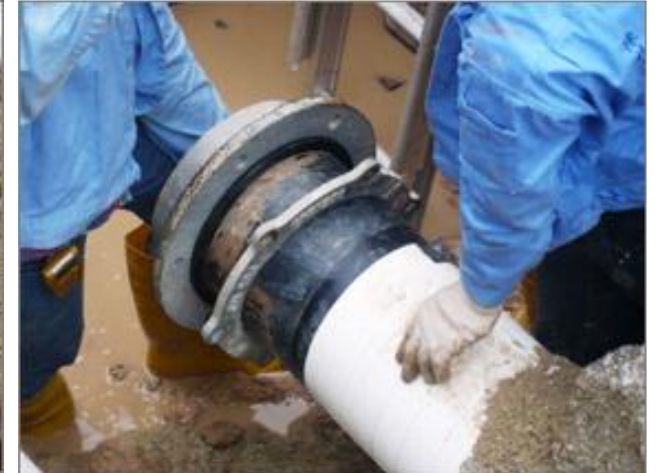
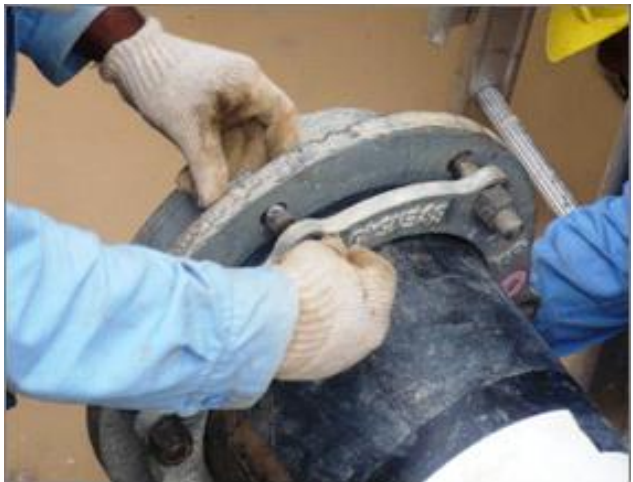
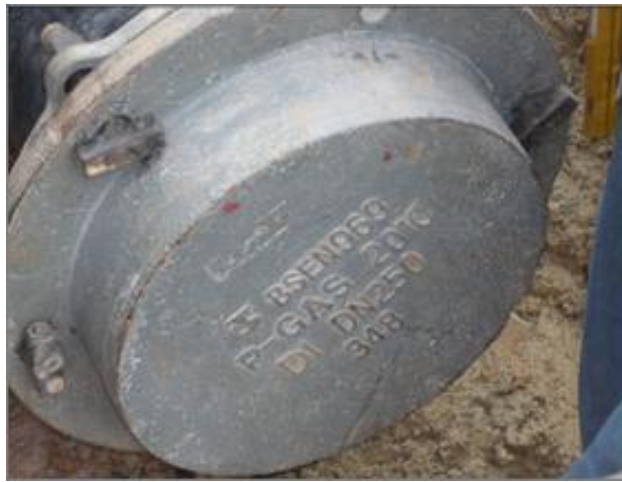
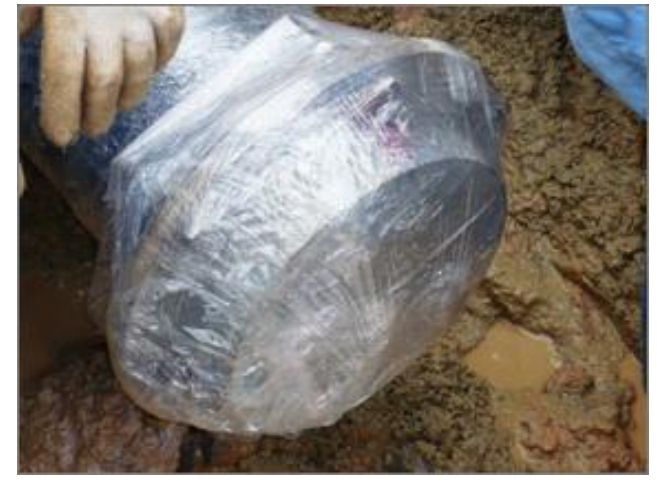
# Pipeline Cap and Assembling Process

Note: Pictures taken after the accident

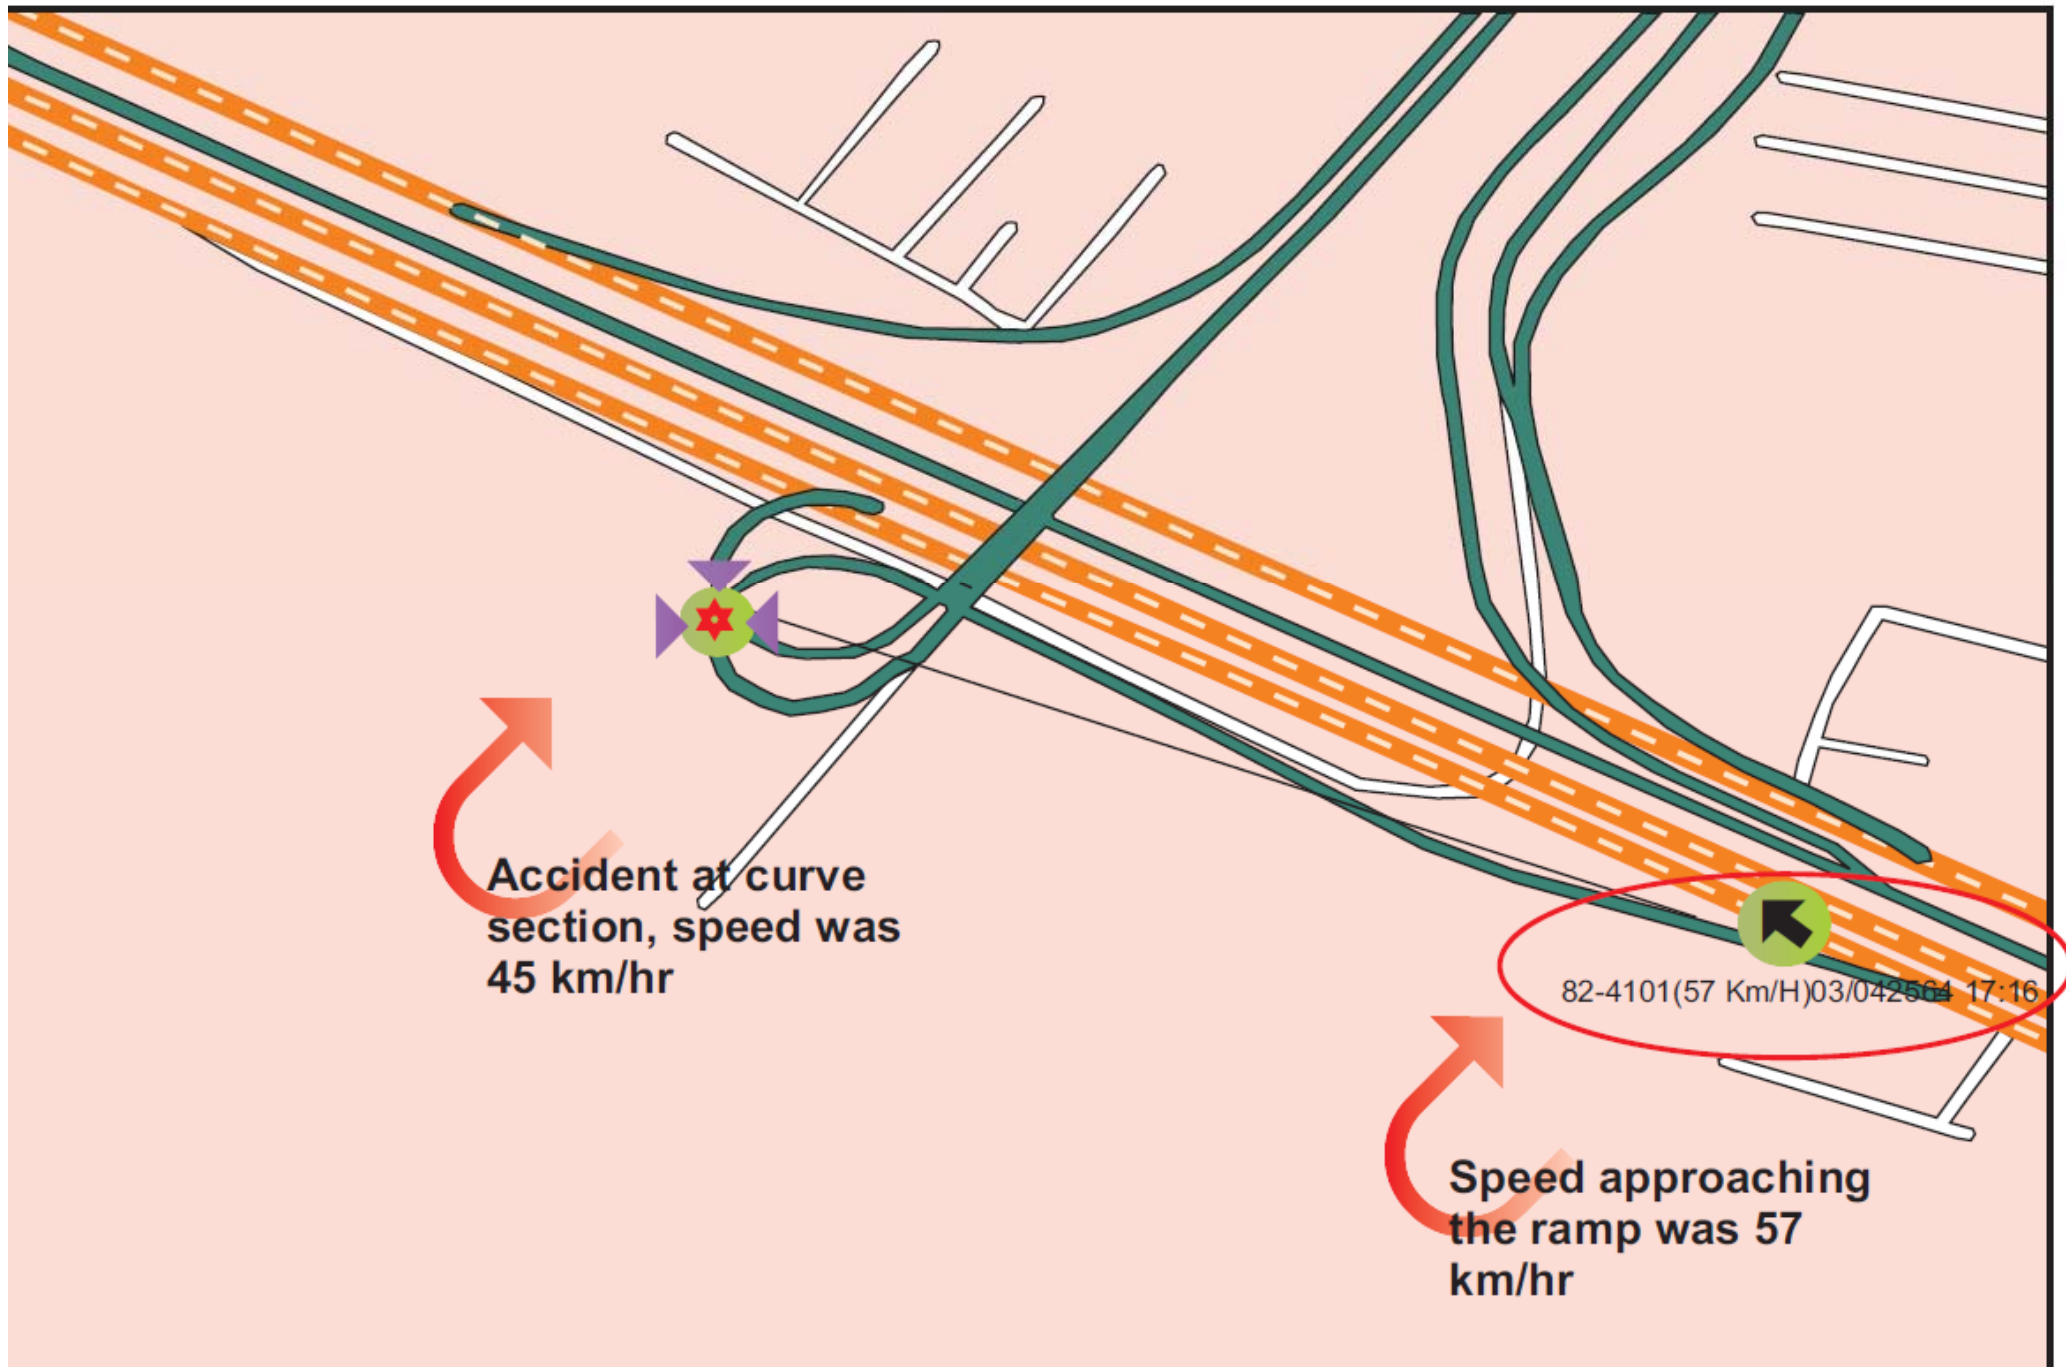
- A fully loaded liquid CO<sub>2</sub> tank-trailer was on its way to deliver the product to the customer at around 5 pm on a Sunday. Traffic condition was light. The vehicle had approached the entrant ramp to an elevated road intersection at a speed of 57km/hr (as recorded by the GPS Black Box). At the curve section of the slip road to the ramp the speed was recorded as 45 km/hr. The driver suddenly lost control of the vehicle and the tank trailer rolled over and hit the roadside guard.

- Due to the impact, some portion of polyurethane insulation foam on the tank broke out and pushed against a gas valve handle (quick opening type valve). The valve was thus opened and resulted in some LCO<sub>2</sub> release.

- The emergency response team arrived at the accident scene later and was able to stop the release safely.
- The driver had his seatbelt on and received slightly injury on his face due to the broken windscreen. He received first-aid treatment at a nearby hospital.

- Total liquid CO<sub>2</sub> release - around 3 tons.
- Estimated repair cost to tanker - US\$ 42,000.

- Safe speed exceeded

The driver was travelling at a higher speed than he should due to the light traffic condition when he was approaching the slip road to the elevated intersection.

- Failure to adopt correct driving technique

He did not slow down sufficiently when he negotiated the curve up the ramp. He had exceeded the speed limit to prevent the rollover from occurring.

- Incident details are shared with drivers – to highlight the data on the actual speeds in the incident and the speed limit which should be adhered to when negotiating a road curve.
- Drivers are reminded to keep to safe speed limit even when traffic condition is light and not to be over confident.
- Company to re-emphasize training for all drivers on the causes of rollover and the driving techniques to prevent it.
- Use of quick opening valves on liquid CO2 tanks should be reviewed as they tend to be opened when there is an impact on the handles in an accident.
- Useful link on rollover prevention:
