**Training Package
TP 13/13**

Recent Incidents in the Gases Industry in Asia

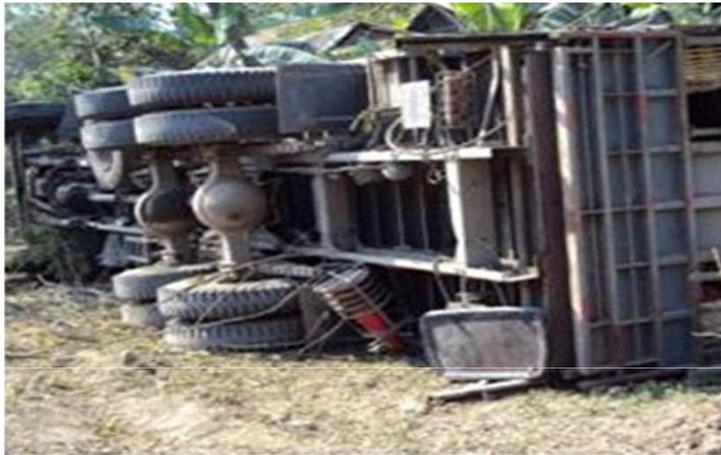
- A cylinder truck carrying 143 full cylinders collided into a third party three-wheel vehicle.
The cylinder truck hit the rear of the three-wheel vehicle when trying to overtake it. The driver lost control of his vehicle which then left the road and rolled over.
- From investigation, the rear axle of the three-wheel vehicle had broken suddenly and caused it to swerve into the path of the cylinder truck.
- The driver of the three-wheel vehicle suffered head injury and was hospitalized for 7 days.
- Both the contracted driver and helper of the cylinder truck were wearing seatbelts and avoided injury.

Cylinder truck's final position after the incident

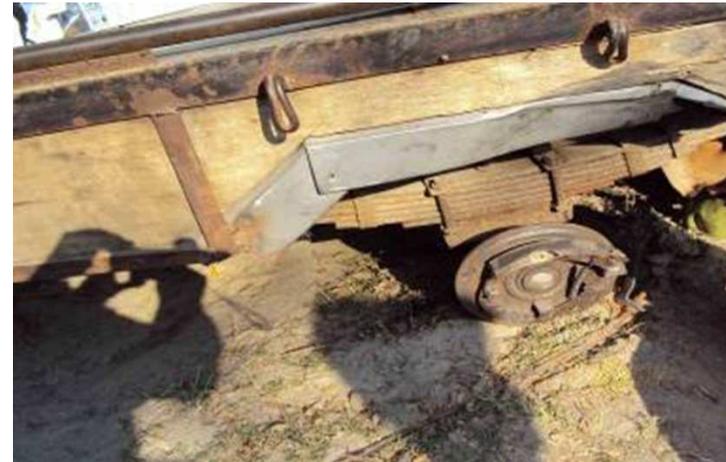
Third party three-wheel vehicle with broken rear axle

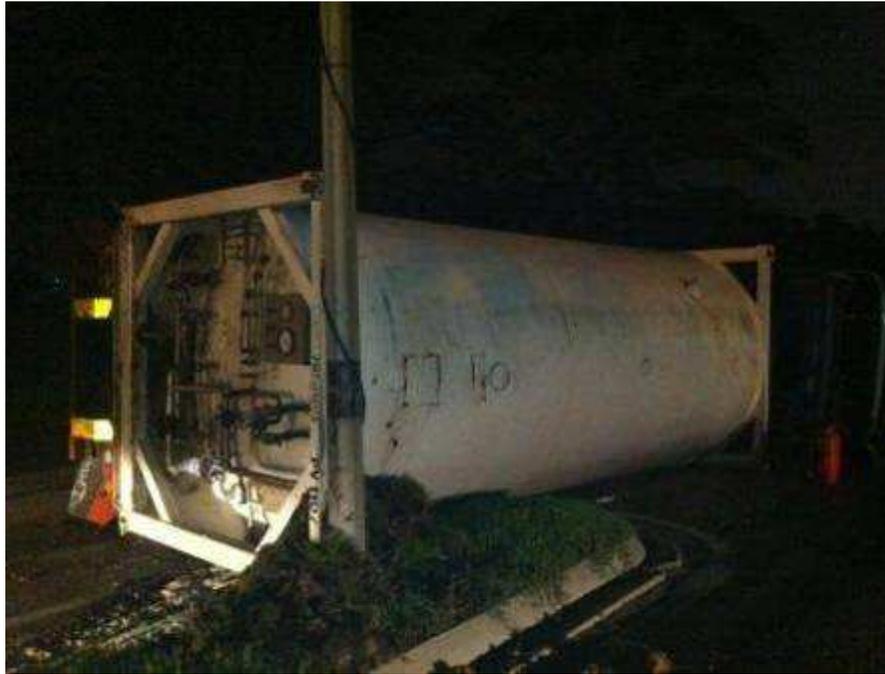
The prime-mover and trailer veered off the road and landed 90 degree on its right side onto the fast lane of the road.

Trailer and skid tank's final position after the incident

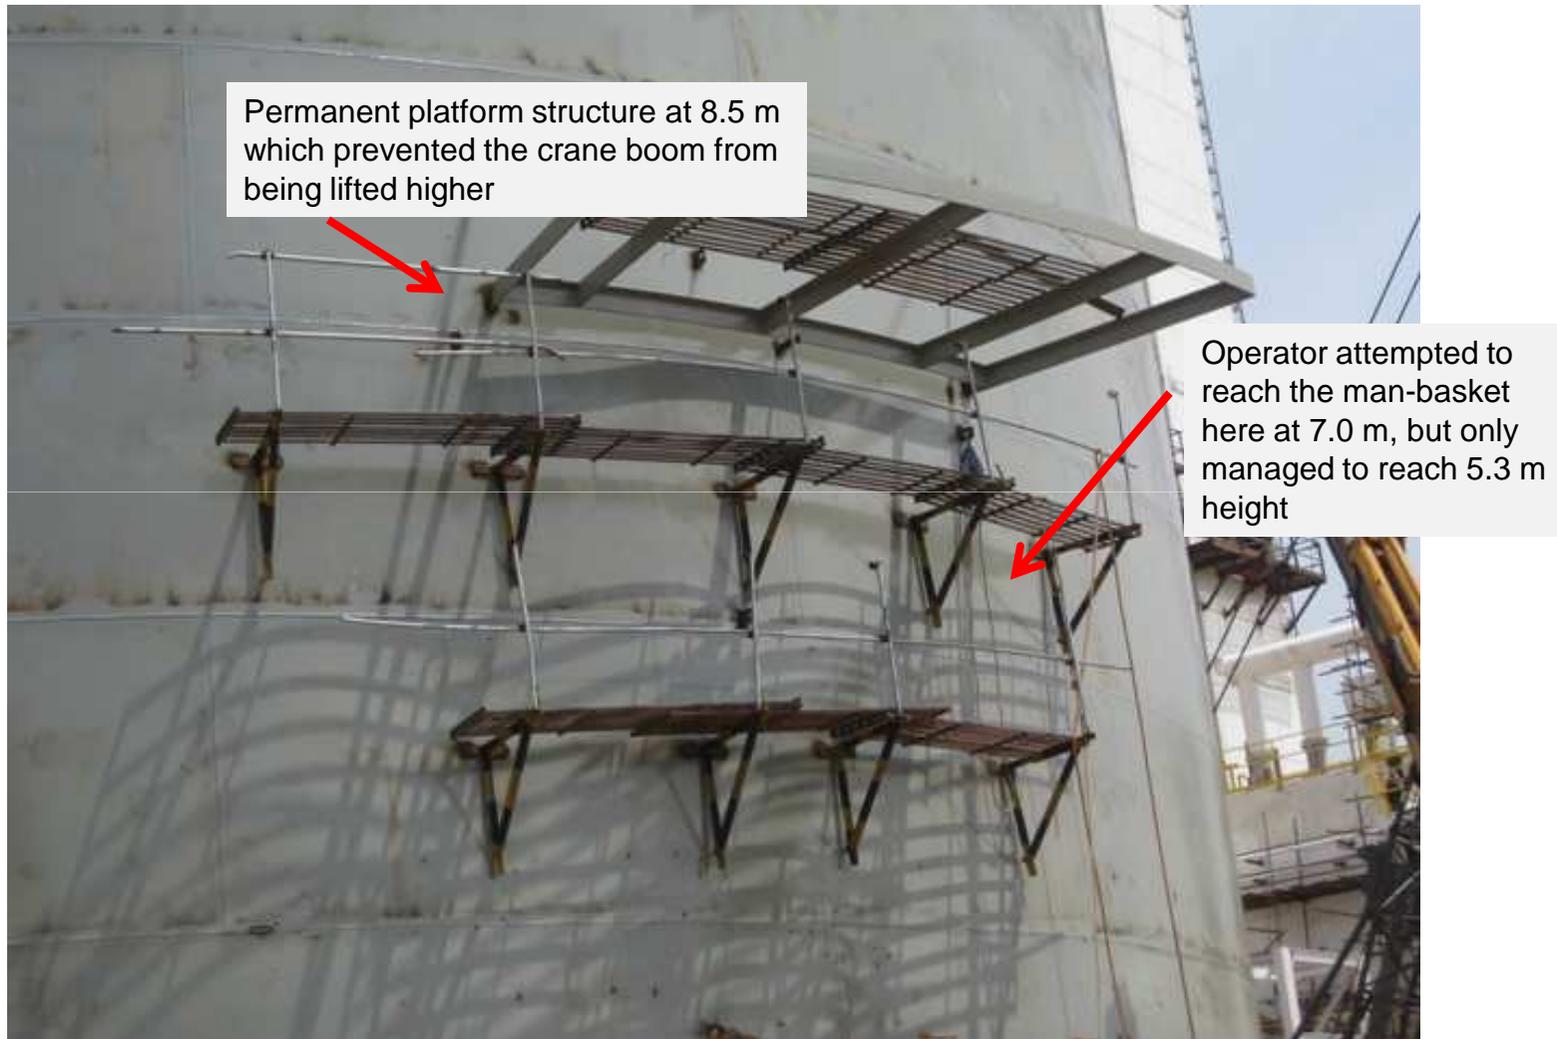
Incident picture showing platforms

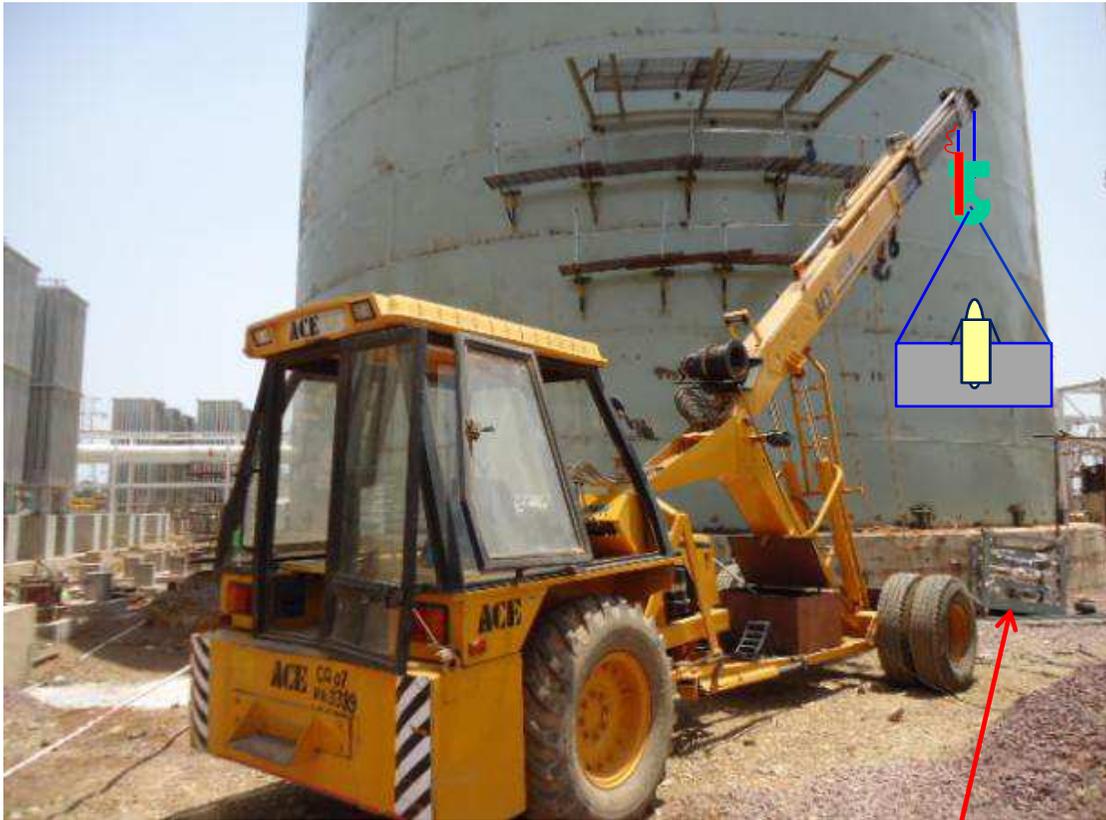
Incident pictures with man-basket (illustration)

Man-basket fell here

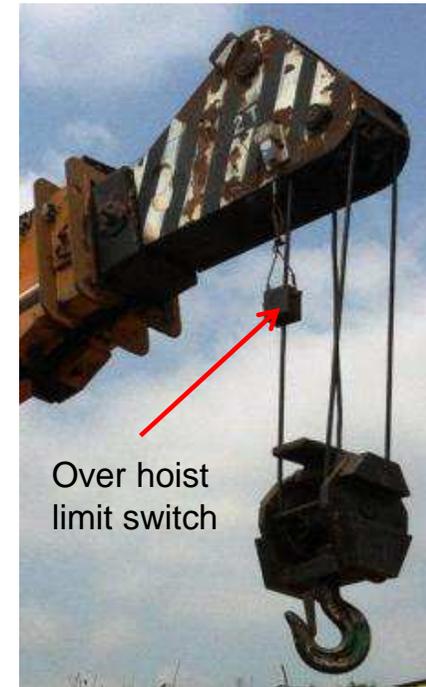
The Hydra crane involved in the accident is considered suitable for the task executed. All safety devices and cable were in good repair.

Over hoist
limit switch

Hook block of a
similar crane

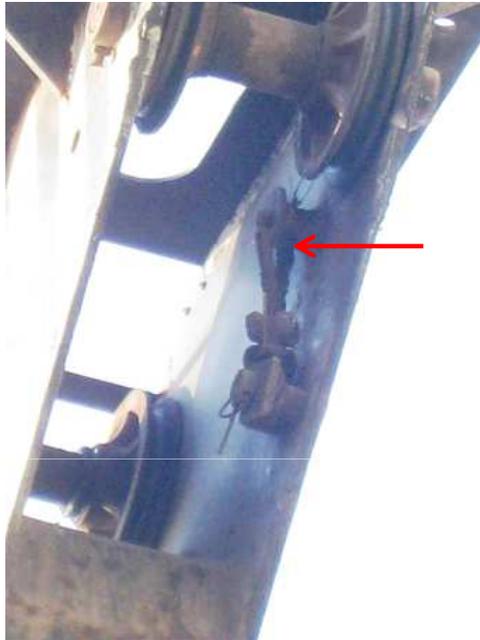
Remaining end of the wire rope at boom's end

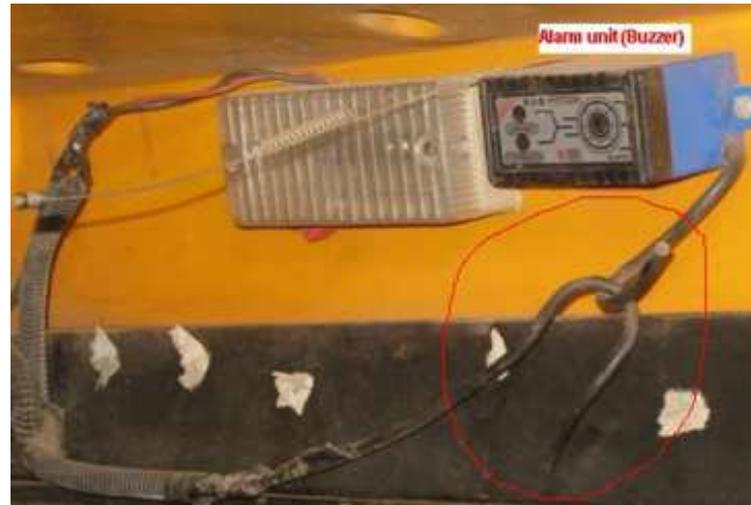
Electrical wire to the alarm was cut

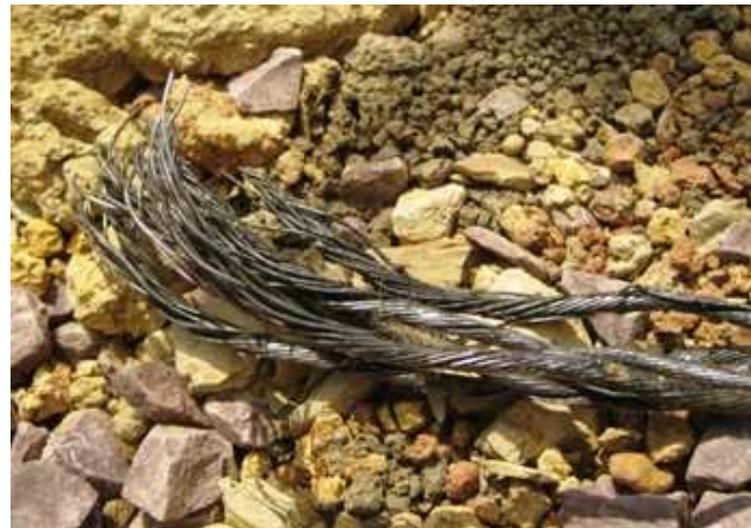
The failed wire rope

- It was found during investigation that the worker attempted to perform a task outside the scope of the assigned Work Permit by reaching at a platform at a 7m level.
- The location could not be reached as the permanent platform structure at 8.5 m level would prevent the boom from further hoisting. The crane operator tried to extend the boom and hoist so that the basket could come close to the far end of the temporary platform.
- However, this activated the over-hoist limit alarm as the hook block came close to the boom. The crane operator decided to disable the audible alarm by cutting the power supply wire. Supervisor was in attendance during the maneuver.
- Further hoisting caused the hook block to press against the boom which led to the failure of the load line due to excess tension and the man basket fell uncontrollably to the ground.

- Removed concerned crane operator and supervisors from site
- Re-assessed safety orientations/operation discipline for contractor's other supervisors at site and replace if required.
- Added one safety supervisor and one field supervisor of contractor to ensure full time supervision for remainder of work.
- Added one safety engineer, one safety watcher and a mechanical construction engineer dedicated to construction project in order to enhance supervision and contractor's safety compliance.
- Conducted a site review /walk about before activities resumed.

- Communicate that any change in work plan, scope or hazard must require work to stop and shall be reviewed by the work permit issuer before restarting.
- Cranes shall undergo re-inspection.
- Highlight lessons to be learned.

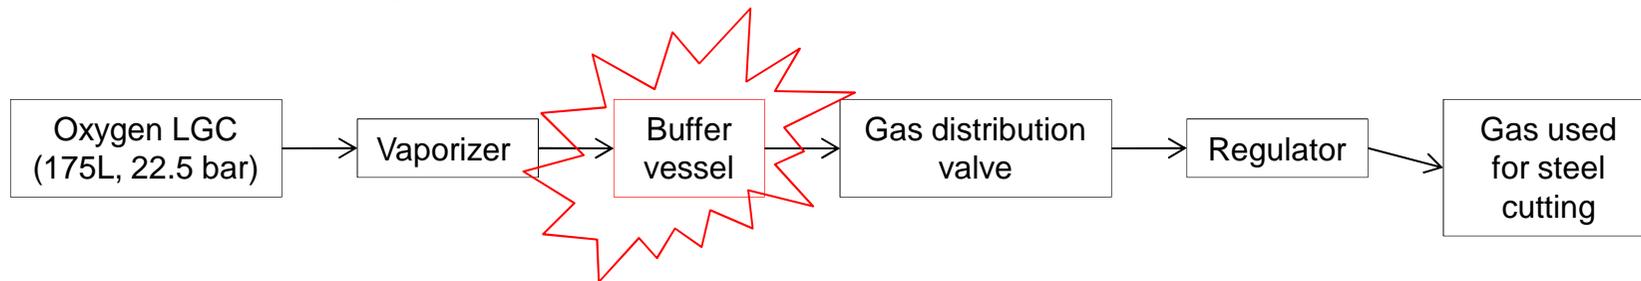
- Vaporizer outlet not installed with thermo relief valve, safety valve or regulator .

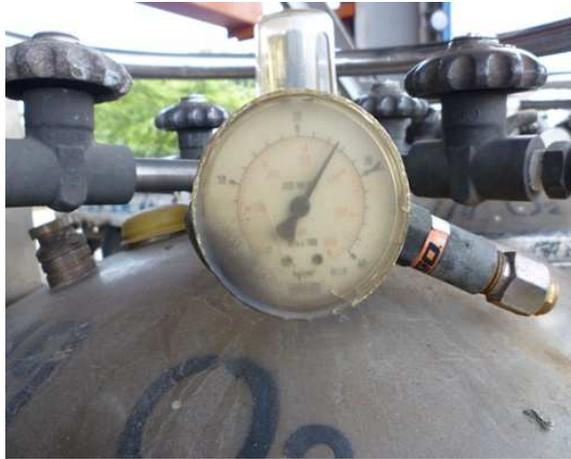
Liquid oxygen supply source (LGC)

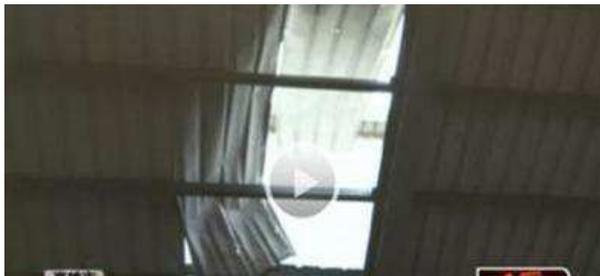
Roof damaged by fragments from ruptured vessel

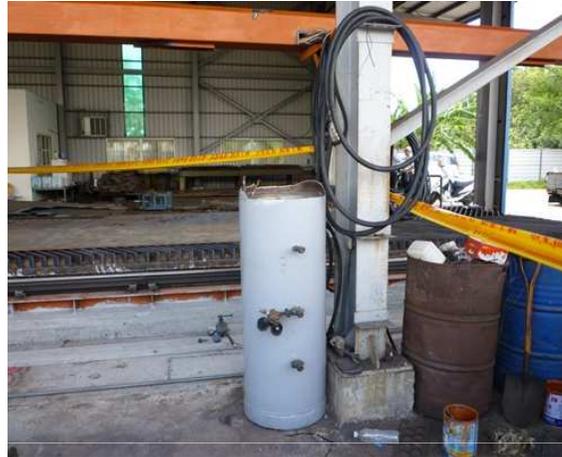
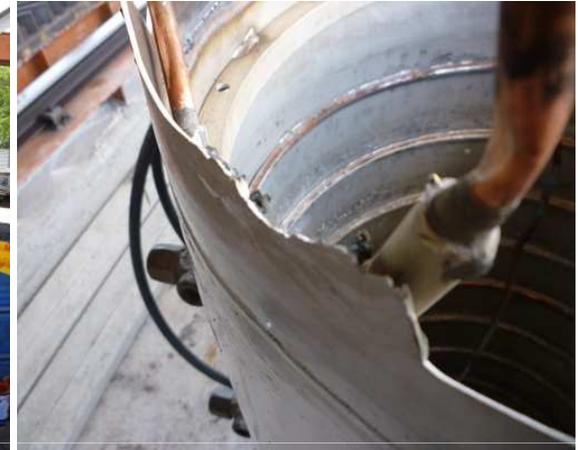
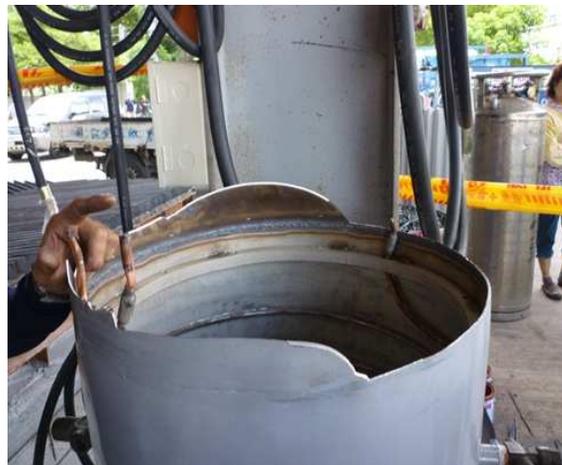
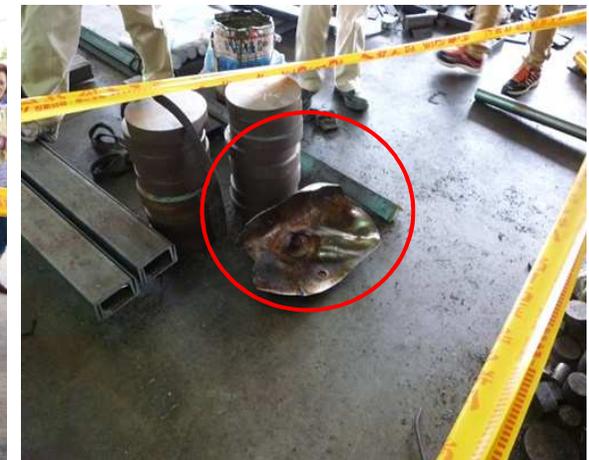
Ruptured buffer vessel viewed from different angles, pictures 1 - 4

- Improper design for buffer vessel
- The buffer vessel was over-pressurized.
- No safety device was installed on the buffer vessel
(Such as pressure relief valve, thermo relief valve or regulator in vaporizer outlet)

- Lack of understanding on the vessel's design requirements for the working pressure.
- No pressure test for buffer vessel after modification was carried out.
- Lack of Risk Management Analysis - Management of Change (MOC) process, Job Hazard Analysis(JHA) and Risk Assessment (RA).

- Design and fabrication of pressure vessels should be carried out only by competent or authorised persons.
- Testing of the gas receiver after fabrication against its proposed designed working pressure was not carried out according to the report when it is a requirement for a pressure vessel.
- Modification made without appropriate Risk Management Analysis
- Contractor and customers should follow proper codes of practice or design standards for oxygen gas system.
