Training Package TP 19/16

Recent (2015) Incidents in the Gases Industry in Asia

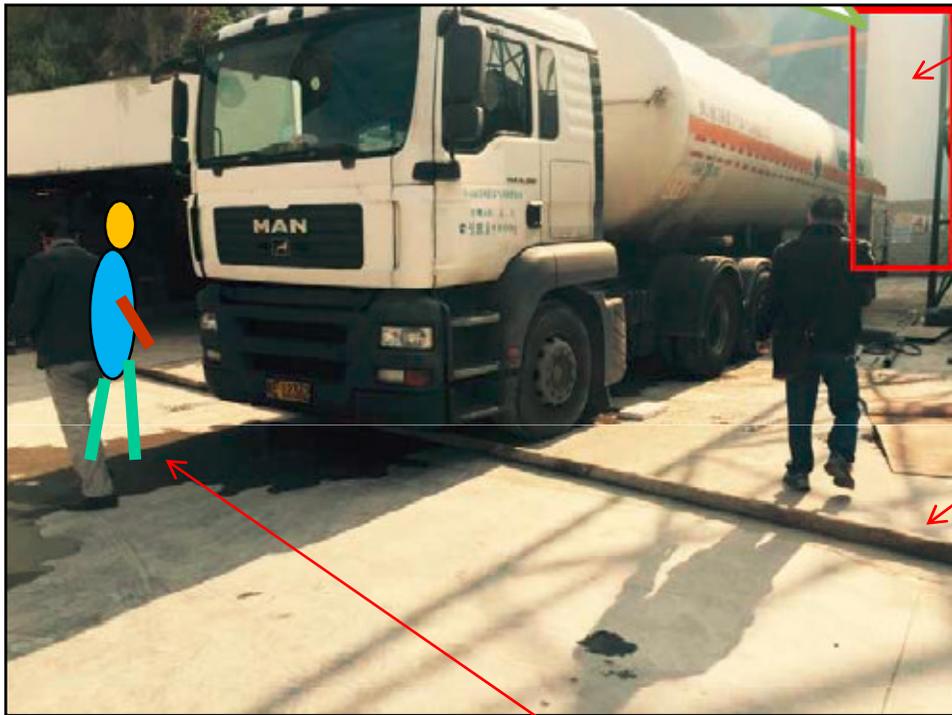
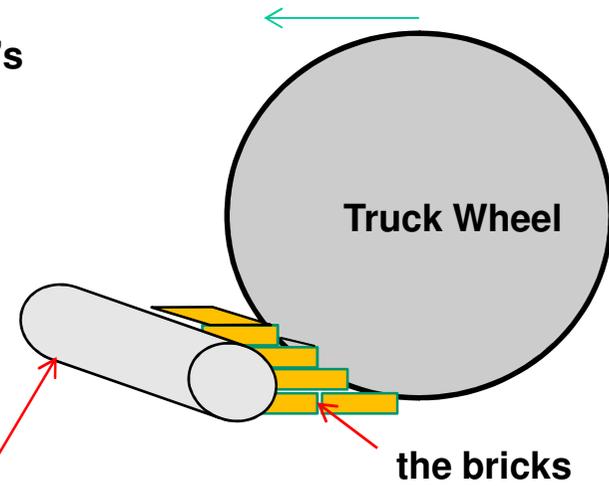
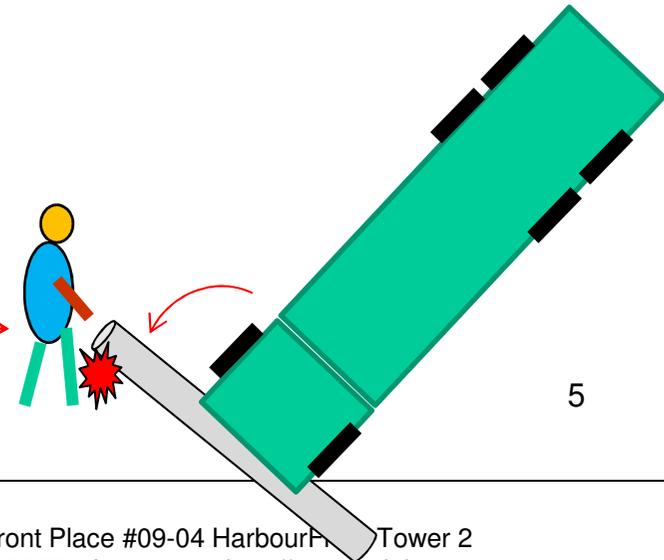
- In the morning, a tanker was delivering LOX to a customer. After the unloading was finished, the tanker left the site to get weighing done. The customer site was under construction and a 6 Meter-DN 80 steel pipe crossed on the road. The driver took several bricks to make a slope and tried to bridge the pipe. The helper stood at the right-front of the tanker to guide the movement. The bricks couldn't bear the weight of the tractor, and collapsed. The pipe shot toward the helper, and hit the helper on the right leg causing lost time injury (multiple fracture requiring corrective surgery).
- Low level of safety consciousness exhibited by both the driver and helper .

Customer's
LOX tank

the pipe

the bricks

the helper's
location

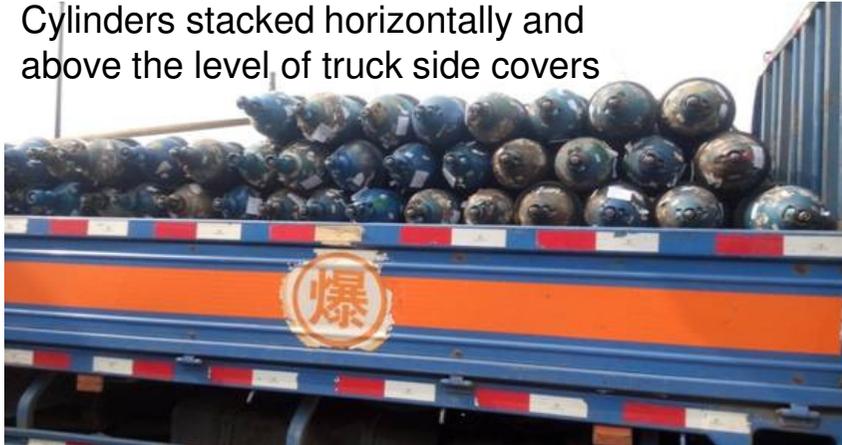
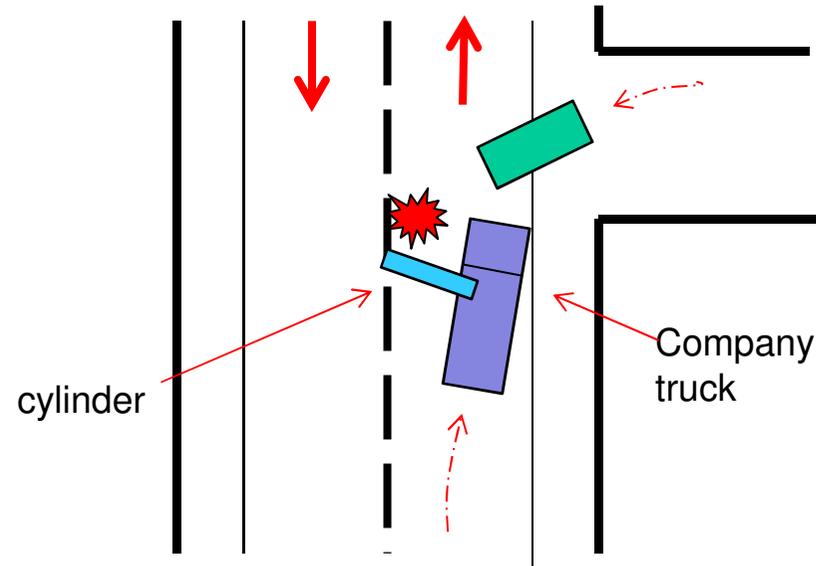
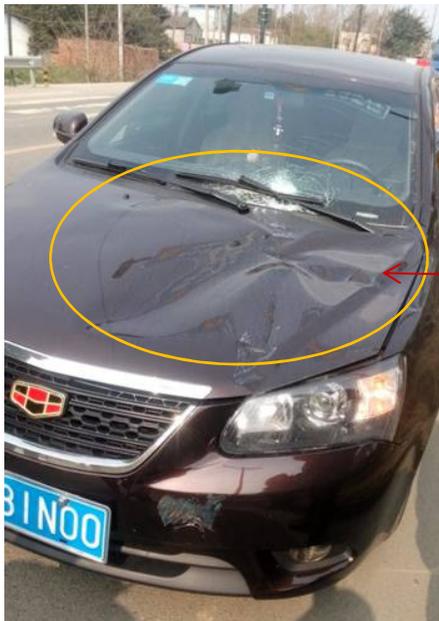
- Around noon of Feb 5, a cylinder fell off from a transport truck to the ground and jumped on to the engine cover of a moving car causing damage to the car. At that time of the event the car was rushing into the main street from a side lane and tried to turn left. On seeing this, the truck driver applied an emergency brake and turned a little towards right. In the event, one of the cylinders slid from the truck and hit the car.
- The cylinders were not held or secured properly.
- No one was injured in the incident.

Cylinders stacked horizontally and above the level of truck side covers

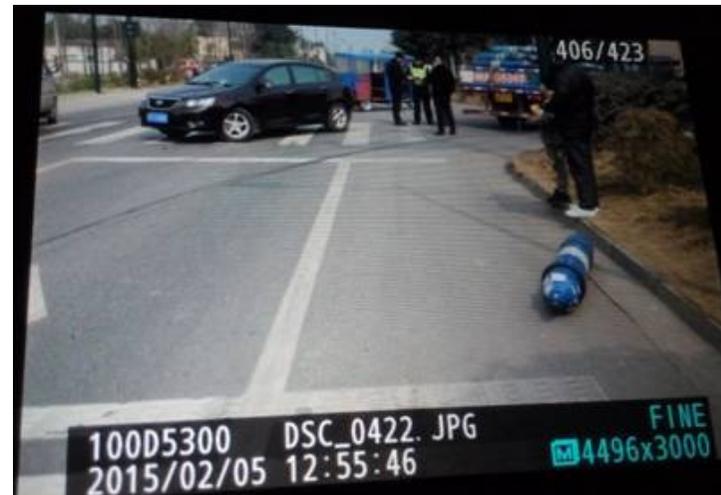
Damage to the car

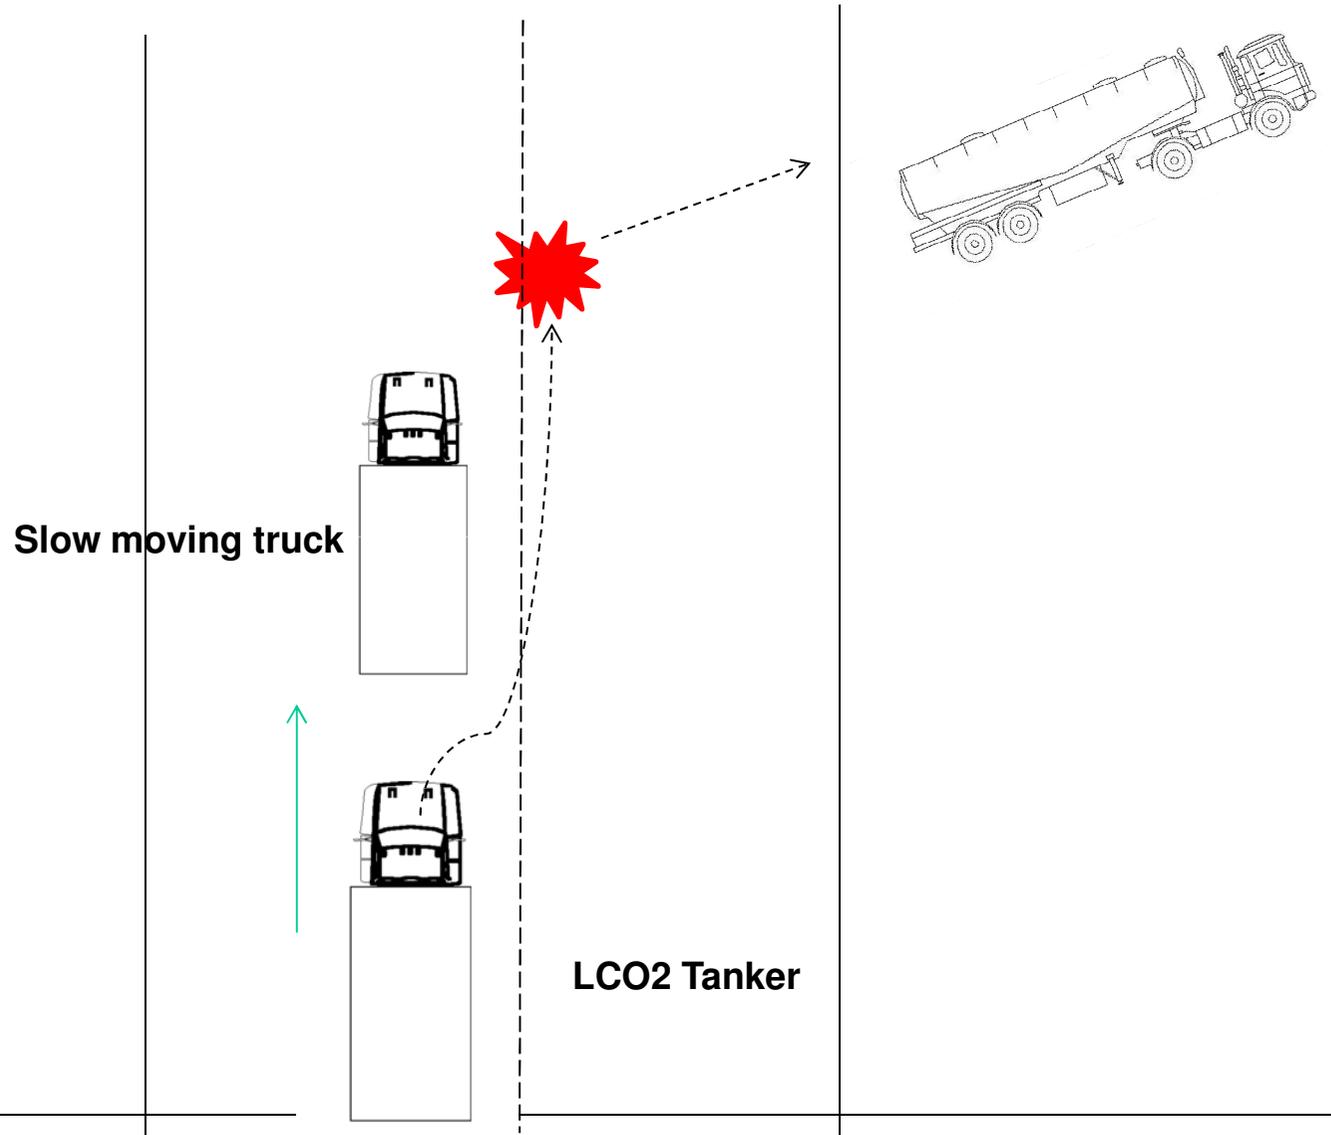
- A contractor driver was driving a road tanker carrying 16 tons of LCO₂. He was travelling on a national highway towards a customer when the road tanker encountered a slow moving truck in front of him, on a straight stretch of road. The driver attempted to overtake the slow moving truck, but during overtaking, the front left tyre burst. The driver lost control of the tanker and it overturned on its right side.
- The contractor driver suffered head and neck injuries, died at the scene. It is believed that the driver did not strap on seat belt.
- The prime mover and tank were badly damaged.

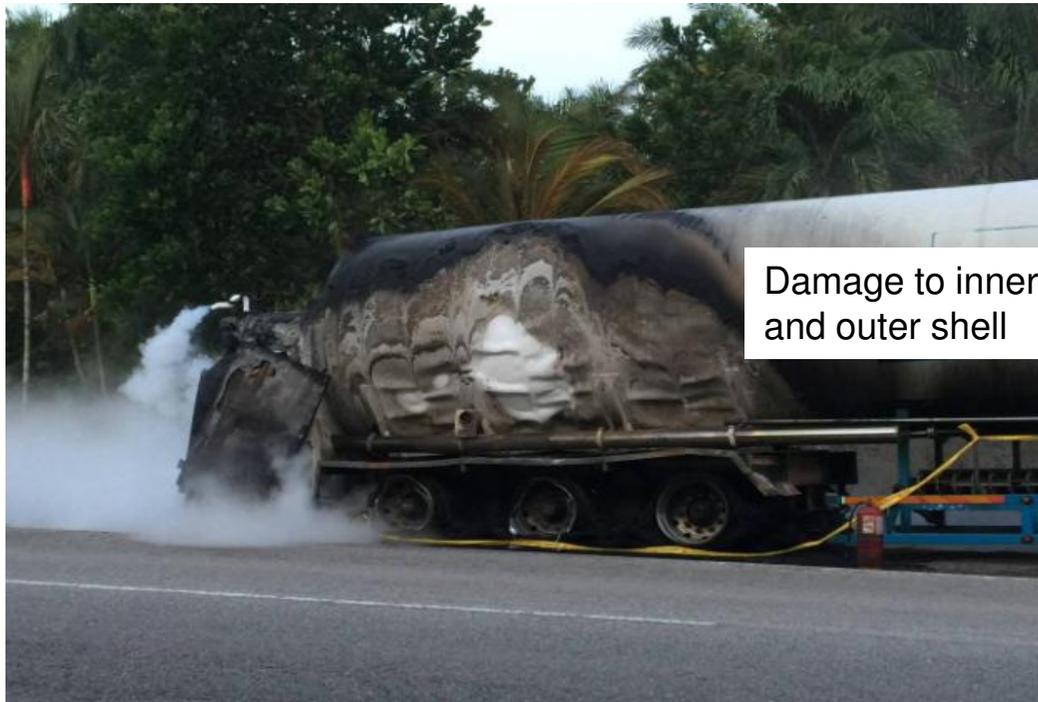
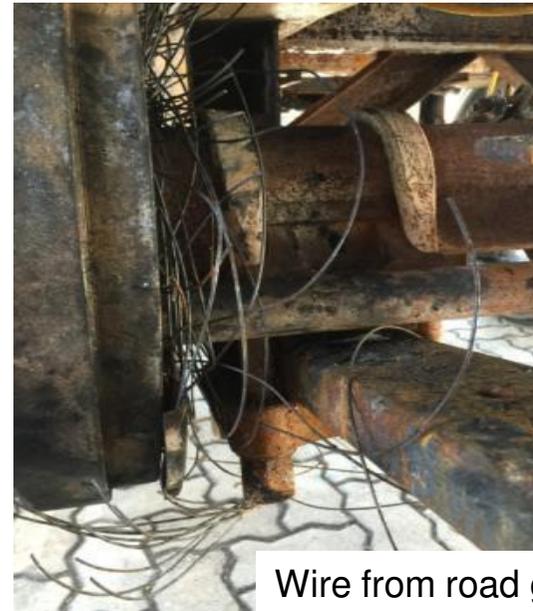
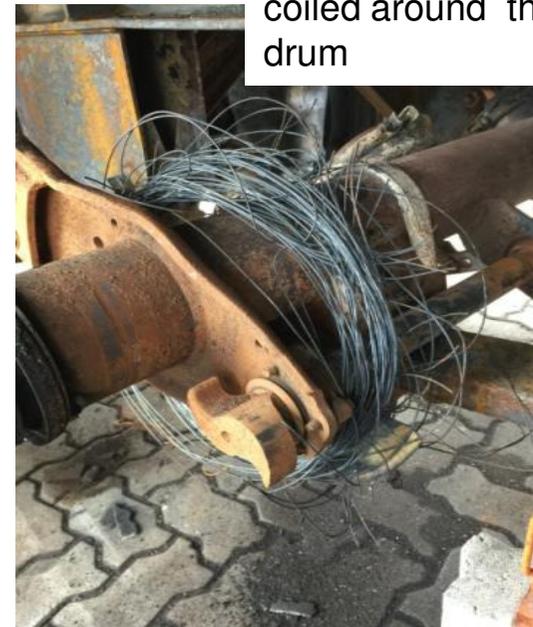
- On way to deliver liquid nitrogen, driver of a trailer heard an explosion sound and found that the left side third rear axles' tyres have caught fire. He tried to put out the fire using on board fire extinguisher but was unsuccessful. He then contacted local Fire and Rescue Department and also lowered the trailer's landing gear and detached the prime mover. Local Fire & Rescue team arrived within 30 minutes and managed to extinguish the fire. Due to the fire spreading to the tanker and the gas panel cabin, outer vessel was damaged including loss of vacuum. This caused the LIN inside the tanker to be heated and pressurized, resulting in tanker safety valve blowing & bursting disc rupture. Eventually a dense cloud formed around the tanker.

- A detailed investigation showed that the coiled wires found inside the left brake drum probably activated the brake. This caused the tire to heat up and explode before catching fire. No injury was reported from this incident.

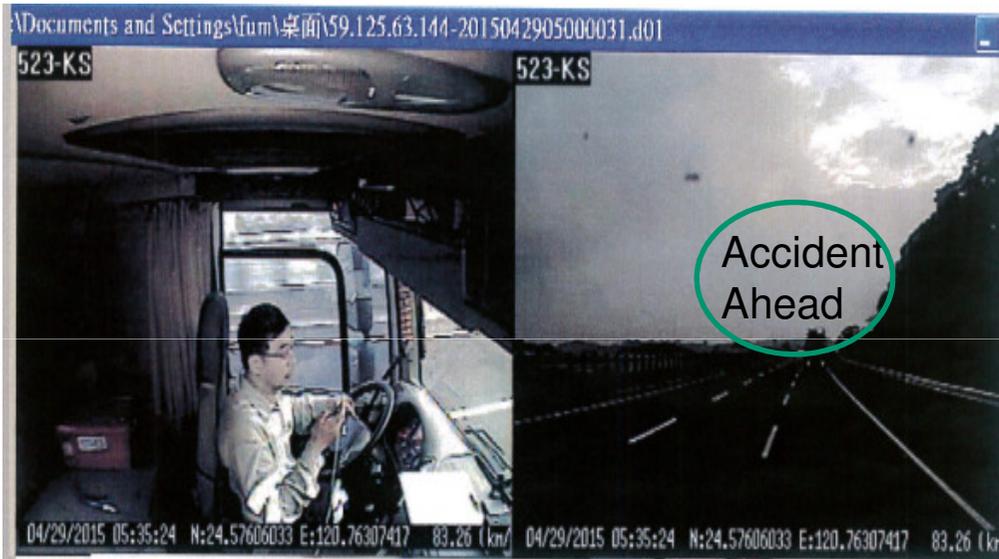
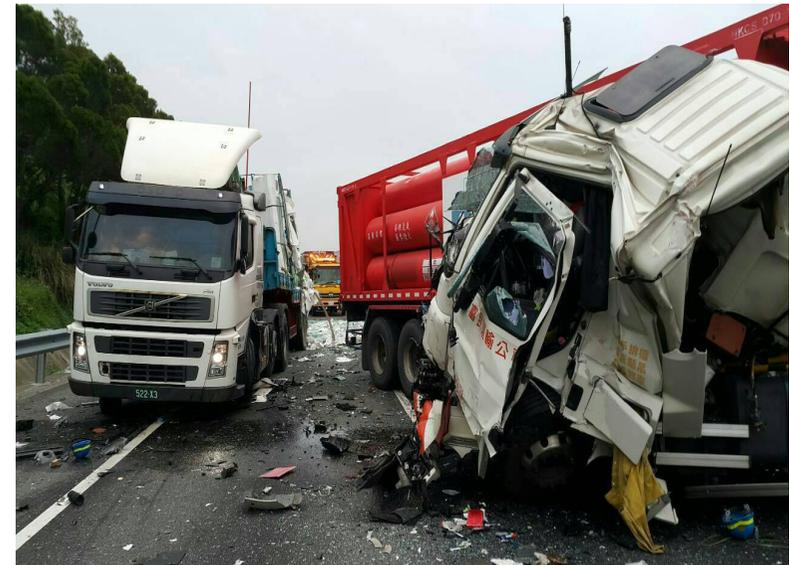
- A driver was on the highway on his way to deliver a full H2 tube trailer to a customer. There was another accident ahead of him (vehicle in fire) but he did not maintain safe distance. The in cab camera showed he was looking at his mobile phone just few seconds before the accident. The driver cabin hit a large trailer in front, causing a domino effect to hit other 2 vehicles in front. The driver cabin of the H2 tube trailer was smashed severely. However, the driver escaped with only small injury to his head, hands and leg.
- Lack of attention on road while driving and driver fatigue were found to be the main reasons for the accident.

Video showed driver was looking at Mobile Phone

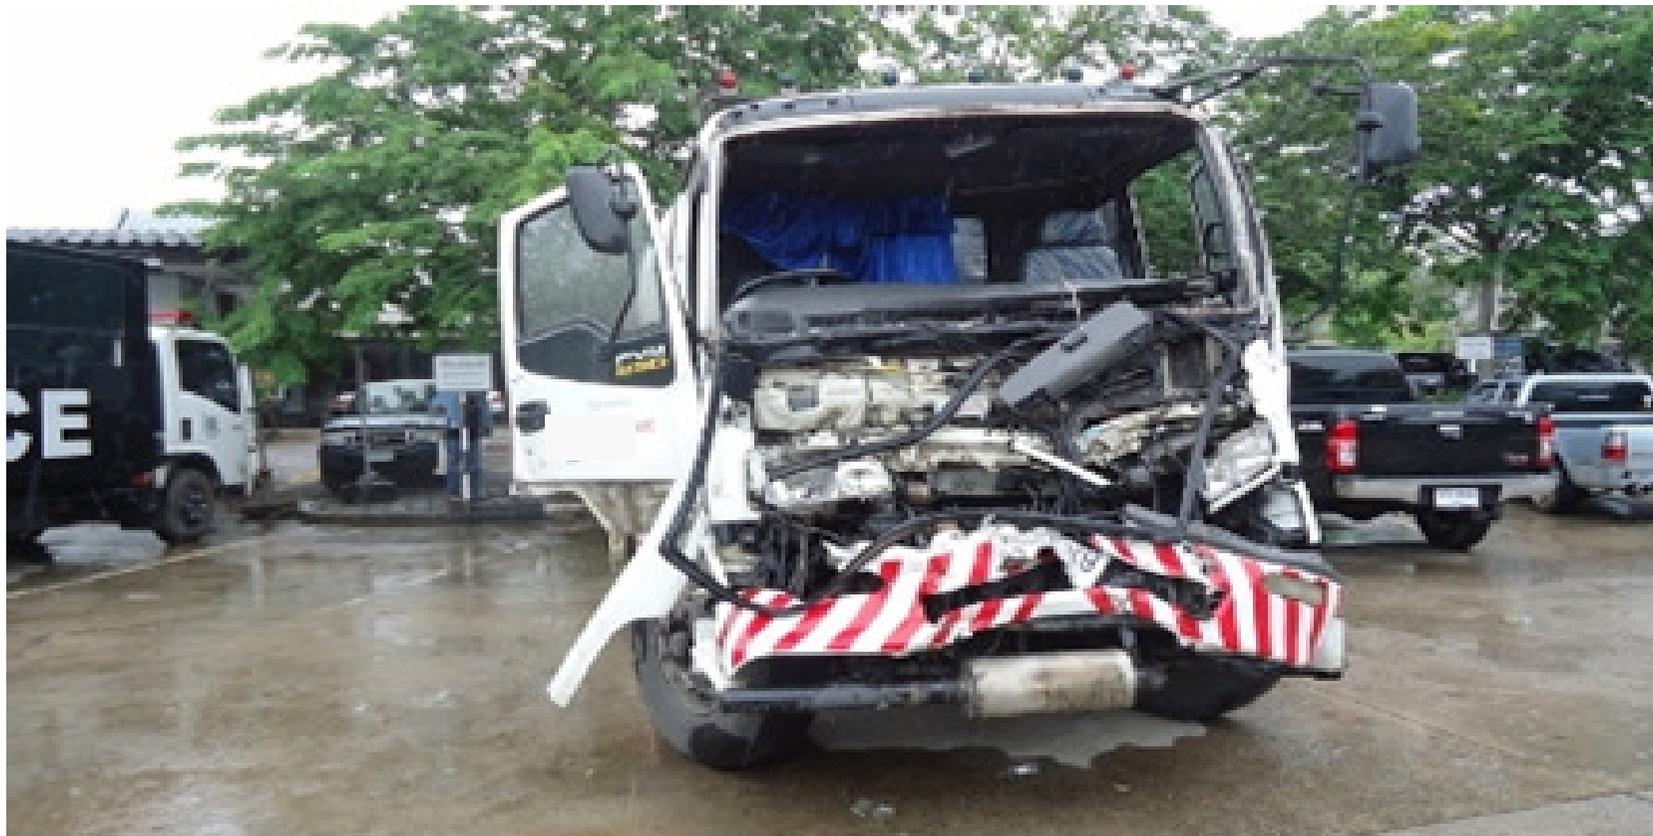
- On his way to deliver product at a hospital, a LOX trailer hit another truck which was stopped in front at a road junction. LOX trailer driver received multiple injuries. His rib was cracked and his left hand was injured requiring 16 stitches. The driver (his left leg) was stuck in the truck cabin for 30 min. His co-driver and 3rd party truck driver received no injury.
- Investigation revealed that the driver felt fatigue before the accident but didn't stop the vehicle.

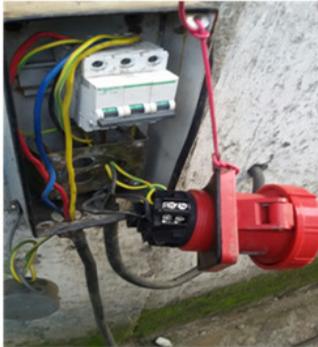
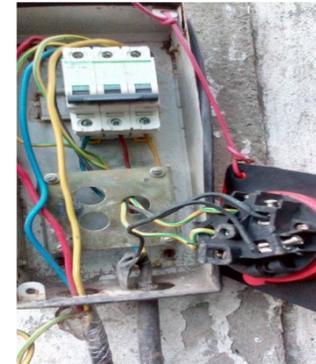
Customer Electrical Panel

- The accident happened at customer site when a tractor trailer was getting prepared for product delivery. The contractor driver was electrocuted thereby suffering a fatal injury.
- Investigation team identified wrong wiring at female and male sockets (male socket altered by some other customer) which caused the tanker pump body and piping system to be electrically energised.
- Driver was informed of the abnormal condition but decided to continue with his activities.

- Temporary connection
- No “Ground” connection
- No “Ground Fault Circuit Interrupter
- “Phase” wire interchanged with “Neutral” connection

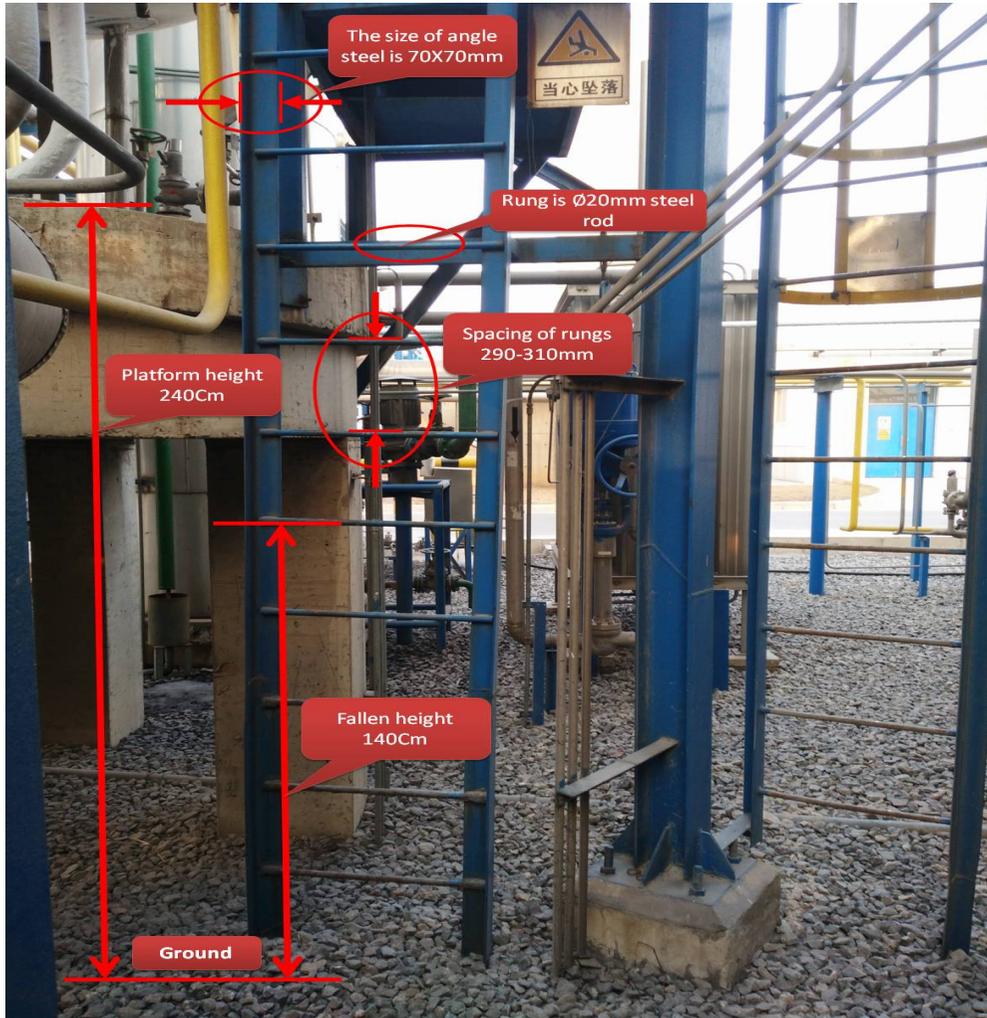
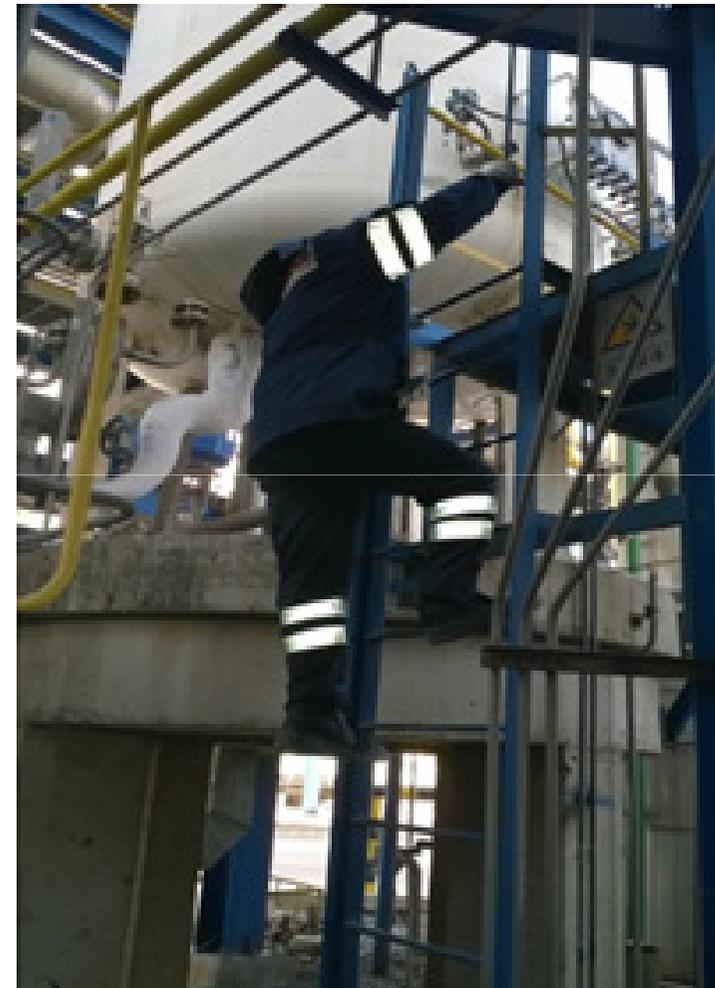
- After finishing the maintenance of a valve which belongs to LIN liquid buffer system, the chief operator went to site to restore the manual valve. While going down the ladder, he fell down to the ground from about one-meter high and injured his left heel. At a local hospital X ray photo showed that the bone of his left heel was slightly fractured and he had to stay in hospital for further treatment (Lost Time Injury).
- Ladder design had shortcoming as the rung was too slippery with diameter only 20 mm.
- Lack of operator concentration while doing the work also contributed to the cause of the accident.

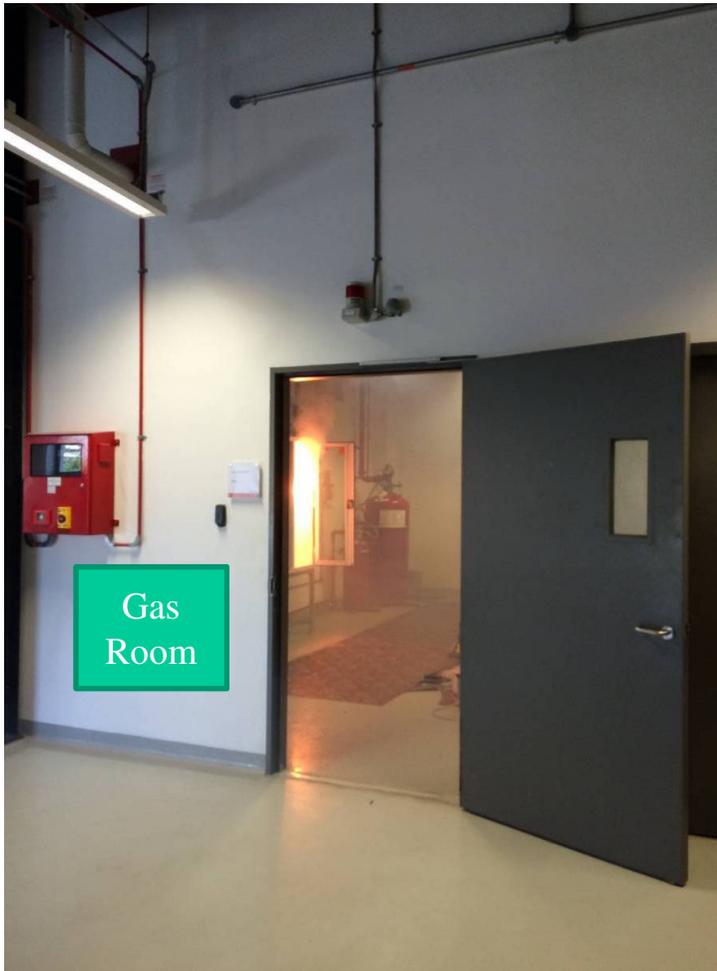
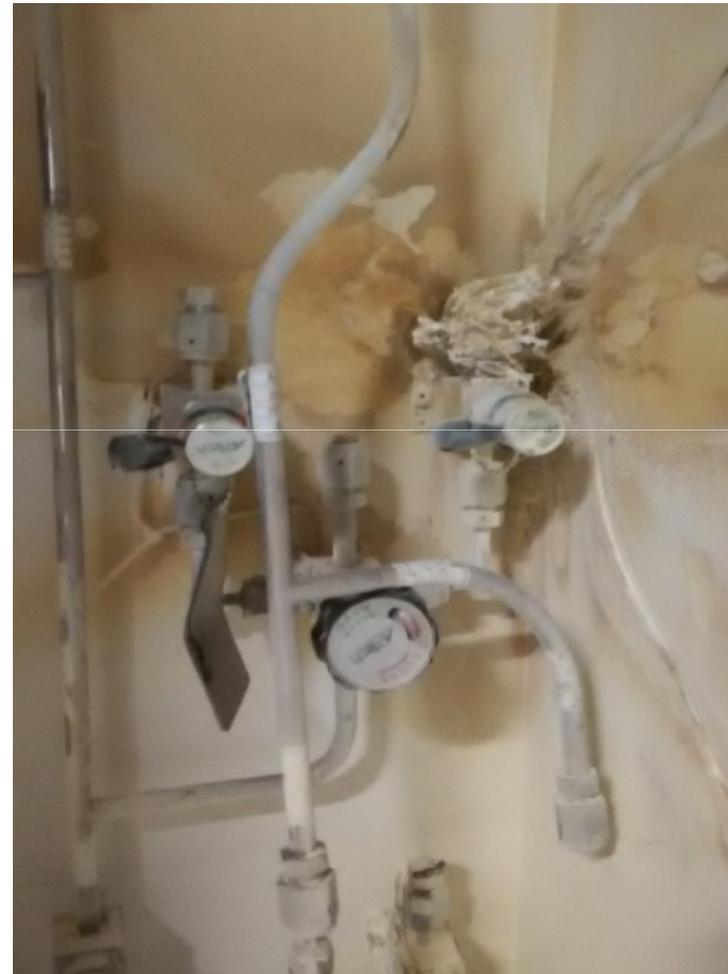
- Silane tie in activity was carried out at a Feed In Box (FIB) in a customer gas room when the fire incident occurred. The tie in work began after getting confirmation from the customer. The contractor wore the full PPE (fire retardant suit, face shield and fire gloves) and was supervised by the industrial gas company Project Engineer. After receiving confirmation that two isolation valves are closed and LOTO applied, the team proceeded to loosen the VCR (vacuum coupling radiation) cap of the spare isolation valve of the FIB. Upon cracking open the VCR cap, there was an immediate “pop” with uncontrolled release of Silane from the FIB. Immediately a fire broke out at the FIB, as Silane is a pyrophoric gas.

- Miscommunication with customer and lack of anticipation & risk assessment were observed to be the main reasons behind the event.

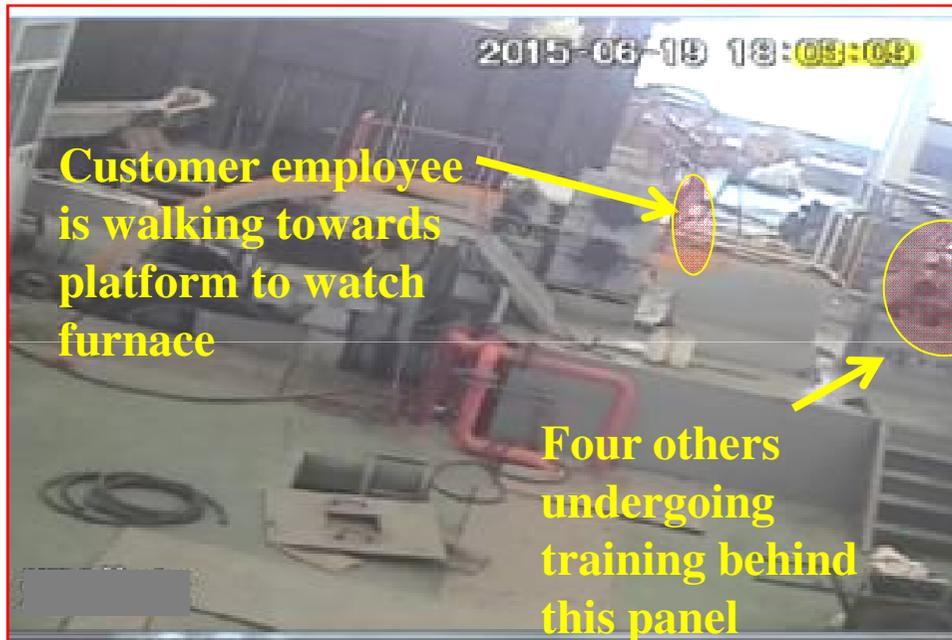
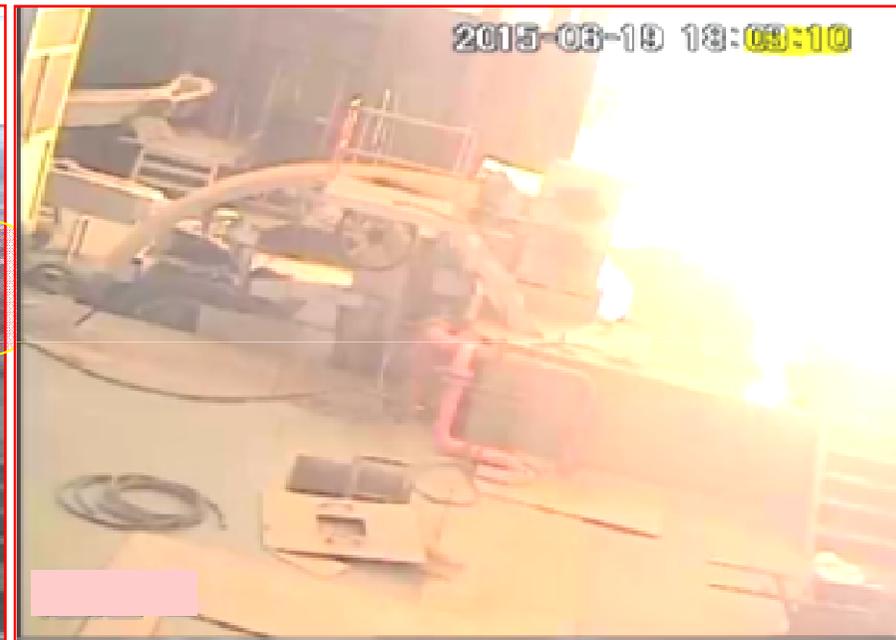
- Flame released from an Oxy- combustion skid caused burn injuries to the employee of an industrial gases company and 4 of the customer employees. This happened when Hydrocarbon based solvent was introduced upstream (by customer) into the oxygen skid that resulted in rapid combustion followed by fire, while the skid was being commissioned. At the time of the event the Engineer from the industrial gas company was providing training to 3 customer techs who were standing in front of a panel. This panel blocked the direct impact to the employees; otherwise their injuries would have been much more serious. Another engineer from the industrial gas company, reacted quickly to the incident and shut off O2 supply preventing further damage.

- Cleaning method deployed by the customer was found to be inappropriate and proper cleaning procedure was also not provided to customer. Flammable solvent was used by the customer in oxygen line for degreasing purpose. Verification of adequate cleaning was also not ensured before commissioning.

Skid condition and people nearby immediately before the fire

Scene at the time of fire

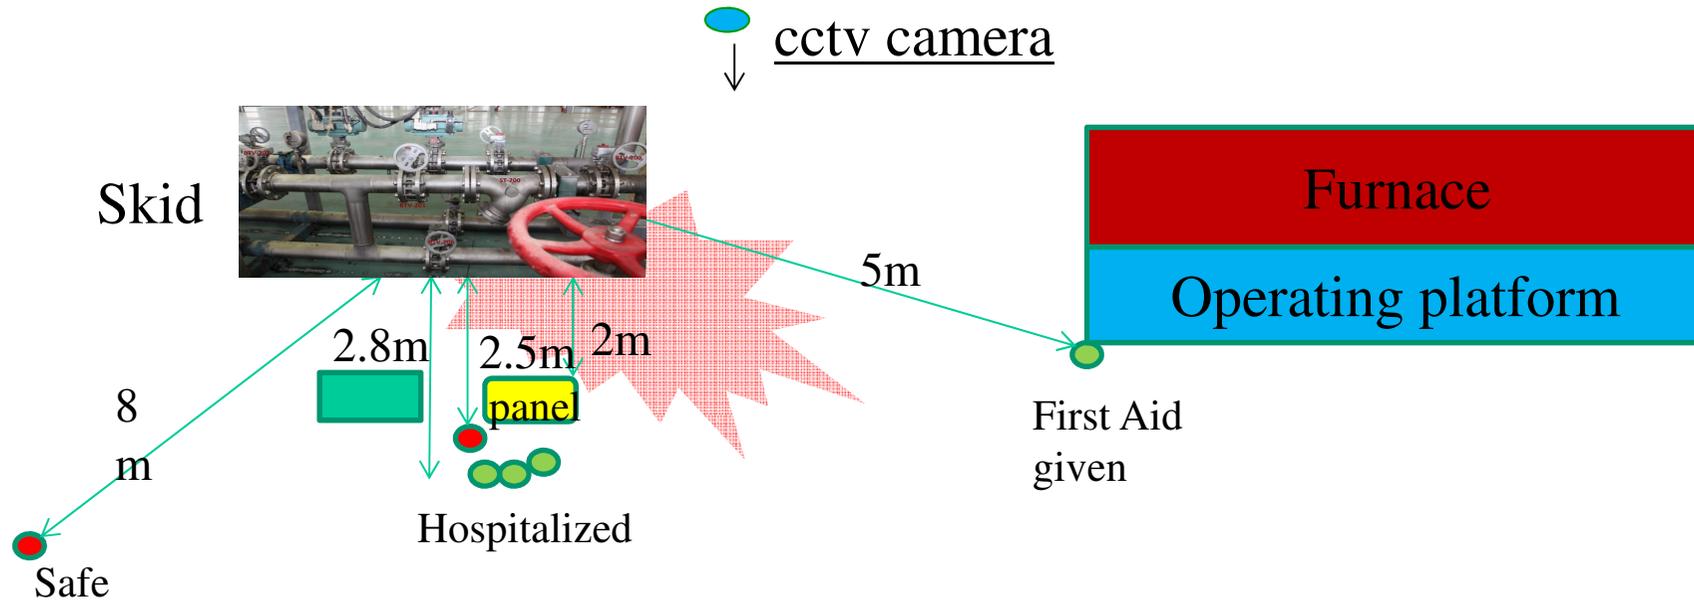
Fire Impact Scene with location of people

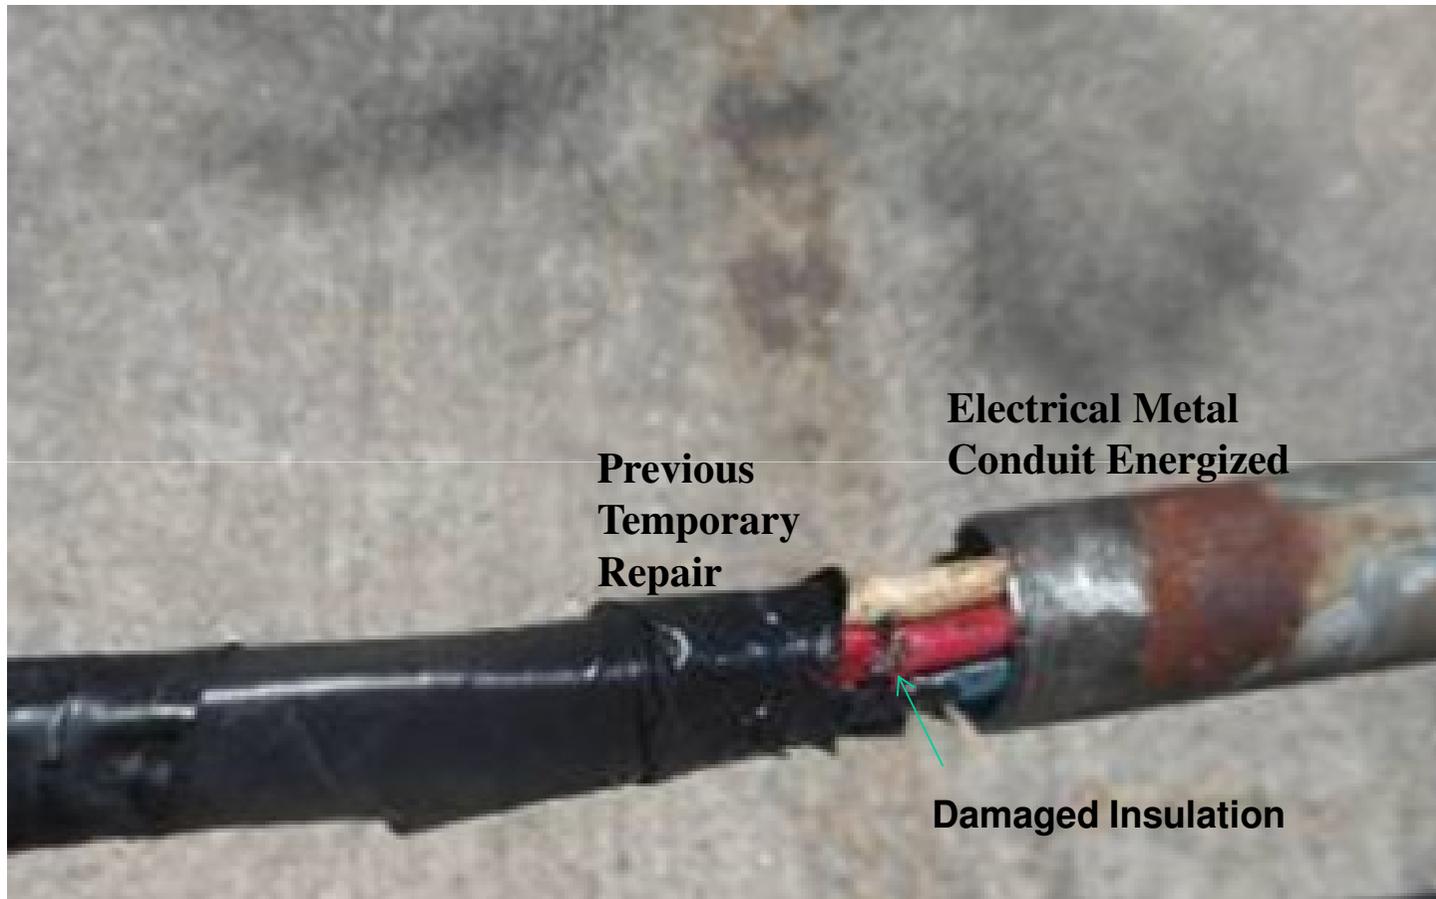
- Contractor fatal electrocution happened whilst installing water pipe. The contractor was installing a polyethylene water pipe and was electrocuted whilst removing an electrical conduit to facilitate fitting of pipe supports. He became unconscious and was given cardiopulmonary resuscitation before being taken to hospital for treatment. He passed away from the injury few days later.
- Lack of personal responsibility for completion/follow up on previous temporary repair jobs
- Permit to Work(PTW) issuer and acceptor unaware of potential electrical hazard and underperformed the electrical isolation (no authorization).
- Failure of Management of Change(MOC) Compliance was also observed.

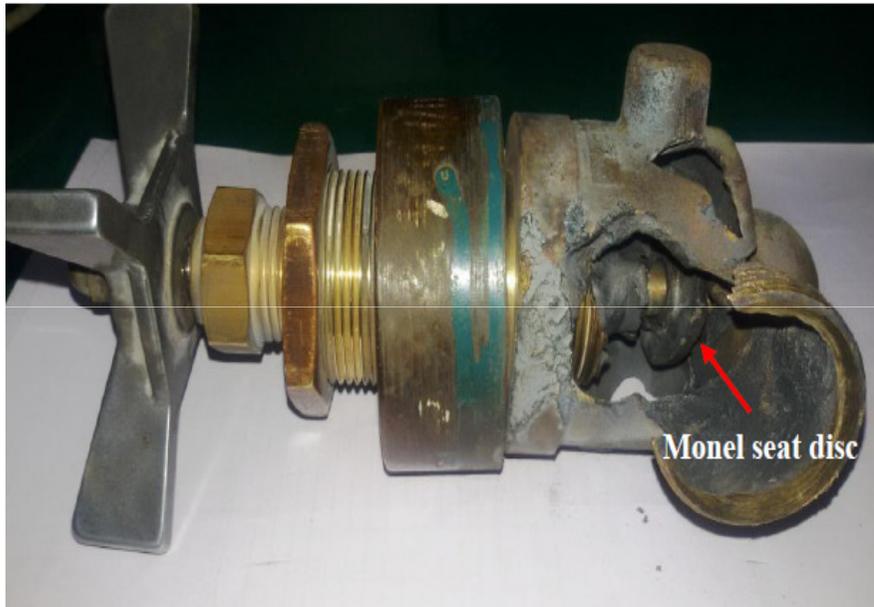
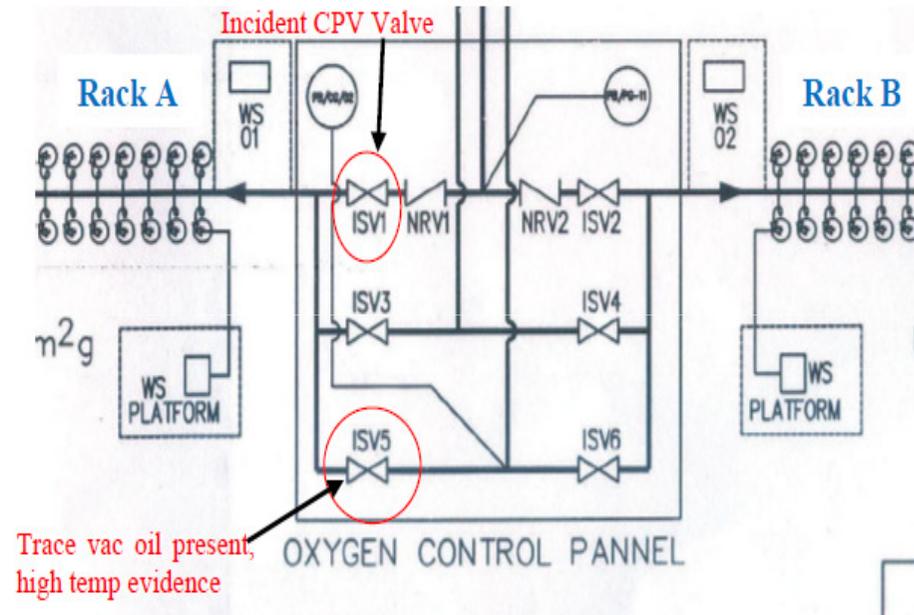
- Process Safety Incident involving energy release happened during rack change over at medical oxygen filling system. A fire occurred at the back of inlet valve (CPV) located on manifold panel which was being opened to change over. Some maintenance followed by degreasing was done on the valve two days back to correct passing of the valve.
- O2 Cleaning procedure was not strictly adhered to during the prior maintenance event.
- Laboratory analysis of the damaged parts from the valve revealed that Aluminium content present in isolation valves was higher than the allowable limits for use in high pressure oxygen system.
