SAFETY BULLETIN 05/10

ASIA INDUSTRIAL GASES ASSOCIATION

Recent cases of asphyxiation in confined spaces in Asia

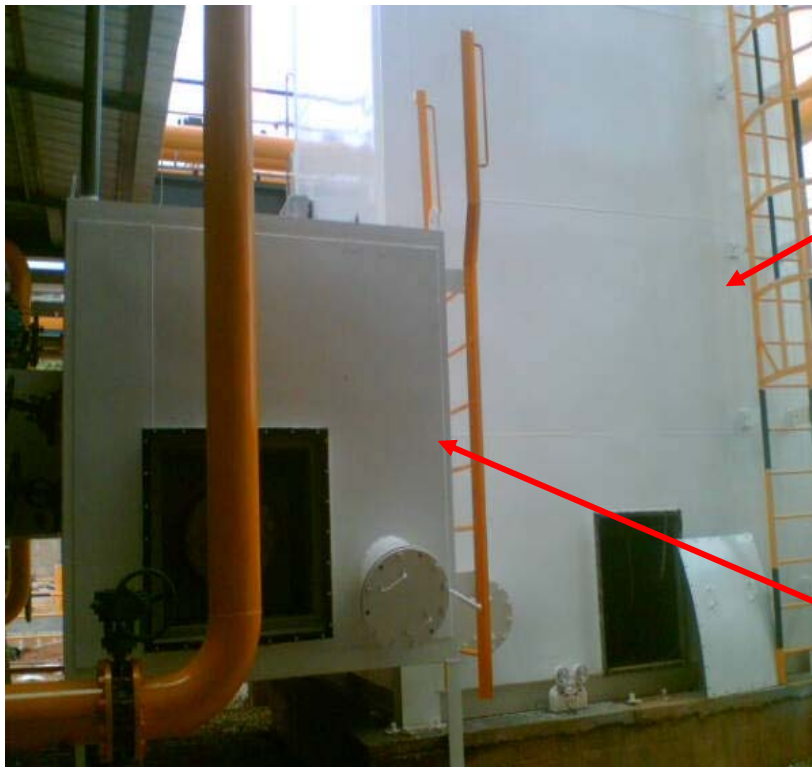
Interconnecting
duct to turbine unit
where engineer
was found dead

Engineer was found dead in the interconnecting duct between the ASU column and the turbine expander while carrying out a leak check on the piping works and equipment in the enclosure. The plant was undergoing cold test. Engineer was from Operations and was working with the engineering

- Safe systems of work are required at all times.
- Confined space entry permits should be used for all vessel/enclosure entries.
- Avoid the use of nitrogen for pressure testing/purging/flushing unless under very specific and exceptional circumstances. Strict authorization requiring specific hazard controls has to be put in place before the use of nitrogen (or any inert gas) for such purposes is sanctioned. Hazardous Work Permit/Confined Space Entry system should be enforced. This appears to be lacking during the construction phase and also during the construction-commissioning interface.

- Gas check, personal atmospheric monitors are required when entry is necessary into enclosures where nitrogen is used or could become present inside the system.

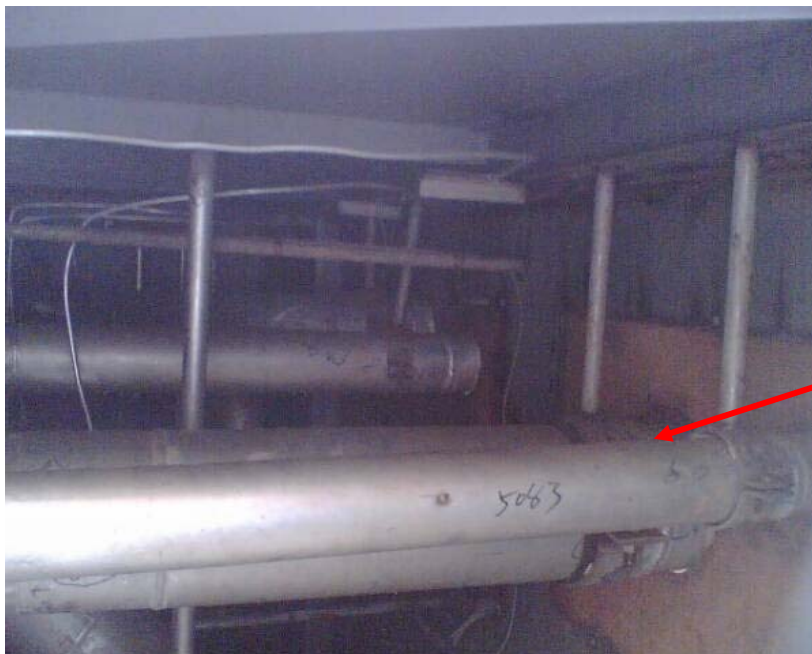
Piping in the
interconnecting
section
