Training Package TP 22/17

Recent (2016) Accidents/Incidents in the Gases Industry in Asia

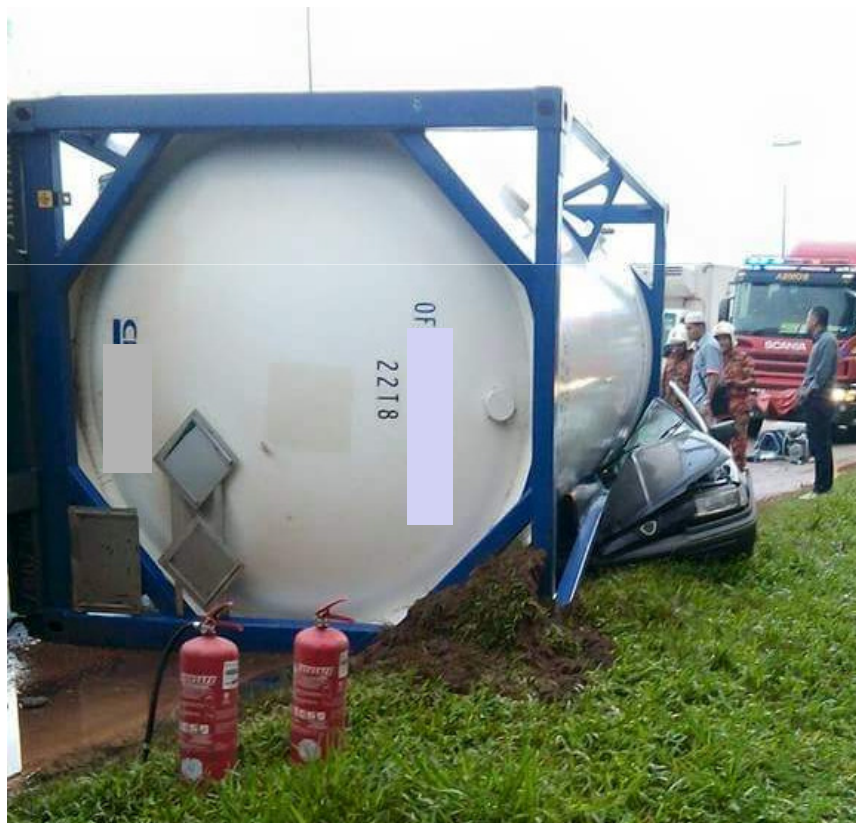
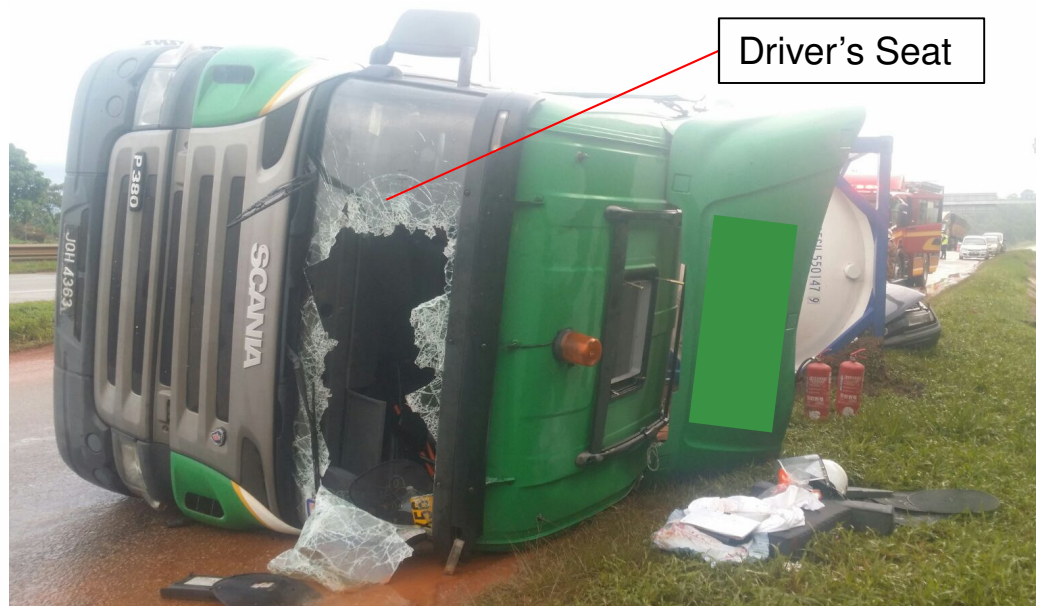
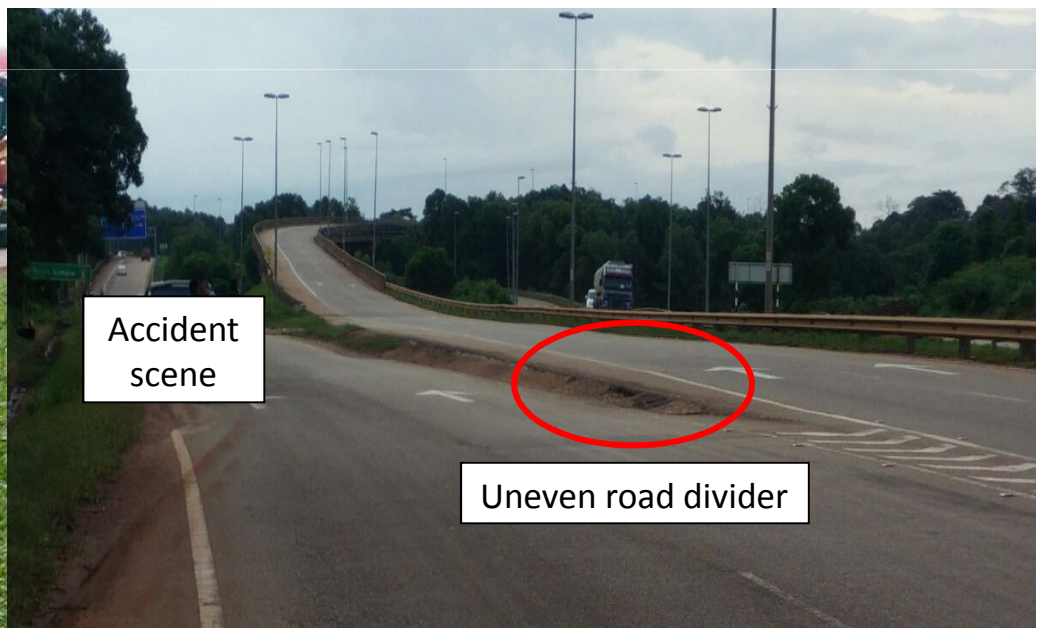
Event #1 Pictures

LIN ISO tanker - roll over

Consequence: 2 Fatalities (contractor truck driver & 3rd party car driver)

At 6:00 am, a full LIN ISO tanker was moving on a straight and wet road when the driver was forced to move right to avoid a slow moving car moving right to avoid a water pool on the road. Doing so, the truck drove its right wheels over an uneven road divider, causing it to go off-balanced, rolled over and crushed the private car it was overtaking. The private car driver died on the scene. The contractor driver was badly injured (neck backbone dislocation) mainly because he was not wearing his seat-belt and passed away 5 days later due to his injuries. The rollover happened at an estimated speed of 40 to 45 km/h.

- Lack of Defensive Driving
- Not wearing seat belt

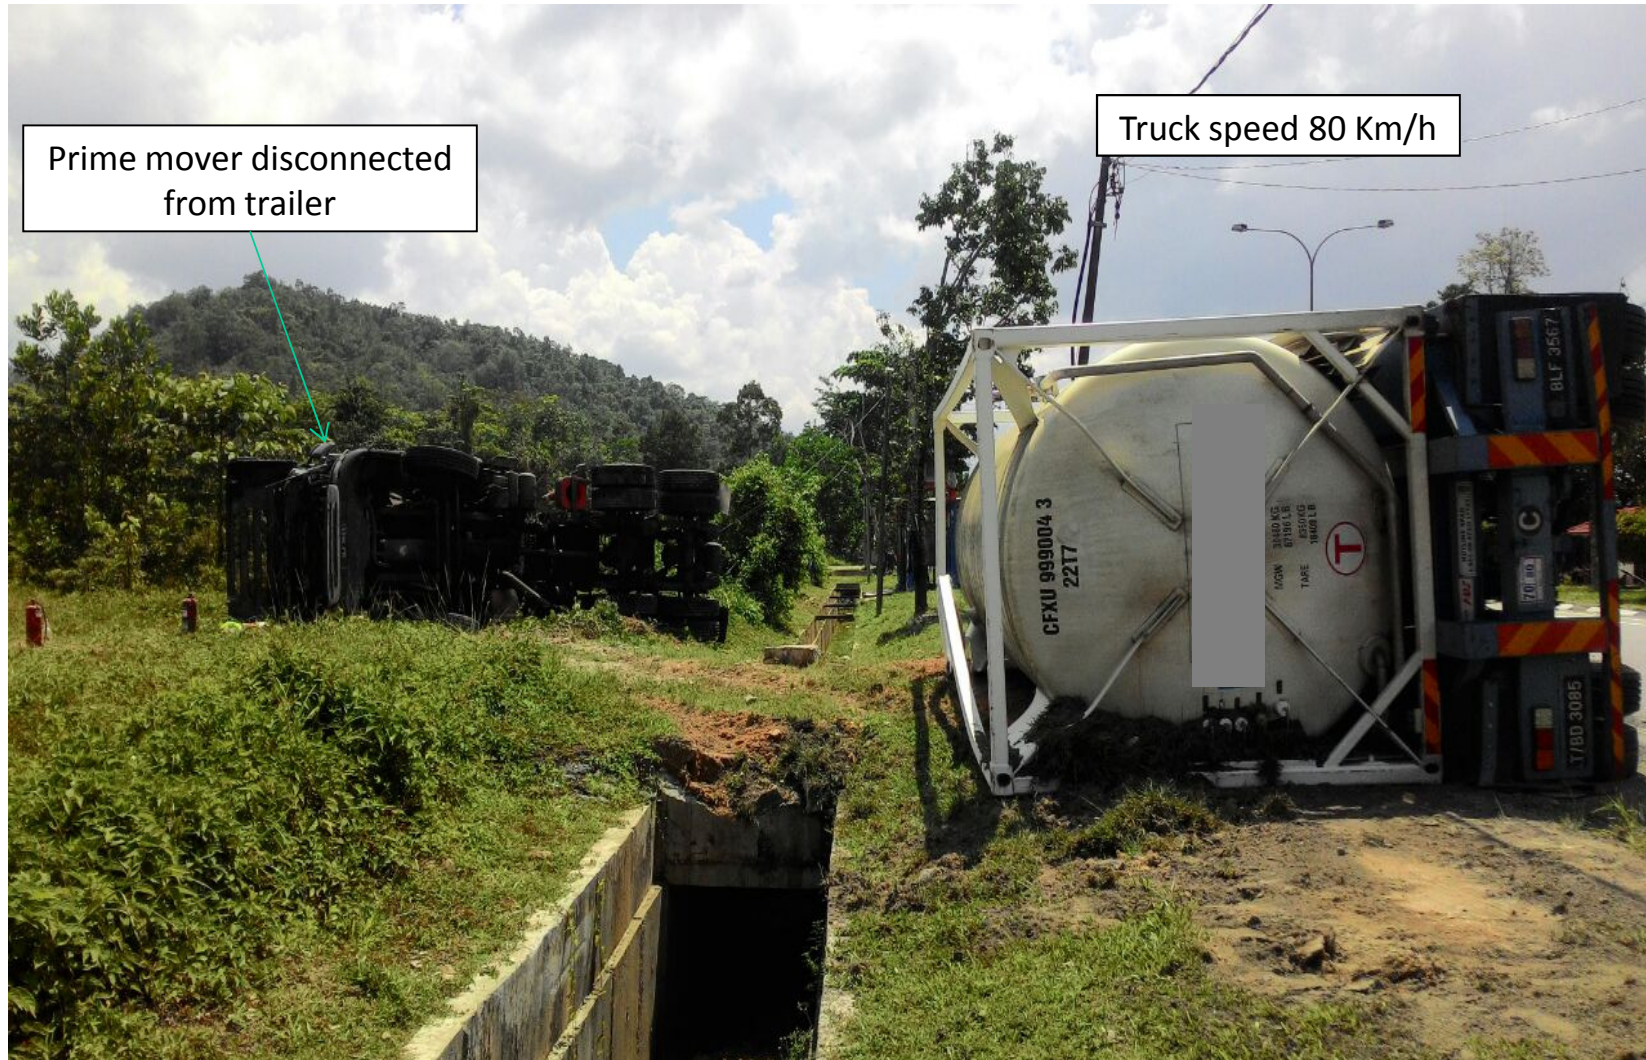
Event #2 Pictures

Product vehicle roll over due to over speed

A Lox ISO vehicle rolled over at a bend due to over speed (80 Km/h instead of 60 Km/h). The road and weather conditions were good and the incident happened around midday. There was no product spillage.

- Over speed (80 km/h instead of 60 km/h as allowed for the bend).
- Possible sleep inertia; the driver was driving for less than 5 minutes after waking from sleep in the sleeper berth.
- Failure of fifth wheel fixation, leading to prime mover disconnecting from trailer
- High centre of gravity of the ISO vessel

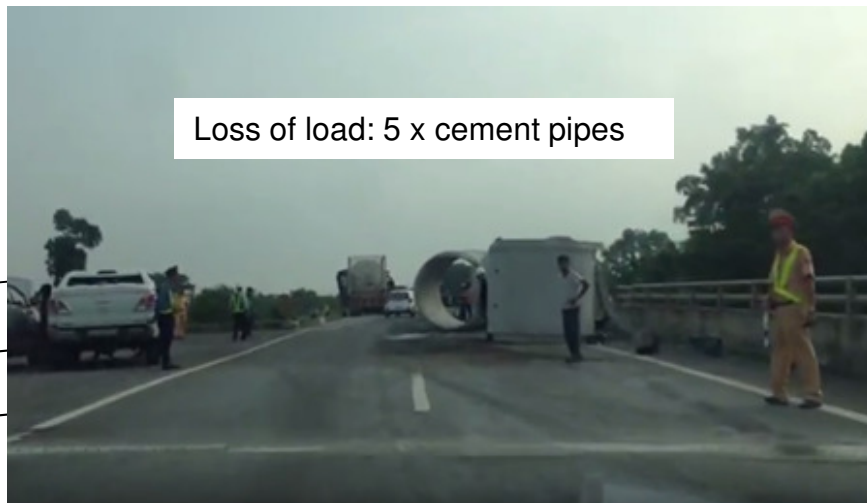
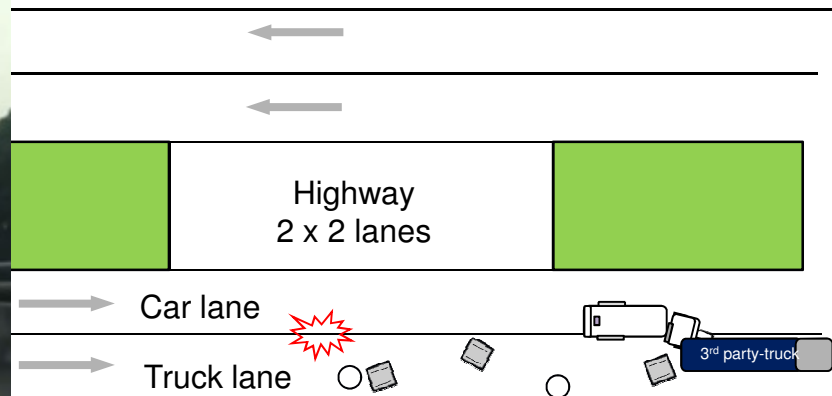
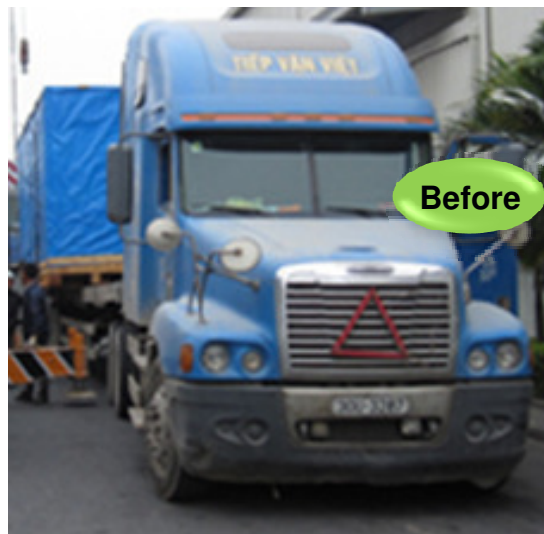
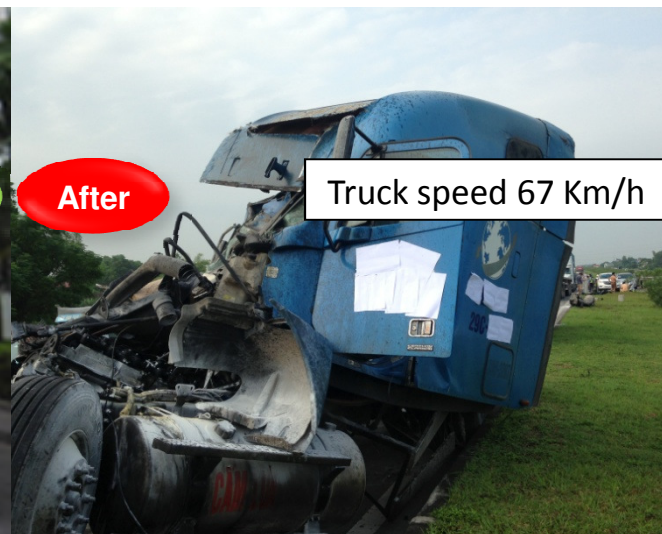
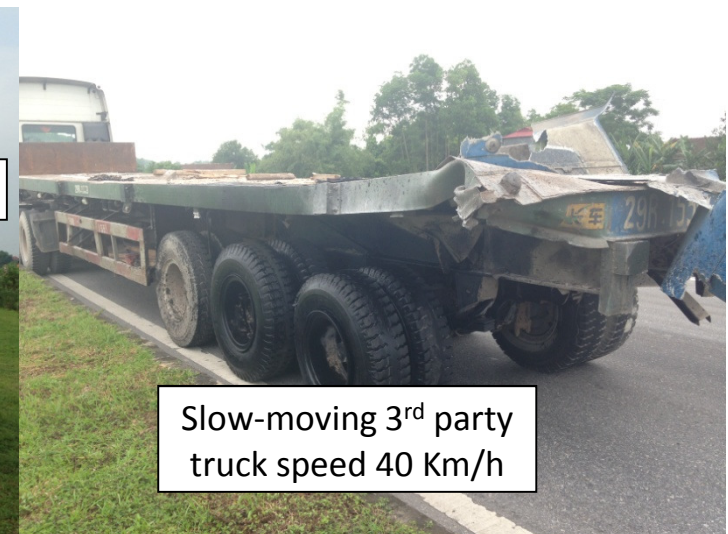
Event #3 Pictures

High severity product vehicle accident

At around 4:23 am, a truck accident happened on the highway while ISO Lin tanker was on the way to deliver to customer. The contractor driver was driving at 67 Km/h when he crashed onto a slow-moving truck (40 Km/h) transporting 5 cement pipes which was in front of him on the same lane. The contractor owned prime-mover received extensive damages at the cabin. Third party truck had slight damages in its tail. No damage to the Lin ISO tanker neither any product release. Contractor driver was tired, saw the truck at the last moment and tried to avoid the collision. He was wearing his seatbelt and sustained only minor cut in his nose (Recordable Injury).

- Driver fatigue. Driver saw the slow-moving truck at the last moment.
- Slow signaling by the 3rd party vehicle

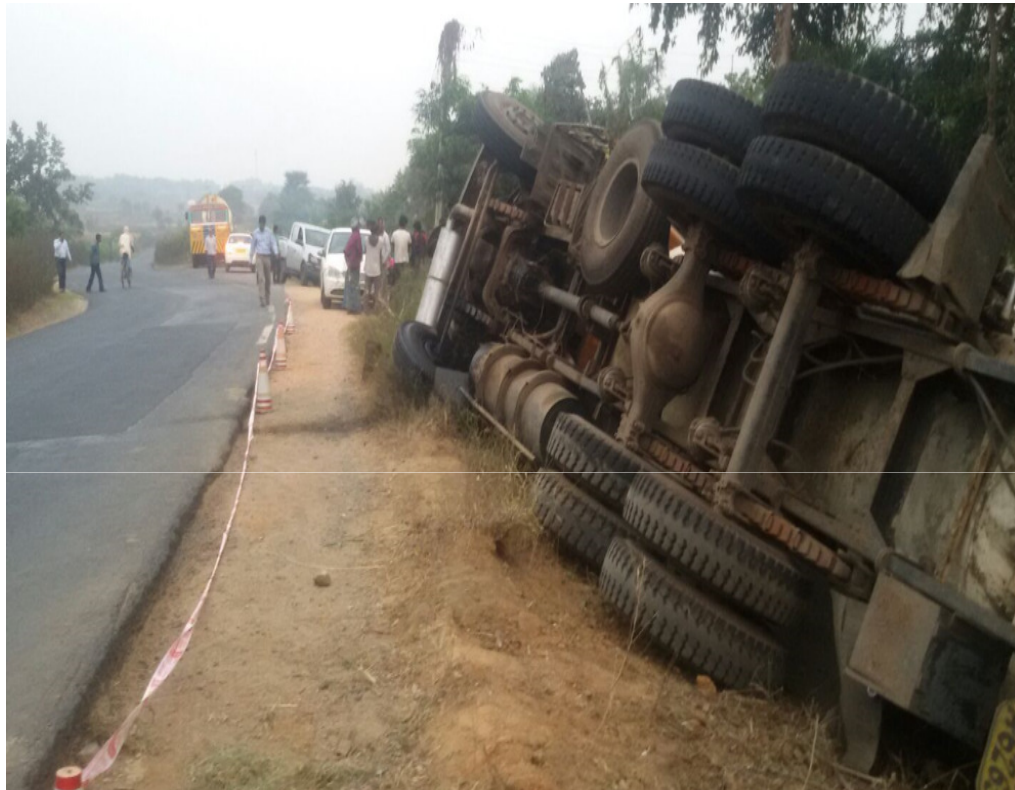
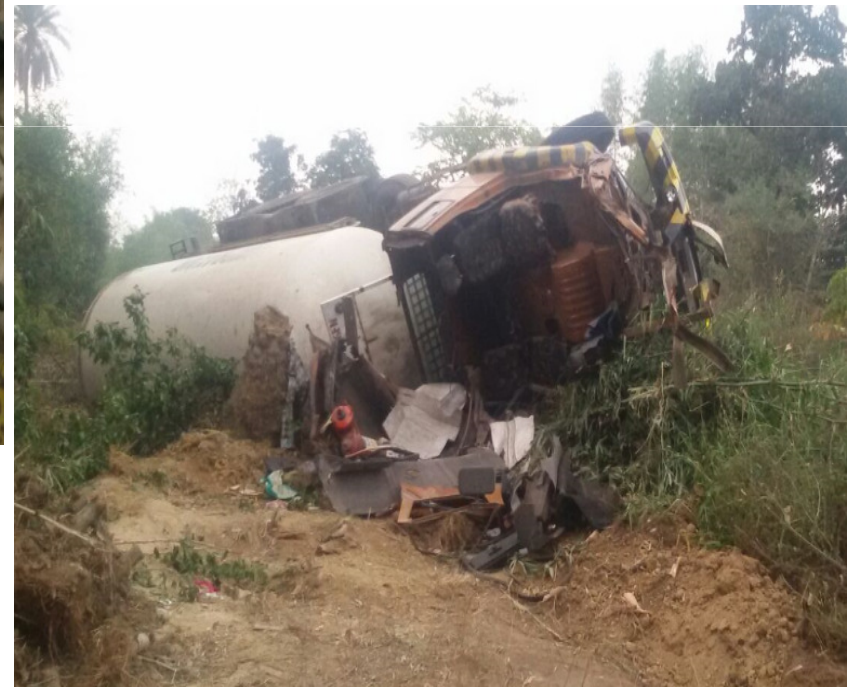
Event #4

Product vehicle roll over

Contractor owned & operated product vehicle while on its way to a customer rolled over by 90 degrees resulting in fatal injury to the seat belted driver (bamboo shrubs pierced the neck and skull). The vehicle cabin had to be cut open to extract the driver. Unfortunately the driver passed away on the way to the hospital

- Aggressive driving (Speed / Driving too close to road edge)
- Lack of practical roll over prevention training ; Route risk mitigation

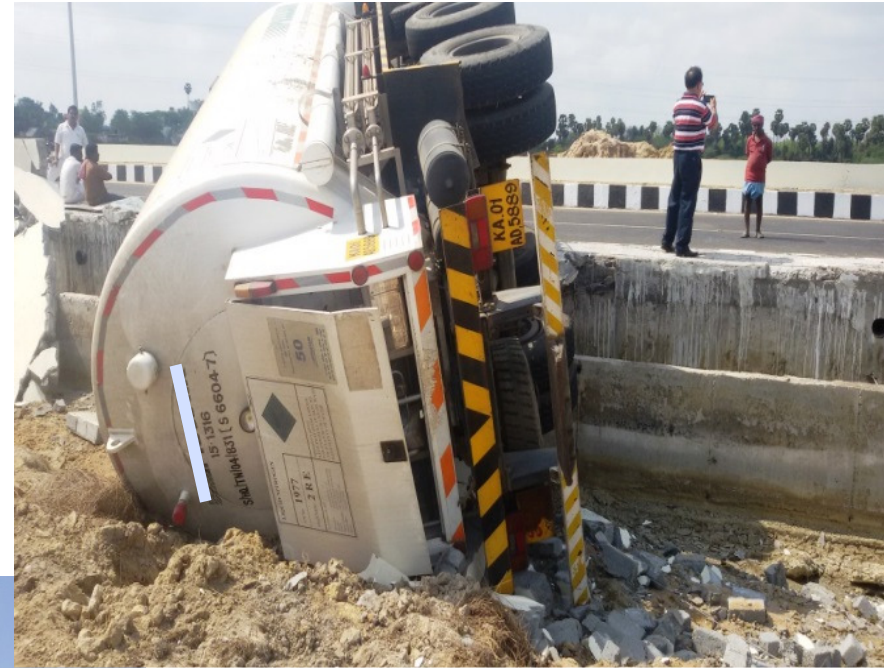
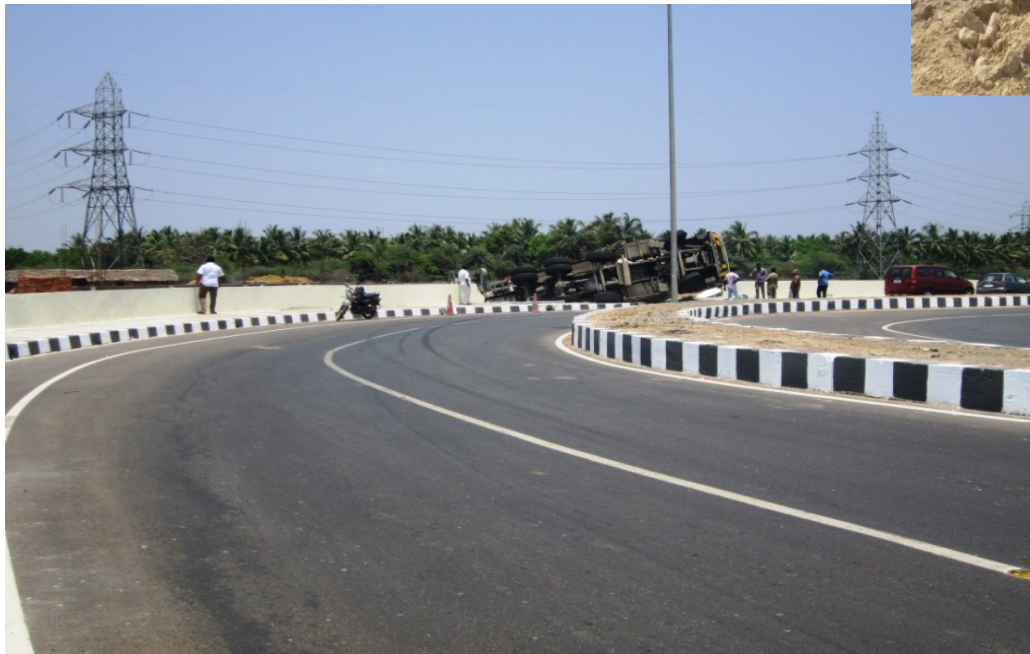
Event # 5

Product vehicle roll over

Contractor owned liquid nitrogen straight truck, rolled over by 90 degrees at approximately 10 kilometers from plant while on its way to a second customer after delivering to the first customer. The truck was carrying a partial load of 9 MT in tanker. The accident happened on a sharp curved section of the road where the driver lost control. No injuries to anyone and no product release.

- Excessive speed in the curve
- Hard braking

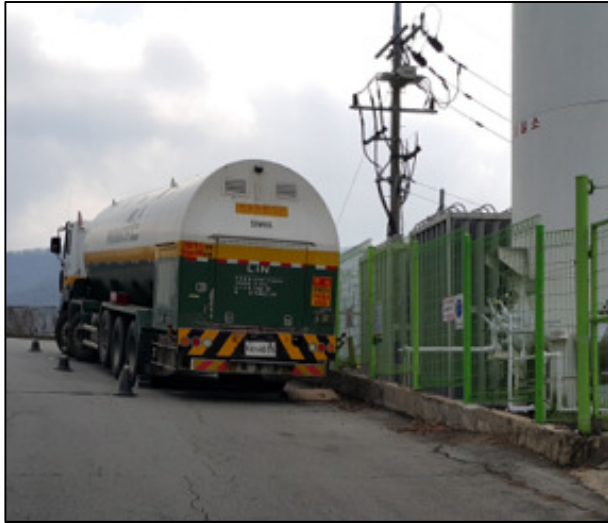
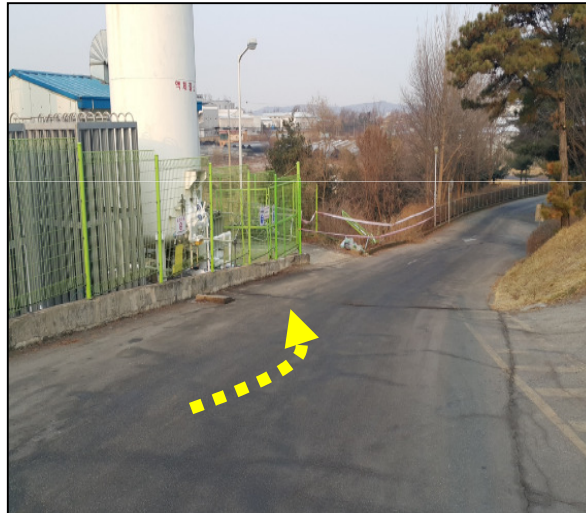
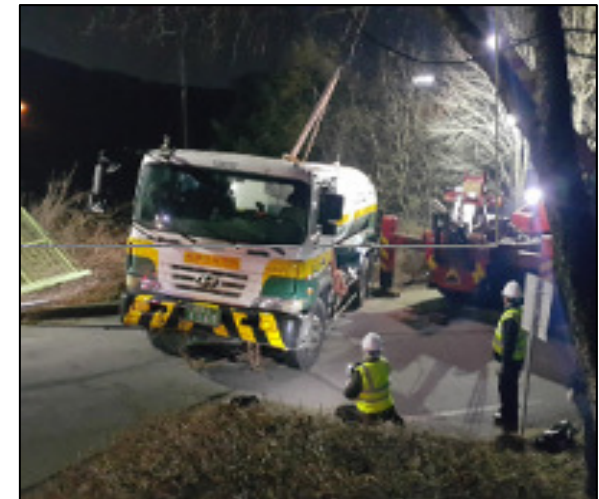
Event #6

Product vehicle accident for not applying wheel chocks

The driver has completed the LIN unloading process, disconnect the transfer hose/and removed the wheel chocks. He climbed up the truck to drive back to the depot however he noticed the power cable still intact and was not disconnected. He then climbed down from the cab and attempted to disconnect the power cable. While doing that, the truck rolled backward and hit the driver who was standing next to the tanker before the truck went into the drain. The customer employee called local emergency number and injured person was sent to the hospital by ambulance. As a result of the impact, his left middle finger, thigh and ankle were fractured and required to undergo the surgical operation.

- The driver failed to secure the truck before he climbed down from the cab (Parking brake "ON" / Not kept engaged in First gear / Wheel chocks not placed).

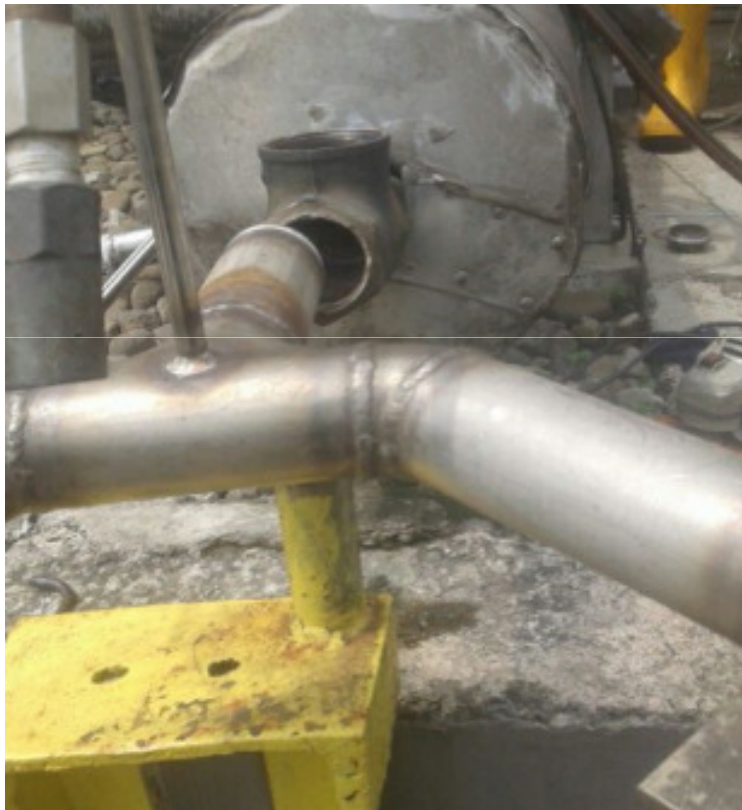
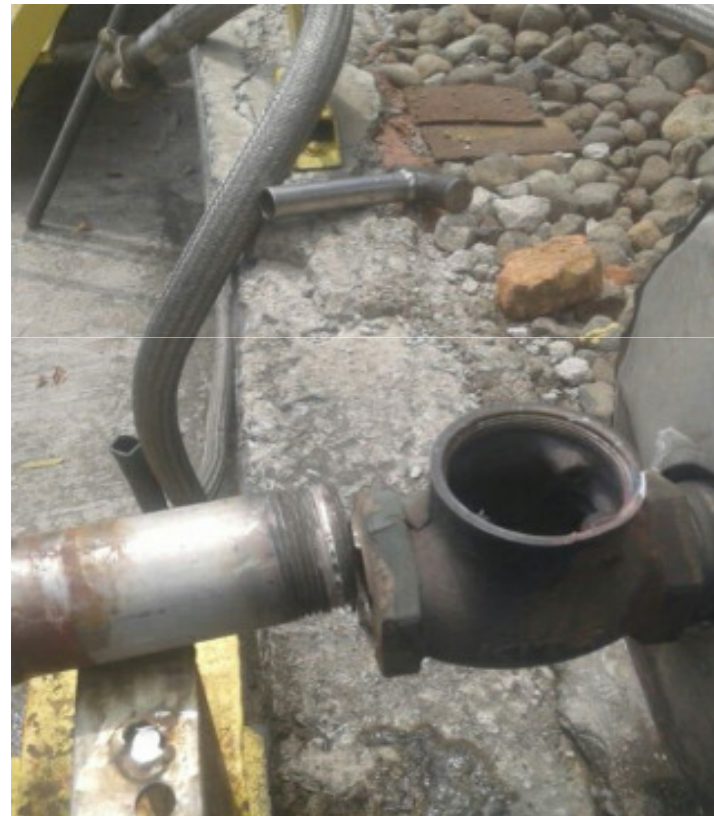
Event #7

Product vehicle pulled away with hose connected

After loading LIN at a filling station, a the driver went to Weighing Machine room to print the load ticket. During that time the residual liquid in the filling hose remained to flow back into the tank. Driver on return from Weighing Machine control room got busy in some paper work and forgot to disconnect the hose and started the truck which pulled the hose and resulted into damage to pipeline and the check valve.

- Driver did not close the valve box door prior to moving off.
- Truck anti tow-away device appeared to have malfunctioned.

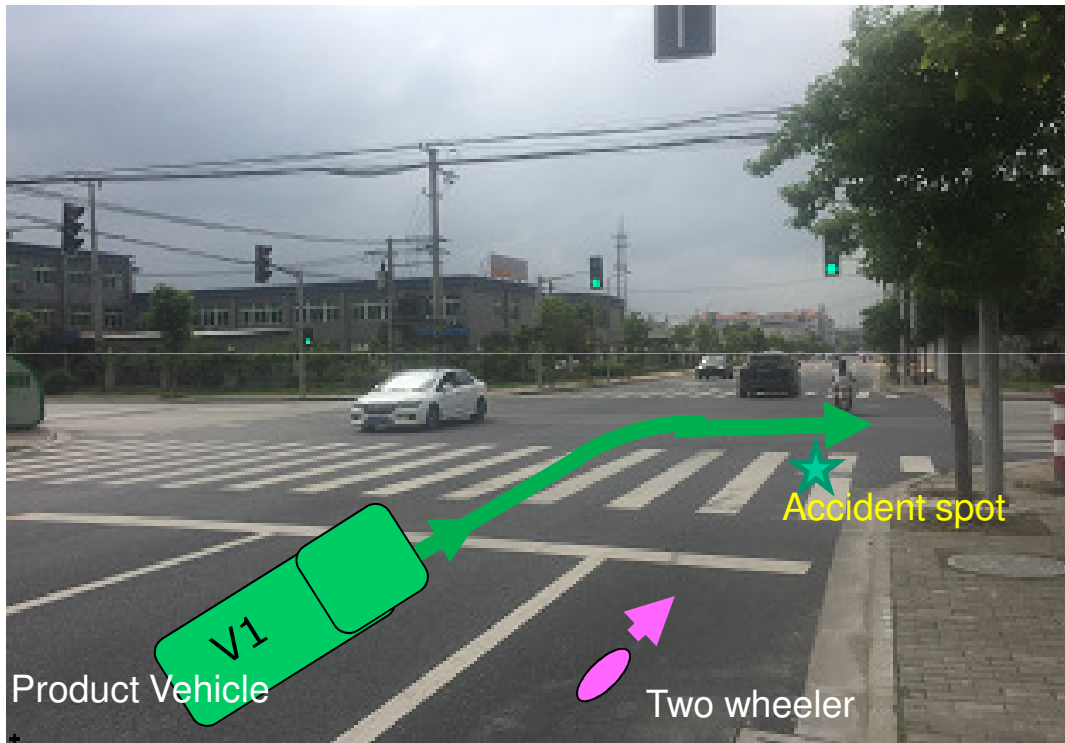
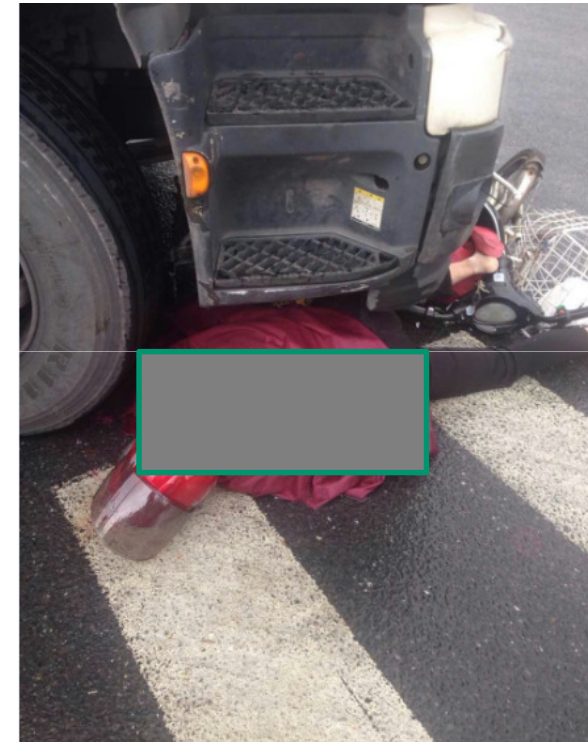
Event #8

Product vehicle hitting a Two Wheeler

While turning right at the traffic light intersection, the truck hit the scooter who rode next to it. Due to the impact the Rider fell down and hit the ground hard. The rider was sent to the nearby hospital and was pronounced dead by the doctor couple hours later.

- Driver failed to check the right hand side of his truck while travelling along with the scooter.
- Driver failed to check the right side mirror before turning the truck.
- Helper did not assist the driver when turning took place.

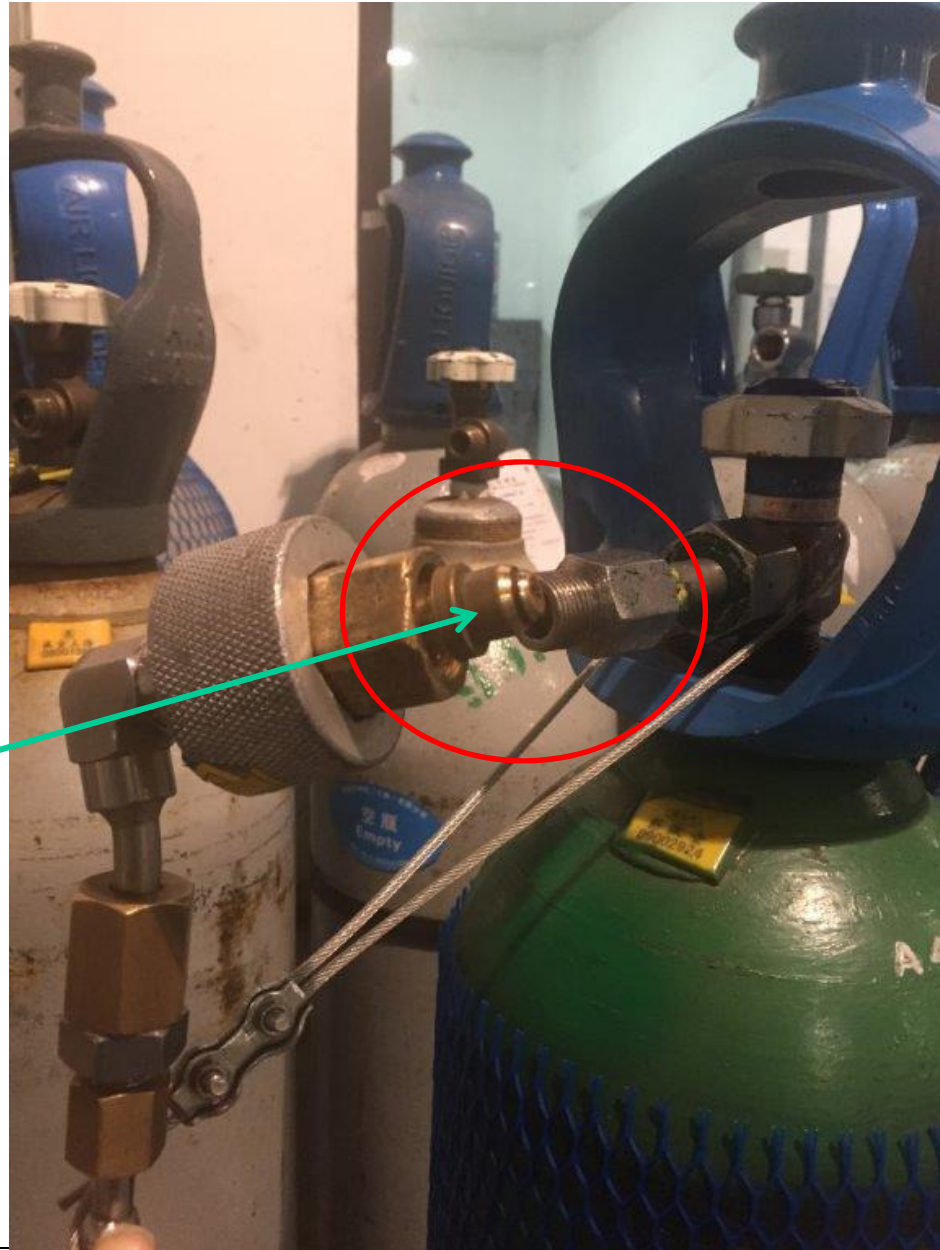
Event #9 Pictures

HP hose connector failure

During the routine work of analyzing a gas cylinder and after having connected the hose, installed the safety cable and opened the cylinder valve, the hose connector suddenly disconnect. The flexible hose under-pressure, swung and hit the operator's face. The operator did not sustain major injury thanks to anti-whip cable properly installed and because he was wearing the required PEE (safety glasses).

- Adaptor thread wear & tear
- Lack of checks & maintenance of adaptors

Failed Connector

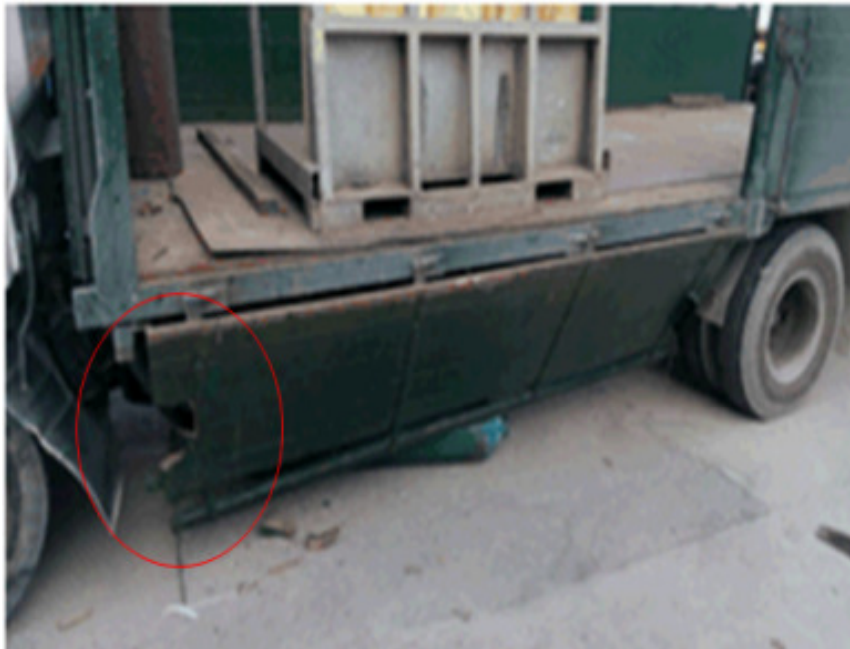
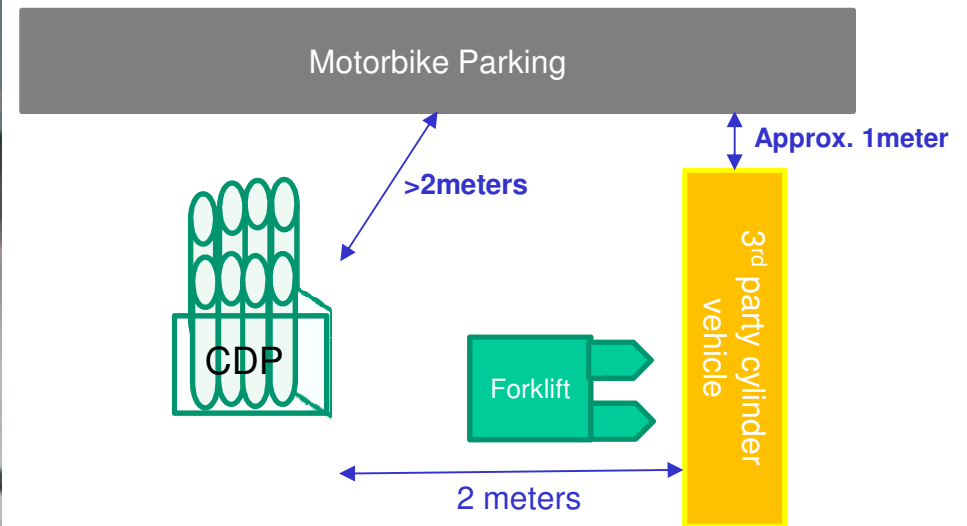
Event #10

Valve shearing off due to Argon cylinder fall

A customer driver removed 6 full Argon cylinders from Cylinder Delivery Pallet (CDP). The cylinders were left free standing next to his truck while waiting for forklift driver to load the cylinders into the truck. While reversing the forklift, he accidentally hit the CDP. As a result, the cylinders in the CDP fell and hit one of the free standing cylinders. The freestanding cylinder's valve sheared off and the cylinder ended underneath the truck with a release of 200bar of product, causing three motorcycles parked within 2 meters vicinity to collapse. There was no damage to the motorcycles and minor damages to the customer truck. No injuries were reported.

- Inadequate compliance with company SOPs and less than adequate risk assessments for unloading/ loading area

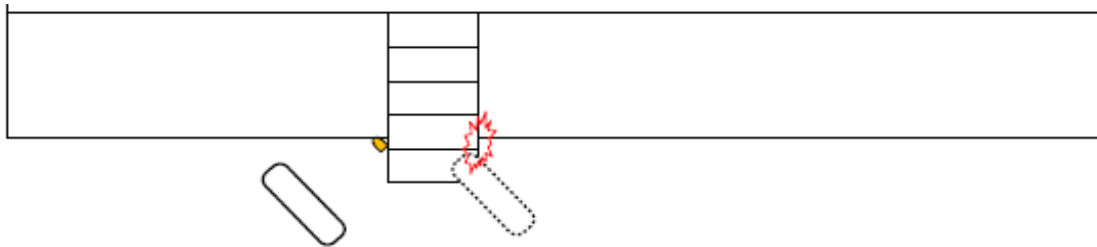
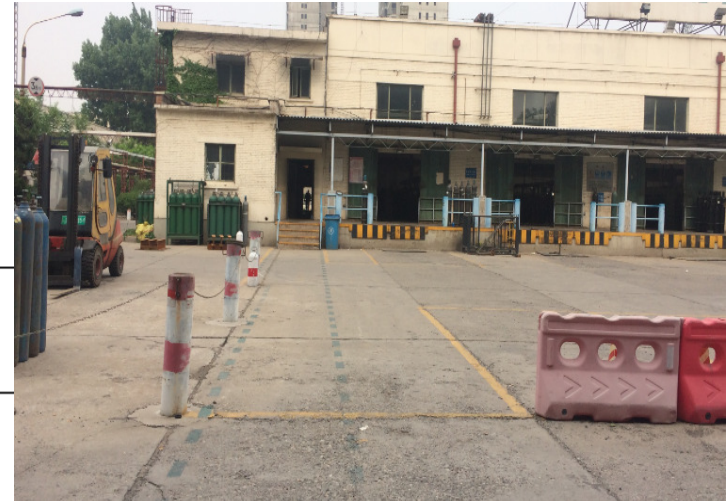
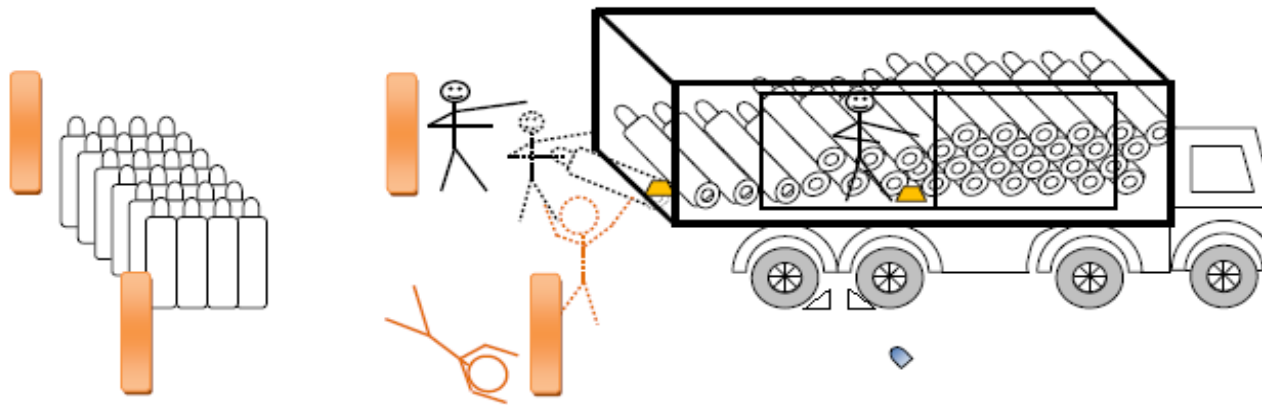
Event #11

Cylinder fall & driver injury

During unloading of empty cylinders from truck to ground, a high pressure Argon cylinder with residual pressure (200 bar) was rolling toward the end of truck compartment floor. Contractor driver attempted to stop the rolling cylinder from falling down the vehicle, failed and panicked leading to tripping and falling on the ground backwards resulting in fracture of the skull and leg. The cylinder fall resulted in the valve shearing off and ejecting the cylinder approximately to 18m away. The ejected cylinder / valve cap did not contact any individual.

- Inadequate procedure / implementation for horizontal cylinder handling
- Unreliable cylinder stopper mechanism
- Inadequate Contractor safety management

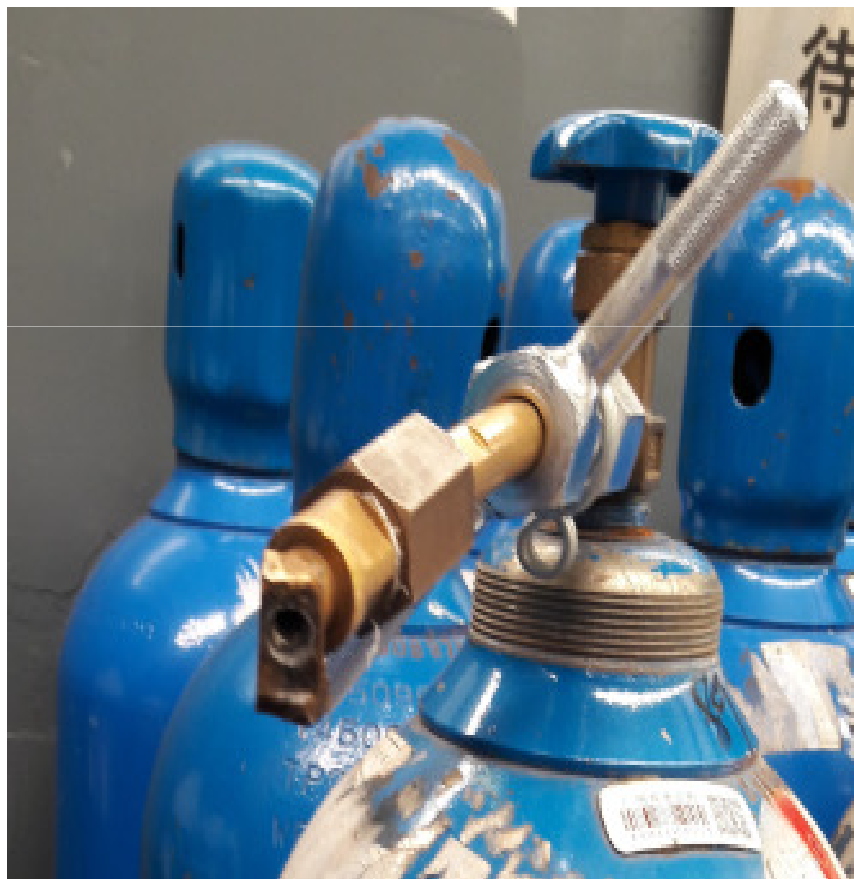
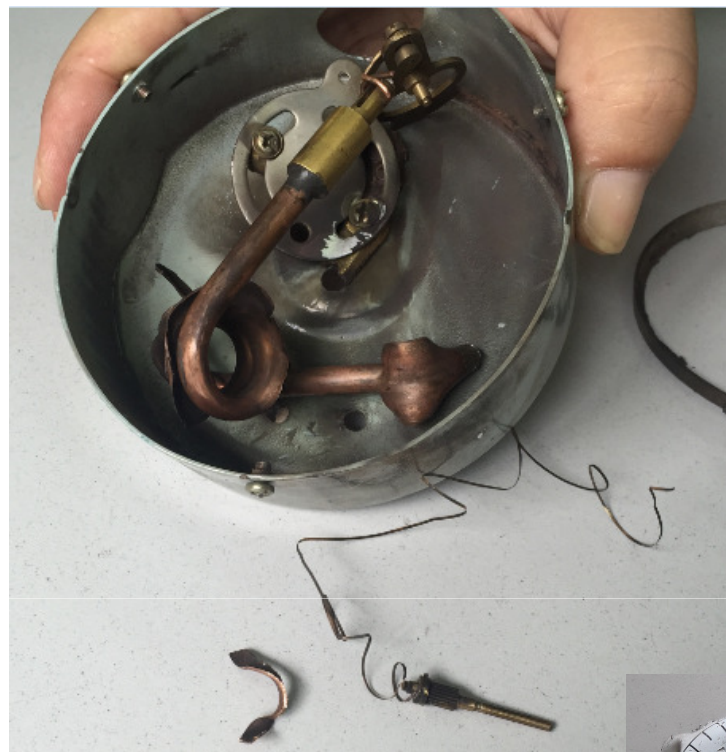
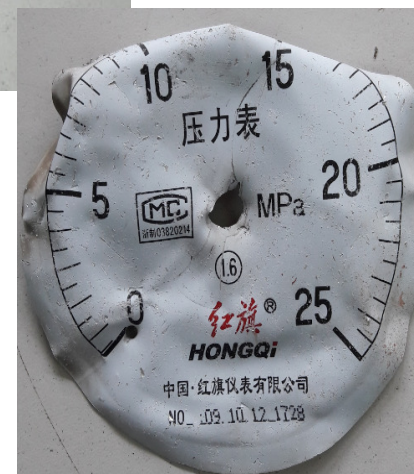
Event #12

Pressure gauge burst during cylinder pressure checking

An operator was injured when doing a pressure checking for medical oxygen cylinder . The incident took place when the operator tightened the screw, and opened cylinder valve slowly. While doing this , the gauge glass shattered injuring the operator on the right side of the chest. The operator was sent to the hospital immediately for treatment. The gauge that was used was not compatible for oxygen service.

- Non oxygen compatible gauge
- Use of portable gauges for pressure checking

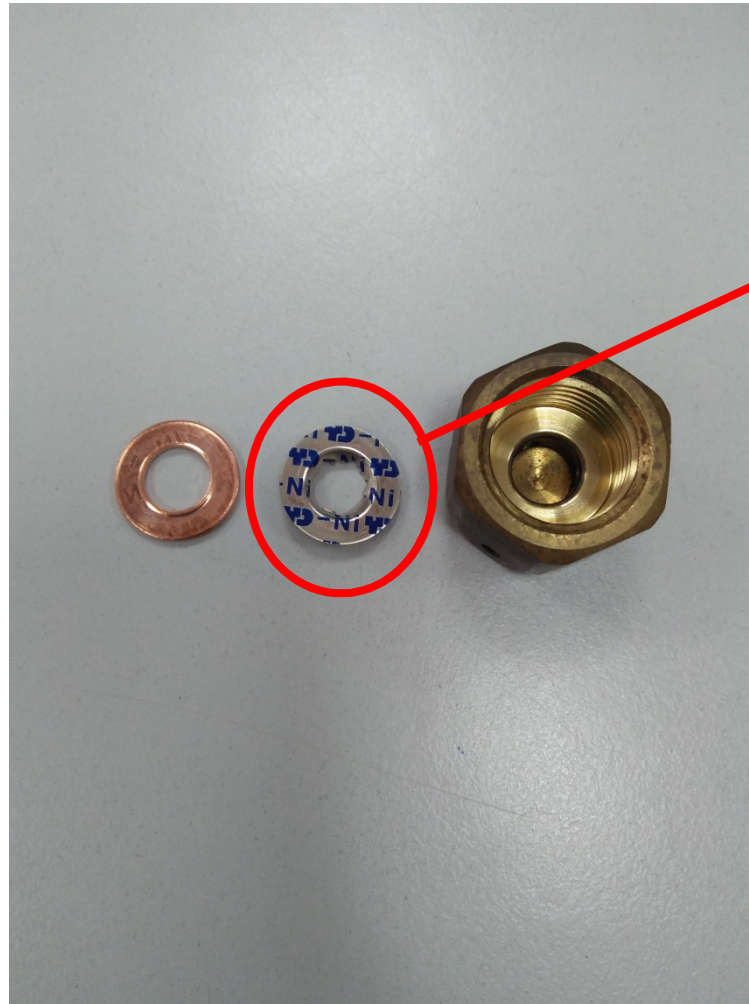
Nickel rupture disc failure of CO cylinder

The operator was analyzing the quality of other cylinders in the cylinder warehouse where he heard a sound which something had ruptured and he immediately evacuated from the warehouse. He went back to the warehouse and found that the ruptured disc of one cylinder was broken and all gases had been released. The gas was mixture of CO in balanced N₂. There was no gas detector in the warehouse.

- The Nickel material of the ruptured disc reacted with CO gas in the cylinder which made the thickness to decrease & this weakened the rupture disc
- Lack of exact procedure to select valve of appropriate specification
- Lack of knowledge of the workforce about reactivity of Nickel and CO gas

Picture of Ruptured Disc

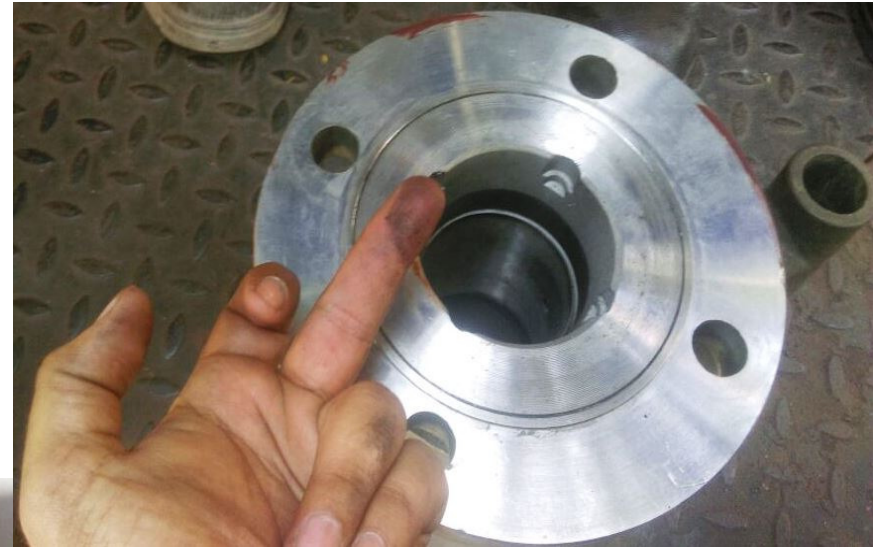
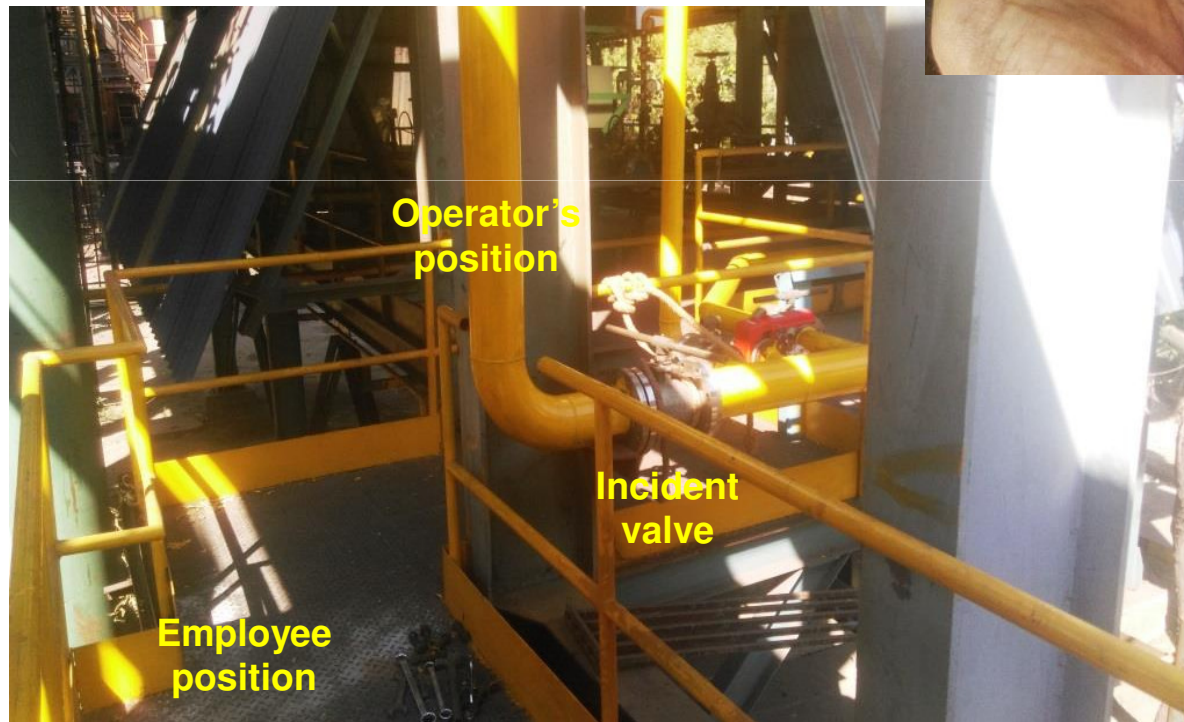
Customer Oxygen pipeline fire

Applications Support employee suffered a burn injury to the right forearm when witnessing the opening of a 6 inch ball valve on a customer oxygen pipeline during the commissioning of a stove oxygen enrichment project. The valve was being operated by a customer technician and oxygen was being charged for the first time in the pipeline when the fire occurred from the upstream flange on the valve. The employee was wearing FRC jacket, the arm of which got burnt.

- Customer did not clean valve for oxygen service / Valve oxygen cleaning certificate not requested from customer
- Less than adequate FRC usage awareness / No SOP for charging oxygen for the first time in pipeline

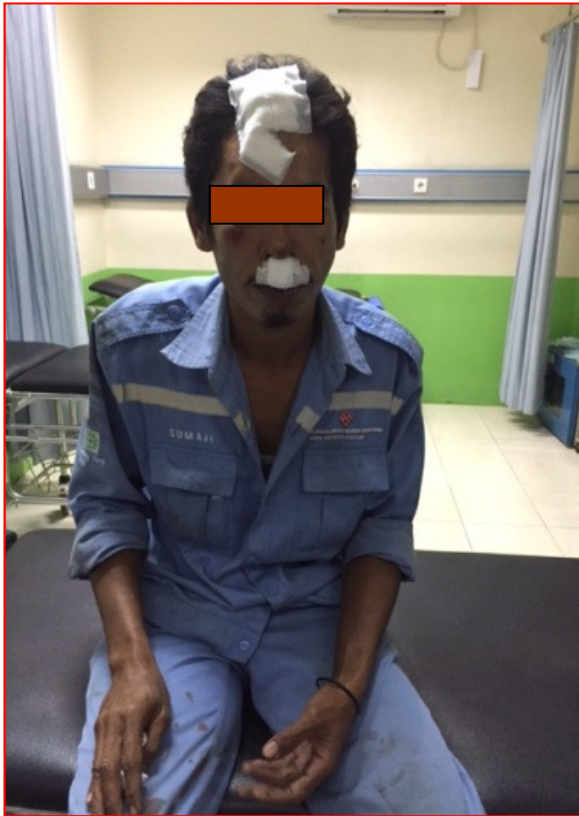
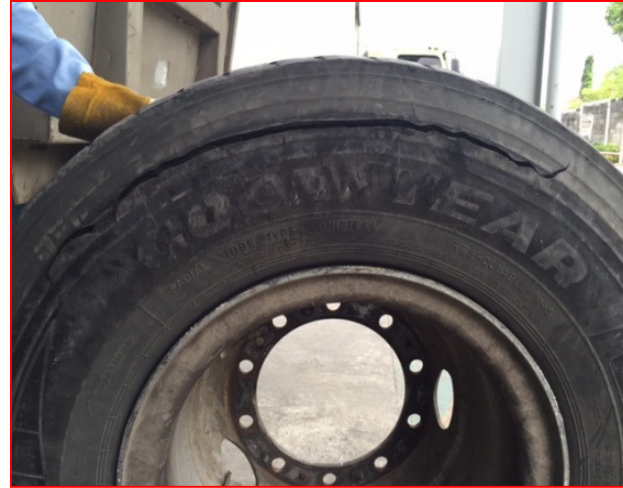
Event #15 Pictures

Tyre burst while inflating after on site repair

During pre-trip inspection of a vehicle, a driver found one flat tyre. The maintenance team dismantled the tyre and decided to fix it on-site. They found the tube flap nipple broken, which was then replaced with a new one. The mechanic squat on the tyre to hold the tyre inflator and his supervisor sat on the tyre to control the pressure then they started inflating the tyre. They hear a “krek” sound when the pressure reached 60 psi, they continued inflating the tyre and suddenly around 70 psi the tyre burst. Mechanic was thrown up and fell with his forehead touching the ground first, and his helmet got detached. He was injured on his fore head and lips (got 12 stitches), and his supervisor thrown to the side but not injured.

- Driver decided to run the vehicle with flat tire for long time the day before
- Mechanic's initiative to repair tire on-site
- Wrong method & tools to perform the task

Injury - forehead & lips
Contractor mechanic has been “ejected”
by the explosion.

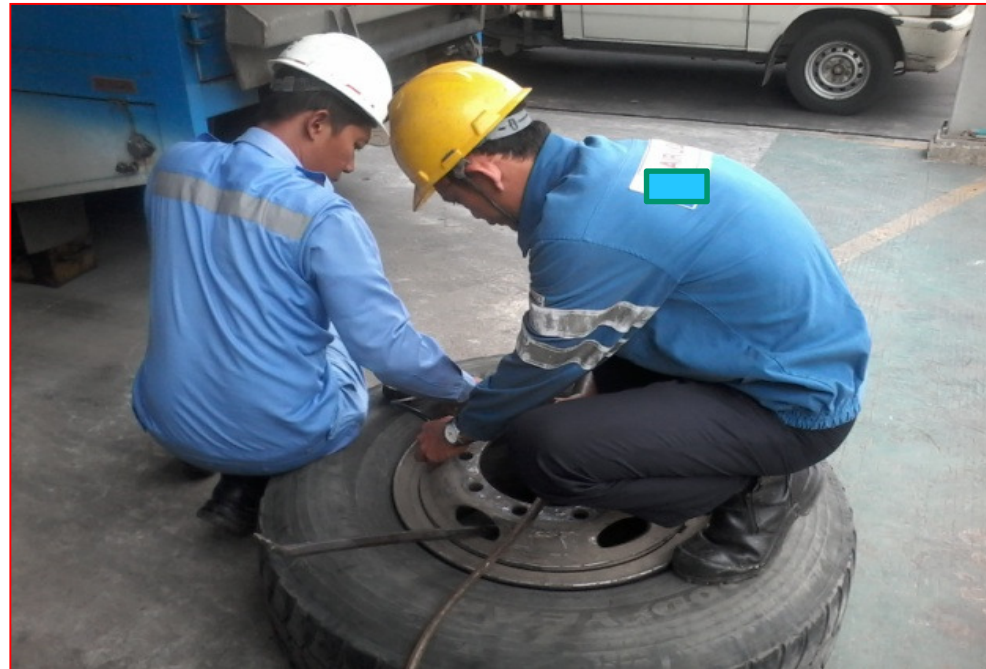
Truck's tyre burst after repair, while inflating
