Training Package TP 22/17

Recent (2016) Accidents/Incidents in the Gases Industry in Asia

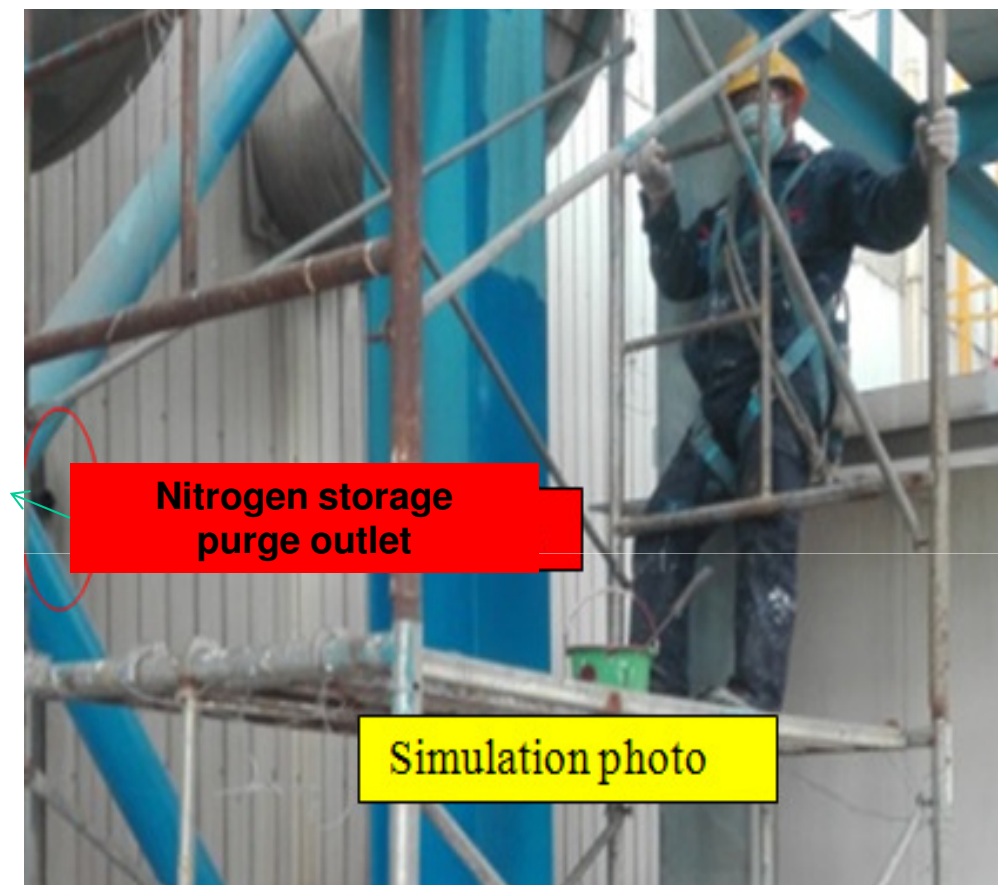
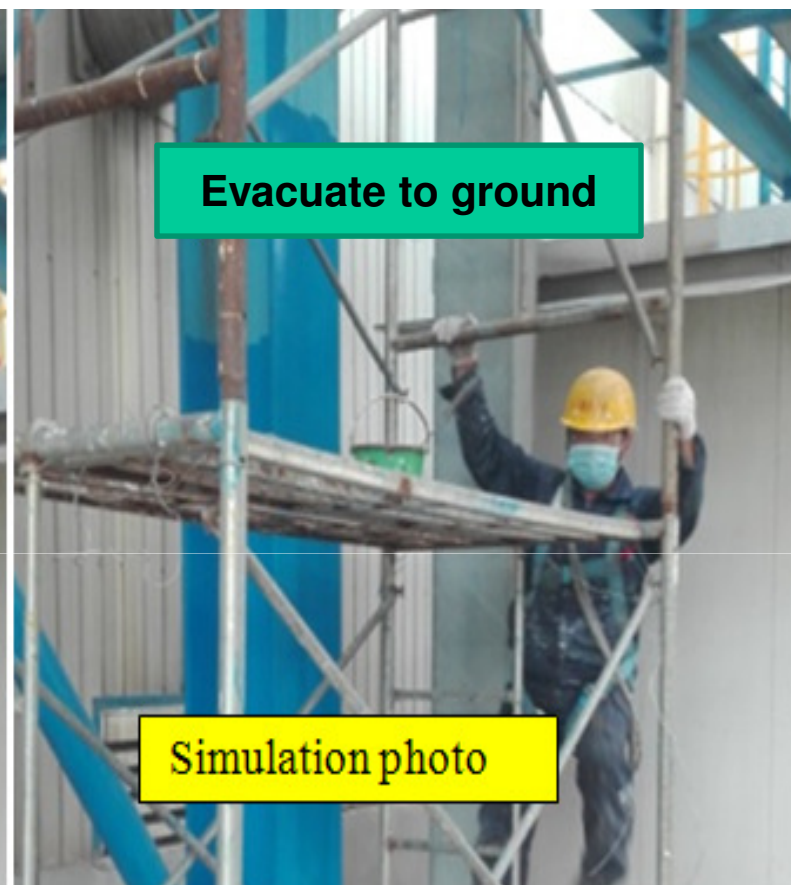
Event #16 Pictures

Painting work in ASU – Oxygen Deficient Atmosphere

Two contractors were doing anti-corrosive painting on pipe gallery near the ASU workshop (one was painting and the other was on standby). After painting the lower part of the steel structure, the contractor climbed up on the moveable scaffold and started to paint the higher part at about 2m height. When he was standing on the first floor of the movable scaffold, his portable O₂ detector alarm went on and showed that O₂ content was 18%. The contractor evacuated immediately and the standby person reported the event to plant management. After inspection, it was found that a N₂ storage tank purge outlet was discharging nearby the painting area which led to low oxygen percentage.

- There was no warning sign around the nitrogen purge outlet.
- The risk with N₂ purge outlet was identified during the risk assessment of the Safe Work Permit but only requirement of portable oxygen detector was identified
- No initial testing was done to determine ambient O₂ content around the purge outlet and the safe work distance was also not defined.

The distance from the horizontal position of nitrogen purge outlet	0.5 m	1.0 m	1.5 m	2.0 m	2.5 m
Environmental oxygen content	12.70%	15.00%	18.00%	20.90%	20.90%

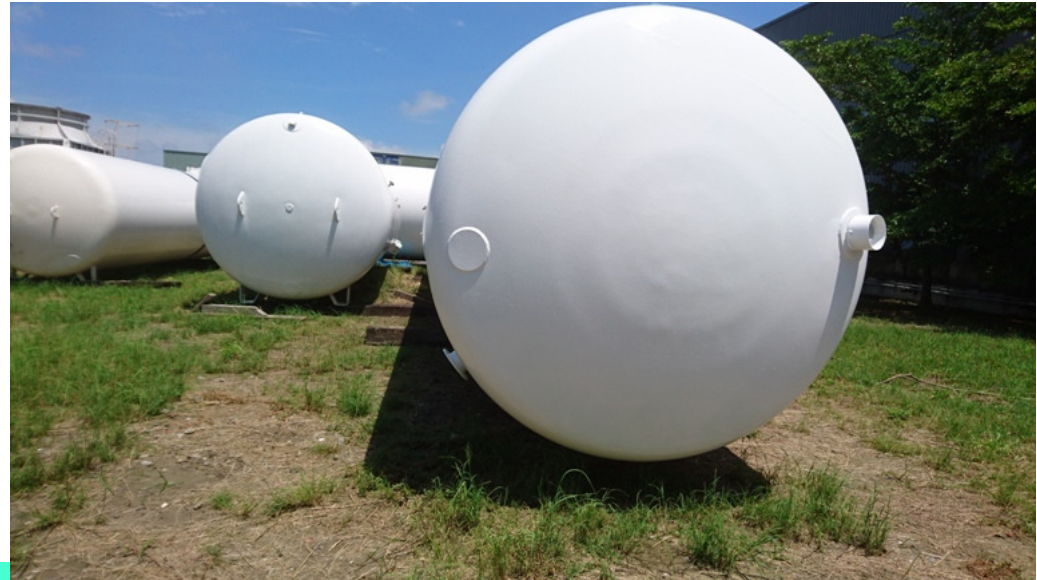
Event #17 Pictures

Rapid swing of Cold Box while lifting

While lifting a N2 generator cold box 30 cm upward in order to re-paint this unit, the cold box swung rapidly towards the employee standing beside. The employee couldn't escape, as he was trapped in a narrow area (0.5 m x 9.5 m) between the cold box and a storage tank. He was hit on his chest, pressed between the cold box and the other tank lying aside.

- The specific risks about this lifting work were not properly assessed.
- A generic lifting plan was used and the injured employee was not involved in the job analysis exercise.

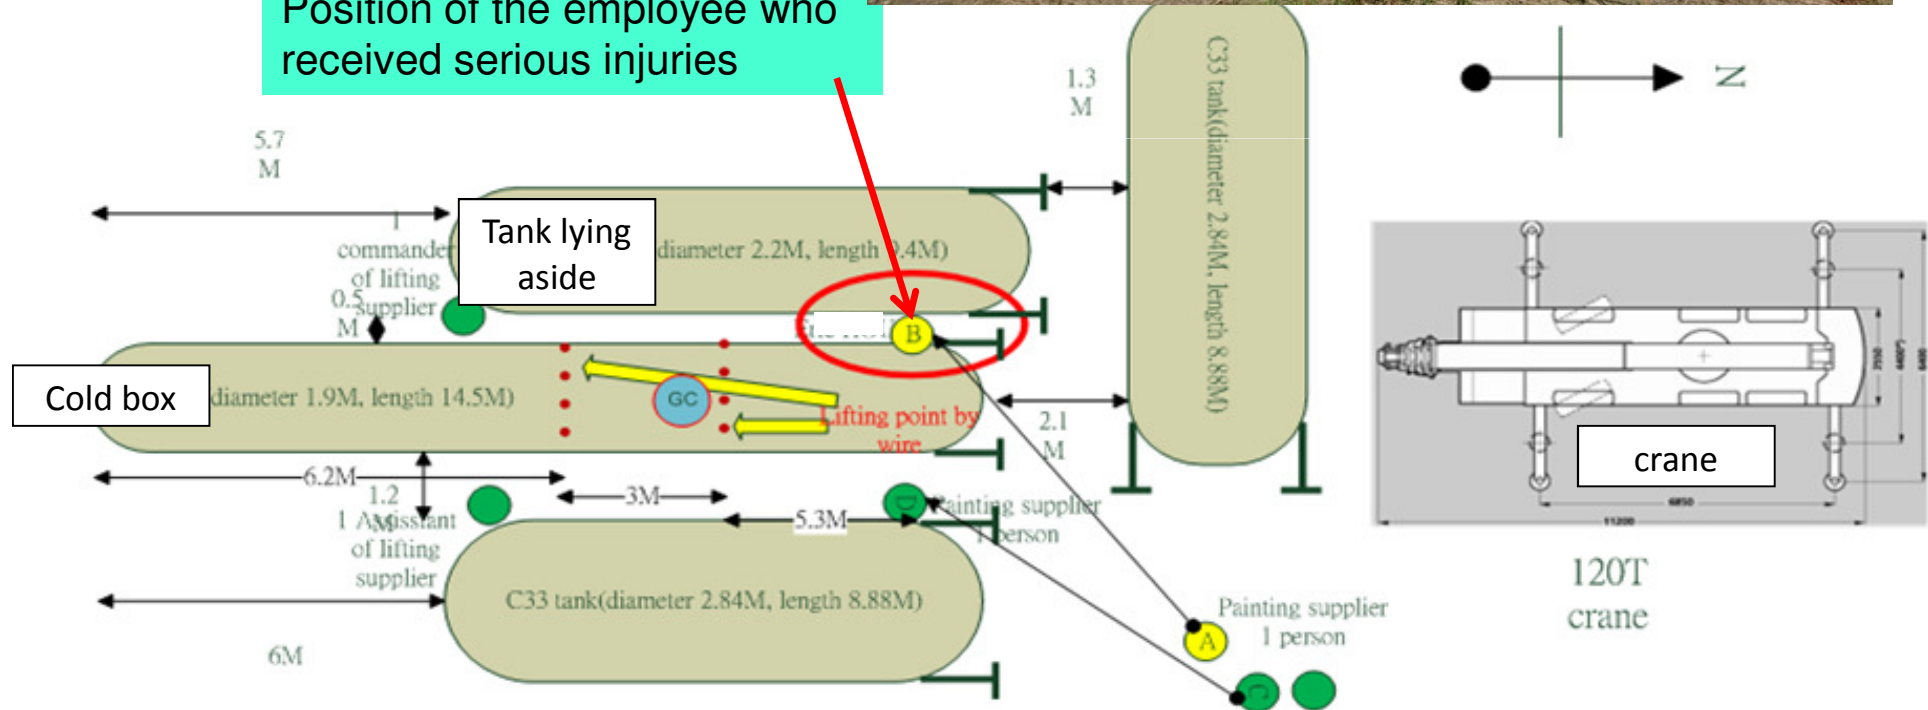
Position of the employee who received serious injuries

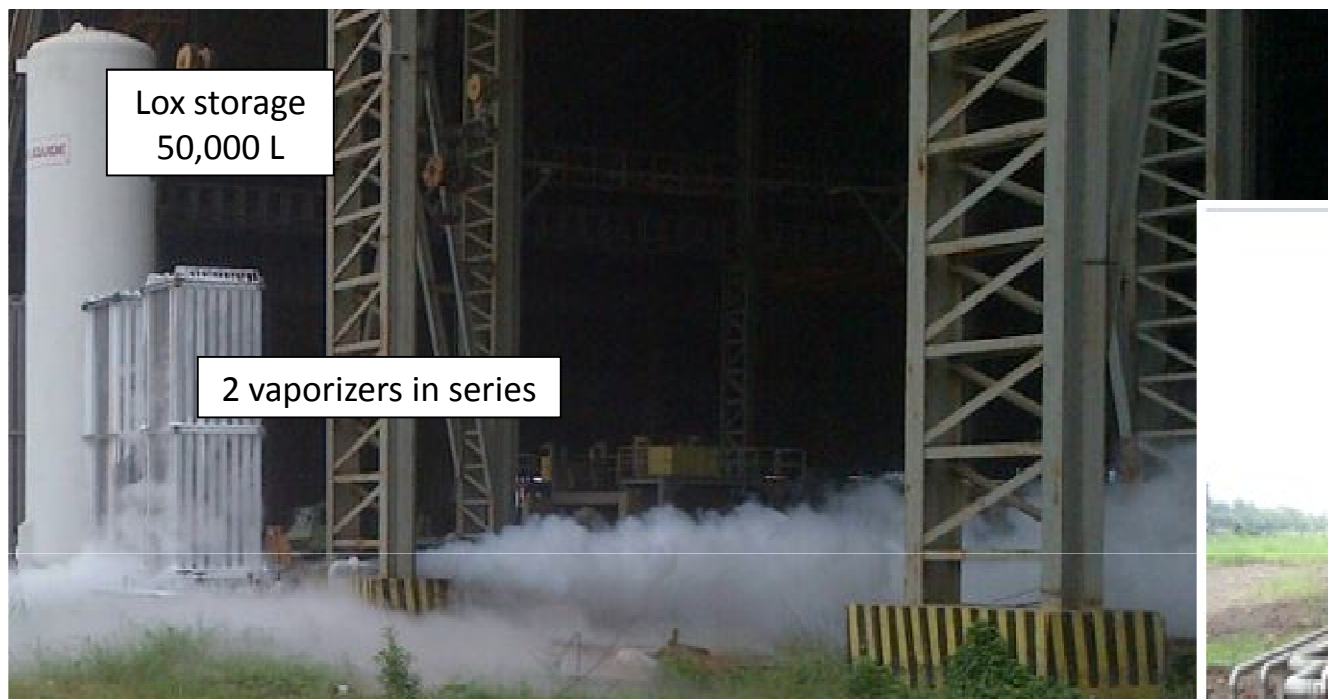
Event #18 Pictures

GOX Pipe line breakage due to Cold Embrittlement (CE)

Low temperature alarm downstream of Lox vaporisers got activated at around 8:00 am at a customer Installation which was not noticed/ignored. Temperature of oxygen gas continued to drop and at around 10:30 am cold embrittlement incident happened, this led to bursting of customer's carbon steel pipe (*20m long x 4" diameter*), interruption of customer's oxygen supply and release of liquid & gaseous O₂ for 10 min. Nobody was injured.

- Protection design : Insufficient CE protection (only alarm, no shut-off valve)
- Sudden increase of customer's consumption beyond vaporization design capacity
- Previous alarm (3 days prior) not properly escalated to HSE & management

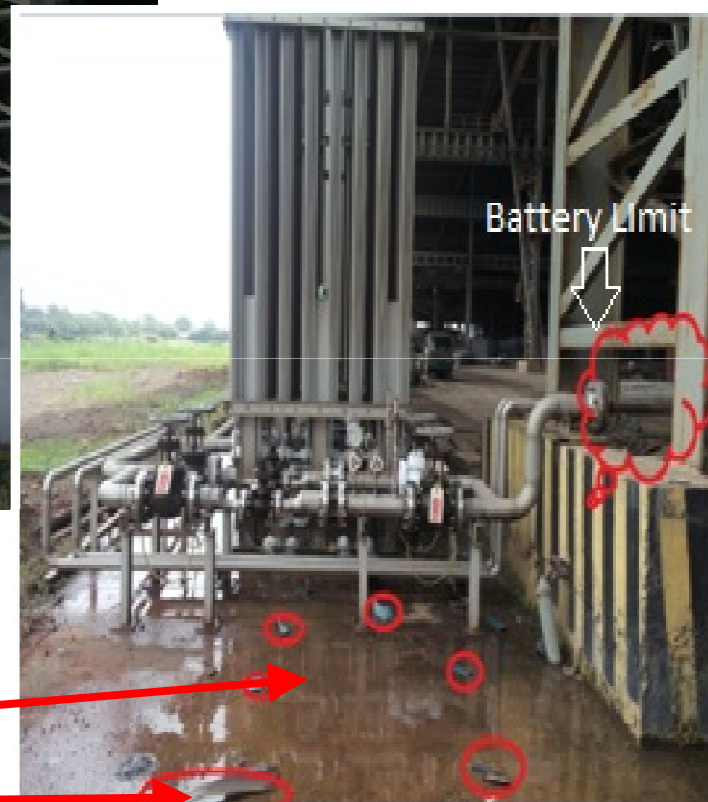
Scattered pieces
of customer pipe

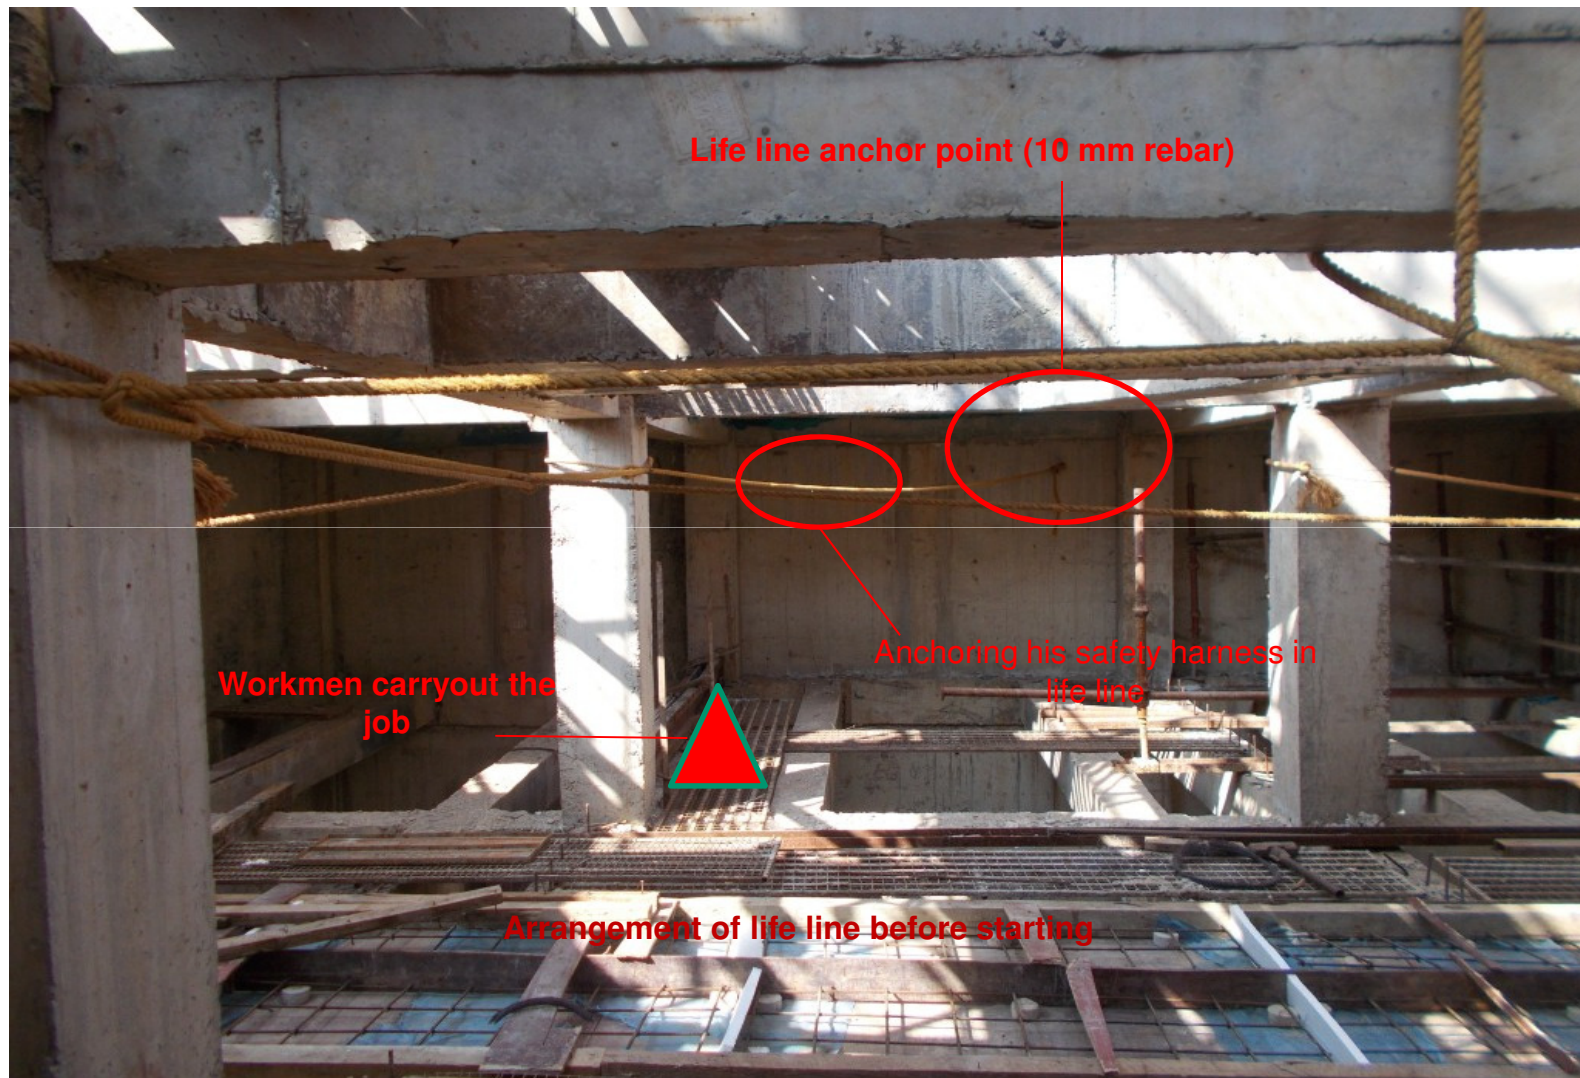
Event #19 Pictures

Workman falling from height

At a construction site two contract workers with safety harness & life line, were tasked to dismantle formwork at 7.8 m of cooling tower when the grating which they were standing on tilted, resulting in a sudden jerk on life line. One end of life line eye hook came out from anchor point, and both workers landed on 3.5 m RCC beam with loose life line & harnesses. One of the workers sustained minor cut injury in forehead & both of them had strain in muscle of waist .

- Lack of risk assessment for implementation of safe systems of work – working at height

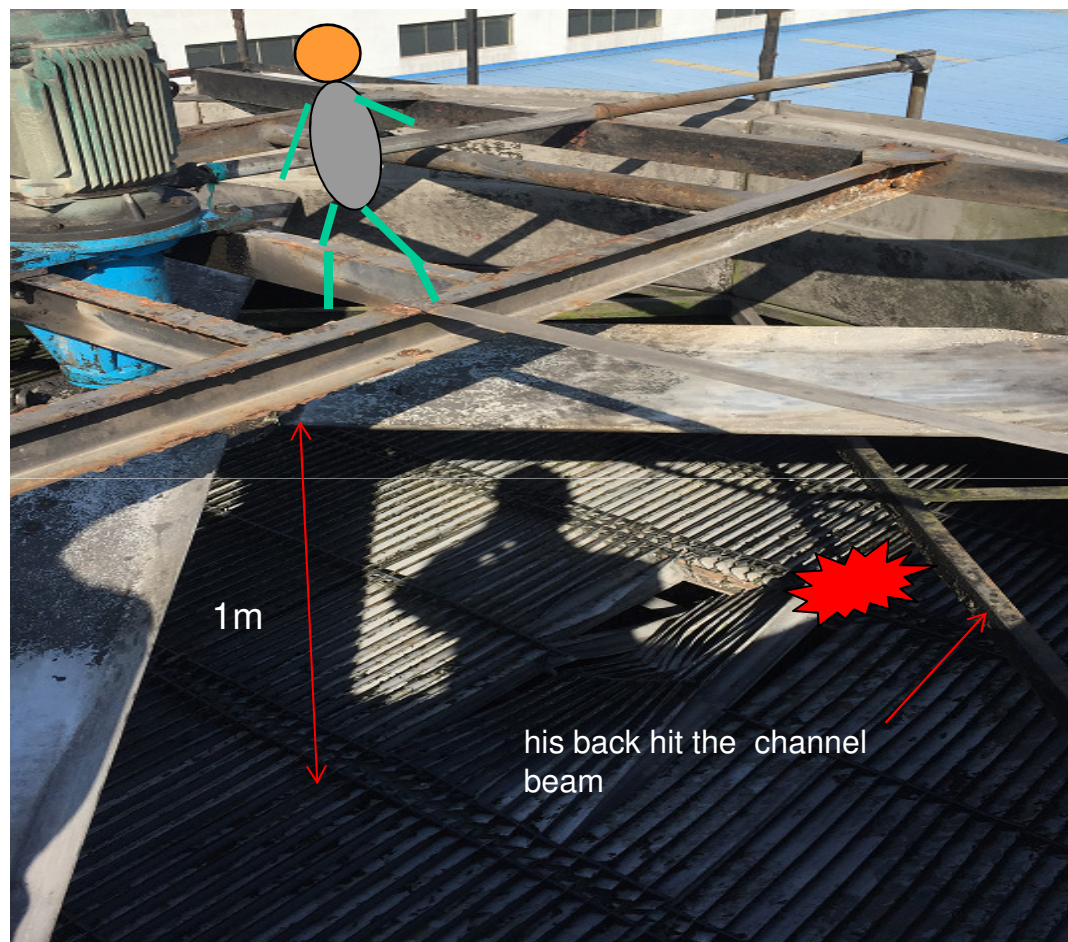
Event #20

Fall accident during maintenance work at height

Around 8:00 am, a maintenance team had finished the repair work on a transmission of a cooling tower fan. While climbing down, one worker slipped on the steel frame which is supporting the fan and fell down (height around 1 meter). His back knocked on the girder and caused a fracture of back rib.

- Lack of fall protection
- The mechanic's unsafe behavior
