Training Package TP 27/20

Recent (3Q and 4Q of Year 2019) Accidents/Incidents in the Gases Industry in Asia

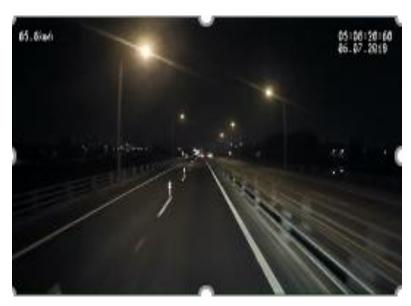
The right-hand side front rim hit the road railing and was damaged

Views from the forward facing camera showed that the driver had a microsleep and the vehicle veered to the right and hit the road railing

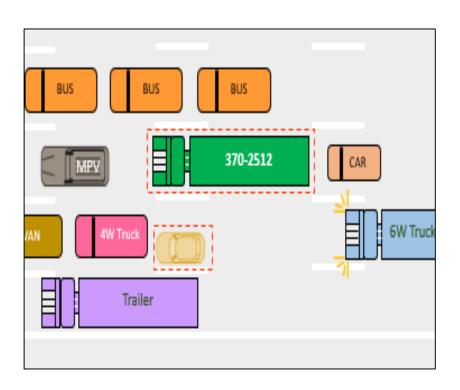
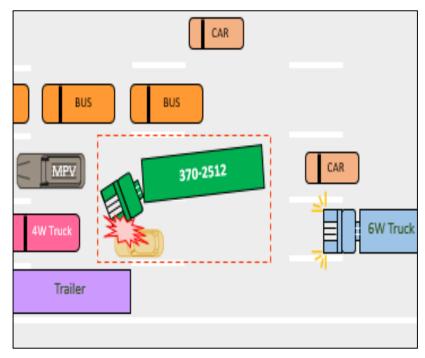
• A product vehicle(PV) driver was driving on the 3rd lane behind a MPV what suddenly stopped on the road. The PV driver reduce speed, stopped the truck and attempted to change the lane. He checked the left mirror and applied left signal. He noticed there was a four wheeler truck passing him on the left and upon passed the PV truck, the driver moved the truck slowly to the left side but the front left wheel of the truck hit the right front side of a personal car that following the four wheeler truck. No damage to the product vehicle but the 3rd party MPV sustained minor damages on the right door. There is no injury recorded in this incident.

- Driver failed to maintain his safe space around him to get the big picture
- Driver used the 3rd lane instead of 1st lane which is meant for the trucks.

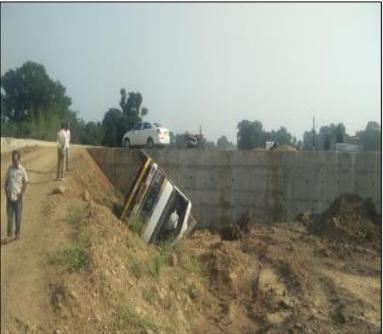
Event #3 Pictures

- Driver failed to observe ahead to make a proper judgment
- Aggressive driving
- Not equipped with roll over prevention technologies

This is the normal route to be used. It was detoured due to road construction

The truck rolled over at the detour road due to uneven soft ground

The poor condition of under construction road

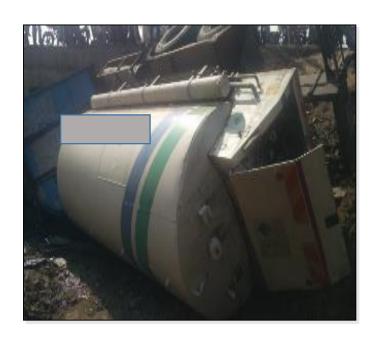
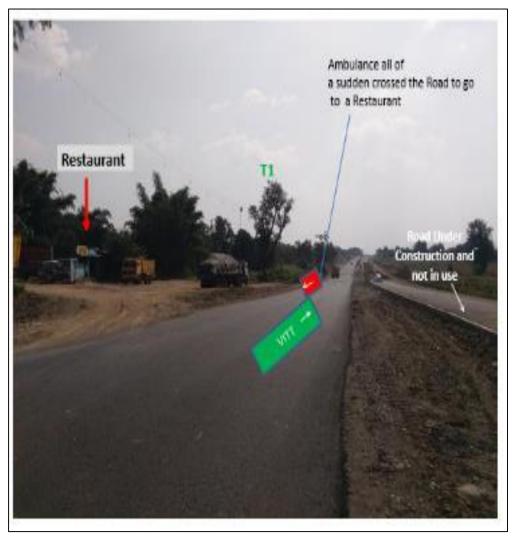
Event #4 Pictures

An empty LIN tanker hit an ambulance which was coming from the opposite direction and was trying to make a turn towards the restaurant. Initially, the ambulance suddenly tried to cross the road and passing the wrong side of the LIN tanker. Due to the speed and impact, the truck rolled over.

LIN truck and the cryogenic tanker unit were badly damaged. Fortunately there was no injury to anyone involved in the accident.

- Driver failed to apply safe driving skills should have stopped his truck to give way to the ambulance.
- Unsafe driving by the ambulance driver.

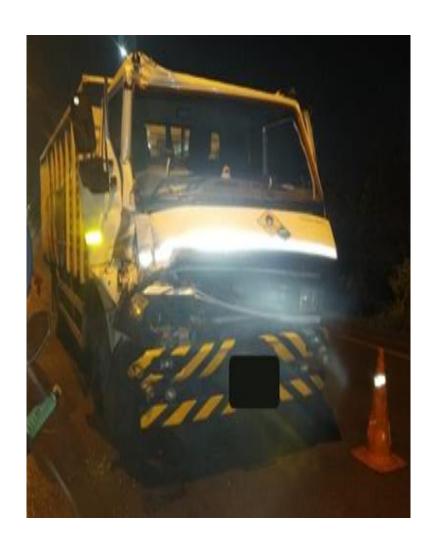
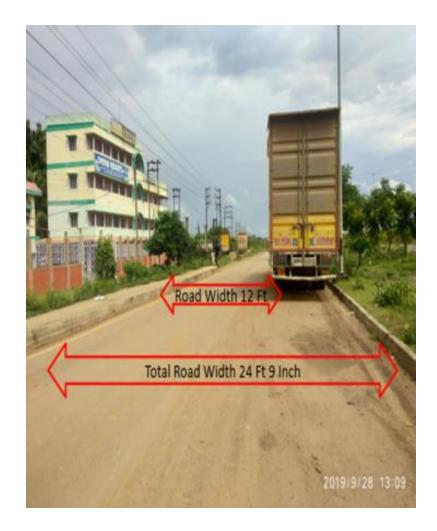
Event #5 Pictures

A contractor operated cylinder truck carrying empty cylinders in vertical cages rear ended a container truck. As a result of the collision, the driver of the cylinder truck received facture on his right leg and some minor scratches & brushes on his right leg and hand.

There was no injury to other two occupants & also no injury to any 3rd party. The vehicle had received moderate damage on the right side front part and windshield were broken. There was no product loss or media attention.

- Driver not applying defensive driving technique for night driving
- Lack of effective feedback to driver by crew in cabin
- Lack of manpower to address communication with driver during shift change
- Third party truck parked on the narrow road passage

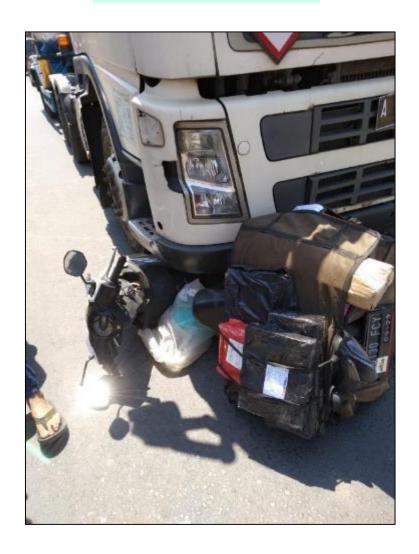
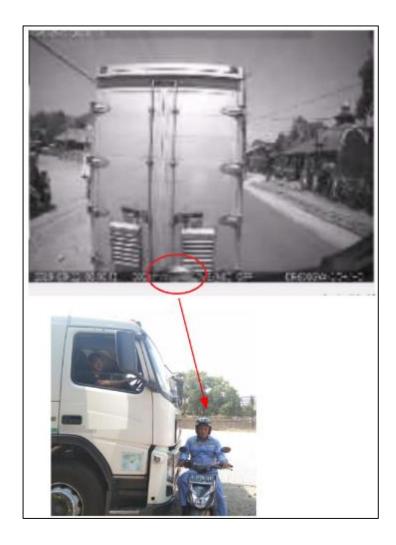
Event #6 Pictures

A cylinder truck was trapped in the traffic. At that moment, there were two motorcycle crossing the road in front of the truck to go to other way. One motorcycle passed through, while the other one stopped at the blind spot area. As the traffic was cleared, the driver started to move and immediately stopped when he heard a sound. His truck hit the motorcycle.

Human Error: Driver failed to check the blind spot mirror.

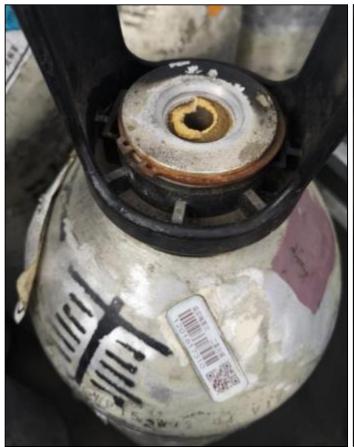
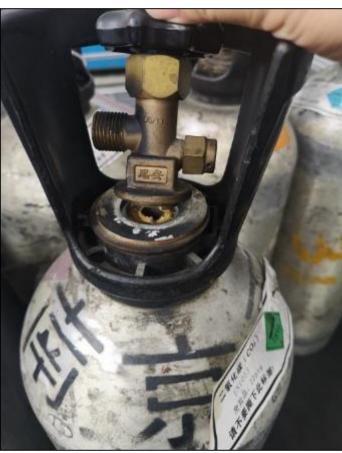
Event #7 Pictures

• At 18:09, in a full cylinder storage area at a filling station the valve of a customer owned 12L CO2 cylinder of was ejected. The CO2 spurted with force but nobody was injured in the incident. The last qualified inspection was on 21 Apr 2018. The valve was manufactured in Jun. 2013.

- Defective valve: suspected that the valve has been cracked for a long time.
- Poor cylinder qualification inspection: the cylinder owner failed to conduct the testing as required

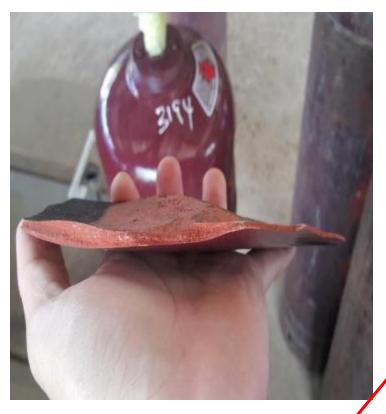
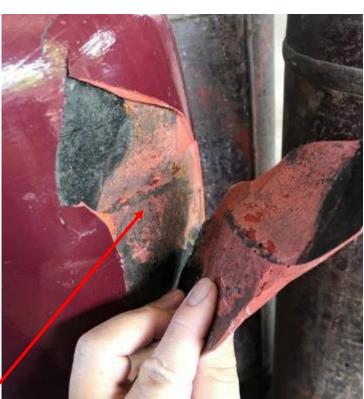
A customer-owned dissolved acetylene (DA) cylinder body's paint cracked during the filling process at 250 psi. It was later discovered that there was a dent on the cylinder which was covered up by putty and painted.

- Illegal modification on the DA cylinder by sub-dealer.
- Cylinder defect is not noticeable during pre-filling inspection. Damage is well
 disguised and hardly visible to naked eye.

Heavy dent mark

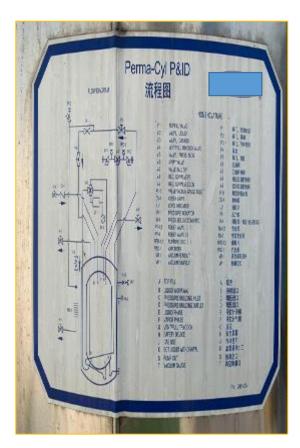
- A customer technician while on a routine inspection at the site, found that the tank was not building pressure. Using a ladder, he climbed up to check on the valves and regulator mounted on top of the tank. He found that the pressure building regulator was not working and decided make a replacement of kind. After isolating valves V5, V8 and V9, he then depressurized the tubing associated with V5 (@ 9 o'clock) by uncoupling the compression fitting (refer photo). This confirmation allowed him to disconnect the 1st connection.

- The V9 valve not closed fully.
- Did not wear appropriate glove for line breaking.
- Did not do line tracing and miss out V3 valve for venting of trapped pressure.
- Not following proper Safety Work Permit and Lockout Tagout procedures.

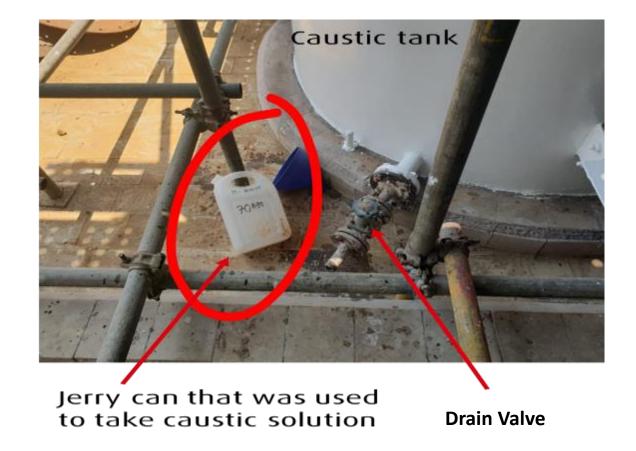
A plant operator was pouring 48% NaOH (Sodium hydroxide) chemical into a plastic drum when his eyes were splashed by chemical following an exothermic reaction that occurred in the drum. He was wearing safety glasses but not faceshield.

- No chemical interaction matrix was developed and training provided
- Risk assessment of non-routine job was not done
- Inadequate implementation of Management of Change (MOC) for use of alternate chemicals
- Unclear or conflicting roles/ responsibilities

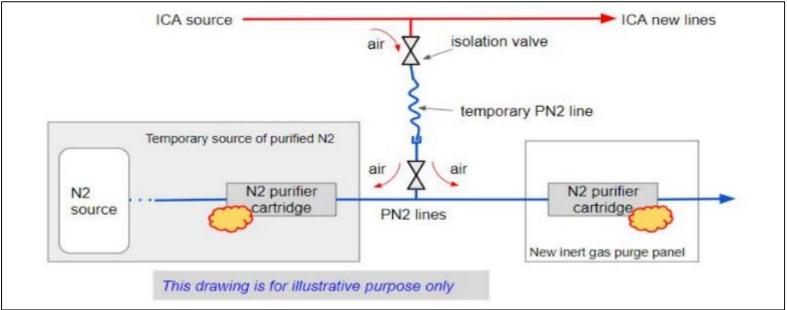
Event #12 Pictures

The purifier cartridges are designed to purify inert gases such as nitrogen which may contain some traces of oxygen. A backflow of air arrived in the purified nitrogen circuit and caused an exothermic reaction with the purifier catalyst causing damage to the purifier cartridge due to excessive heat generation.

The temporary purified nitrogen line used to purge the new Industrial Compressed Air line was not disconnected after use. Isolation valves on the Industrial Compressed Air line and purified nitrogen line were not closed when not in use.

- Temporary connections were not being considered in the Commissioning phases - gap in pre-start up safety review
- Less than adequate engineering control

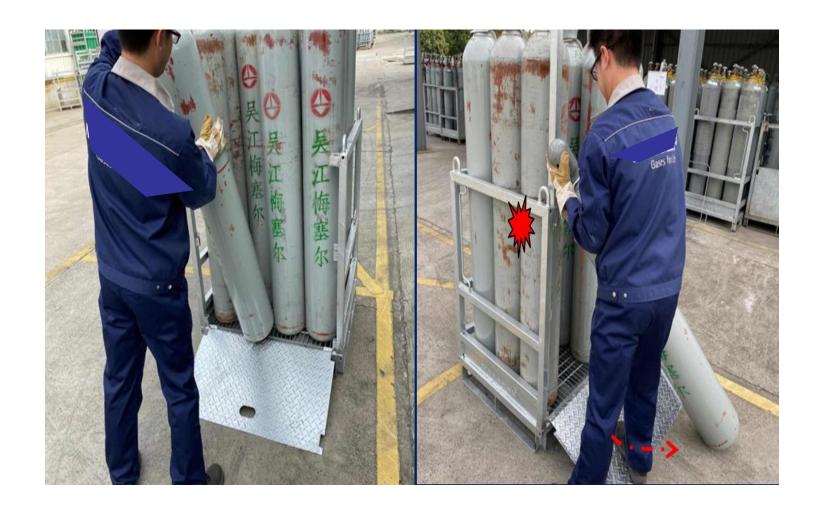
Event #13 Pictures

Around 15:00 hrs, a helper suffered a fracture on the middle finger of his left hand while he was unloading the cylinders from a pallet. One cylinder fell down by his incorrect operation, and he tried to hold the falling cylinder, but failed. The cylinder hit his hand and caused the injury.

Unsafe act by the helper - The helper pulled the cylinder forcefully, and caused the bottom of the cylinder slipping off the loading cant board

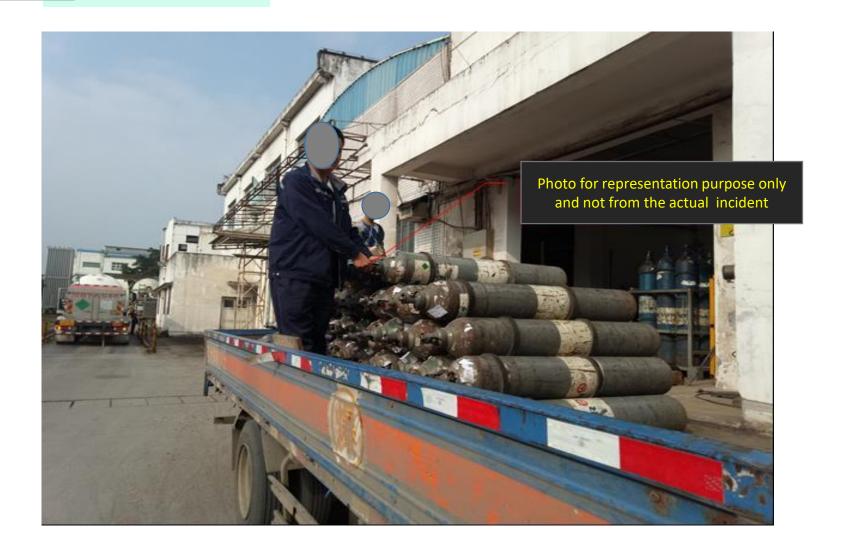
Event #15 Pictures

A cylinder loader slipped from the truck on the ground during cylinder loading with his head and right shoulder to the ground. After medical check, the loader injured with subcutaneous blood stasis of the brain, and some soft tissue contusion at his right shoulder

- The operator stood on the truck and pulled the cylinder, posing a risk of falling
- The old fixed bottle cap is easy to loosen due to its long life
- Horizontal transportation has a higher safety risk than vertical transportation

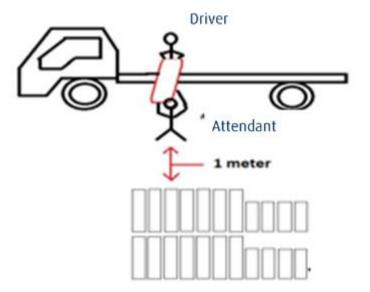
A driver and his helper were unloading empty cylinders from the truck when one of the horizontally laid cylinder slipped and made contact with other vertical freestanding cylinders on the ground. The helper who was holding an empty cylinder had his finger pinched when the cylinders started to impact each other. He was brought for medical treatment immediately.

- Lack of risk assessment for flatbed truck loading/unloading activities
- Lack of MHE(Mobile Handling Equipment) at site such as tail lift and side lifter.

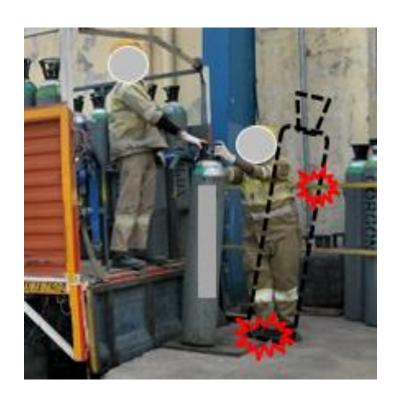
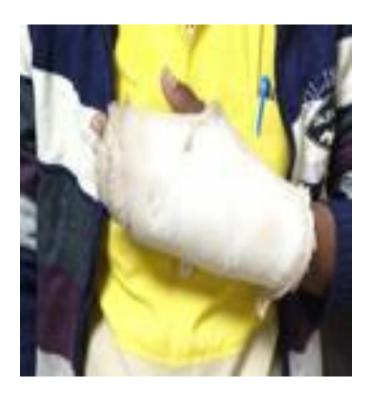
A cylinder helper was unloading full cylinder when one full cylinder got unbalanced and was about to fall down on the ground. The cylinder helper's left-hand palm was caught between the cylinder and the cylinder holding restraint. He suffered a fracture on the index finger.

- Inappropriate manual handling techniques
- Vehicle is not equipped with tail lifts for unloading/loading activities
- Lack of supervision of unsafe act for loading/unloading activities

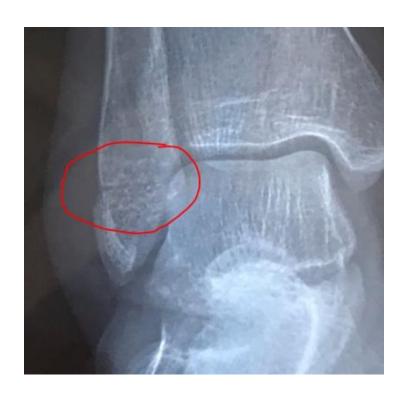
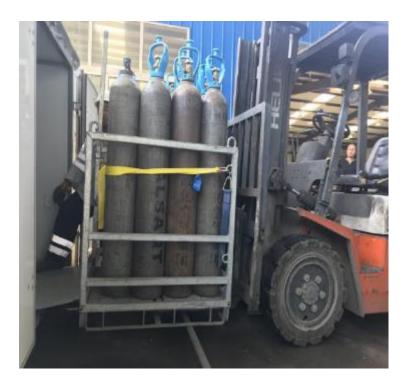
An employee went in front of a cylinder basket immediately after the forklift stopped when a cylinder toppled from the basket and hit the employee's right ankle, resulting in a fracture. The incident happened when he was unloading cylinders at a customer's site.

- Human :Stood In the line of fire
- Organisational : Job Hazard Analysis was not conducted

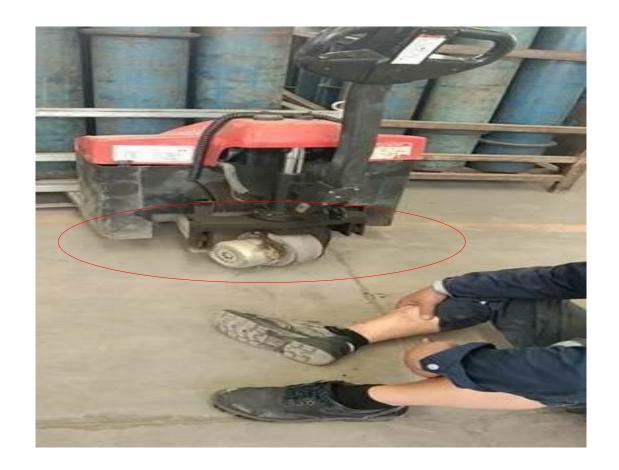
Event #19 Pictures

A helper was using an electric forklift to move the pallet in the filling station.
The electric forklift couldn't be stopped due to the fault in the control system
of the electric forklift and the improper operation of the helper. The helper
got a injury on his right foot

- The operation button of the electric forklift was out of order
- The protective cover was missing
- No risk assessment for this operation (small space between the pallets)

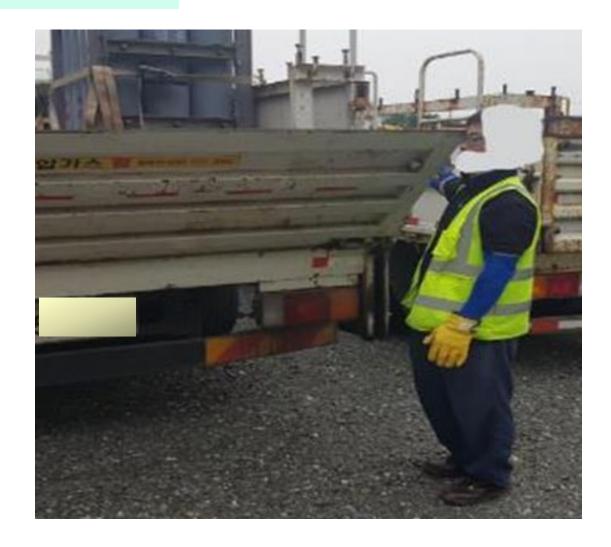
Event #20 Pictures

After delivering bundle cylinder to a customer, the driver stood next to the vehicle to remotely operate tail lift to raise up. Suddenly the lift unfolded and the right side of the lift grazed the driver's right side of forehead.

- The driver stood on the line of fire to operate the tailgate with distraction he was looking at the other side when the switch was operated.
- Lack specific Job Safety Analysis or Safe Working Instruction
- The ground was slopped about 15 degree.

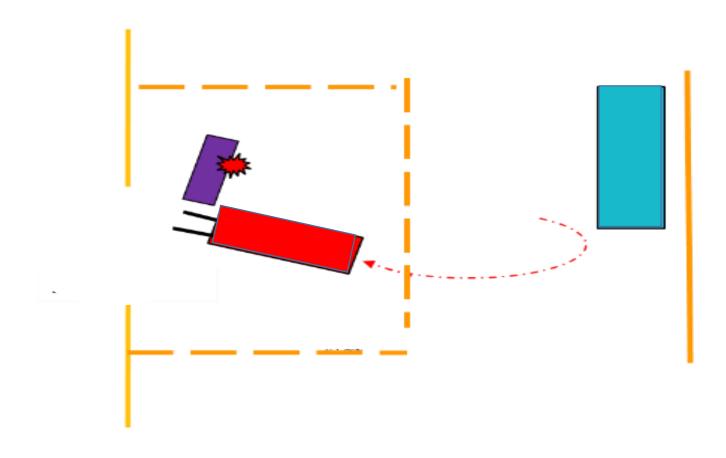
• The incident happened at a site which was in the transition period from construction to operation. A contractor was driving a forklift with a electric low voltage electric cabinet (size: 800 mm * 1000 mm * 2200 mm weight: 200 kg). The incident happened when he arrived at a gentle slope, the low voltage electrical cabinet got dumped at a contractor employee, and pressed his left body to the ground. The employee suffered a multiple soft tissue injury (foot, vertebra) who was wearing a safety helmet but no safety shoes.

- The contractor fails to strictly obey the safety operation rules and isolate the unloading area
- The forklift driver did not strictly follow the operation rules of forklift and did not fix or lay down the objects that might be dumped

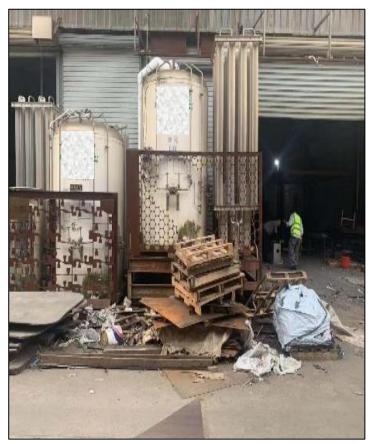
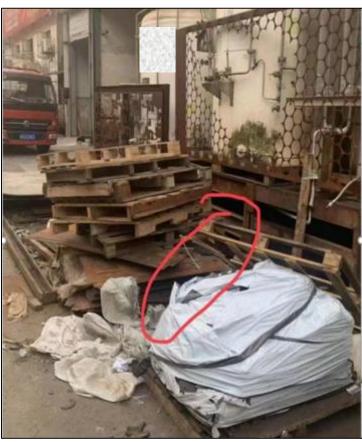
Event #22 Pictures

Around 18:30hrs a Mini Bulk driver delivered LIN to customer. There was a lot sundries around the tank and the driver had to stepped on them to vent the tank. After he opened the vent valve, he tried to step back out without turning around due to the space limitation, he was tripped and his right hip landed on uneven objects. The driver stood up and found nothing except a little pain on his hip. Afterwards he continues the last 2 deliveries.

- Poor safety awareness at trip hazard, doesn't follow 'Master The Basics'.
- Poor housekeeping and insufficient lighting at customer site.

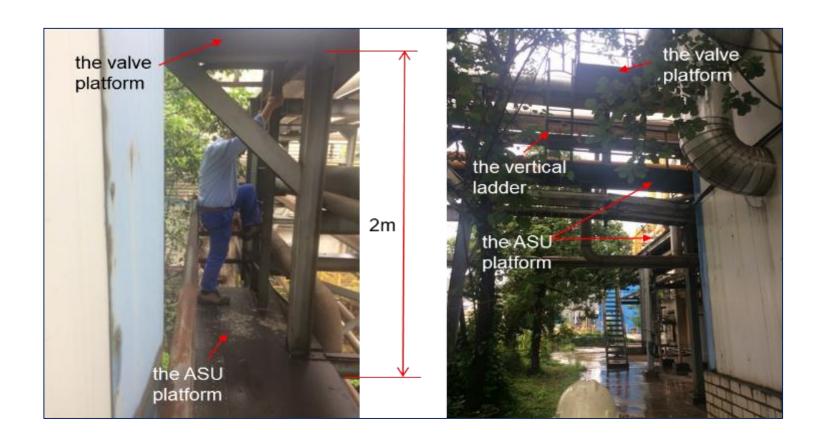
Around 23:30 hrs an operator heavily dropped to a platform after checking/operating a valve which was located on a valve operation platform for a pipe rack. He suffered from a calcaneal fracture of his right foot. The operator was wearing appropriate working shoes. The ladder was not too high and the operator also didn't hold any tool in his hands.

• Act of negligence - While climbing down the ladder the operator assumed to have reached the platform. So he loosened his grip on the ladder and fell down.

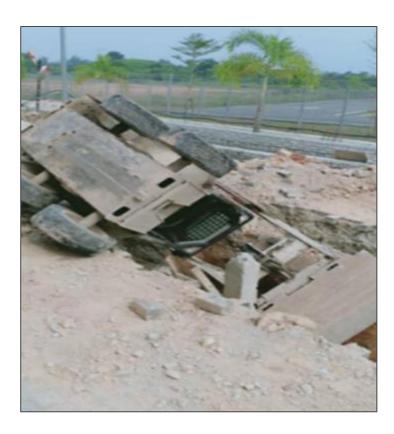
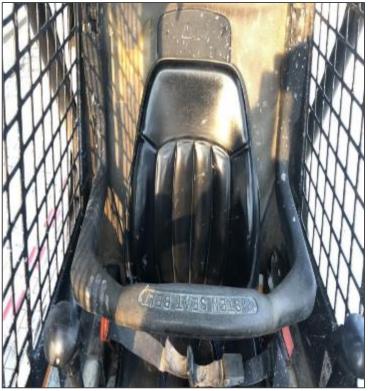
At a piling site, a skid steer loader (Bobcat) was used to lift a pile head waste (around 1 meter length and 160kg weight) from a trench. While removing the pile head waste, the soil and interlocking brick underneath the bobcat near the trench slid, causing the bobcat to lose its balance and subsequently rolled on its side.

- Failure of contractor to inform that Bobcat to be used for suspended lifting during subsequent JSA session
- Lack of competency of PTW(Permit to Work) issuer
- Site management monitoring/ engagement insufficient
