Training Package TP 28/20

Recent (H1 of 2020) Accidents/Incidents in the Gases Industry in Asia

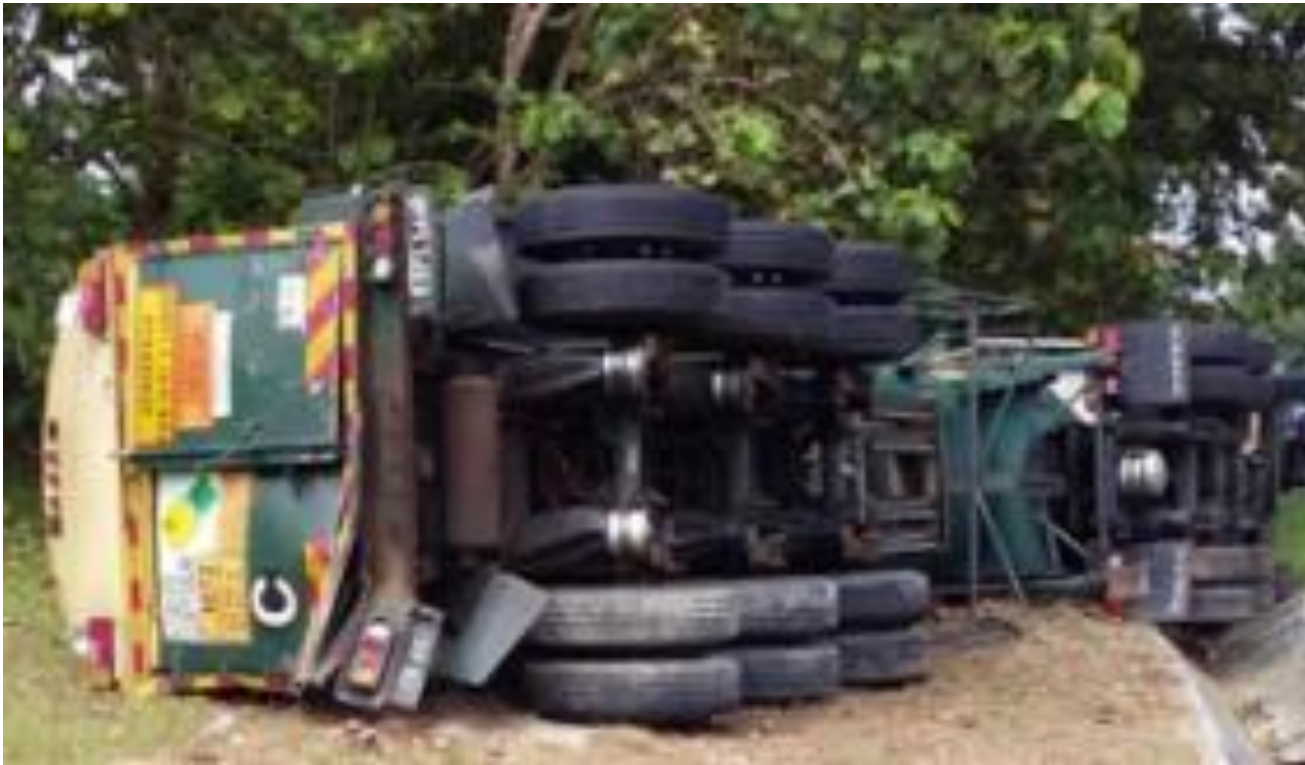
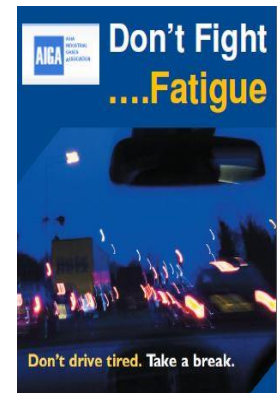
LOX tanker with full load heading to a customer from a terminal was rolled over at around 06:00 hrs. The road was dry, and driver was cruising less than 78km/hr; which was below the max allowable speed of 80km/hr. There was no streetlights, but the truck headlight was bright enough. There was no injury to the driver, however, the co-driver sustained minor scratches on the left upper thigh. The driver wore his seat belt, while the co-driver was resting in the sleeper berth.

There was no product release, but the tanker was badly damaged. No 3rd party was involved. No major environmental impact in this incident.

- Driver had a micro sleep - there was no sign that he applied the brakes.
- Driver felt sleepy about 15km before the rollover scene but there was no safe area for him to stop the tanker.

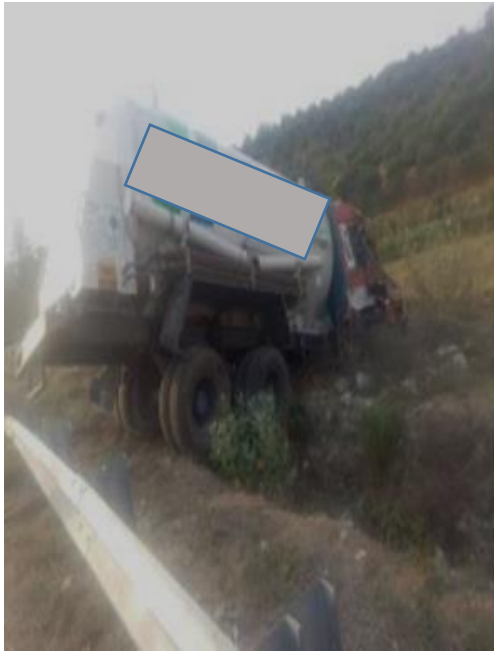
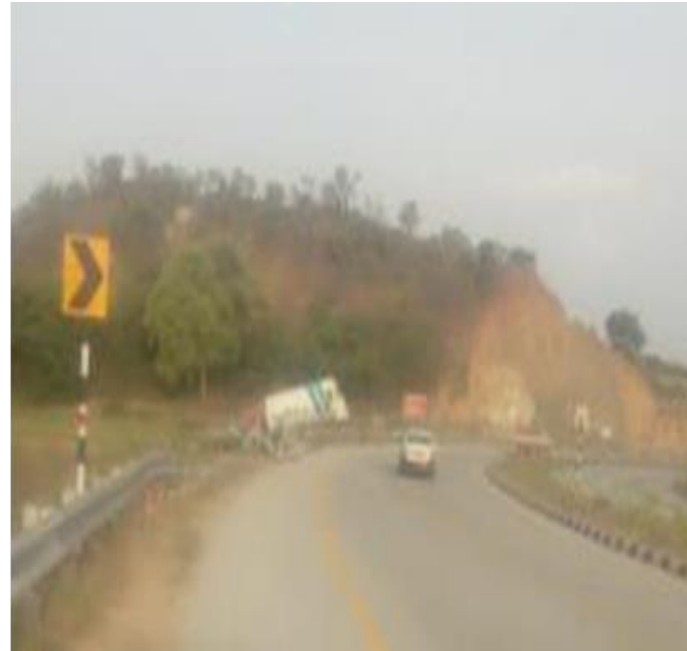
Due to the speed and impact, the truck was rolled over and the driver was fatally injured. No major environmental impact in this incident.

- Driver lost control of the empty product tanker due to rush driving
- At risk behavior - High speed while moving downhill and negotiating the right curve road
- Not using seat belt

Roll over + No seatbelt ⇒ Driver fatality

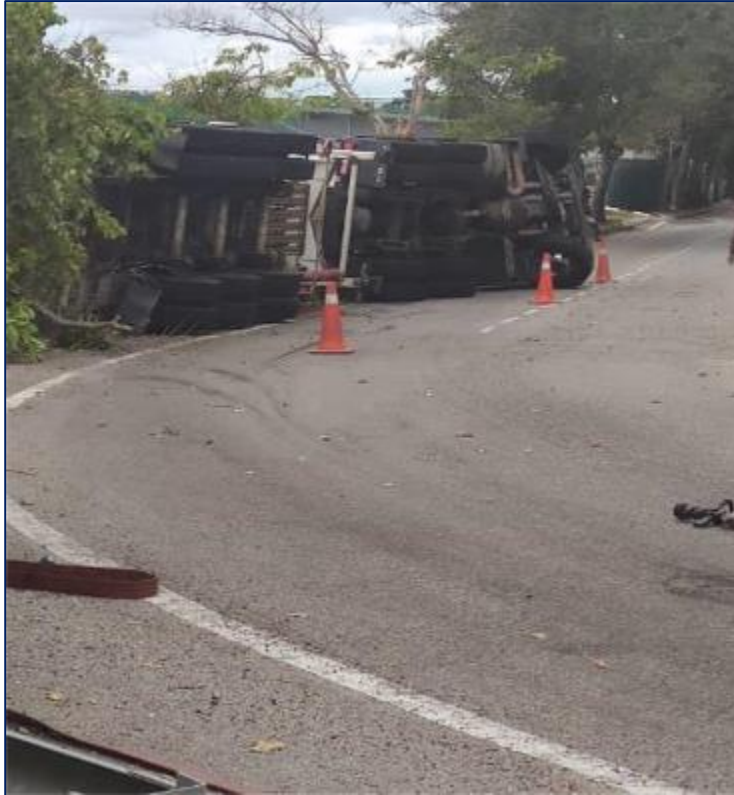
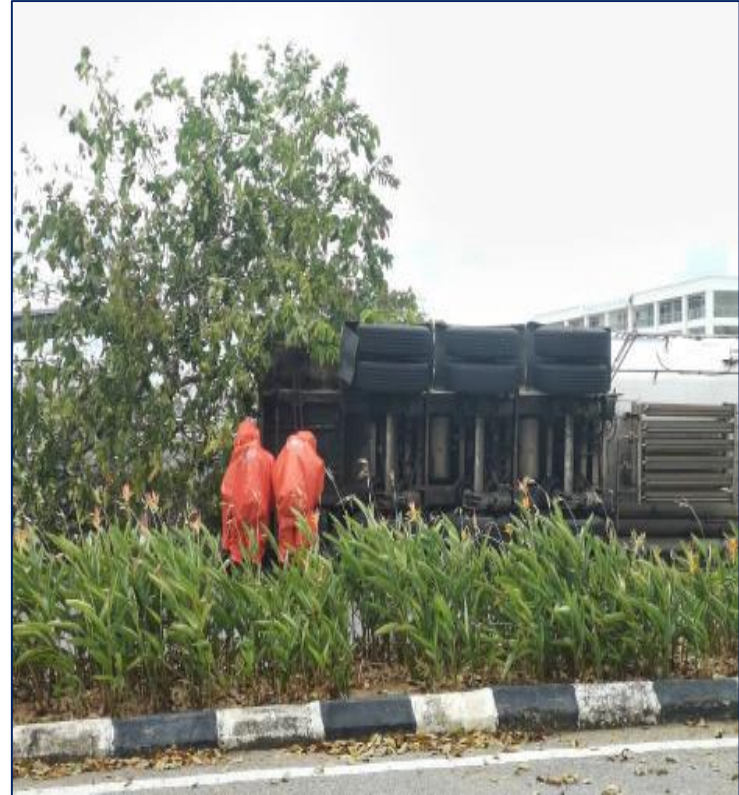
A 3/4th loaded LN2 trailer driven by a contractor driver was involved in a single vehicle roll over while negotiating a sharp bend. The driver was wearing seat belt and sustained minor scratches on his left hand. There was no product release. Local authority emergency response teams were present for the recovery of the product and vehicle.

- Driver at risk behavior – Speed higher than required
- Inconsistent monitoring of in cab camera and feedback to driver/gap in Driver Coaching
- RSS was not completely implemented and less focus on the functionality
- Not following vehicle inspection/preventive maintenance procedures

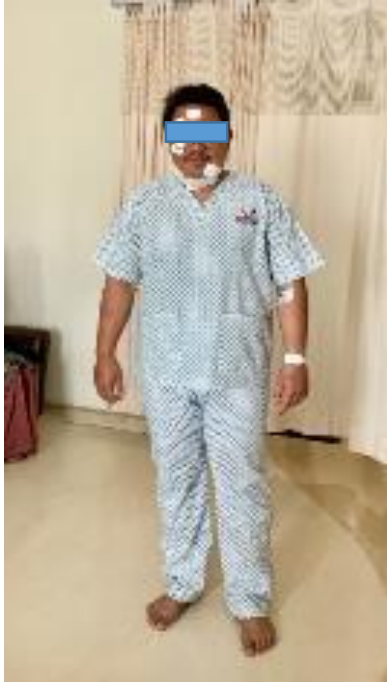
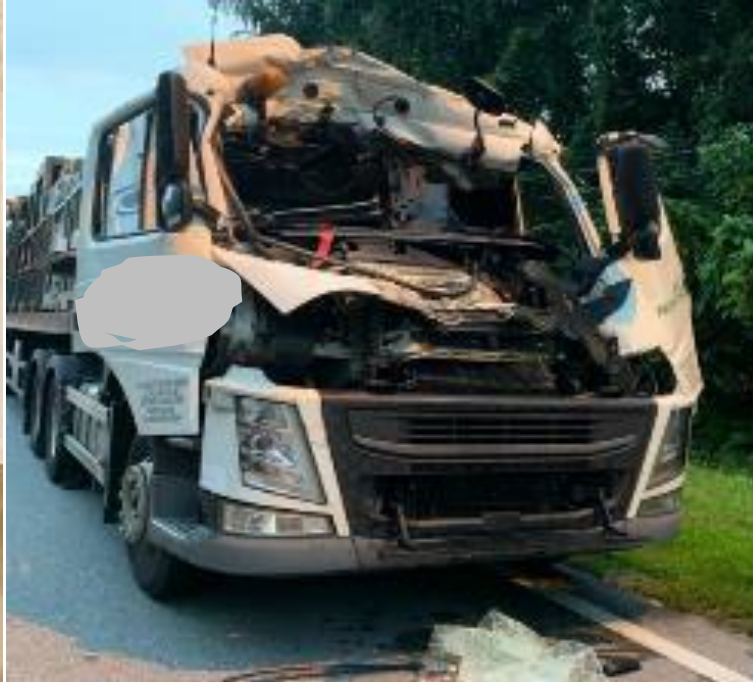
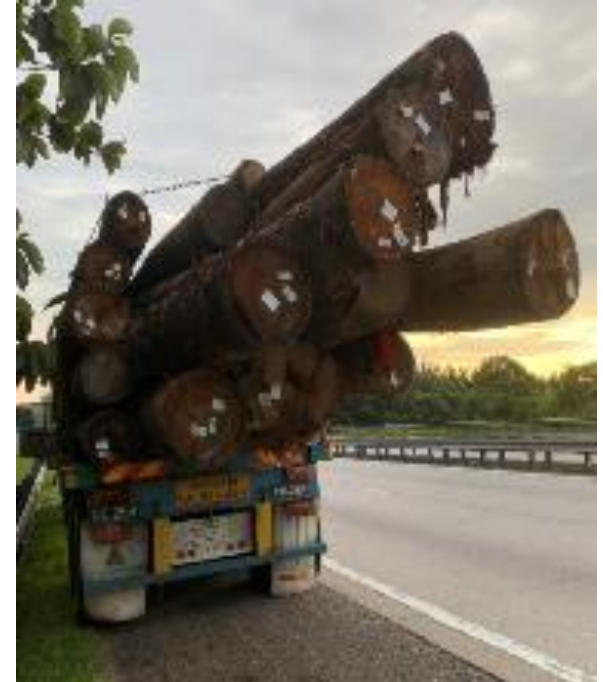
The incident happened at around 2:30am. The tractor truck was badly damaged while there was no impact to the packed cylinders and the trailer. The trailer was hooked to the replacement tractor head and continued the journey.

- Lack of safe space ahead - based on the brake mark and impact
- Travelling too fast for the road conditions - night driving with poor visibility of the overhung timber logs.

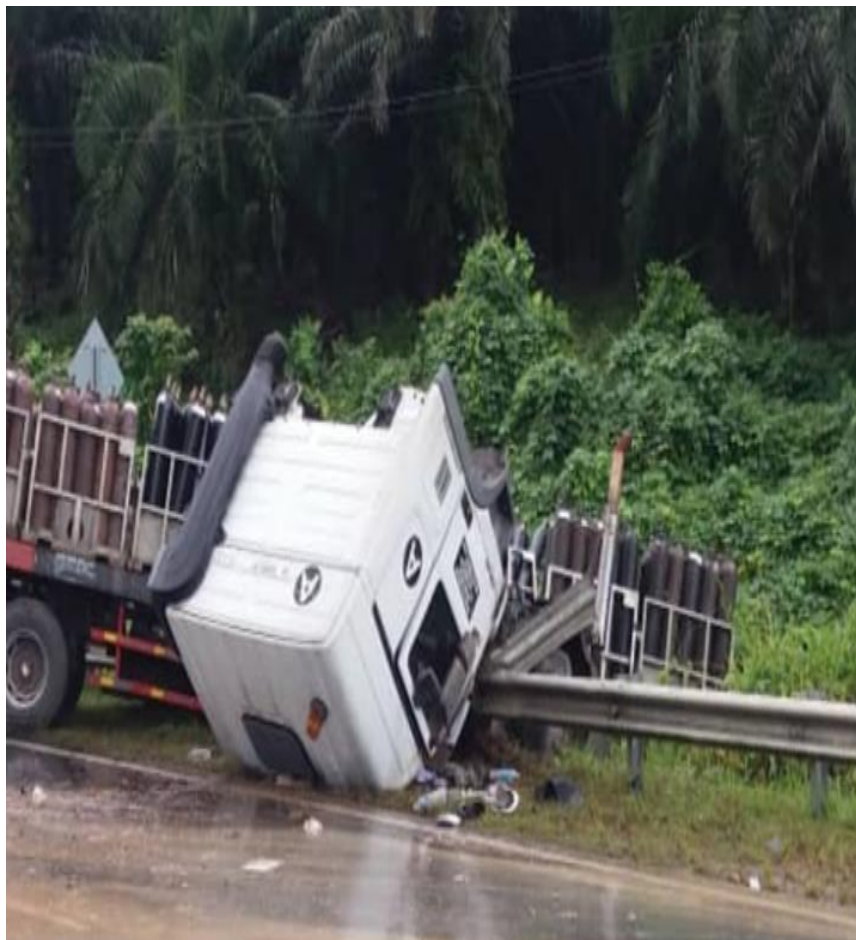
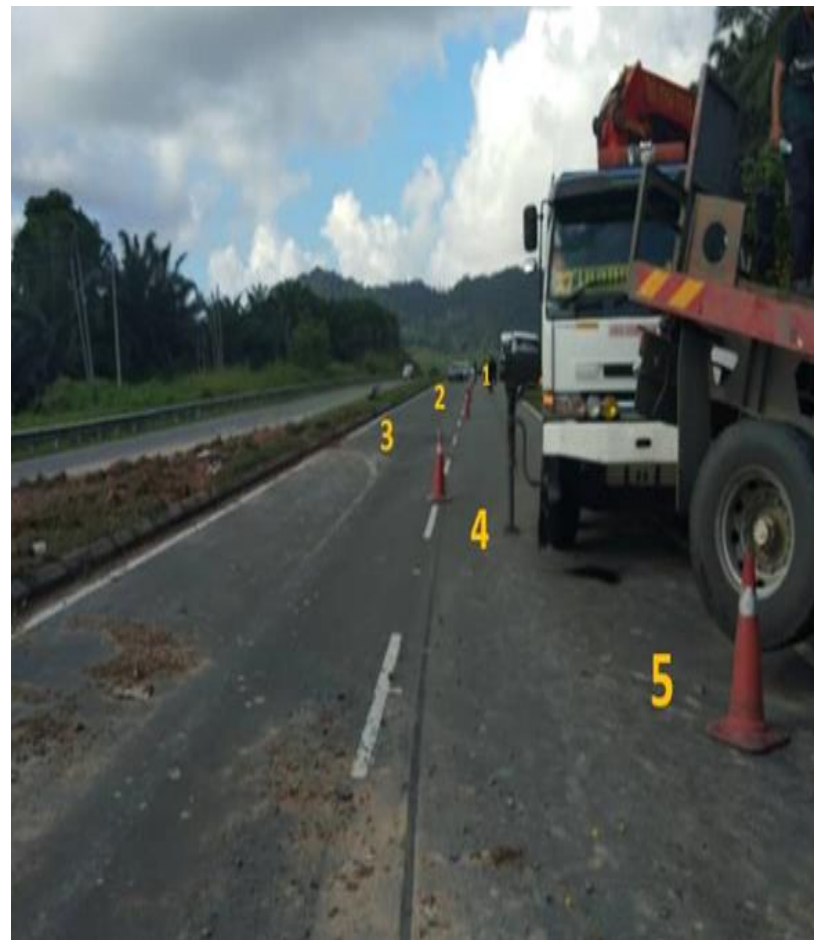
The road surface was slippery due to rain when the prime mover swerved to the RHS onto the median and later steered to the LHS and finally jack knifed left into the ditch. The impact caused the vehicle ran over the road railing and had its cabin flipped over. The driver suffered minor bruises to his left shoulder

- Bald tyres and Lack of maintenance inspections
- Driver at risk behavior with speed
- Contractor Management – Insufficient Checks and balances
- Inadequate Route risk assessment

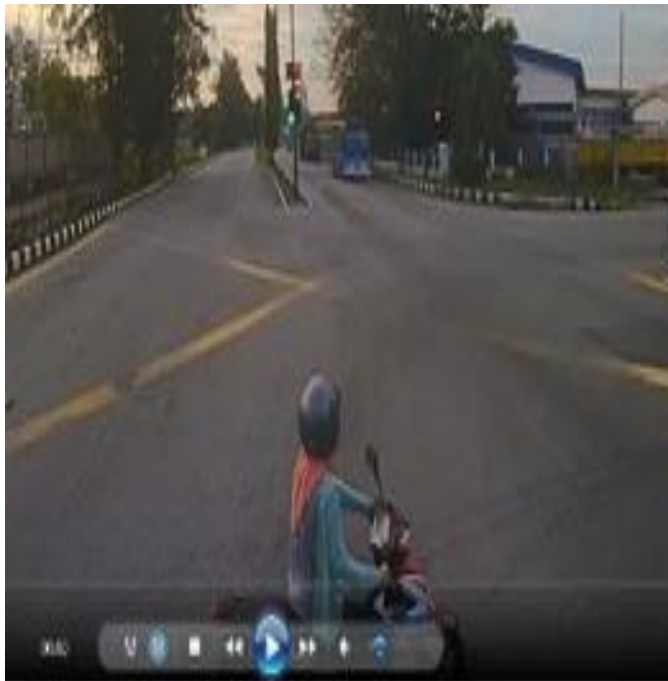
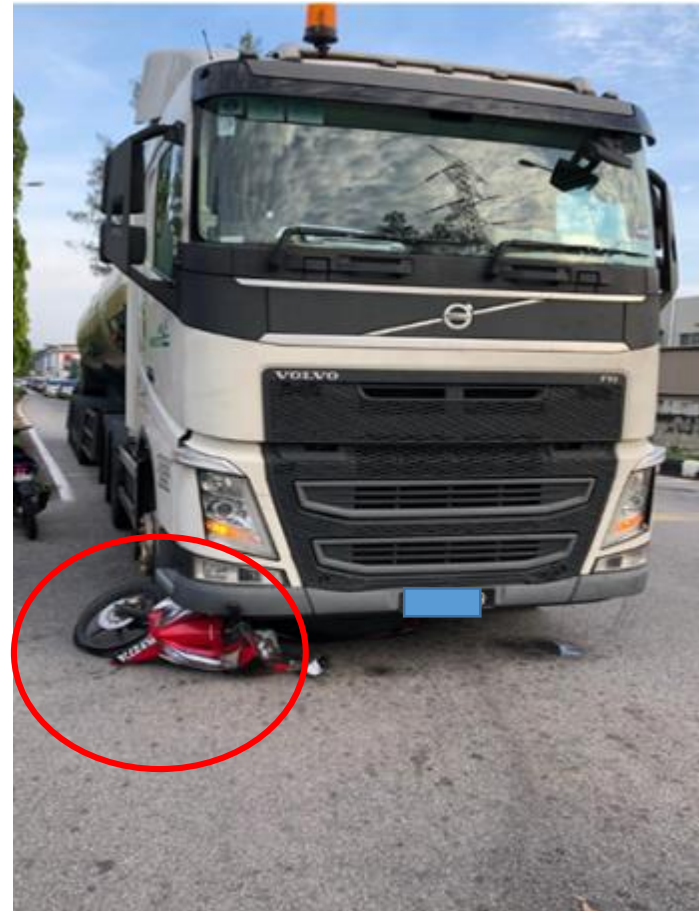
The driver immediately stopped the truck and got down to investigate. The motorcyclist fell down but escaped with slight cut at the ankle. There was no damage to the truck, but the motorcycle was badly damaged.

- Driver started to move truck one second before the light turned green
- Motorcyclist was in the driver's blind spot due to height of the product vehicle driver cabin

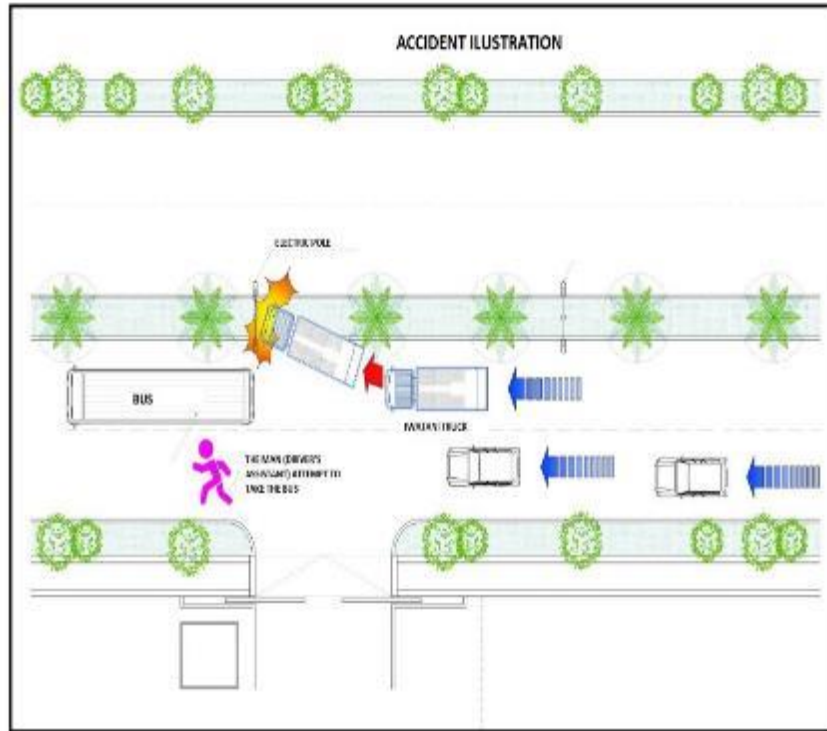
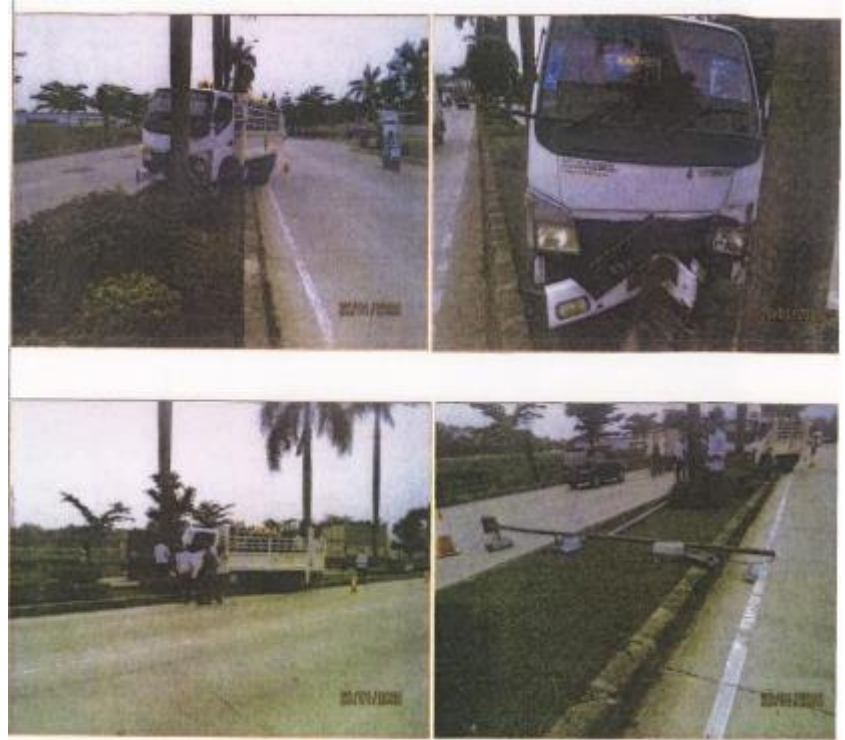
A cylinder truck crashed toward an Electric pole while the bus in front of truck suddenly applied hard break to pick up a man in the way. The situation made truck's driver spontaneously turned the steering to right side to escape rear ending the front bus. The truck went up the way separator and hit an electric pole . The truck speed was 40km/hr at the time of the incident.

- Poor attitude of box truck driver (emotional and aggressive).
- The cylinder truck driver not focus in driving. (chatting with co-driver made him lose concentration and late to anticipate the situation)
- Not maintaining safe distance with the vehicle in front.

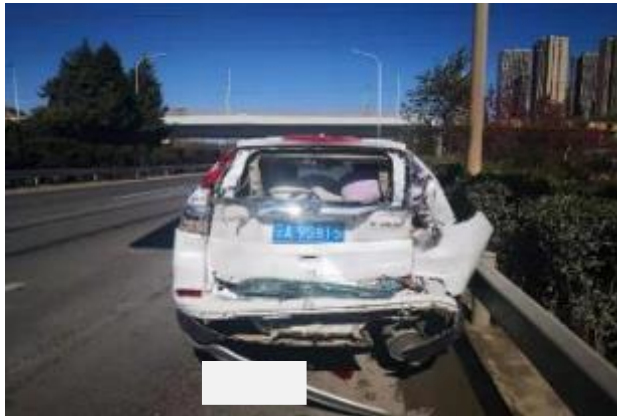
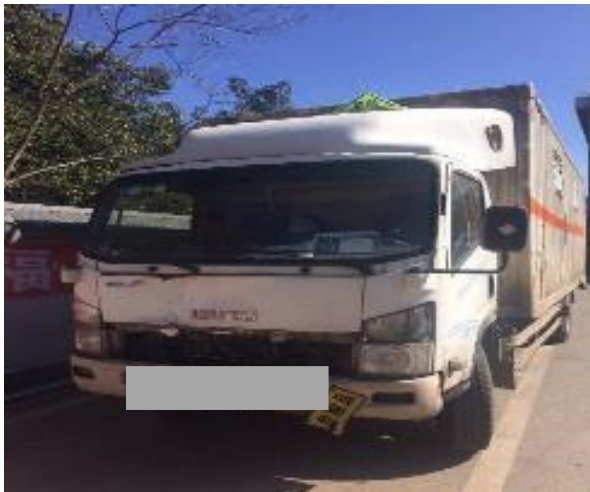
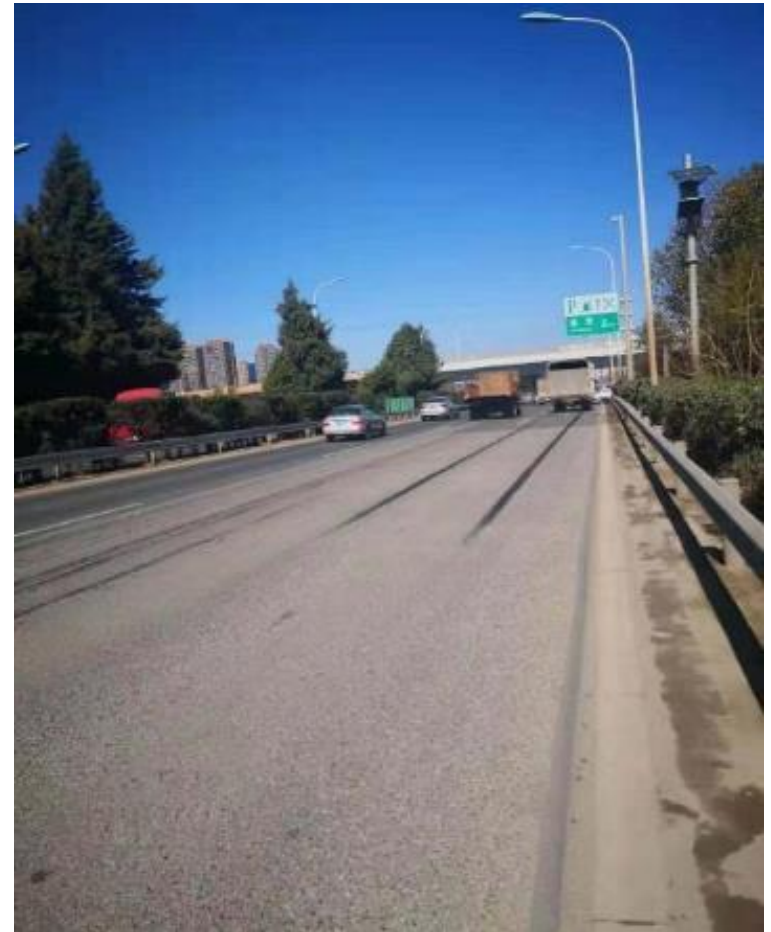
- Too close to the car in front
- Failure of rear wheel brake/ poor brake maintenance QC

Too close to the car in front, no traces of rear wheel brake mark.
Failure of rear wheel brake

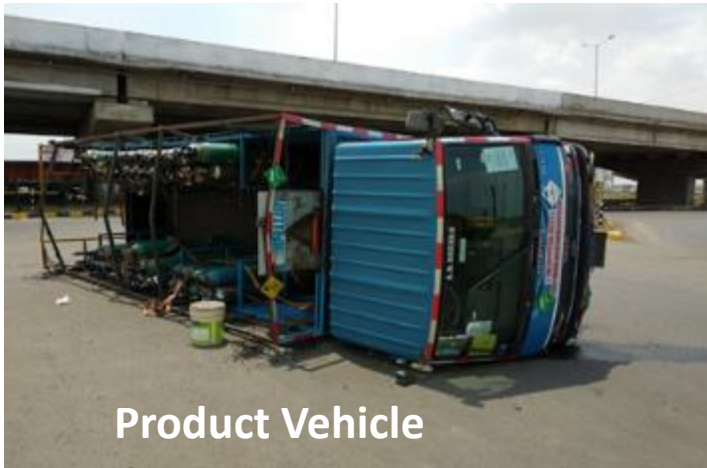
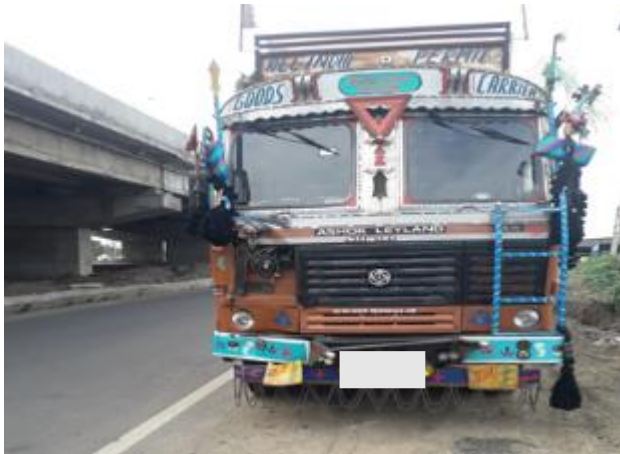
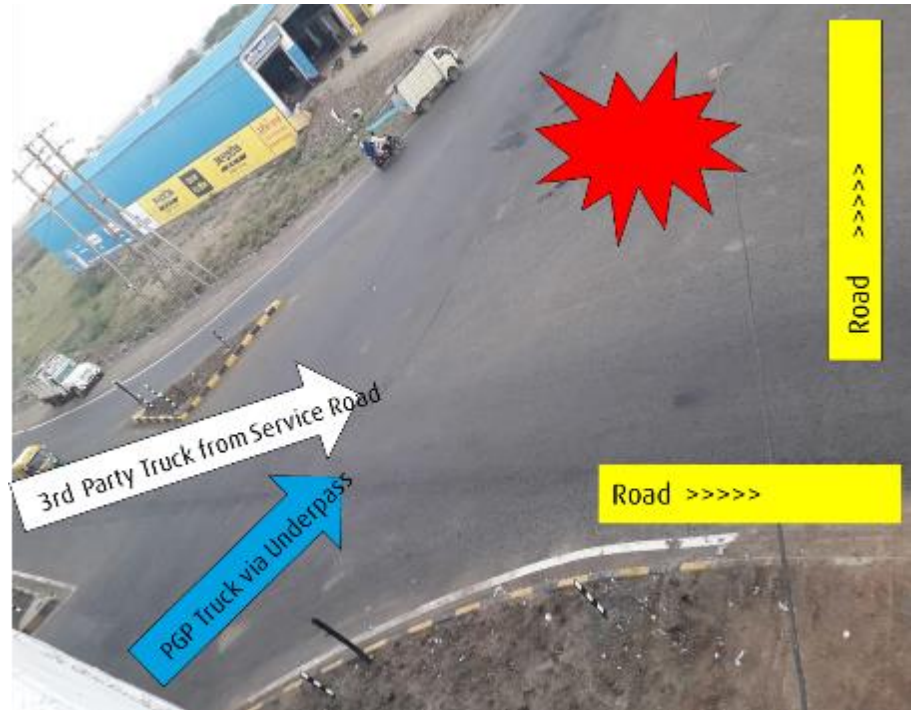
Contractor operated product vehicle loaded 50 full & empty Argon-CO2 mixes cylinders, met with an incident at the intersection. While the product vehicle was negotiating the intersection, a third party trailer came from the left lane and hit the side rear-end of the product vehicle. Due to this impact product vehicle rolled over to its right at 90 degree. Speed of the product vehicle was 16 KM/H at the time of collision. The driver was seat belted and received no injuries. Also there were no damage or dents on the cylinders. The third party trailer received minor dents only.

- 3rd party vehicle from service lane failed to control speed when approaching intersection
- Failure to yield the “Right of way” (Posted signages)
- Failure to lookout for vision barriers
- Failure to check in all directions and leaves a space cushion before starting up at intersection

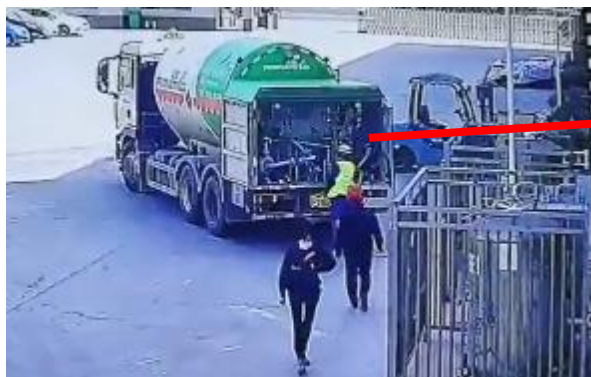
Driver wanted to close the liquid phase valve to finish CO2 tank filling, but he opened the vapor phase valve by mistake

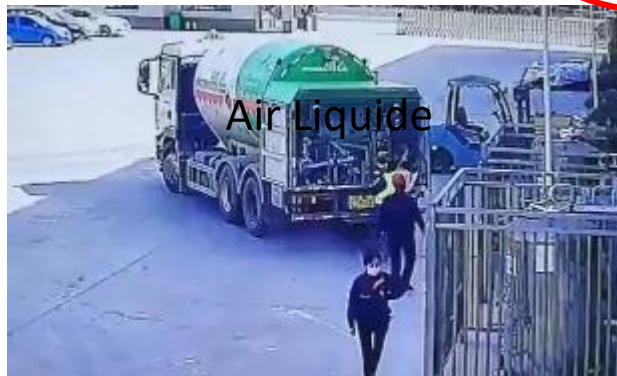
The high pressure CO2 gas ejected suddenly from vapor valve and knocked on the driver.

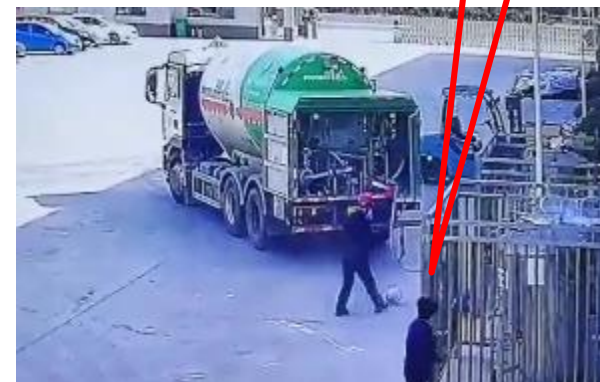
Driver was knocked down on the ground and injured

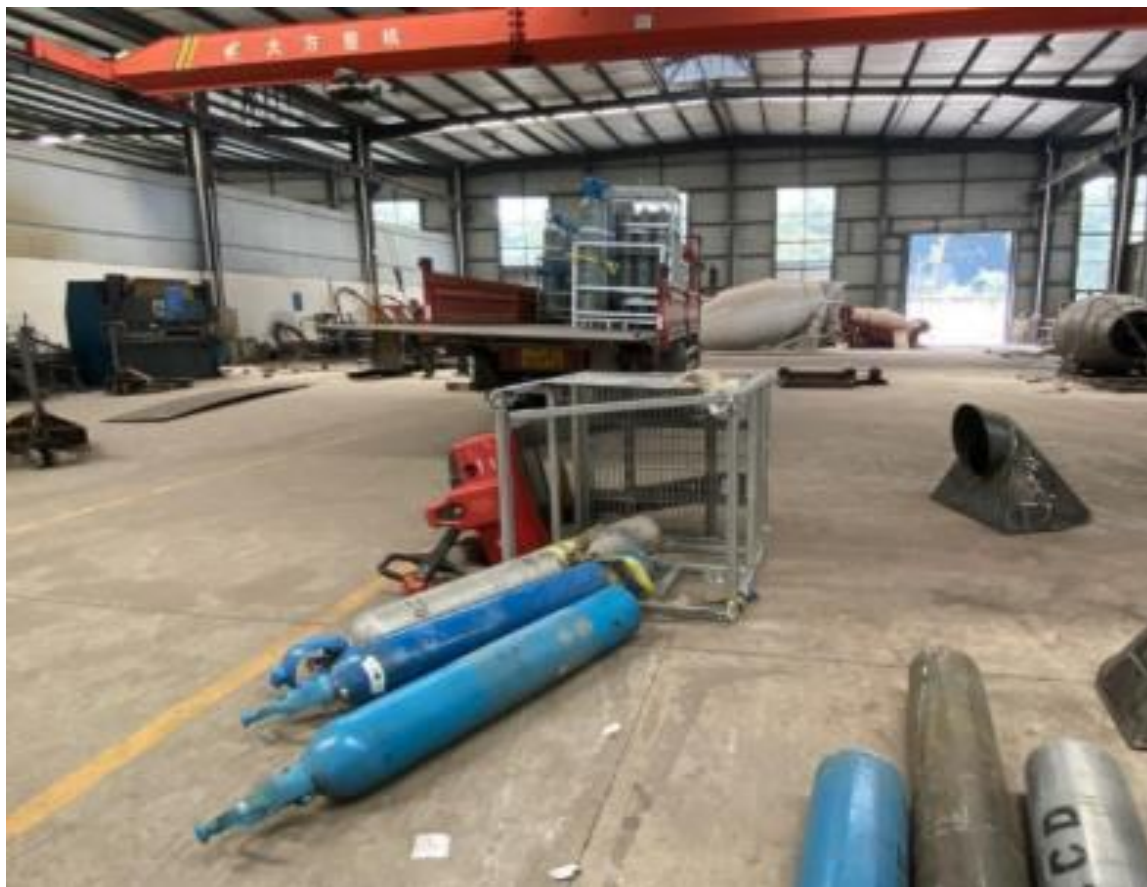
A driver who was operating an electric pallet jack was pulling the basket of 6 cylinders onto the tailboard. While he was at the tailboard, it suddenly tilted downward causing the driver to lose balance. The pallet jack, driver and cylinder fell off the truck. Some of the falling cylinders hit the assistant who was nearby resulting in multiple fractures.

- Human Error : Assistant pressing both down and tilt button at the same time
- No clear definition of roles in the unloading process (who to operate and when to operate, what to do etc)

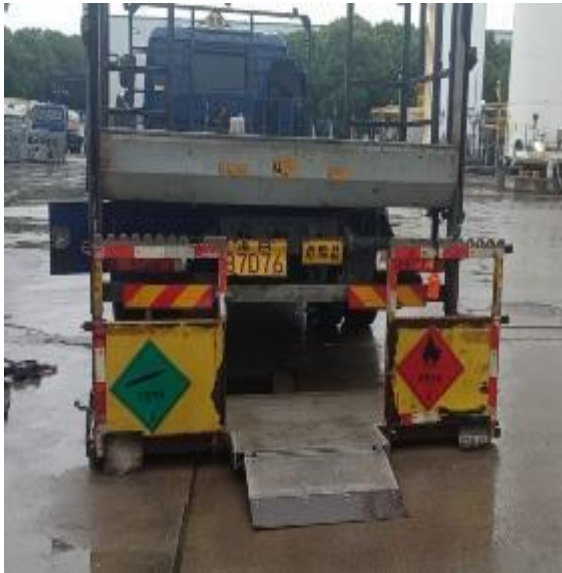
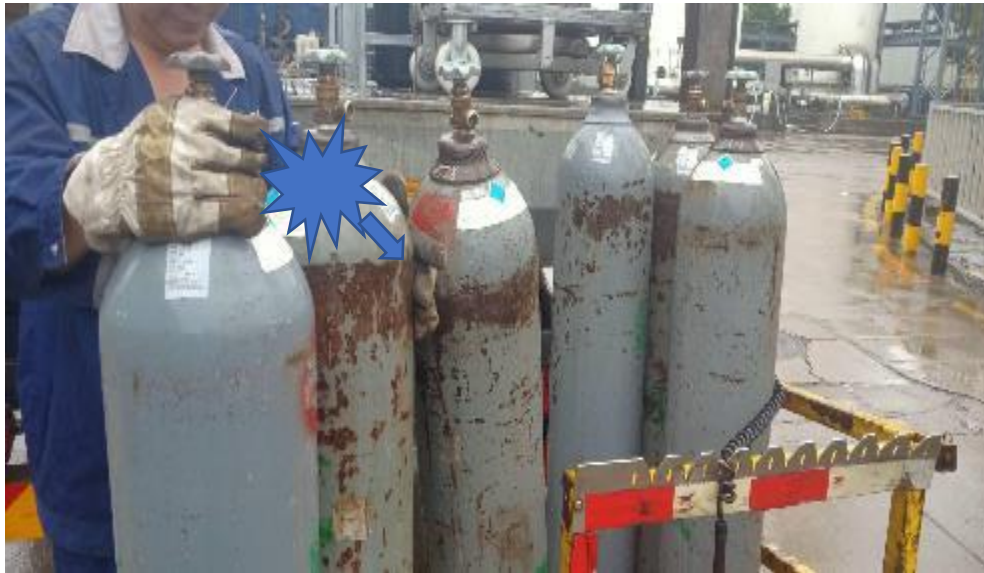
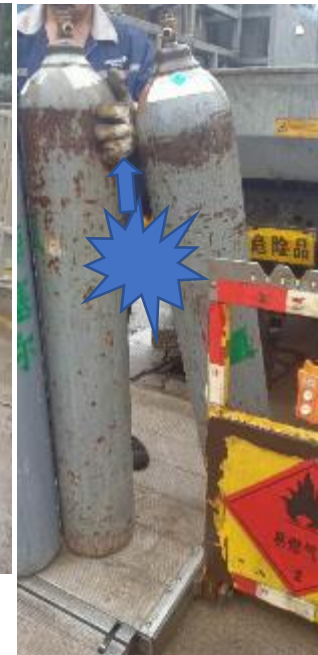
A driver and a escort recalled the empty cylinders at customer site with rear lift gate truck. 4 cylinders had been placed on the lift gate and the driver tried to roll 2 cylinders at the same time on the lift gate. One of the 4 other cylinders was about to topple when the driver tried to stop the falling cylinder with his left hand but failed. His hand was pinched by 2 cylinders and he suffered a fracture on the third metacarpal on left palm

- The driver tried to stop a falling cylinder
- Failure to follow safe handling of cylinder by the driver when he rolled two cylinders at the same time
- Failure to fasten the cylinders on the lift gate with chains

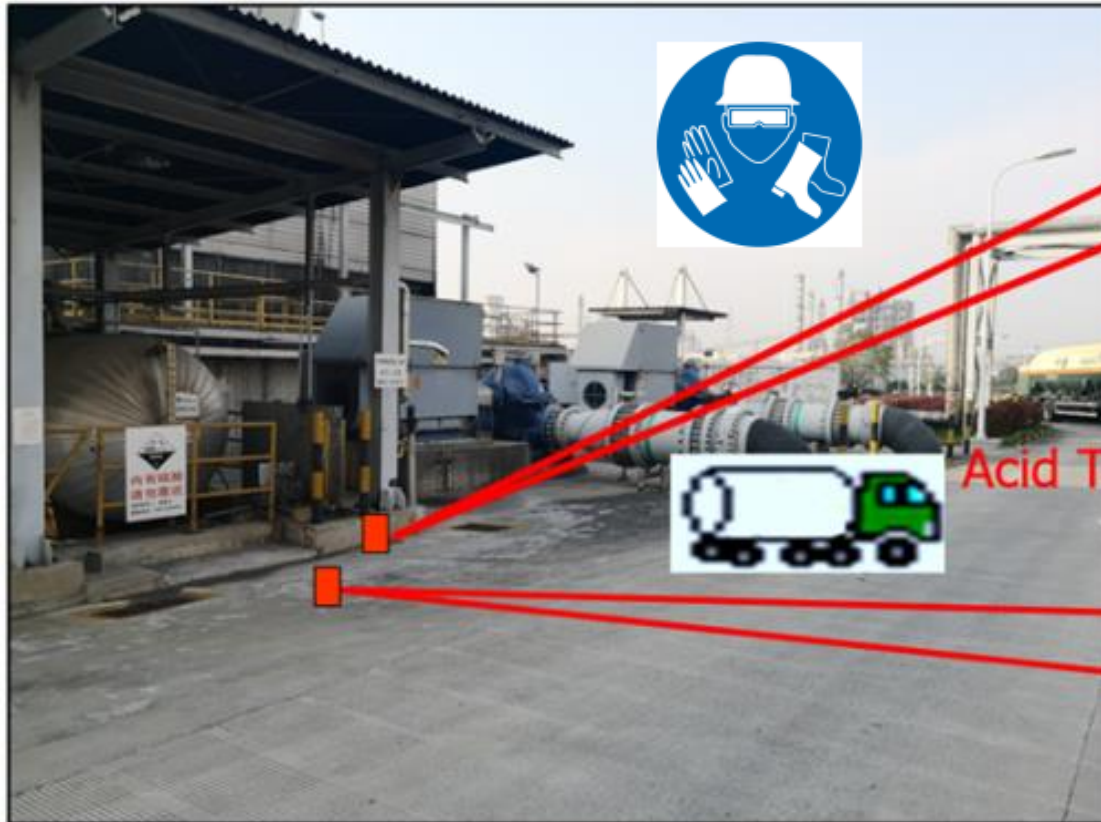
Disconnected Hose

- Sulfuric acid unloading hose broke apart at the hose connection.
- Driver doing Acid delivery did not obtain permission from the customer's employee before re-opening the tanker's valve to the unloading hose.
- Site operator didn't wear suitable PPE, such as face shield, apron, etc.

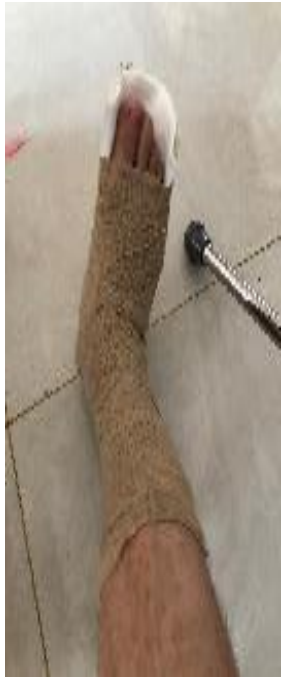
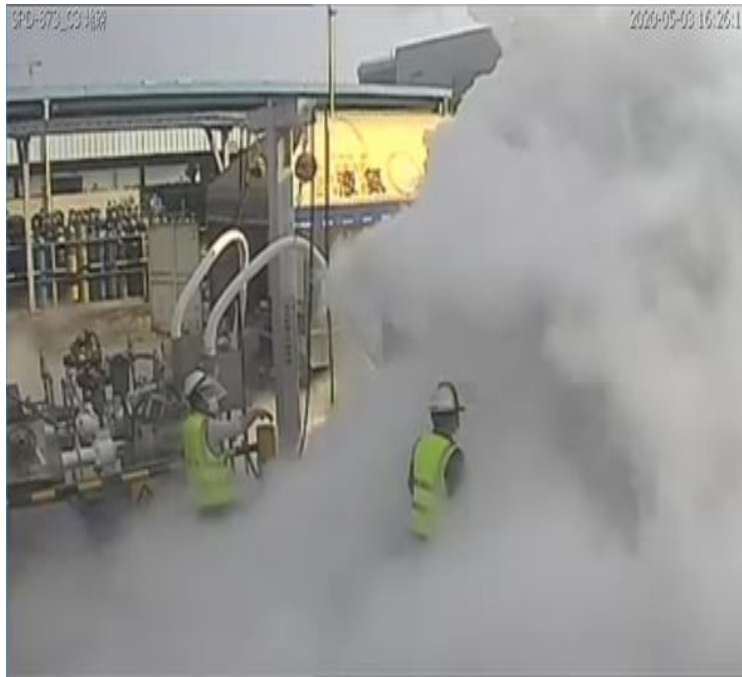
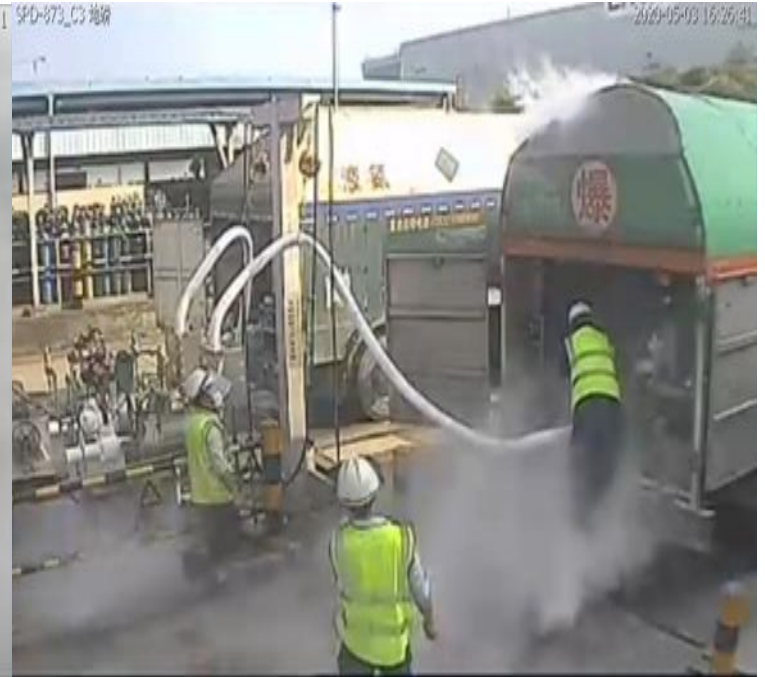
LIN tanker was on loading when the driver saw both filling stations tripped automatically in the Scale Room. Thru' the Truck Scale room window, he also observed that some vapor cloud was discharging from the trailer's PSV nearly at the same time. The driver rushed to the trailer rear. He stepped on the edge of the road, fell down and sprained his right foot. Then he opened the trailer vent valve to release the pressure, the PSV got reseal within 80~90 seconds. This led to a large amount of vapor cloud on site.

- Incorrect fill setting
- Driver was not trained to respond to overfill situation

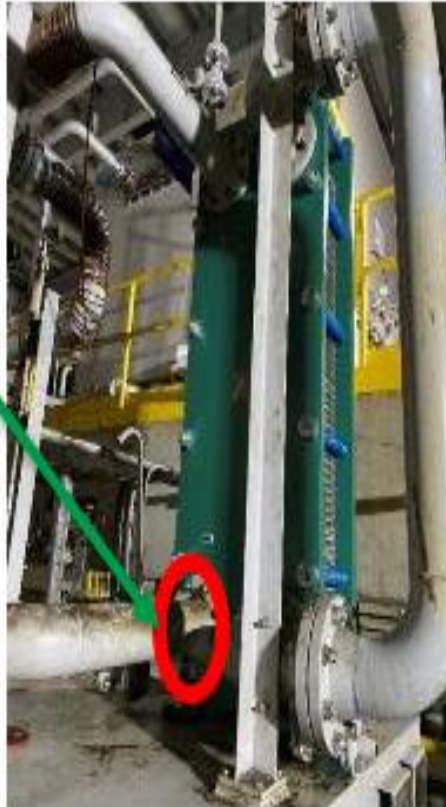
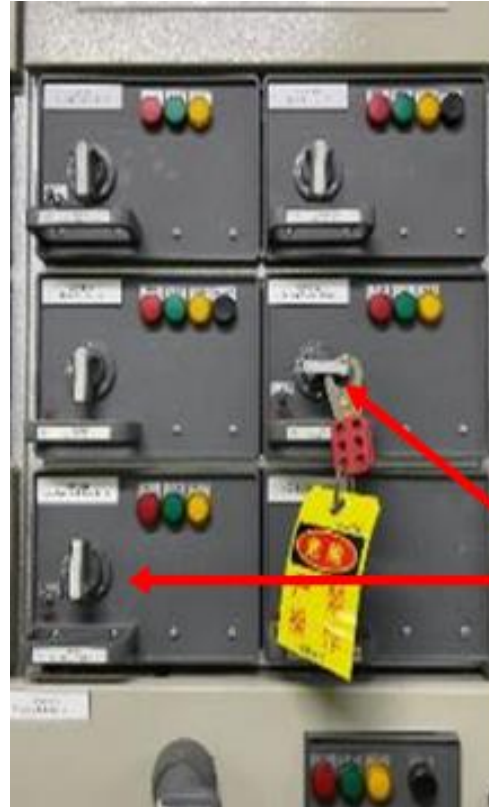
- Functional engineer did not work together with SWP Issuer
- Wrong switch was lockout and tagout
- Blind flange was not installed on oil pipeline

Cooler was removed and pipeline kept open with plastic film covered.

1. Wrong switch was locked (G122 vs K122)

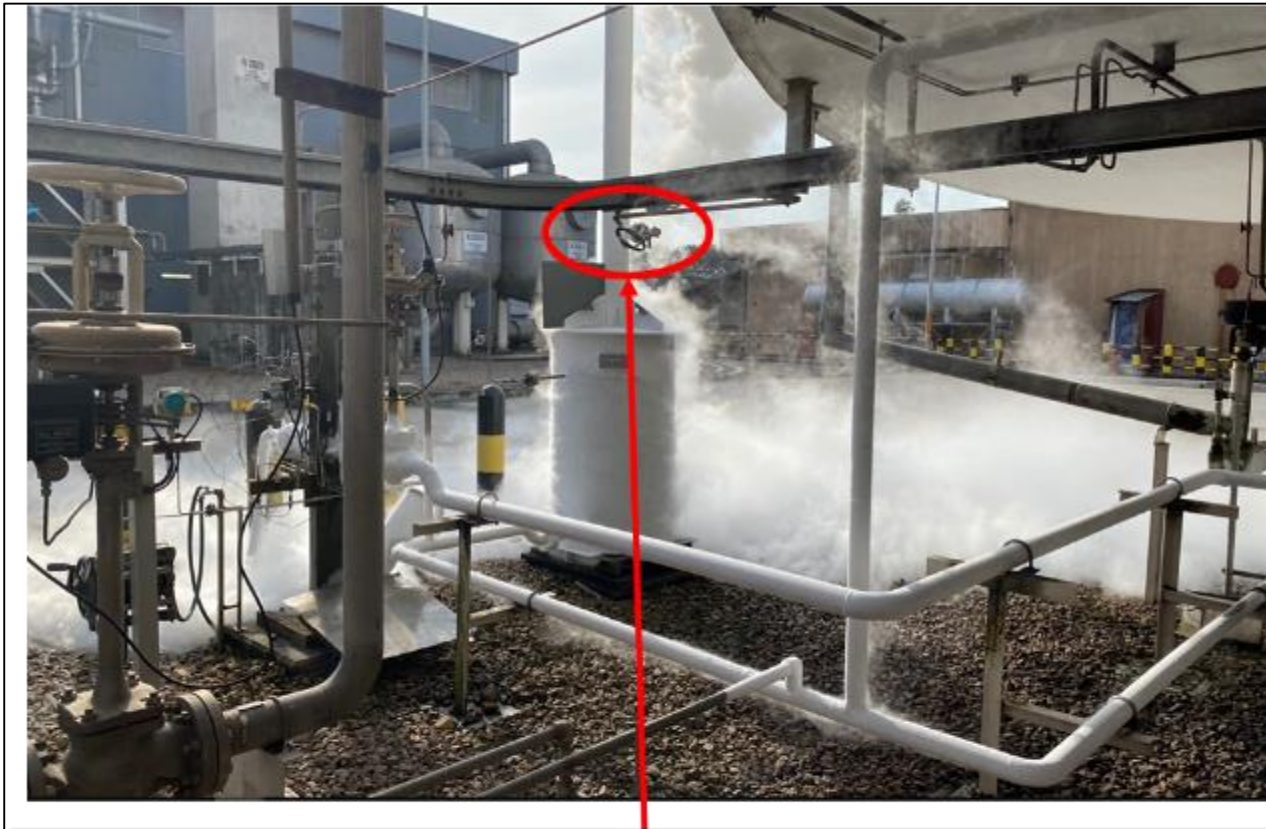
- Inaccurate level on transmitter
- Wrong setting of timer on Temperature device
- Instrument fault – no device to monitor LN2 product cooling temp
- Communication gaps between operators (remote and site)
- Lack of understanding on alarm management

Dump pot overflow sensor at -195.7°C , indicate the liquid N_2 had reach the top of dump pot.

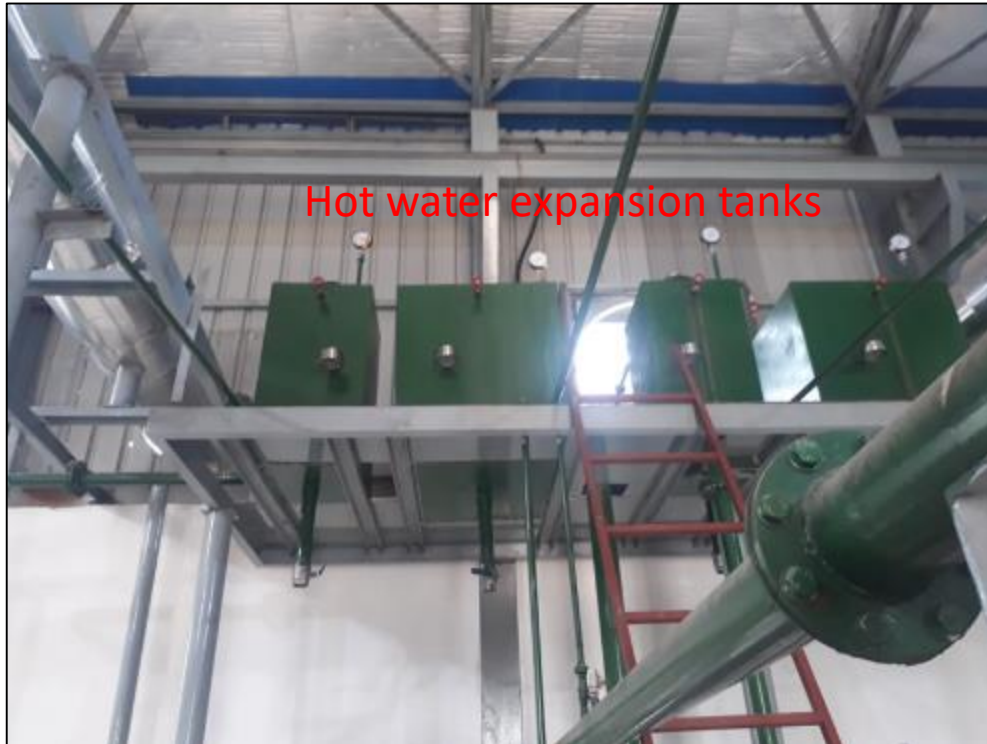
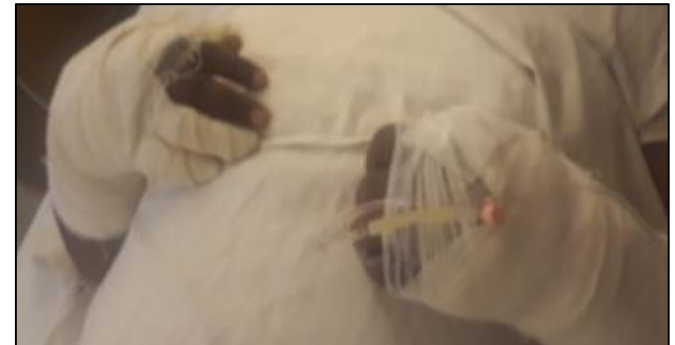
A contractor was exposed to hot vapor when he opened the top inspection cover of the gas engine generator expansion tank to check water level. He suffered 7% scald burns on his face, forearms and hands. 25 Days off work.

- Proper PPE was not used - Arms and face were not protected
- No permit to work was used.
- Non standard operating practice to remove the tank cover for inspection
- Tank pressure was not verified before inspection cover was opened
- Sight glass was removed and not replaced

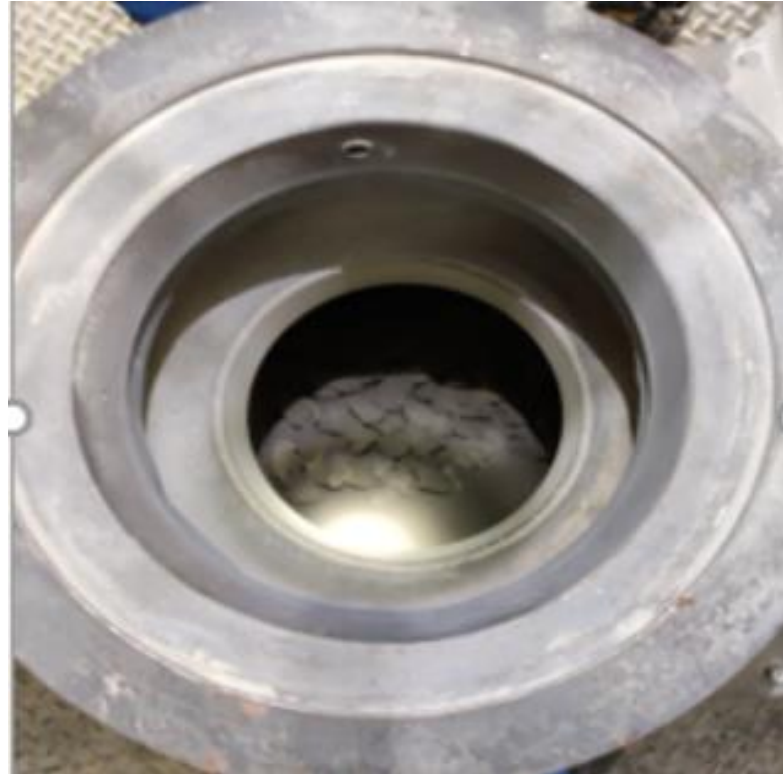
Generator hopper –no sign of internal fire

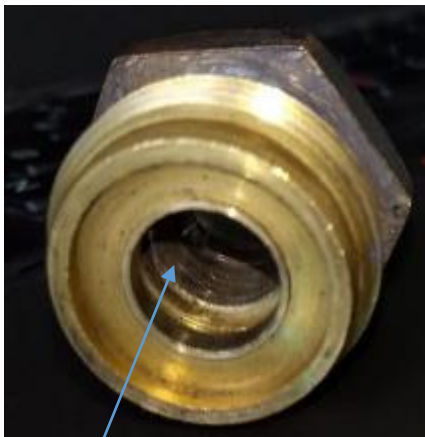
- The lack of O-ring on the sealing surface of the cylinder valve and the contamination on the sealing surface increase the possibility of valve leakage.
- Not taking Proper measures to check the seal of the cylinder valve during filling.
- Turning on and off oxygen valves too fast.

- No O-Ring inside the valve gland
- O2 leak during filling

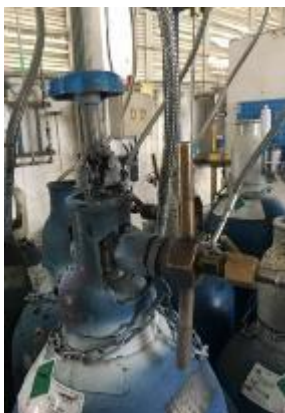
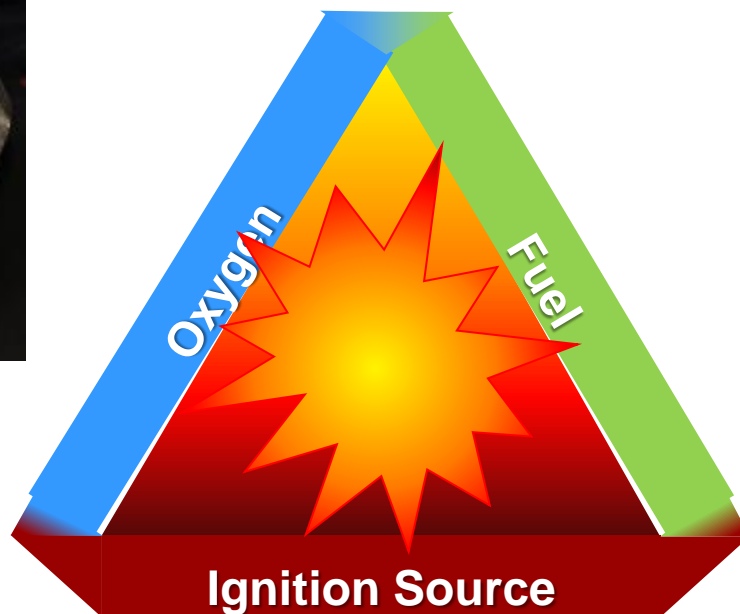
- Friction when close the valve?
- Electrostatic discharge?

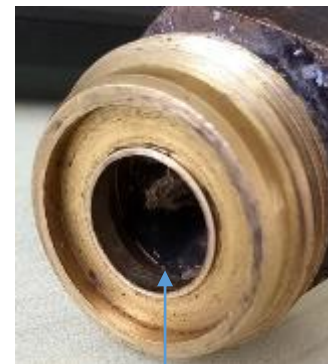
- Dirt inside the leak valve
- Dirt also be found inside the same type valves
