Training Package TP 28/20

Recent (H1 of 2020) Accidents/Incidents in the Gases Industry in Asia

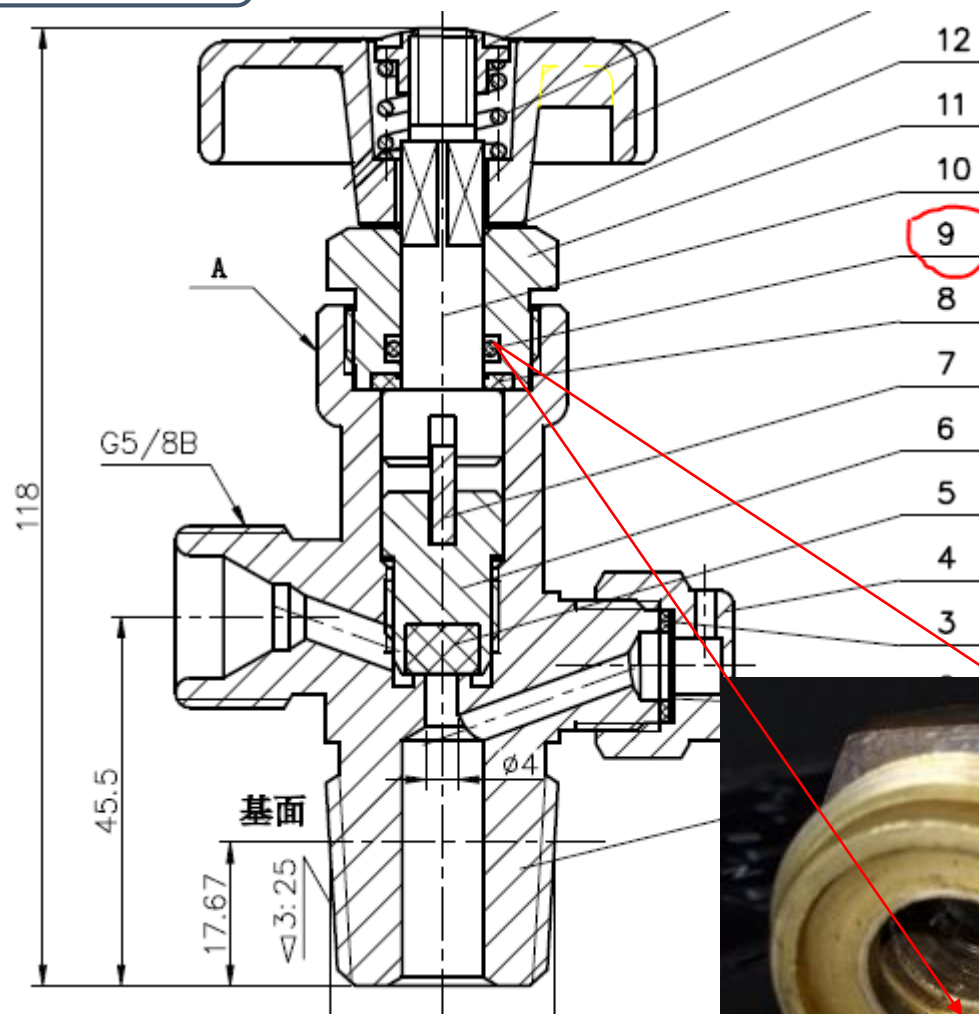
In the leakage valve, there is no O-ring in the slot (position 9)

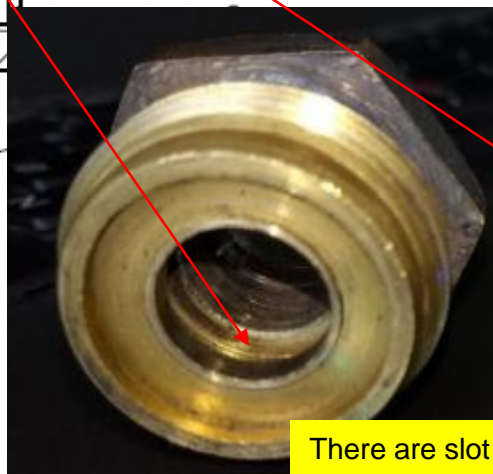
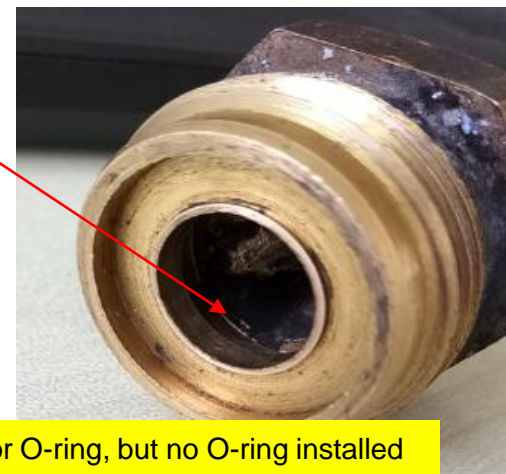
There are slot for O-ring, but no O-ring installed

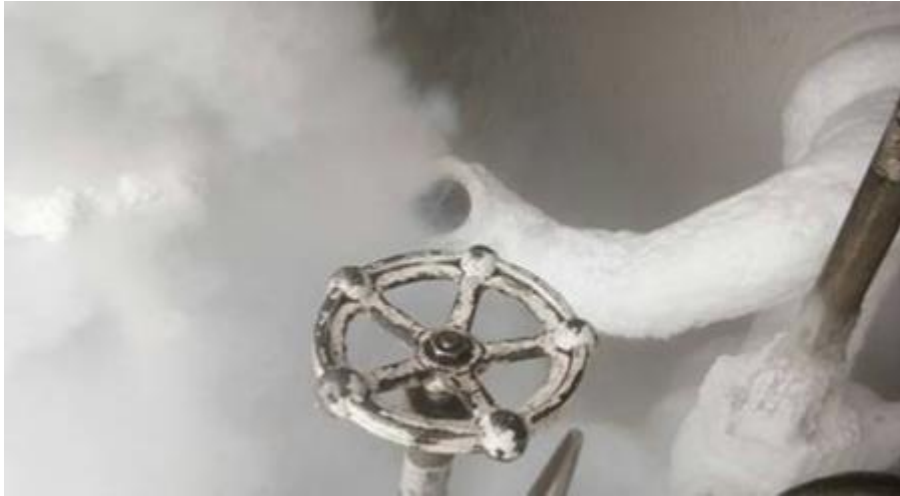
- At risk behavior by driver- use of improper tool to tighten/tap valve
- Old design of tanker – valve bonnet not provided with retainer

Released point inside the cabinet

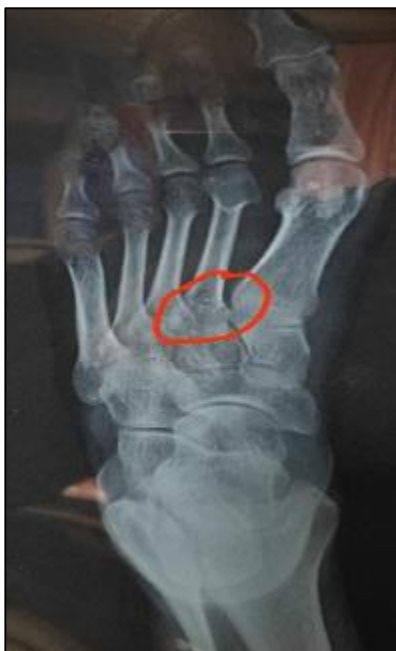
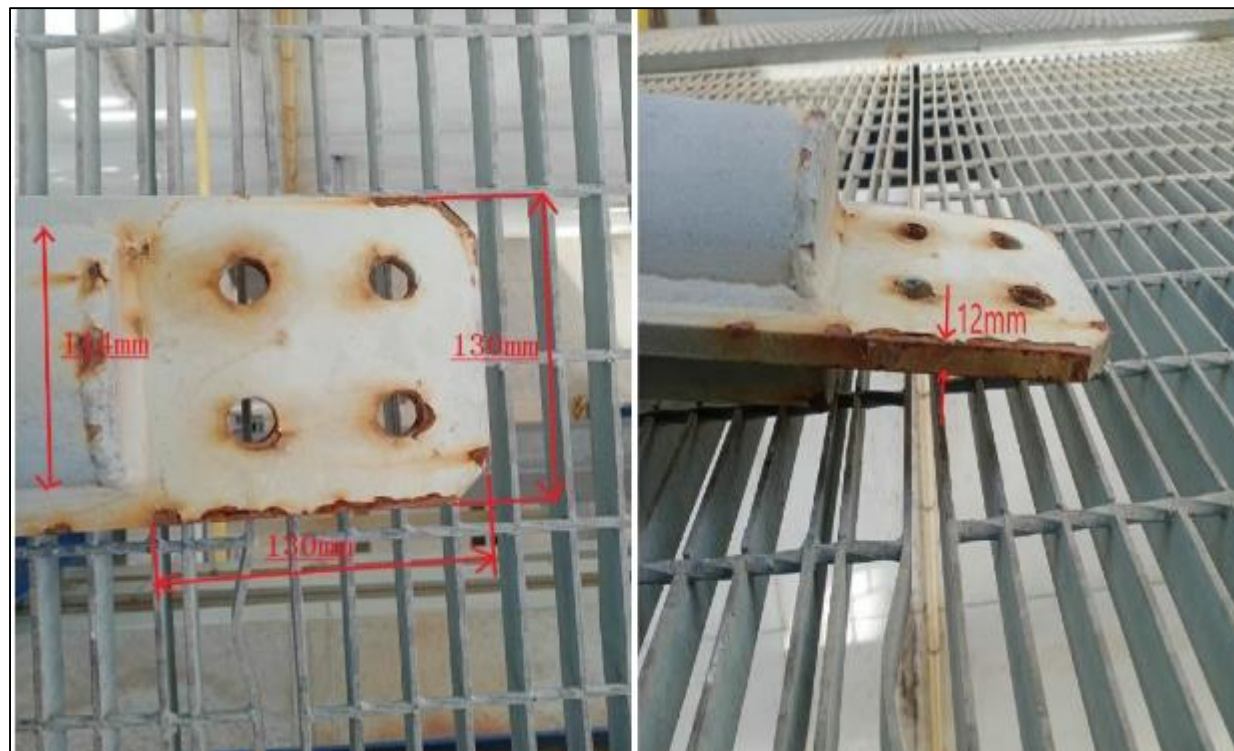
One contractor removed the bolt and shook the crossbar of the hanger in order to separate them. At that time, the pole fell and hit the back of the contractor's foot. The injured person was sent to the hospital immediately.

- The person was in the line of fire
- Ineffective contractor Management, SWP not applied

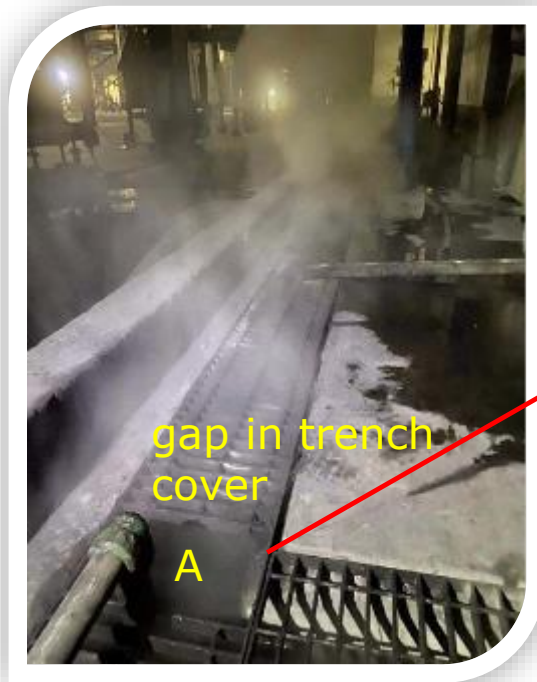
- Employee did not focus on the ground and was not aware about the surrounding; he did not notice the gap in the trench due to the hot steam vapor.
- Gap in trench was not identified fully, part gap in trench was covered and the other part was not.

A. Gap in trench
-size was 28cm L x 18cm W x 40cm depth
-hot water temperature by steam trap discharge
-injured employee right foot stepped into the trench gap

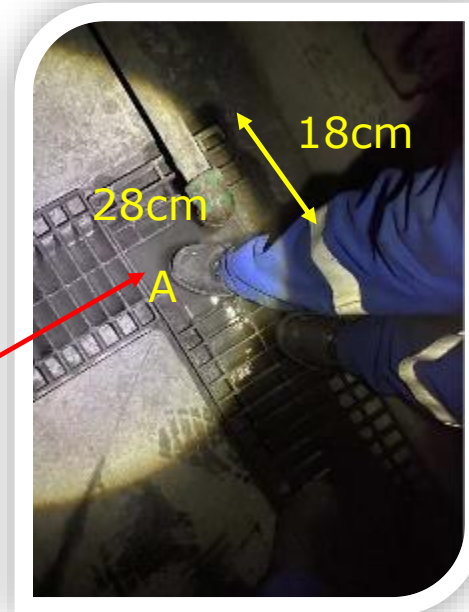
A. Gap in trench
-insufficient lighting in this area
-steam condensate discharge with gap in trench cover and large vapor in this area

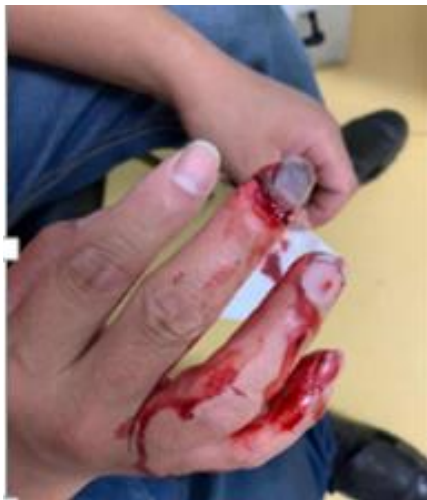
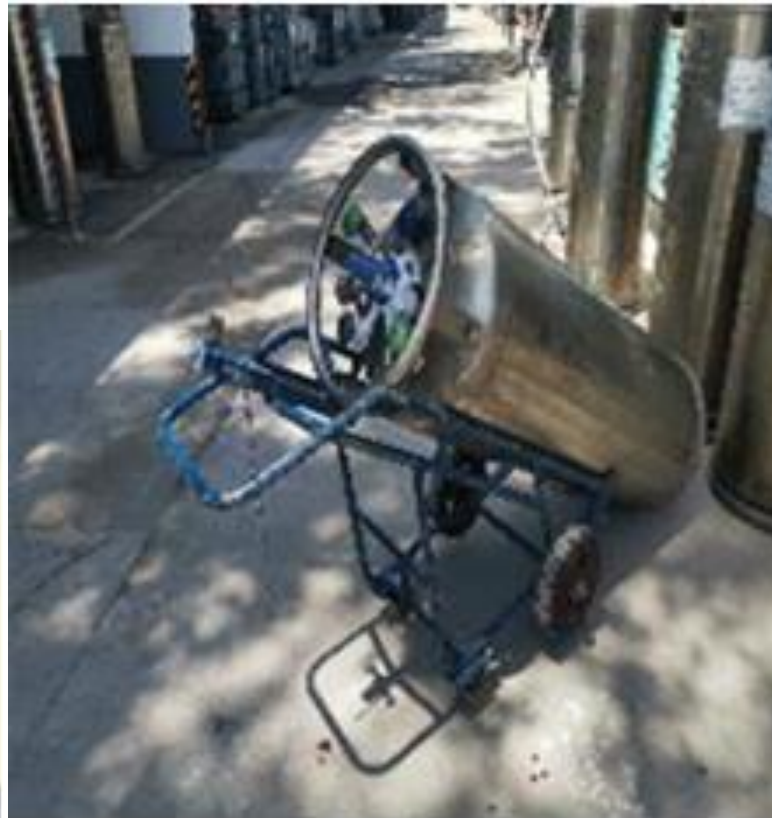
An operator after finishing an argon dewar transfilling was intending to unload the dewar from the cart and put it to upright position. However, he failed at the first time due to heavy weight of the full dewar, but he didn't notice the pothook had already loosened. When he tried for the second time, his middle finger of right hand was pinched by the space between the dewar and cart due to hand slip. Though he wore hand gloves but the injury from the pinch required stitches for wound recovery as was advised by the doctor.

- Lack of full attention while performing the work: Operator was feeling a little tired after moving five dewars
- Fastening device on dewar cart was not working well due to wear

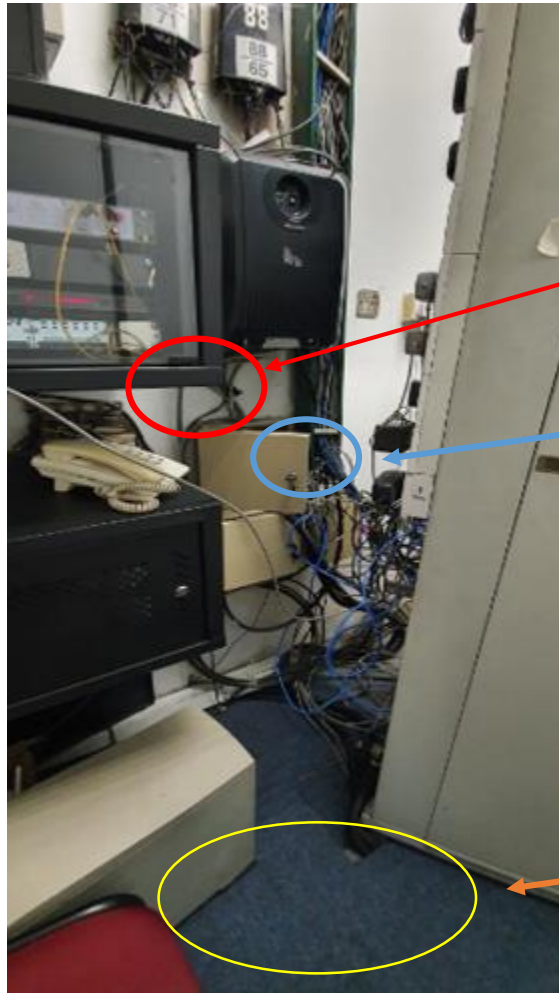
- Poor housekeeping in the server room
- Employee failed to identify hazard and not trained for the task
- Extended working hours during COVID19 lockdown

Corner of metal panel
where employee hit his
head against

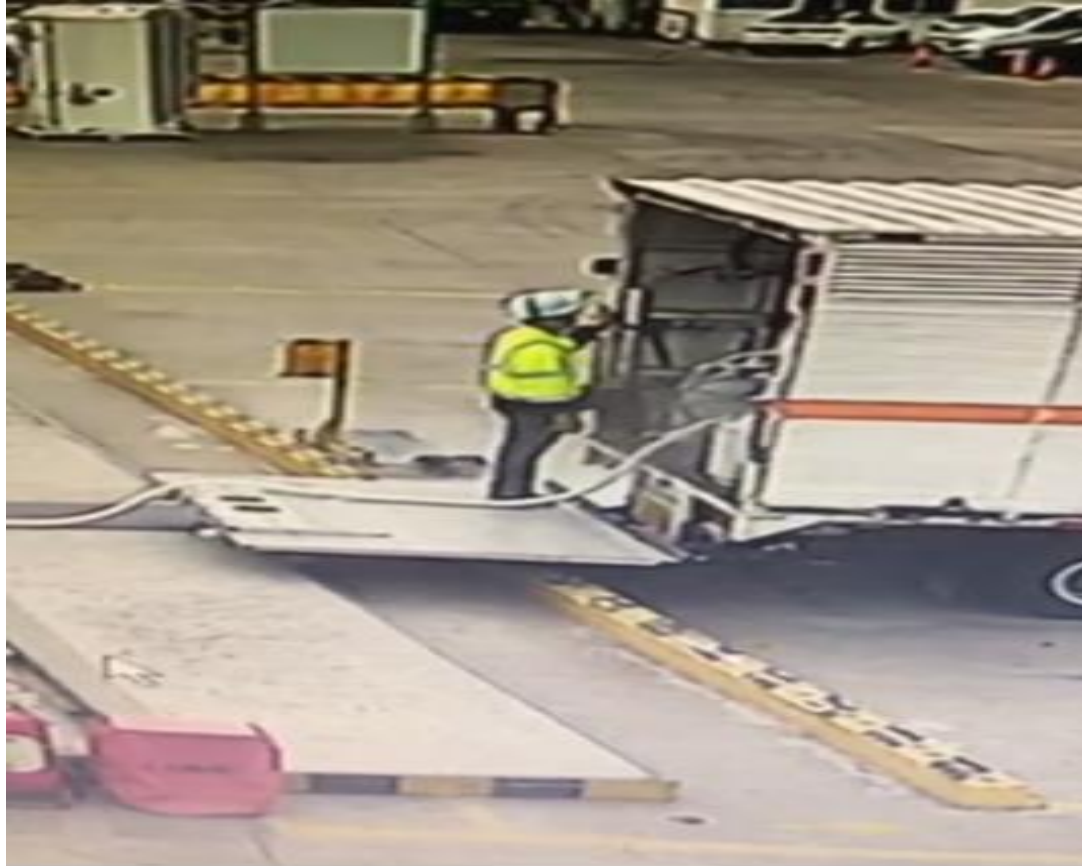
A driver of a LN2 micro-bulk tanker was standing on the tail lift while doing product transfer at a customer site. When approaching full loading, the driver got off from tail lift to close the valve of the depot tank, but he lost his balance and sprained his foot. He could continue working though he felt a little pain.

- Did not follow procedure to lower the tail lift before dismounting
- Underestimated the height of tail lift to the ground
