Recent (H2 of 2023) Safety Incidents in the Gases Industry in Asia

© AIGA 2024- Asia Industrial Gases Association. All rights reserved.

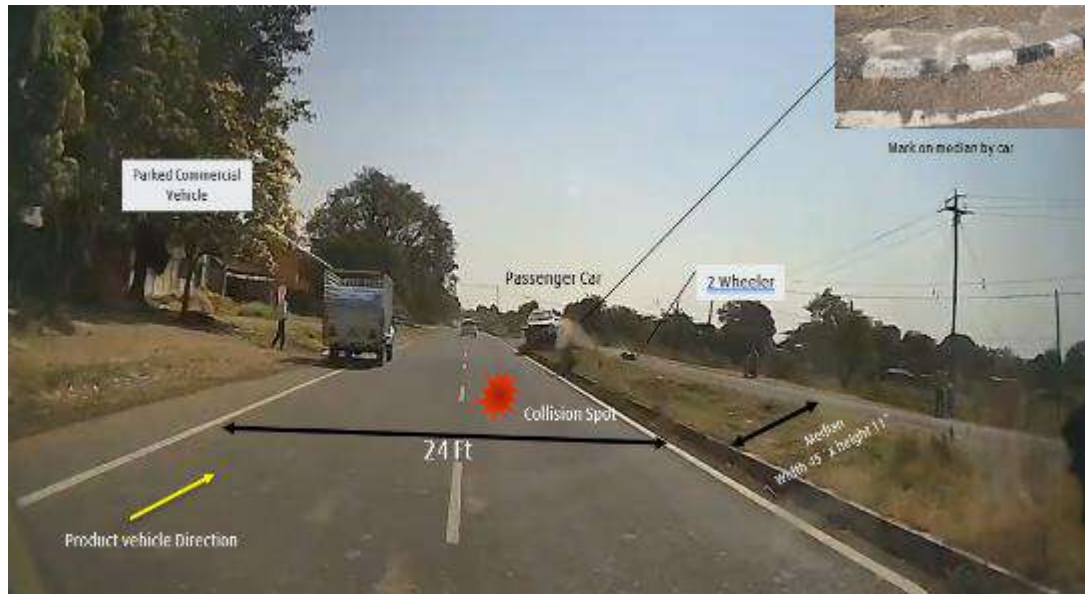
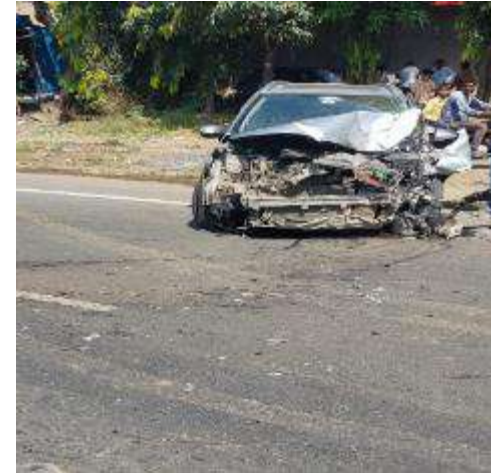
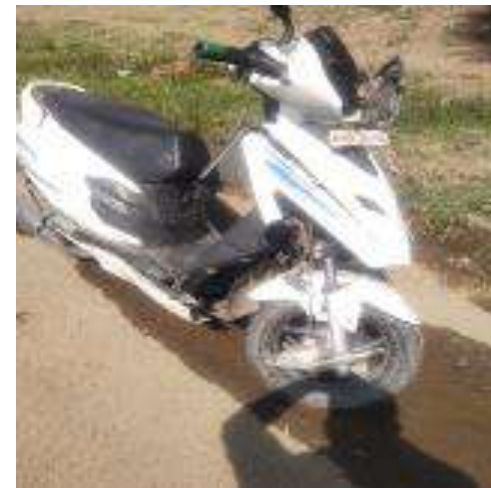
At 14:23hrs a product vehicle travelling at speed of about 46km/hr in its' legal lane was involved in collision with a 3rd party passenger car. The 3rd party car lost control at high speed, ran over the road median after it hit a 2-wheeler and entered in the lane of the product vehicle, hitting the vehicle on the front left side. Two-wheeler was approaching median on incorrect side. There were no product release and no injuries to the product vehicle driver and helper. 3rd party passenger car driver and passengers received injuries of various degree with one of the rear passengers had to be hospitalized for chest injury. Two wheeler rider also received stitches.

- Passenger car was trying to avoid colliding with the two-wheeler after losing control
- Need for ongoing driver awareness campaign on vulnerable road users & "Expect the Unexpected"

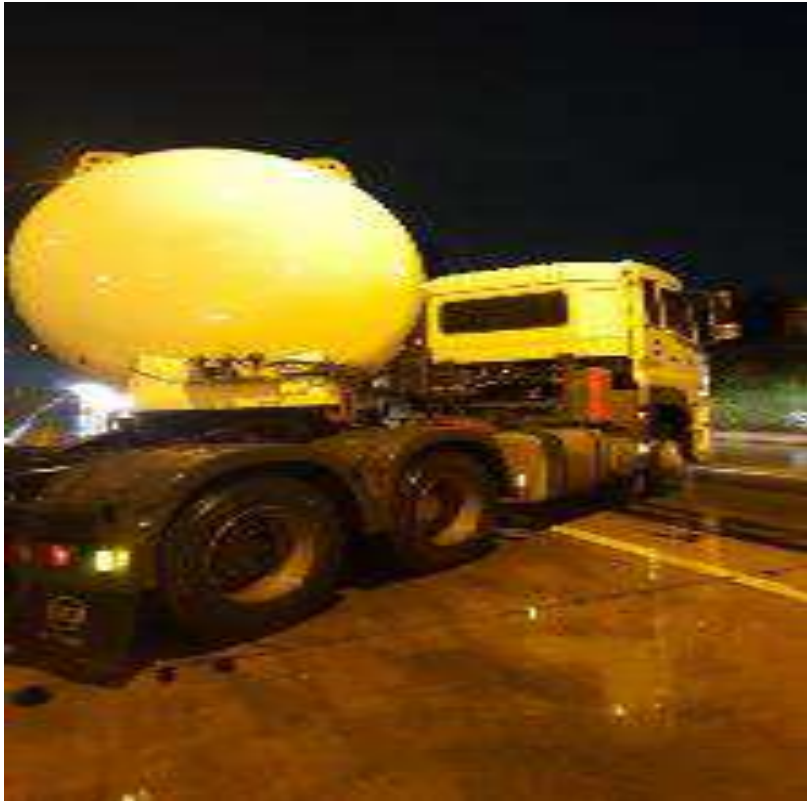
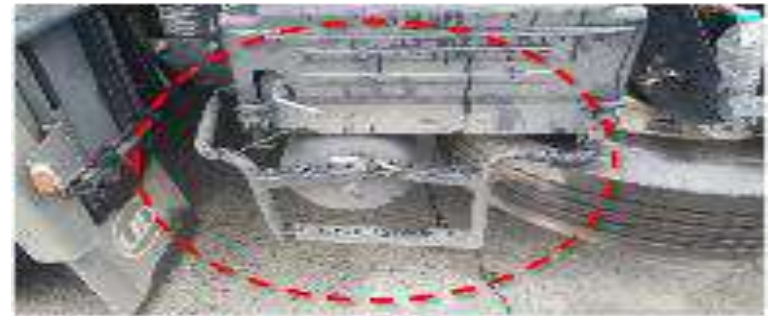
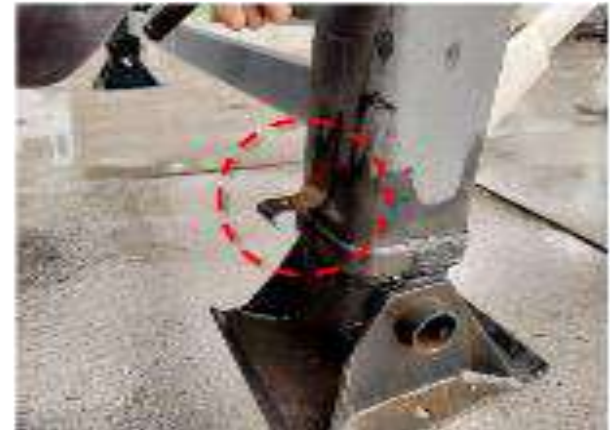
Approx. 21:00hrs, a contractor operated full Liquid Nitrogen tanker was driving down a slope on wet road condition at speed of 48km/h as he applied brake to slow down for turning left at road junction, the vehicle skidded and lost control resulting in jack knife.

There was no injury and no product release but minor damages to vehicle

Vehicle damage

- Gaps in contractor management – no periodic assessment carried out on competency
 - Lack of competency of garage technicians performing preventive maintenance on fleet
 - No documented procedure and training for preventive maintenance on brakes etc
- Less than adequate tyre inspection procedure for drivers
- Driver oversteered to avoid crash and his speed was higher for an wet road condition.

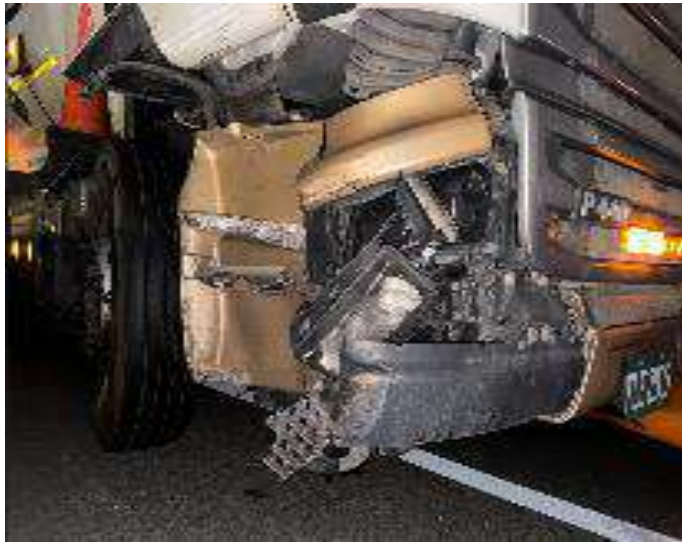
Around 17:48hrs, a contract driver was driving a products vehicle at 78km/hr on the expressway to another plant for product pick-up. There was a broken-down concrete truck which was parked on the road shoulder and partially invaded the traffic lane. The concrete truck driver did not apply the safety cones nor switched on the hazard signals. The condition was dark during that time. When our driver was approaching that area, he did not realize the parked concrete truck and was unable to react promptly to avoid the collision. As a result, the right side of our tractor collided with the parked concrete truck. The right-hand side of our tractor and the left side of the concrete truck sustained significant damages.

Damage to the Product Vehicle front right side

- Driver failed to reduce speed to suit night driving with poor visibility.
- 'Get The Big Picture' and 'Position' the tanker to be able to see ahead.
- Follow the Defensive Driving key 'Leave Yourself An Out' to escape from such hazard.

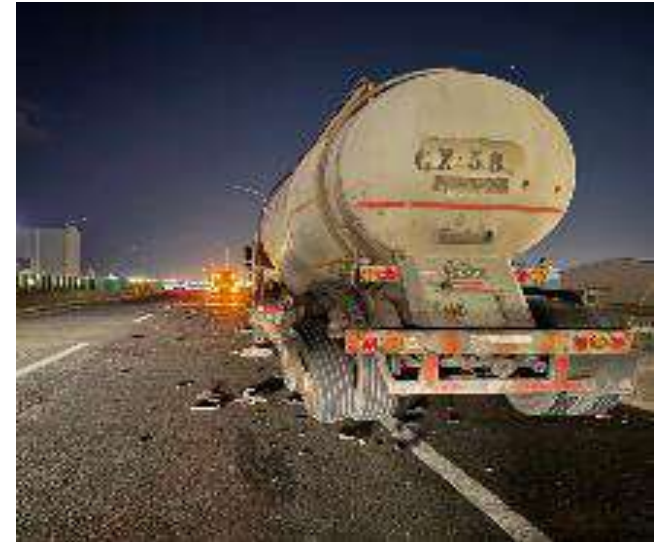
Concrete Truck

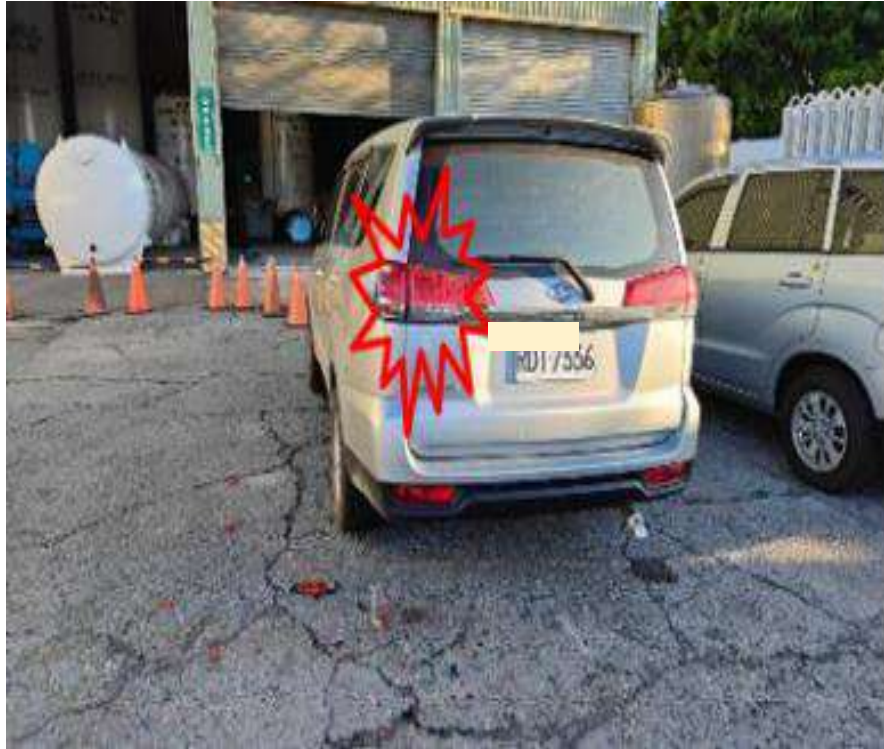
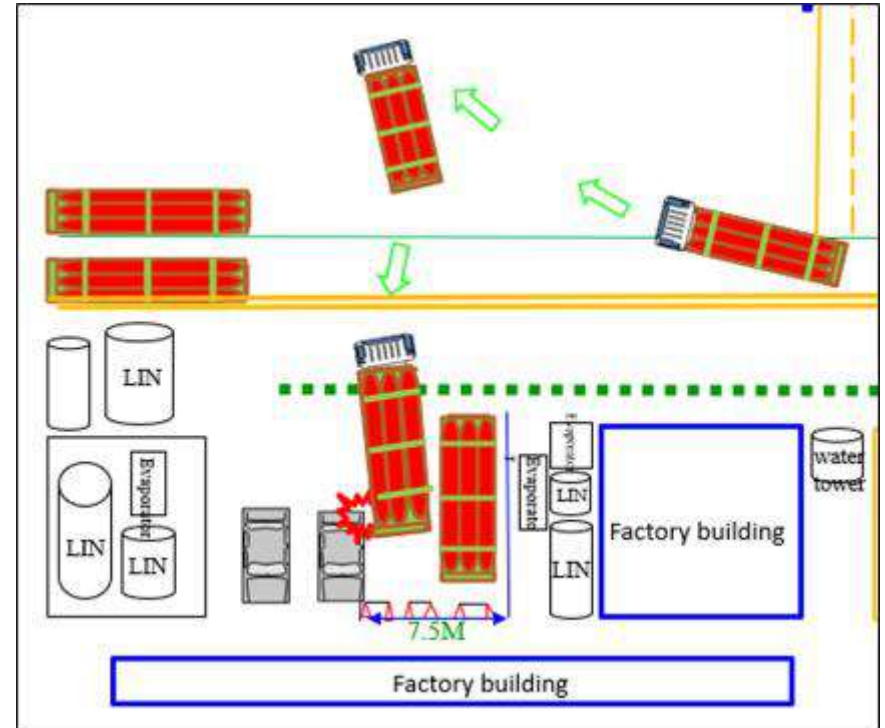
Around 21:31hrs, a contract driver decided to park the Bulk Hydrogen Tube Trailer(BHY TT) into the allocated parking space. He carried out GOAL. While reversing, the rear left side of the BHY TT collided with the van that was parked next to it. The rear light of the van was damaged as a result of the collision.

- Driver misjudged the space required for the BHY TT.
- 'Stop the job' when visibility is poor.
- Mark out the designated parking lots in the parking area.

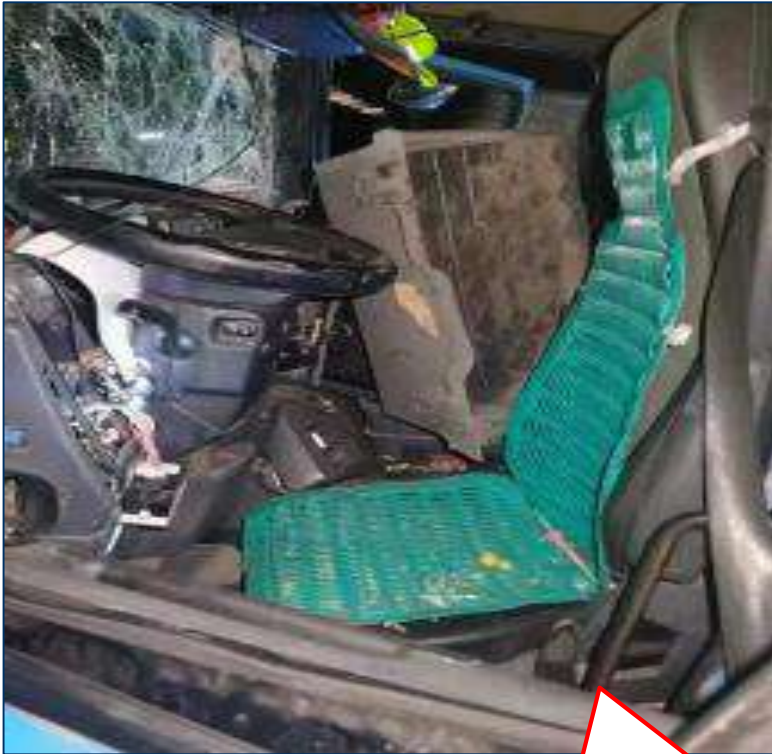
At around 18:09 hrs, an employee driver with a contractor escort was driving an empty LIN tanker on the way back from delivery. When driving off the highway and approaching an intersection of a provincial road, the tanker hit a stationary third party truck waiting at a traffic light. Ambulances arrived at the scene promptly and sent the driver and escort to local hospitals for emergency treatment. The driver passed away in the hospital soon after arrival. The escort's left leg was fractured and his jaw received 5 stitches. There was no product leakage however the LIN tanker was severely damaged. There was also no third party injury. During investigation it was found that within the last one minute before collision, the In-cab camera captured the driver closed his eyes four times. The accompanying escort was checking the new route direction on his smartphone due to road closure, thus he was also not focusing on the road before the collision and could not alert the driver. An automatic system generated alert happened to warn the driver but that was when the truck was too close to the vehicle in front. It came just <1 sec before the collision.

Cabin condition after collision

- The driver had been identified as High Risk Driver previously, but there was a lack in follow-up for the improvement actions - having a close loop system is the key for all types of Safety management, including the management of identified high risk drivers.
- Driver warning system based on technology to meet the purpose

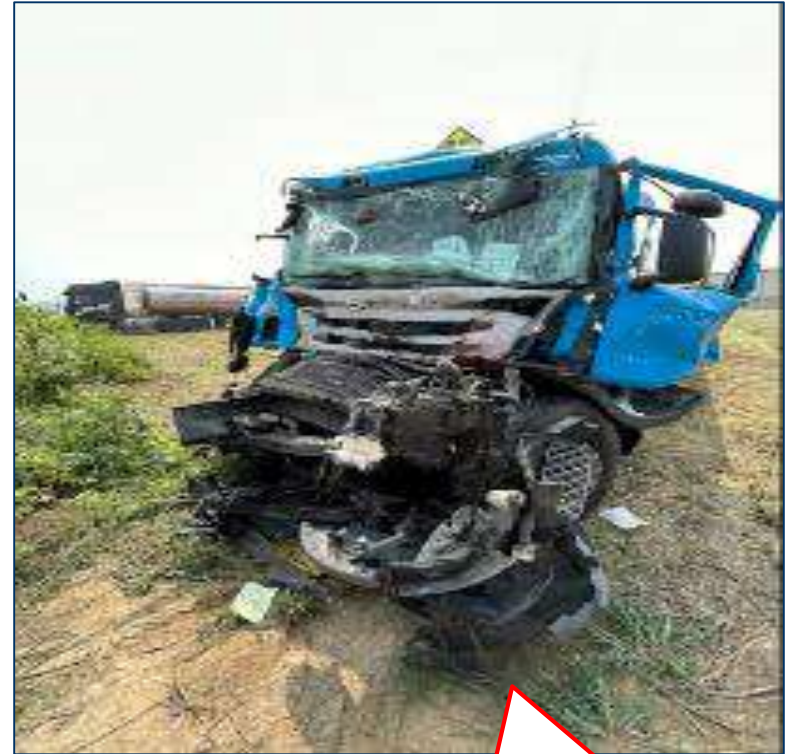
Severe damage to tractor

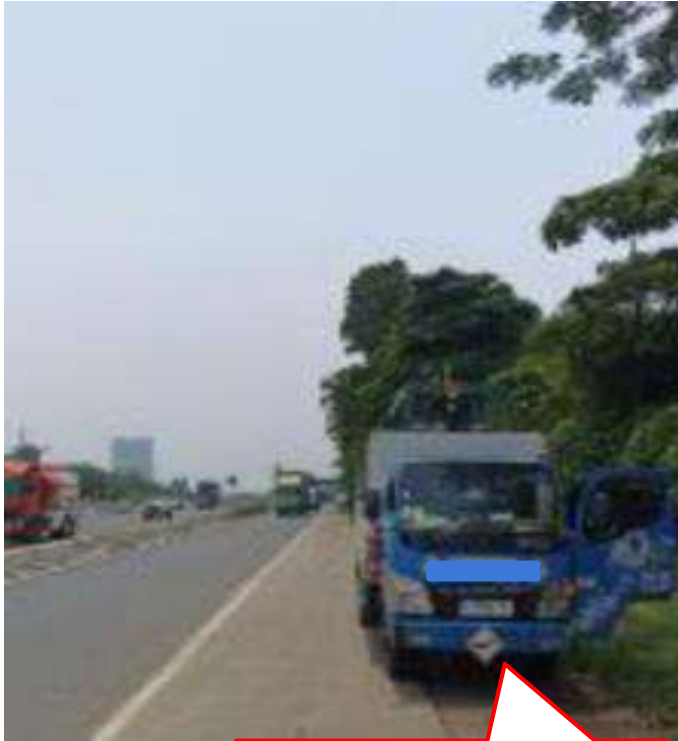
A driver just finished loading pallet to customer site and was about to leave the premises. When rolling down the window to make a transaction at the toll gate, the driver noticed a strong odor like burning of grease coming from outside. After completing the toll transaction, the driver decided to stop the truck and look for the source of the smell. Upon checking, the driver found that the left rear tyre was overheated and there was melted lubricant around the wheel rim. The driver called the maintenance team who arrived soon at the location and immediately carried out inspection and replacement of the tyre. It was found that tyre 4 was deflated that resulted in tyre 3 and tyre 4 rubbing against one another. Tyre installation did not comply with tyre manufacturer's installation standards. The site does not have any tyre management standard procedure nor assigned workshop.

Emergency parking

- Change existing tyre and check all the existing tyres on trucks based on Manufacturer standard.
- There is a need for assigned workshop to do tyre management and SOP on tyre management with installation & maintenance guidelines.

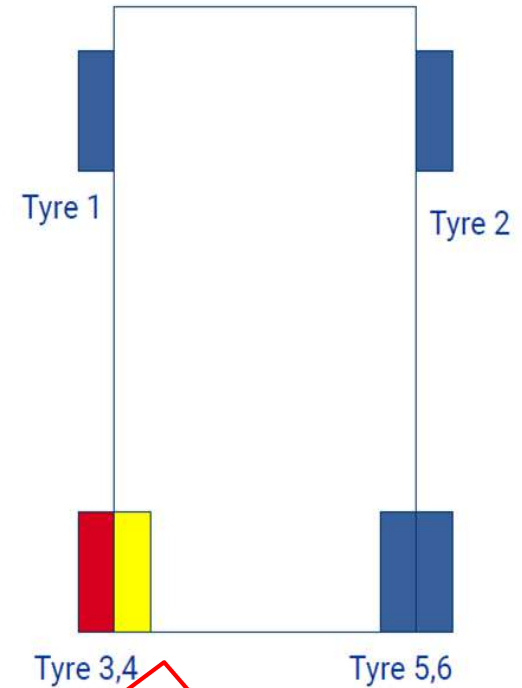
Overheating of Tyre 3 was caused by deflation of Tyre 4

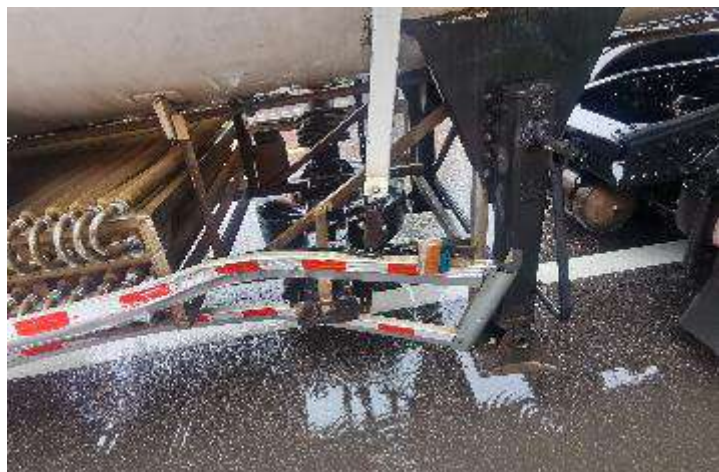
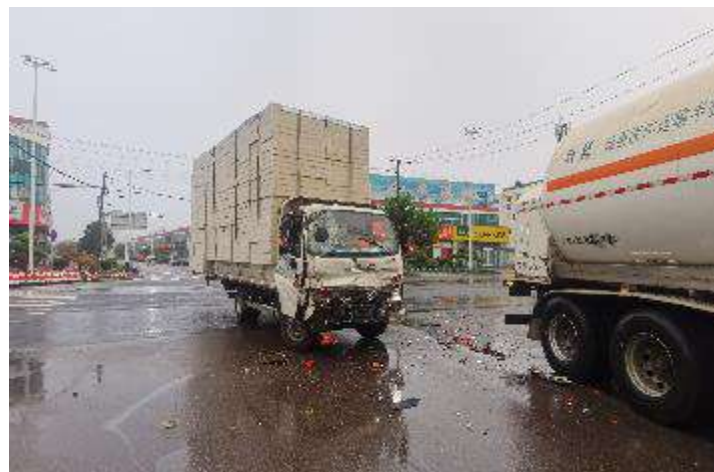
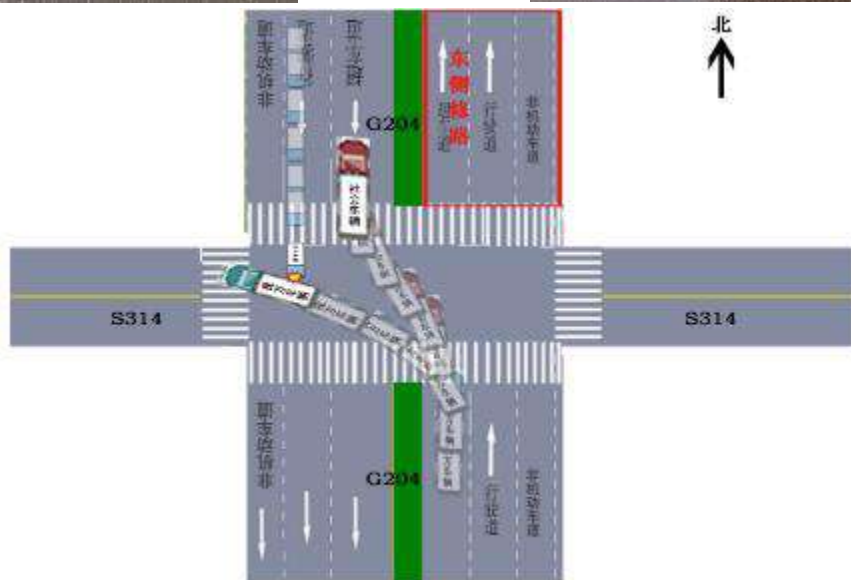
A liquid nitrogen tanker drove to a junction and needed to turn left. The turning wheel of the left-turning vehicle was completed (the front of the vehicle had passed the junction, and the half body of the trailer was still in the junction) when it collided with the vehicle going straight opposite.

There was no injuries, no product leakage but the right bumper of the trailer was damaged. The 3rd party vehicle received damages to front bumper, hood, the right door and other areas in certain degrees.

- In the process of turning left, the vehicle did not slow down or stop when crossing the center line of the intersection with obstructed vision.
- Did not communicate effectively with the other vehicle; the other party did not perceive the existence of the N2 Tanker

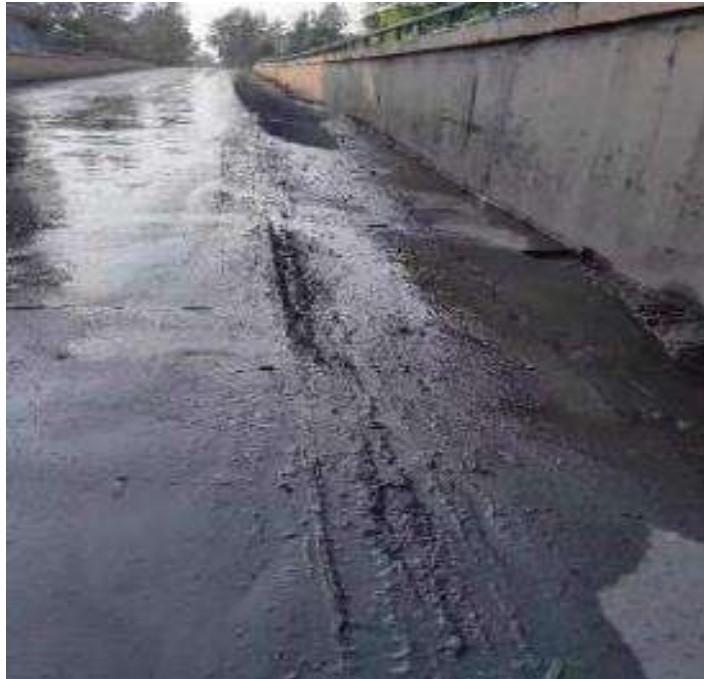
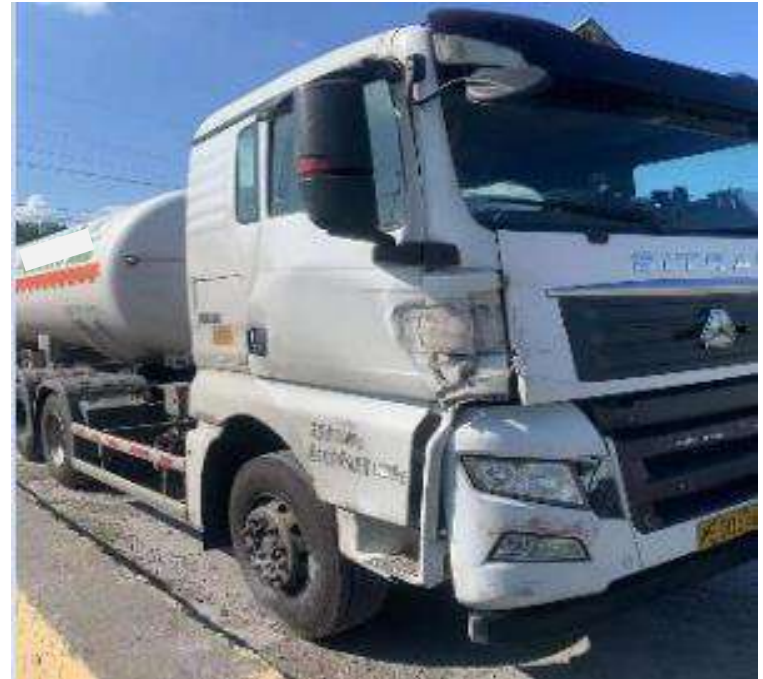
At about 14:30hrs, a Bulk Liquid tanker was passing through a viaduct with slope and wet road conditions. It appeared that the wet road was mixed with water and oil. The tanker lost control, moved to the right and crashed into the concrete guardrail. Due to the impact, the truck right door was damaged.

- Driver failed to reduce speed while passing the wet road condition
- Observe ahead and anticipate the hazard that may be present

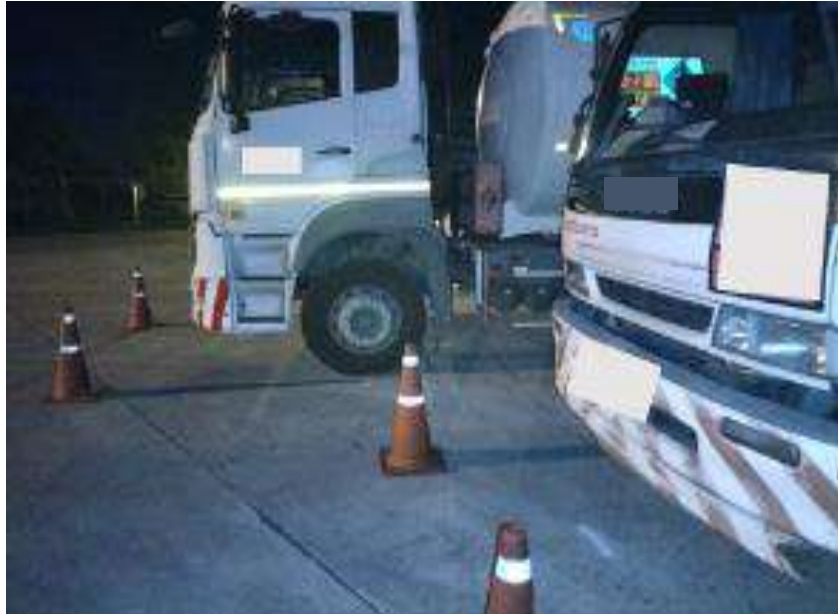
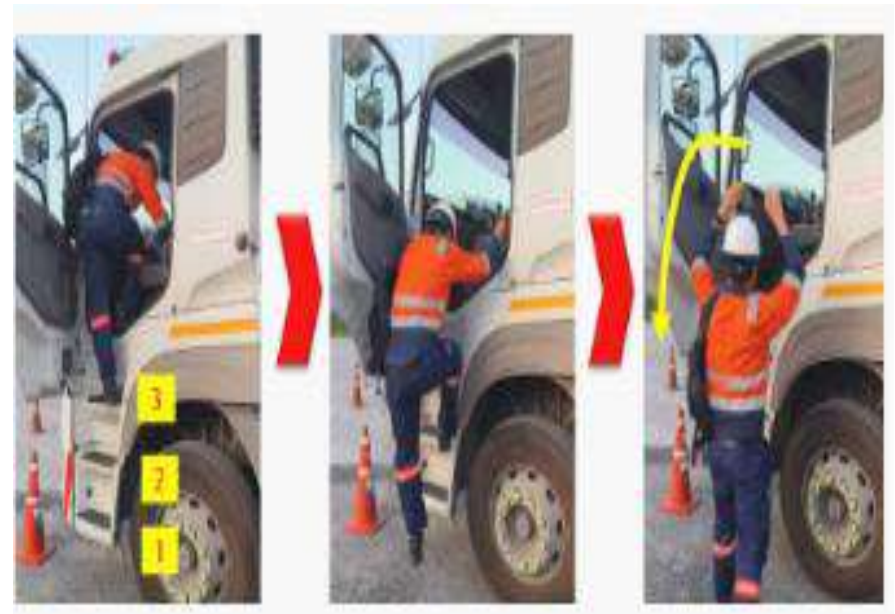
A driver, after parking the truck at deport parking area went to the office for paperwork. Later upon recalling that he has left his ID in another truck earlier, he went to this truck. He opened the left side door of the truck and entered. He was then getting out of truck by stepping backwards when he fell backwards. This caused him a head injury and was sutured with some stitches.

- While getting off the truck the driver did not make 3-point contact for stability
- Helmet was not securely worn with chin strap fastened

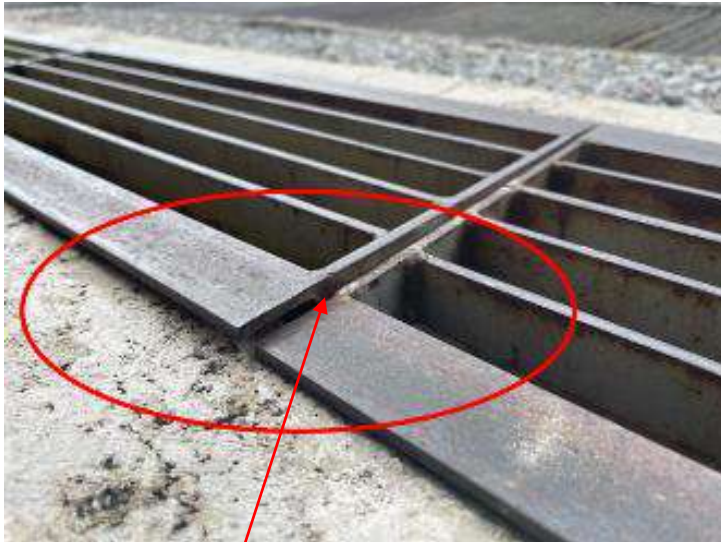
Around 10:53hrs, a day-shift contract boiler operator was walking towards the chemical analysis room after recording the site water treatment chemical inventory. He crossed over from the tarmac walkway onto the drain grating. He felt his left safety shoe got caught on the edge of an uneven drain grating. He tripped, fell onto the drain grating and sustained cut to his forehead and nose. He proceeded to rise from the fallen position independently and headed to main office. First aid was applied to the wound by the plant manager and maintenance mechanical supervisor to stop the bleeding. He was then sent to the clinic for stitches to the wound.

Uneven drain grating

Boiler Operator did not walk on the site designated walkway and also needs to focus on the path ahead while walking

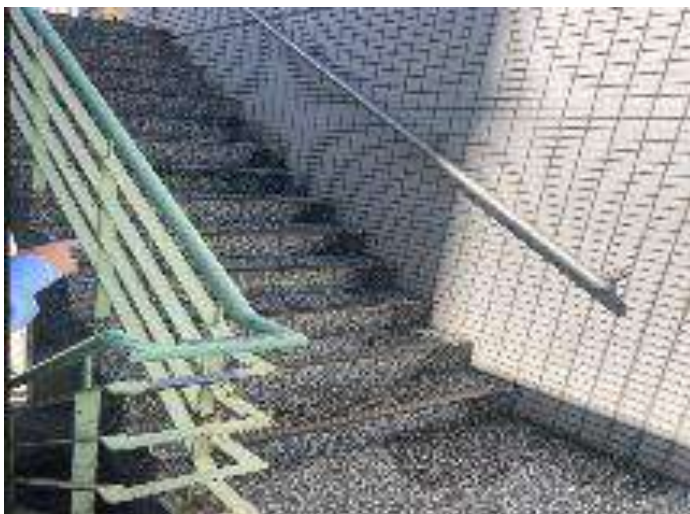
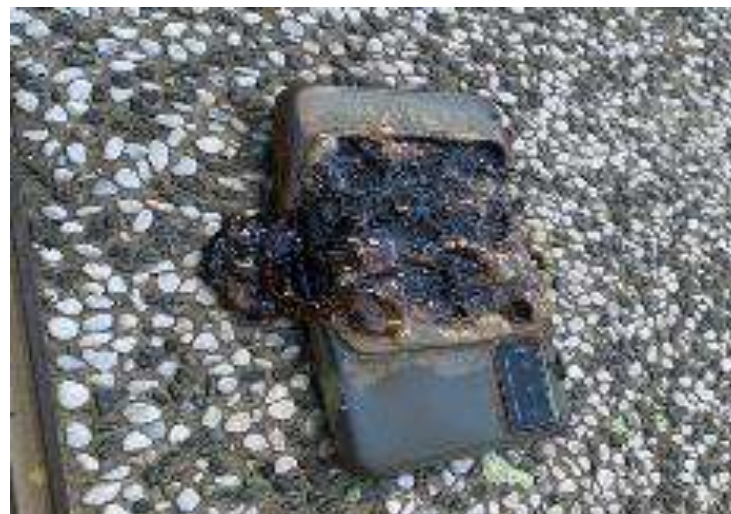
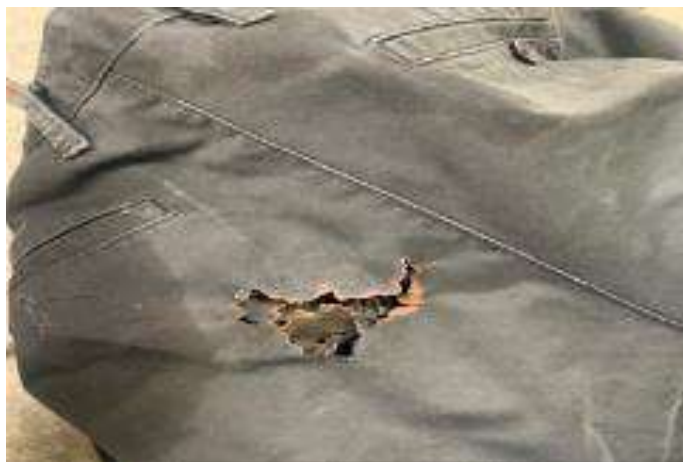
About 8:45 hrs, a plant operator was walking down the stairs towards the control room after collecting the cooling water samples. He slipped, fell and felt heat from the mobile phone in his pant's left back pocket when he stood up. Immediately, he threw out the scorching cell phone. He informed his supervisor and went to the hospital. The doctor diagnosed moderate burn and treated with pain killer and anti-tetanus injection. Operator returned to the site for continuing with the work for the day.

- Wear anti-slip safety shoes with deep sole threads and remove sand/debris underneath the shoes.
- Operator was distracted; holding two measuring cups without lids. Replace with sample bottle with lid.
- Relocate the water quality analyzers to upper floor, to avoid walking down the stairs

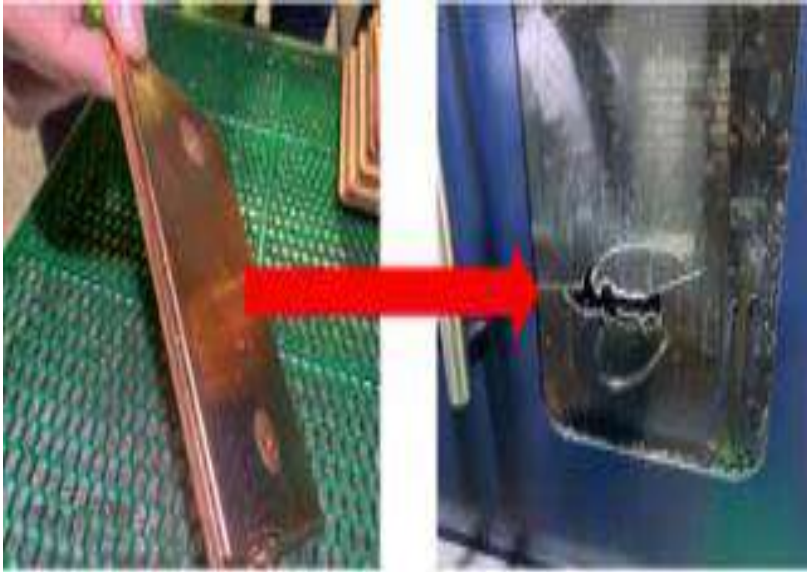
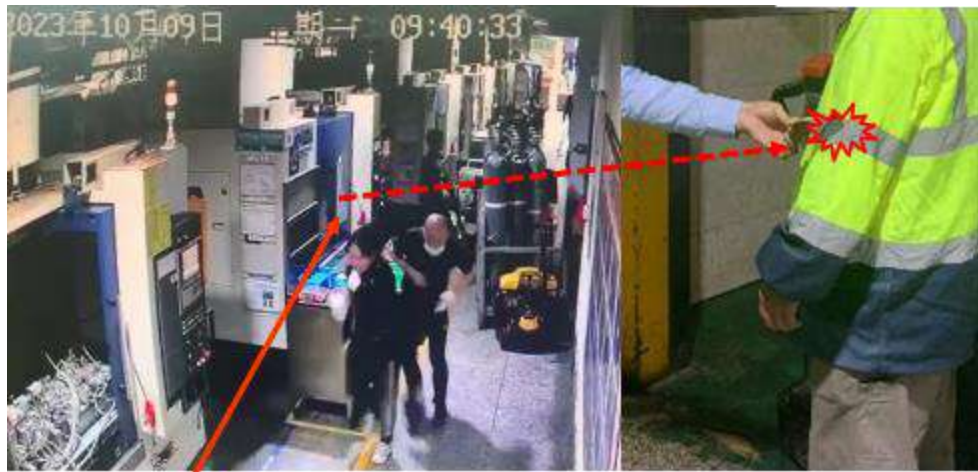
At about 9:40 hrs, an employee was delivering gas cylinders to a customer. While waiting for the elevator at the customer's workshop, his left elbow was hit by a copper plate, ejected through the acrylic protective guard of the CNC machine. The copper plate was 15cm long, 8cm wide, 0.5cm thick, and weighs 300g. Customer site personnel immediately bandaged our employee injured area. He was taken to the hospital for treatment by an ambulance.

CNC machine

- Strengthen the protective guard of CNC machines
- Be aware of surrounding work environment
- Share this incident with all drivers and escorts

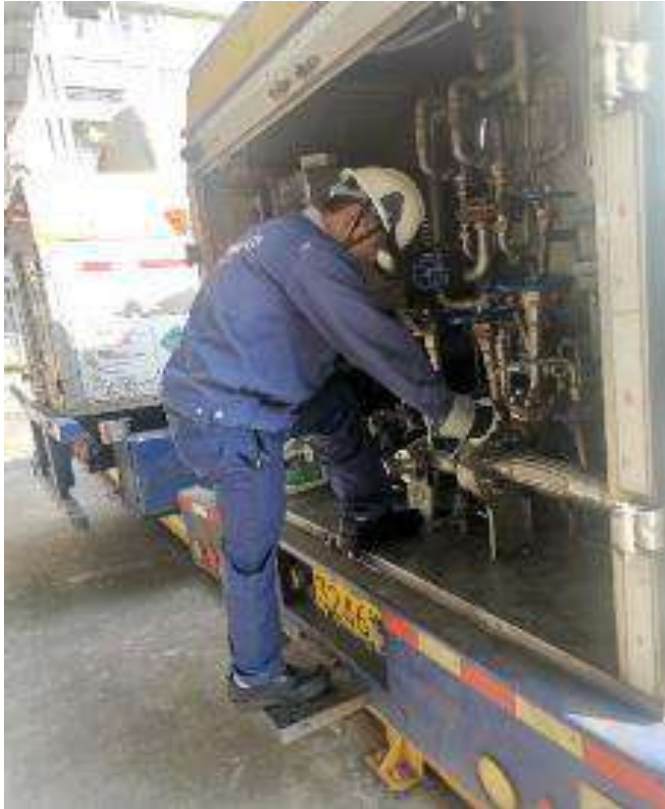
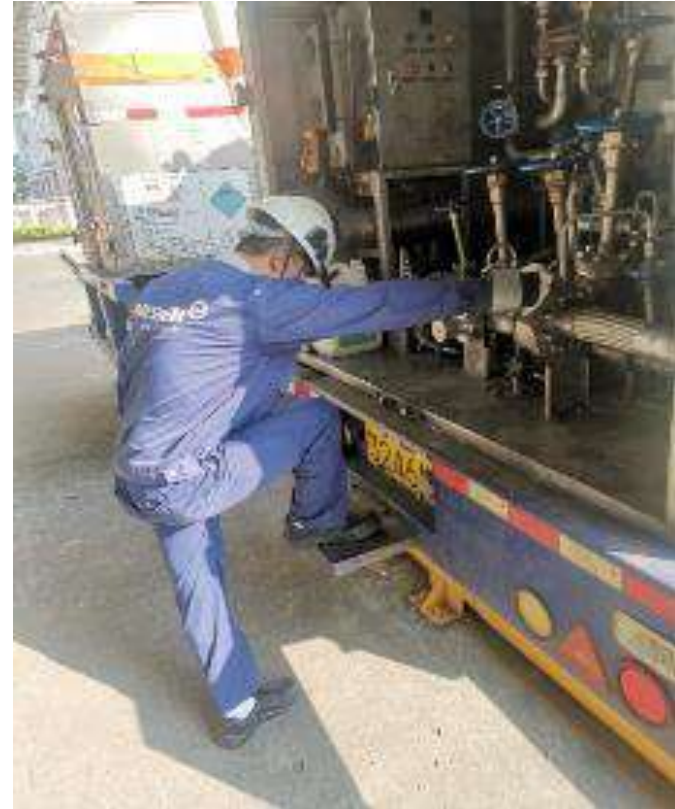
At a customer site, a driver missed his step and fell to the ground while he was climbing down from the valve operating box on the rear of a road tanker. The driver did not use the footboard while climbing down from the valve operating box. His ligament of elbow joint was torn.

The right way for going up and coming down –
Use three point contact

- The safe operating practices that make sure to use the ‘Three-point contact’ should be defined and trained be imparted to the drivers accordingly.
- The risks of the actives that up and down the narrow operating boxes were not identified, and therefore safe operating practices and training were not developed.

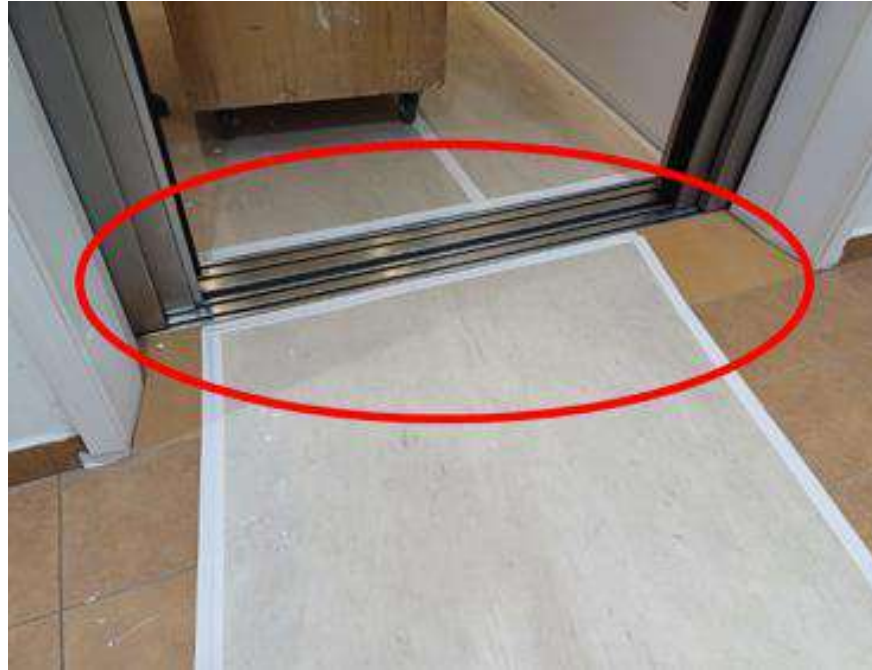
An Operator was pushing a trolley transporting 2 cylinders towards the cargo lift. One wheel got caught in the cargo lift doorway gap, causing the trolley to stand upright. This sudden upward movement and impact caused his left shoulder to be dislocated. The injured person had reported the incident to his supervisor. This incident resulted in a lost time injury where the injured person was granted 20 days medical leaves for dislocated shoulder.

- Due to complacency, the injured person was using only one hand to push the cylinder trolley instead of using two hands, caused him to lose control when to pass the cargo lift doorway gap as one wheel got caught in the gap.
- Improper assessment of risk. Floor was found to be uneven due to some renovation works are going, which leading to the unstable movement of the cylinder trolley from all the way to the lift.

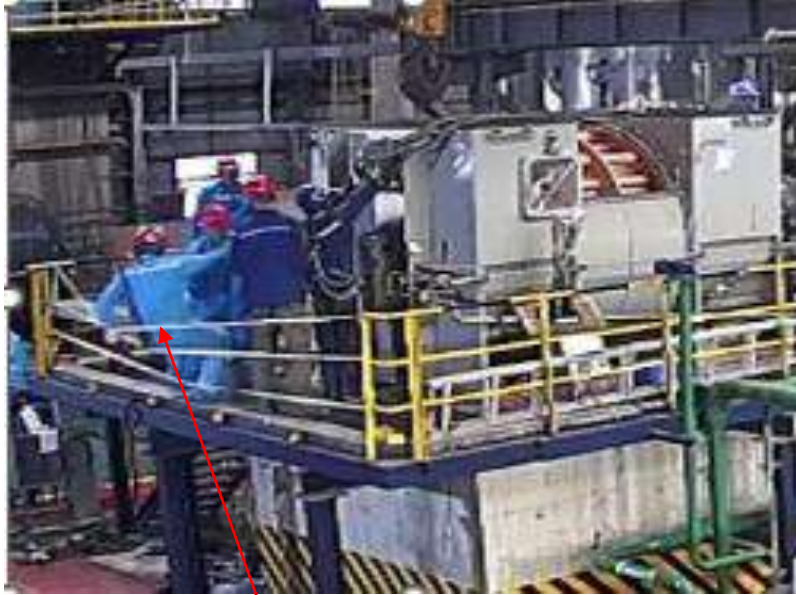
During the maintenance of a compressor, a equipment engineer went to the equipment platform to discuss the hoisting scheme. He fell down from the second floor platform (height 2.5m). Due to the height limit of lifting, the factory removed the platform guardrail in advance and temporarily surrounded it with a yellow warning belt. Correct wearing of the helmet, prevented any head injury of the employee but he received fracture in temporal bone and on left rib.

Guard rail was temporarily removed

- Lack of fall prevention measures (such as safety nets, temporary quick-removal protective railings or hard isolation of the edge area) after the original platform was removed.
- The personnel responsible for the maintenance failed to effectively identify operational risks and take effective measures
- Need for refresher training to people carrying out such activities

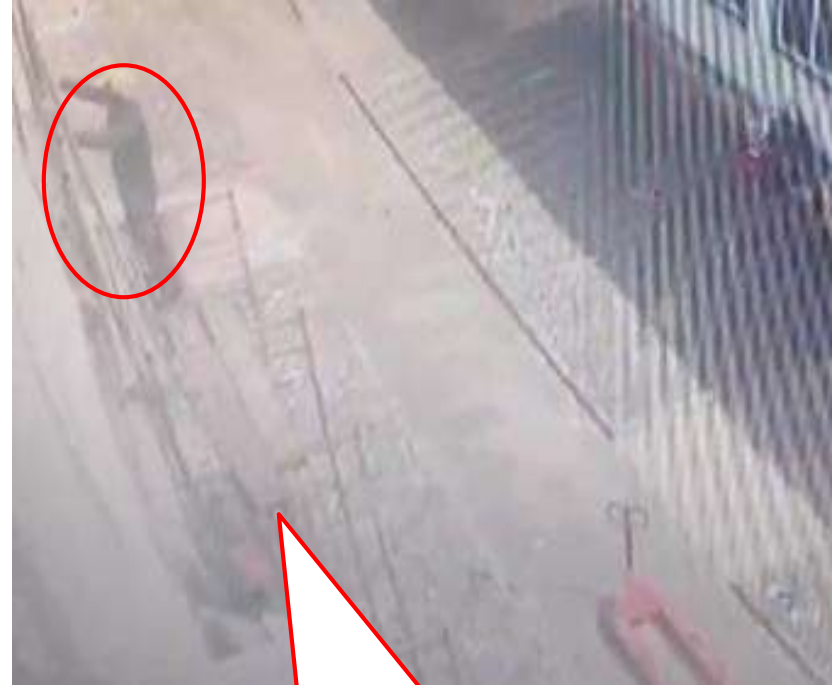
Both contractors were not wearing fall prevention equipment and also no Safe Work Permit was issued for this task. Also there was no written identification of risks and control measures. Site coordinator was not on site when the contractors climbed onto the scaffold to perform the work. Contractor's qualifications were not verified on site, and site did not have any trained and qualified safety Supervisor. Also the mothballed facility was not included in the Company's system management.

Contractor falling from 3.7m

Contractor not wearing fall prevention
equipment

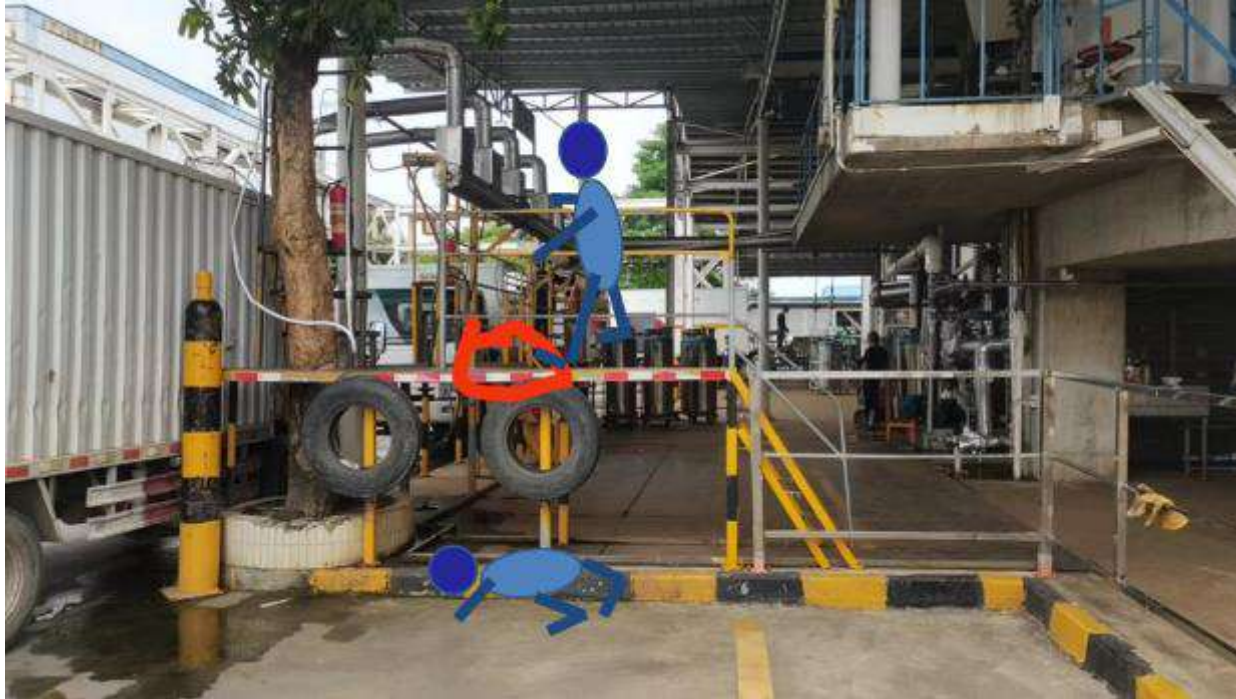
At a cryogenic liquid dewar filling site, an operator missed his step on the dewar filling platform (for fishtruck) and fell to the ground. the operator got a fracture of a transverse process of his lumbar. When walking on the platform, the attention of the operator was not concentrated, he missed his step and fell to the ground

- Inadequacy in work place design – narrow unguarded platform at height
- Training for safety awareness and behavior safety based observation
- Carry out proper risk assessment for workplace

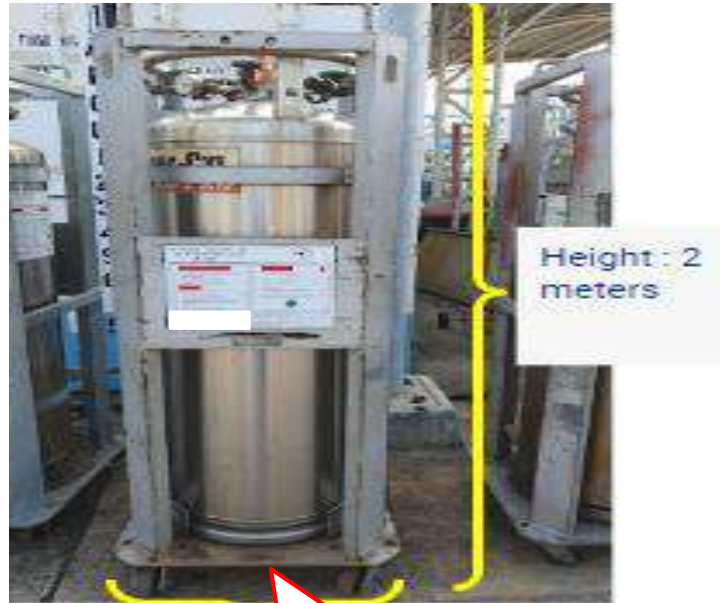
Upon diagnosis at the hospital, the X-ray showed a fracture on his spine bone (T12). No surgery was required but the driver had to stay in bed to restrict his movement.

- Tall & Narrow Base
- Small Wheels

- BSV conducted on this task previously but did not highlight that driver's position was in the line of fire when performing PLC handling
- Insufficient PLC frame design leading to easily topple due to high COG and may fall outside its base from any uneven floor condition
- Need for enhancing safety awareness for Customers and PG drivers on PLC handling

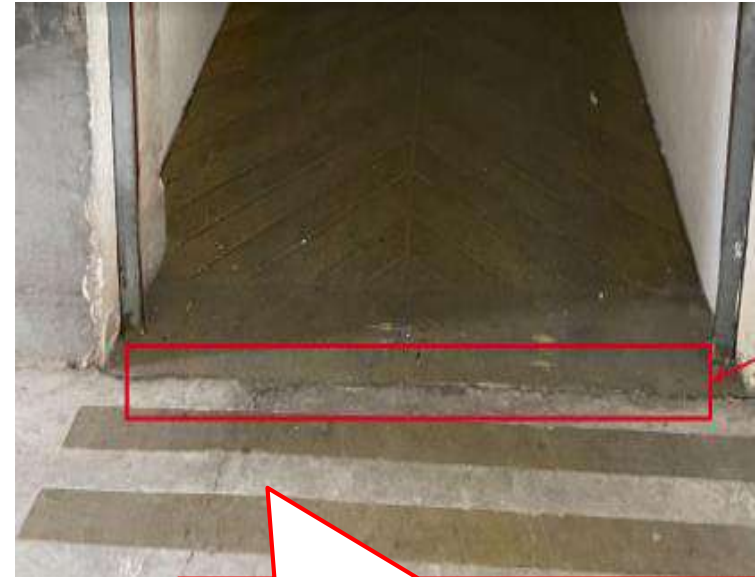
Unsmooth concrete joint at the beginning of the slope

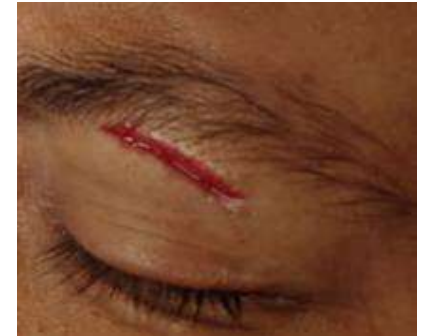
Laceration on eye lid

- Conduct MOC for design safety reviews
- Revise and improve procedure
- Conduct job observations and engage team

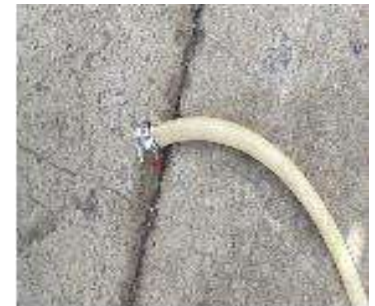
Sharp Edge of the Clamp

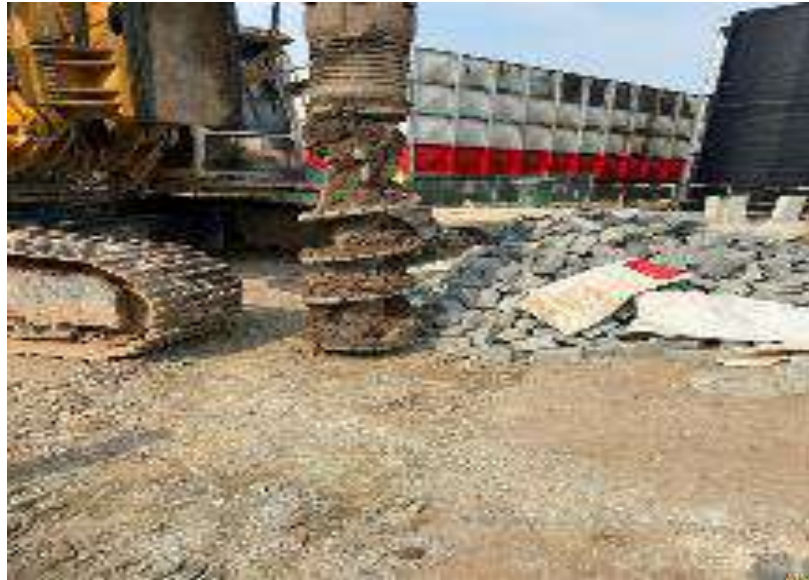
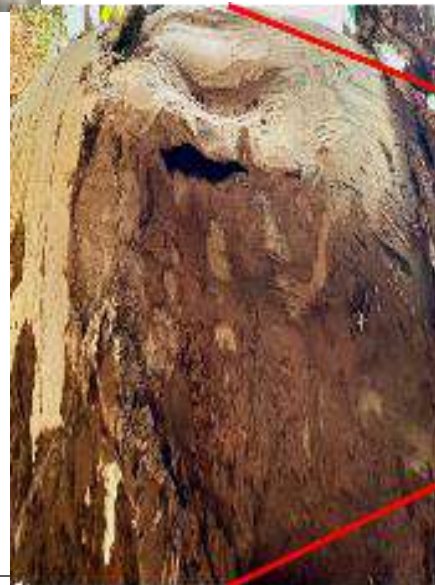
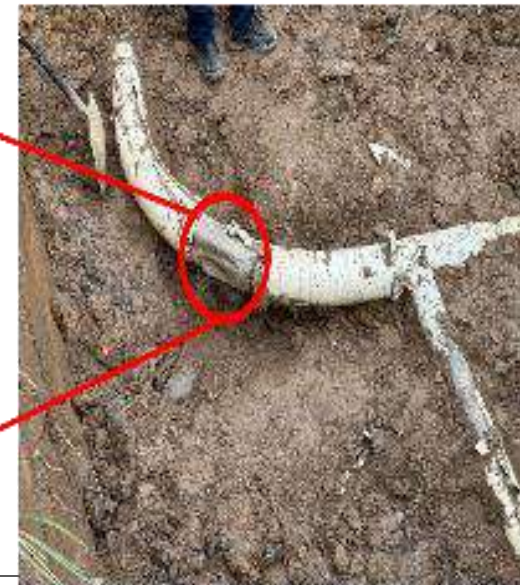
Gaseous Nitrogen (GN2) underground pipeline at customer premises was punctured by customer construction team. The pipeline was damaged by a bore pile machine. The pipeline was for supply of gaseous nitrogen to various customers at an industrial area.

Total estimated amount of GN2 released was 23,700 kg (~4.86 hrs), based on the flowrate at around 4,876 kg/hr what caused temporary interruption of GN2 supply to two pipeline customers.

- Customer internal communication failure as their main contractor did not communicate to their subcontractor regarding the live pipeline at their pile points.
- Clear scope must be identified as well as the sequence of the works must be clearly established with customer, when there are different agencies involved for the pipeline relocation works,
