Recent (H2 of 2023) Safety Incidents in the Gases Industry in Asia

© AIGA 2024- Asia Industrial Gases Association. All rights reserved.

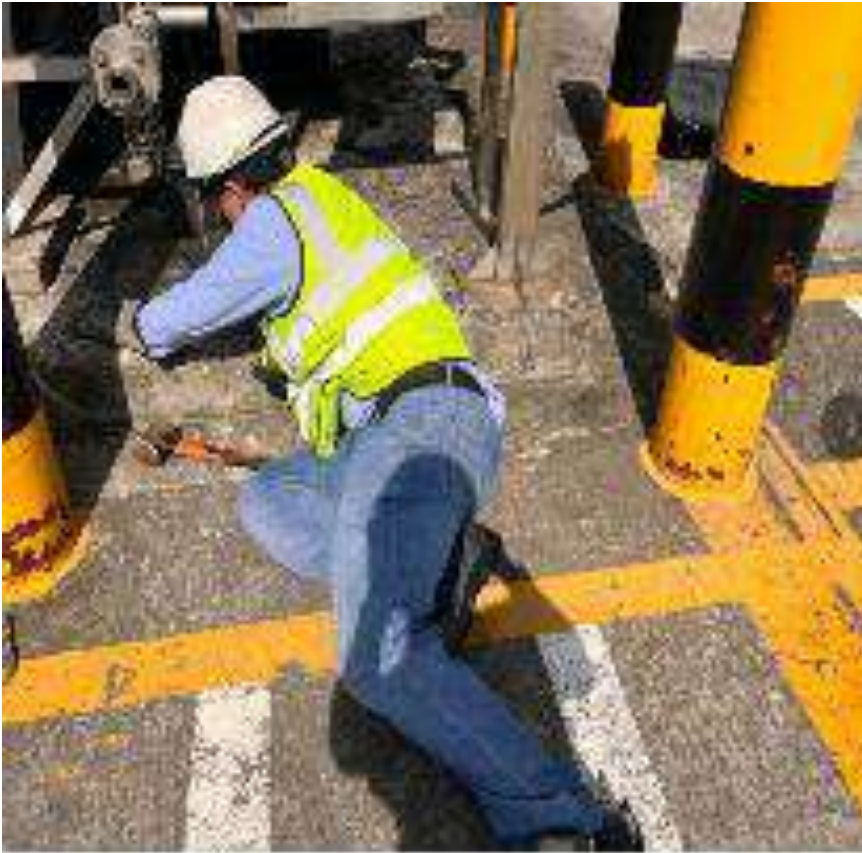
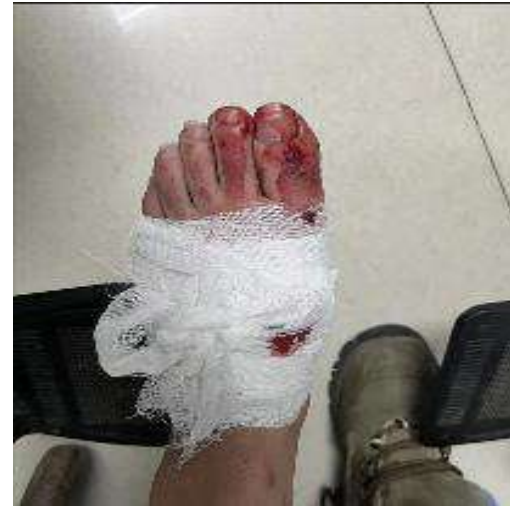
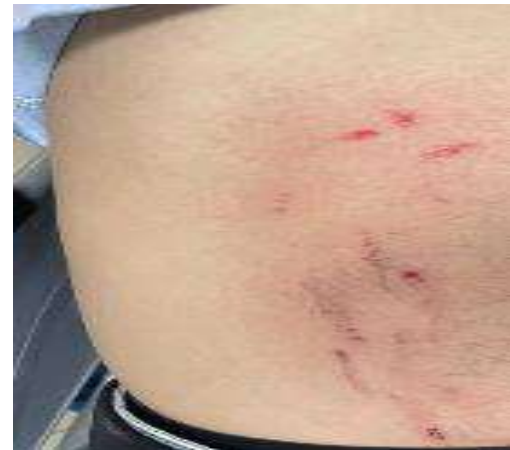
About 7:24hrs, a driver (Driver1) found that the fill coupling was leaking while filling the LCO2 Micro Bulk Truck at a plant. The driver hit the LCO2 tank's fill connection with a brass hammer to tighten it, and the gas return hose suddenly detached from the tank's fill coupling. The hose swung and hit the driver's foot (Driver1), causing a deep cut to his left foot. He fell down to the ground and his abdomen was bruised. The driver (Driver1) closed the CO2 tank gas globe valve immediately. Another driver (Driver2) closed the valve on the tanker and shut down the pump. The injured driver's leg was bandaged and sent to the hospital immediately! The X-ray results showed that the foot had a traumatic injury without fracture but the injury on the left leg required some stitches.

- Hose female coupling was not fully tightened into male headpiece thread
- Apply too much Teflon tape onto male thread
- Driver did not use the anti-whip chain on the hose

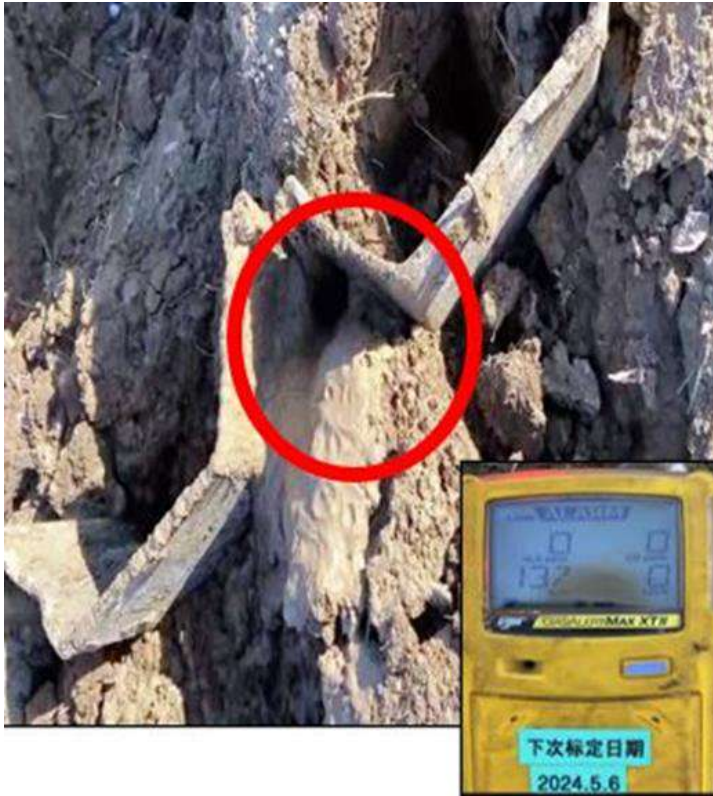
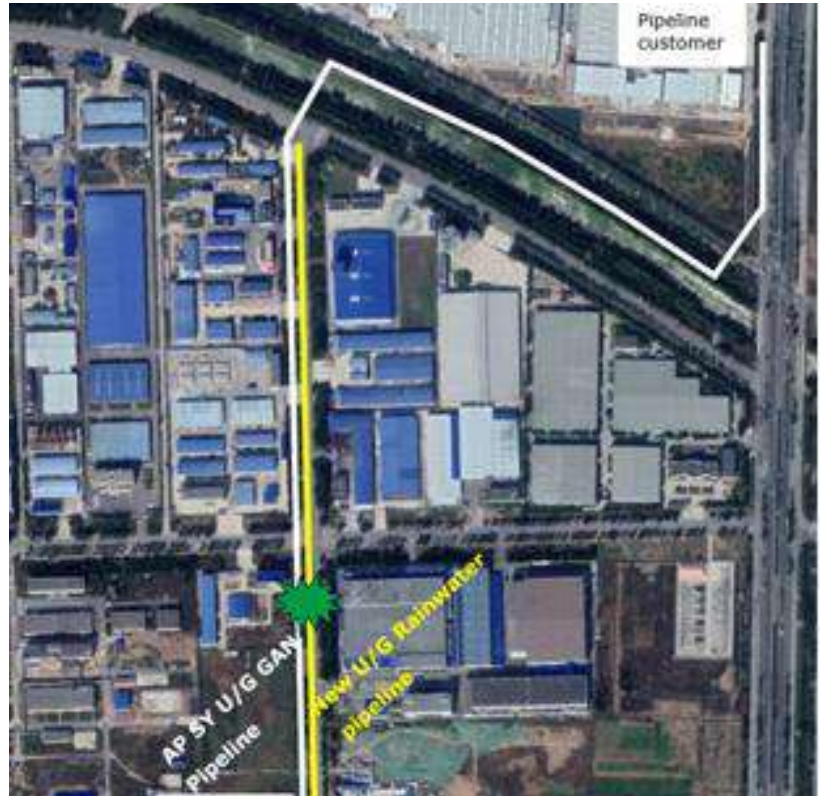
At about 8:50 hrs, underground gas nitrogen pipeline was hit by steel sheet piling during municipal construction. Nitrogen leak caused the pipeline supply pressure to drop and the backup system kicked in accordingly. The N2 pipeline was isolated at 9:18 hrs. No personnel injury was reported.

- N2 pipeline location (piping route & depth cover) was inconsistent with the as-built drawing.
- Site Ops Team lack tools and methods for underground pipeline detection. Qualify pipeline detection vendor.
- Improve pipeline SOP. Update related drawings and records.

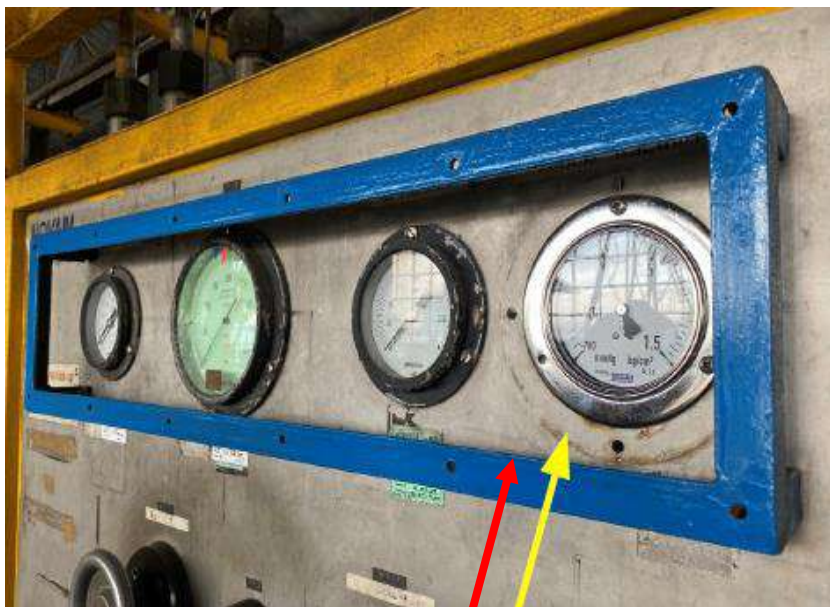
Newly replaced vacuum gauge

- Carry out Risk Assessment and provide over pressure protection
- Provide protective cover (polycarbonate) to all gauges at Refilling ramp.

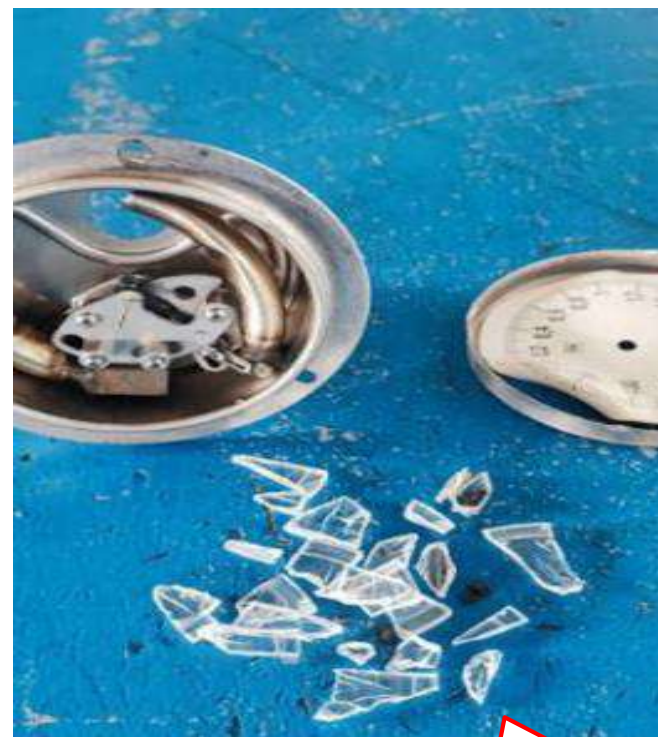
A cylinder refilling personnel was working in the nearby laboratory when he heard a bursting sound coming from the refilling ramp. Upon checking, the team found out that the Vacuum Gauge at one of the ramps has burst. The pressure in that refilling ramp was at 200 bars when the incident happened. Luckily, there was no injury reported as there was no one working in the vicinity at the time of the incident. Cylinder filling activities were stopped immediately. The refilling team then replaced the damaged vacuum gauge.

It was found during investigation that night shift refilling personnel started the purification process and turned over the activity to the next shift. Day shift operator who continued the process failed to check if the vacuum valve was closed before starting the filling process (as per facility SOP, vacuum valve must be closed before the filling process).

Damaged vacuum gauge
regulator and scattered
broken glass cover

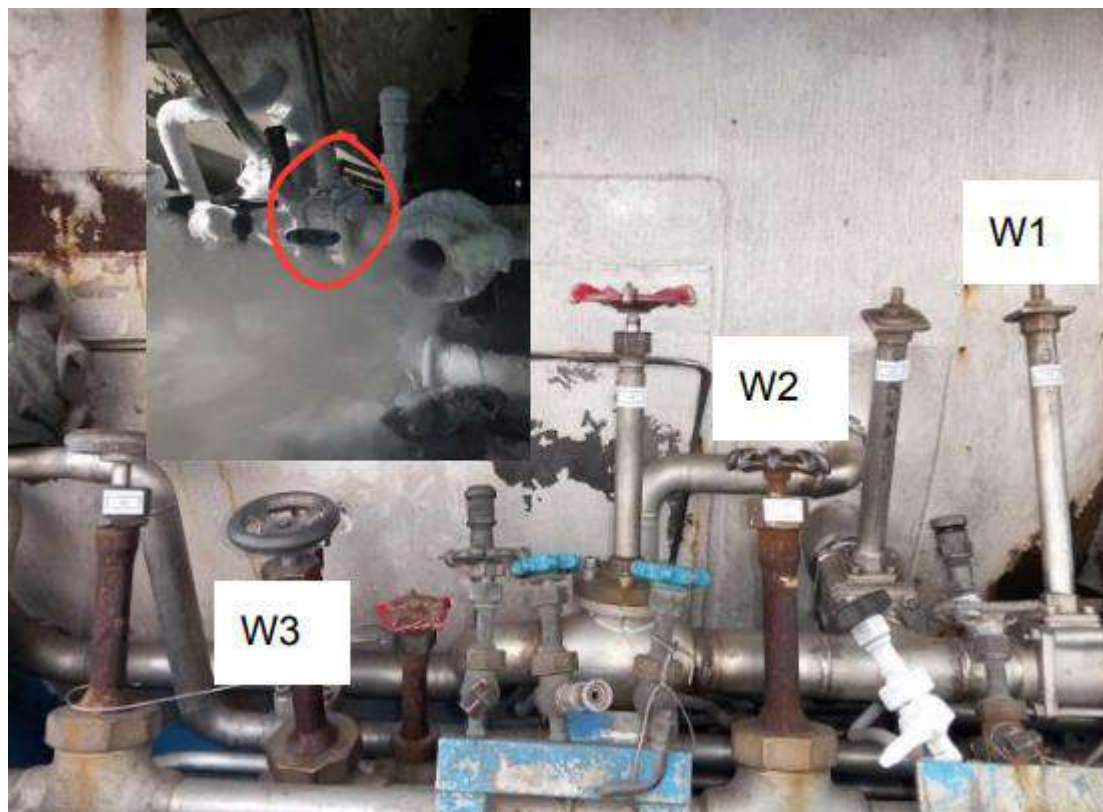
A tanker driver tried to disconnect the flexible hose from the tanker while there was still residual pressure inside the hose which happened during a automatic filling sequence. After 30 min of yellow light (indicating of residual pressure of more than 0.3 barg), the driver decided to loosen the 'bayonet coupling' while communicating with the operator about the condition. The operator arrived on site to check the conditions and told the driver to immediately close the bayonet. Instead the driver knocked open the valve while the operator was holding the bayonet's flexible hose. Within few minutes, LOX splashed over the operator causing irritation to his right arm. The operator immediately flushed himself with fresh water and was escorted to the nearest hospital for further treatment.

- Report any issue to supervisor when ever there's a deviation in the automation
- SOP on management of deviation

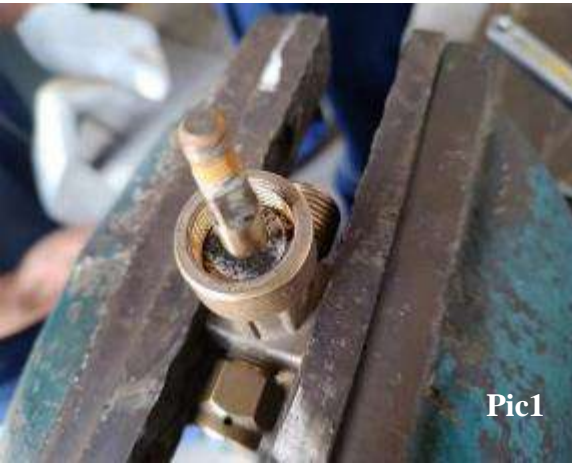
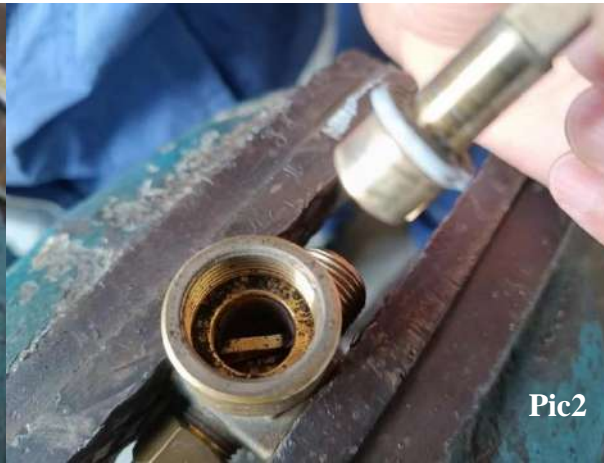
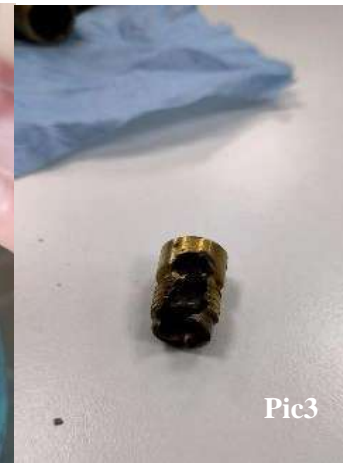
Around 13:44 hrs, a HP O2 cylinder valve suddenly failed several minutes after the finish of the filling (P: 15.2Mpa, T: 45 C) which resulted in the O2 blow out from the valve with flash flame. No one was injured. Dirt particles might have blocked the closure of the valve gasket and caused local deformation of the gasket, eventually causing a sudden oxygen leak. It is suspected friction between the high velocity gas flow and the gasket and/or the impact of particles caused ignition source. The valve spool gasket was tested and confirmed to be made of polysulfone which incompatible for oxygen service , not PTFE as claimed by the manufacturer.

Before the customer's oxygen cylinders were put into use, the filling station did not carry out the internal inspection, which failed to eliminate the risk of the cylinder valve with a small amount of grease, rust, dust and other debris.

- The oxygen cylinders hosted by the customer should be properly inspected before the first commissioning.

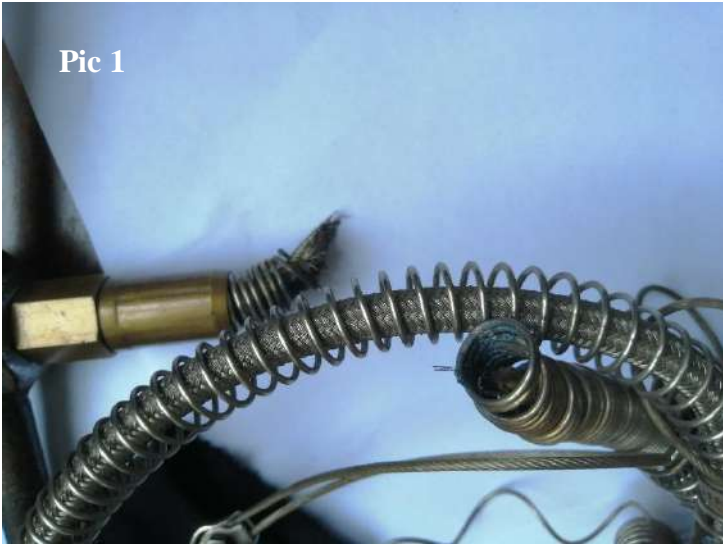
Pic 1

A filling station was filling a batch of industrial oxygen - 69 40L single cylinders. At 16:05 hrs, all cylinder valves were closed after the filling finished (pressure 14MPa). The incident happened when the filler opened the discharge valve on the manifold to relieve pressure. Both ends of a filling hose on the manifold suddenly exploded with shooting out of about 200mm high-blue flame from the broken end of the cylinder valve, accompanied by jet-like fireworks and a huge sound. A filler near the accident cylinder was grazed on the back of his left hand by the rebound of the burst hose. Both ends of the filling hose were broken, and there was burn mark at the end close to the valve connection (Pic 1), on the valve inlet and the connection of the filling clamp (Pic 2). The valve spool had a melted cavity and the sealing gasket was completely burned out Pic(3).

- It is important to have a full proof oxygen cleaning management system and practice for O2 cylinder filling.

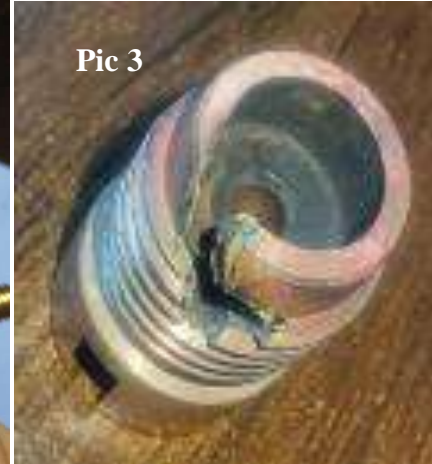
Pic 3

It is suspected in the process of cylinder turnover flow, the cylinder valve was polluted by grease, and it was not found before filling. Also the filling system has been in operation for a long time, and no filter was installed on the oxygen pipeline. Also the system has not been purged during the years' of operation, what led to chance of accumulation of certain metal oxide particles.
