# Recent (H2 of 2024) Safety Incidents in the Gases Industry in Asia

# Recent (H2 of Year 2024) Safety Incidents in the Gases Industry in Asia

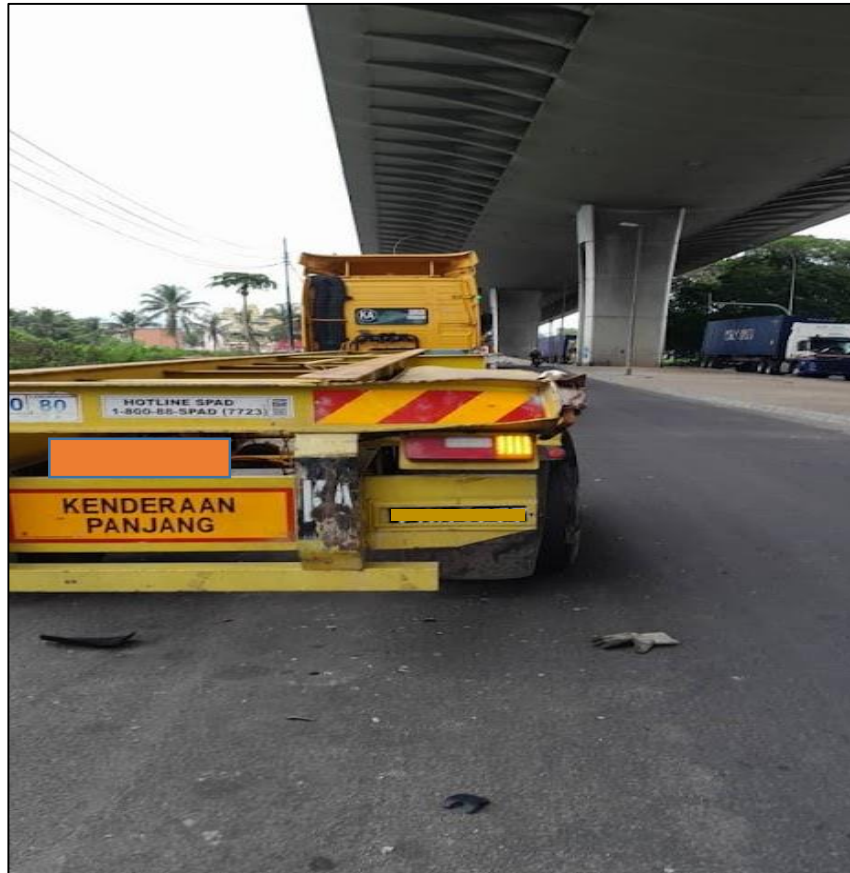
Thru the in-cabin camera, it was found that he was distracted with wiping his face with a cloth at the time of accident. It was observed that before the accident, he was also using his mobile phone and drinking water while driving. There are instances when he did not hold the steering wheel with both hands. During the accident, the 3rd party trailer was parked illegally at the roadside causing the road to be congested and the product vehicle driver hit the back of the trailer. The side mirror and the left side of truck's body were damaged.

3rd party trailer parked at the roadside

- Lack of Defensive Driving like distraction (wiping face with cloth) caused accident
- Unsafe behavior with use of mobile phone and both hands off the steering wheel

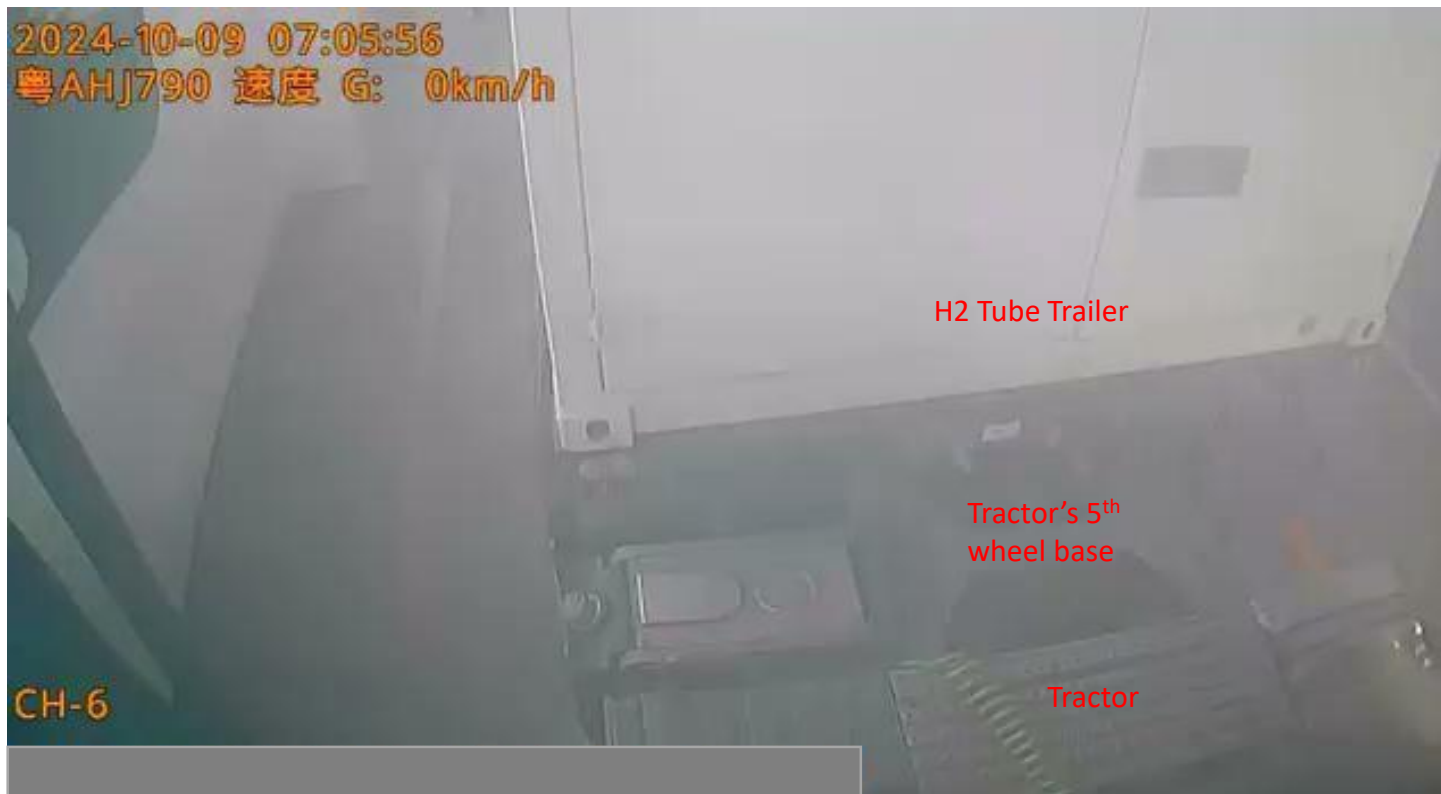
Around 0707 hrs on a day, a product vehicle driver wanted to truck out the full H2 tube trailer from the filling bay. The driver then coupled the tractor to the full H2 tube trailer. While moving the H2 tube trailer out, the tube trailer got separated out from the tractor. The supporting legs of the trailer did not touch the ground and were not damaged. The driver reconnected the tractor and trailer by lifting the tractor air suspension and raising the support legs. No product leakage and no one was injured in this incident.

Trailer was separated from tractor

- Strictly follow the tractor/trailer coupling procedure and the need to inspect the engagement of 5<sup>th</sup> wheel and kingpin after coupling of tractor/trailer.
- Potential High Severity Incident if tractor gets disconnected on a busy highway.

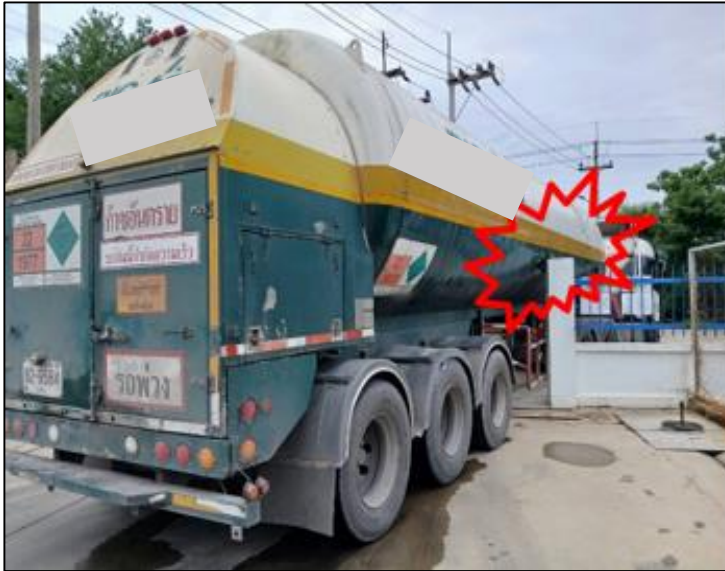
No injury was recorded. The truck outer vessel was damaged, and top of the concrete gate post was broken.

Liquid Bulk Truck knocking into concrete gate post

- Driver failed to secure the liquid bulk truck by activating the brakes.
- Driver was distracted as he intended to return the gate pass.

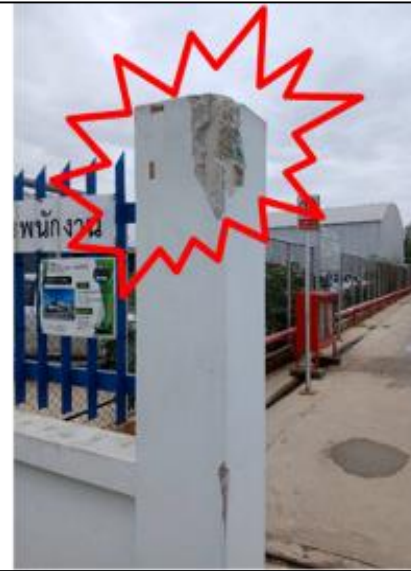
Damaged concrete gate post

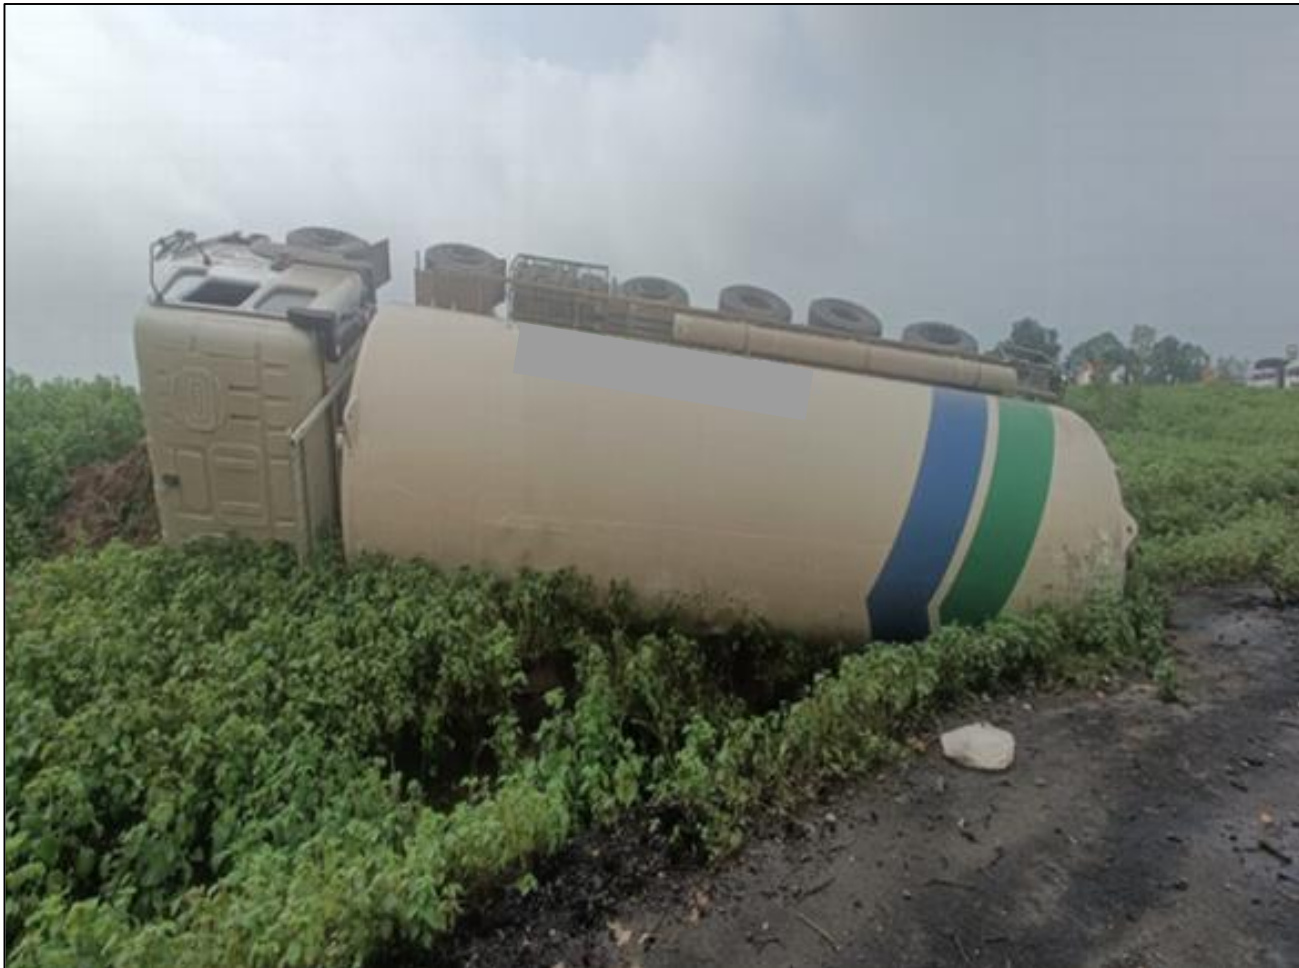
Upon investigation, the driver was found to be fatigued and had a microsleep. He momentarily lost control before going into the soft sloping ground on the left. The driver had been driving continuously for about 2 hours before the roll-over. There was no Fatigue Detection System installed in this tanker.

Rolled Over Tanker on soft slope ground

- Driver had a micro sleep.
- Driver did not take an adequate rest and was fatigued while driving behind wheel.
- Take a break when you get fatigue symptom eg. yawning, heavy eyes, and loss of focus.

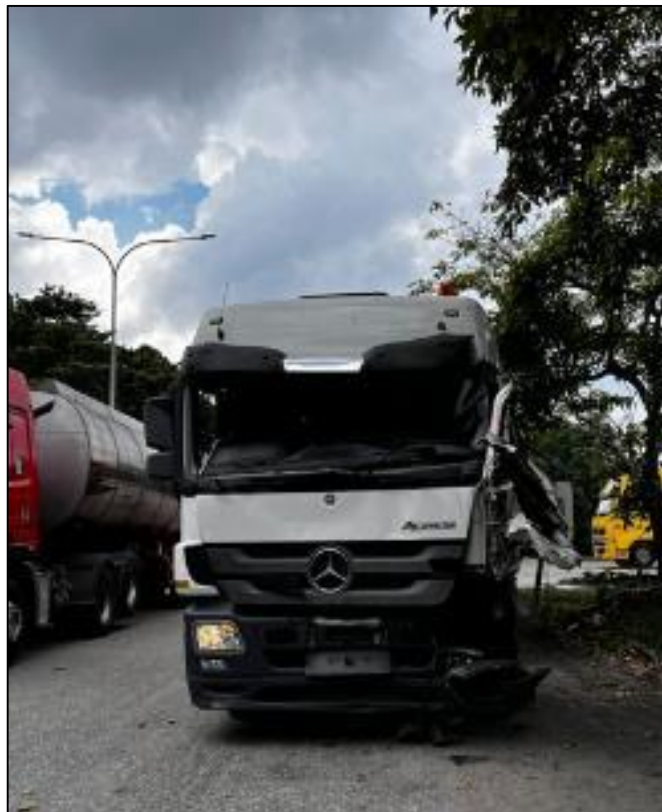
At about 1040 hrs., a product vehicle driver was driving the Bulk Hydrogen Tube Trailer (BHY TT) on the lane and intended to make a left turn at the road junction. He slowed down the BHY TT and signalled. When he turned the TT to the left, a 3rd party container truck travelling behind the BHY TT overtook the BHY TT on the left and collided into BHY TT. The left side door, left mirror, front mirror, cabin and left front bumper of BHY TT were damaged. There was no personnel injury and product released.

Front view of damaged BHY tractor

- Exercise lane discipline - Drive in the middle of the lane.
- Ensure that the space is clear before making a turn.
- Yield or stop the TT to give way to other vehicles.

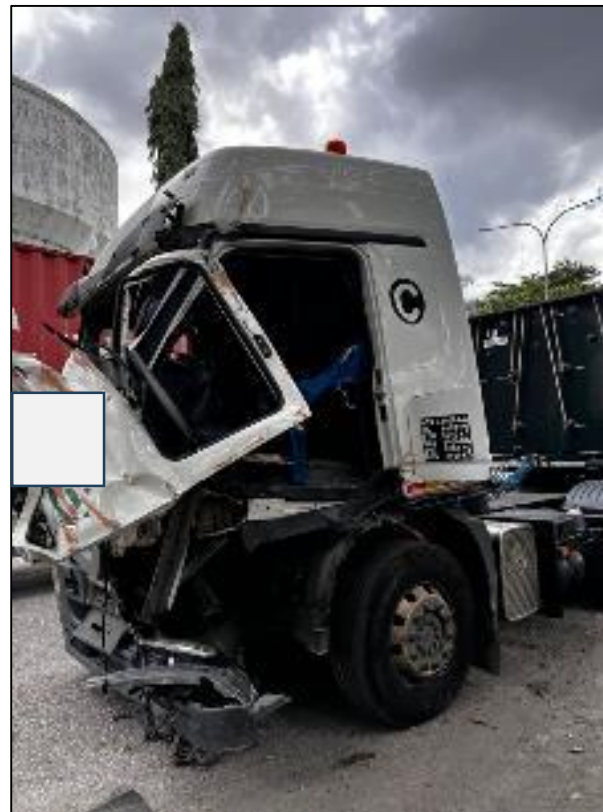
Serious damaged to BHY Tractor

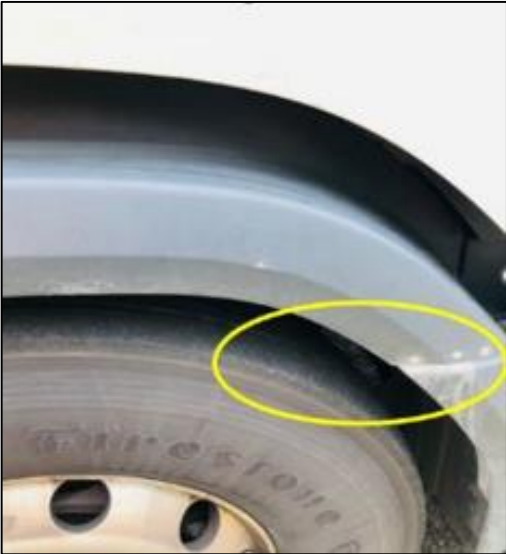
Scratches on vehicle's fender

- Driver failed to stop the tanker before the gate and assess situation.
- Do not rush.

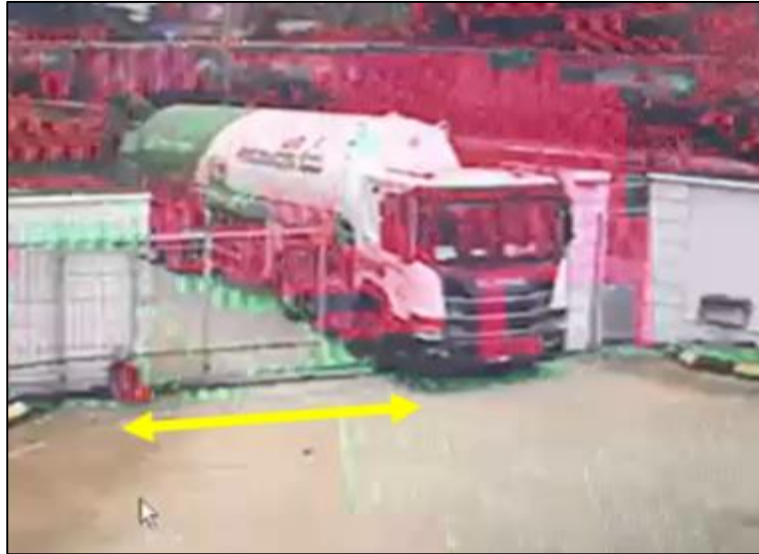
At about 1248 hrs, a product vehicle driver drove back a Liquid Bulk tanker to the facility to load product for customer delivery. While approaching the main gate at a speed of about 11 km/hr, the main gate was moving to close the entrance. The gate has a sensor activated system. Driver kept moving and stopped the tanker along the path of the moving gate. Due to faulty sensor, the gate kept moving and hit the tractor. The gate collapsed and was damaged from the impact. The tanker fender was scratched. Driver did not report the incident to his supervisor as he was rushing to fulfil the delivery.

Tanker entering the main gate while the auto gate was closing

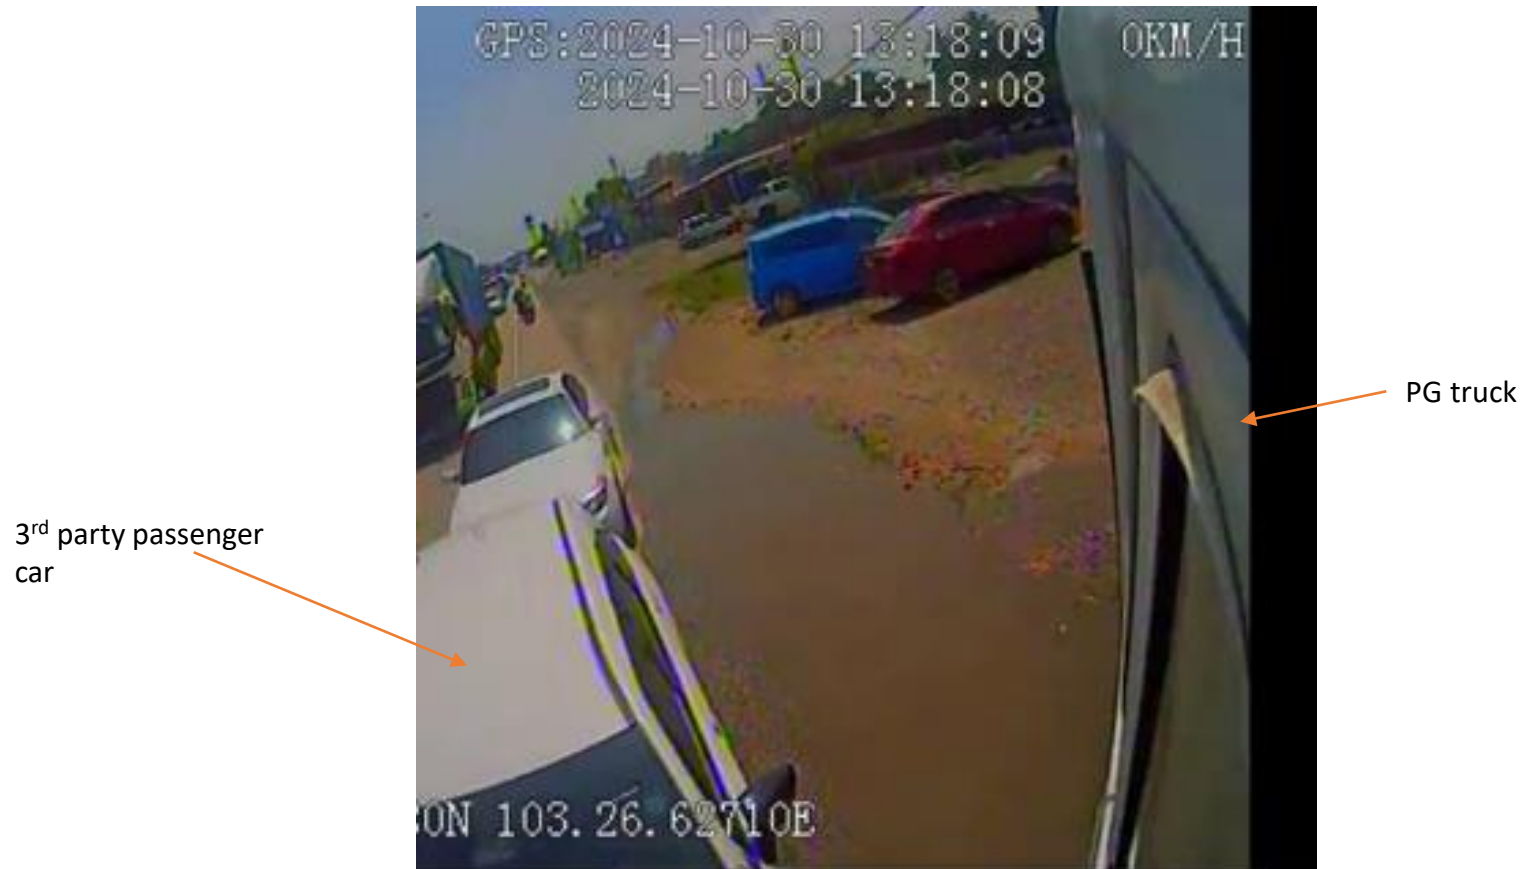
The PG driver attempted to reverse the PG truck to his left into the customer site while the PG truck protruded out on the main road and hit a stationary 3<sup>rd</sup> party passenger car (the car was stop due to traffic jam). Due to the impact, both the PG truck and the 3<sup>rd</sup> party passenger car had a minor damages. There was no injury and also no product leakage reported in this incident.

Side mirror view of PG truck colliding into 3<sup>rd</sup> party car

- Assess the area around you for safe reversing. Perform Go Out And Look (GOAL) to ensure that you have the safe route to be taken.
- Be vigilant with the poor site condition. Report all the non-conductive customer site conditions to the supervisor.

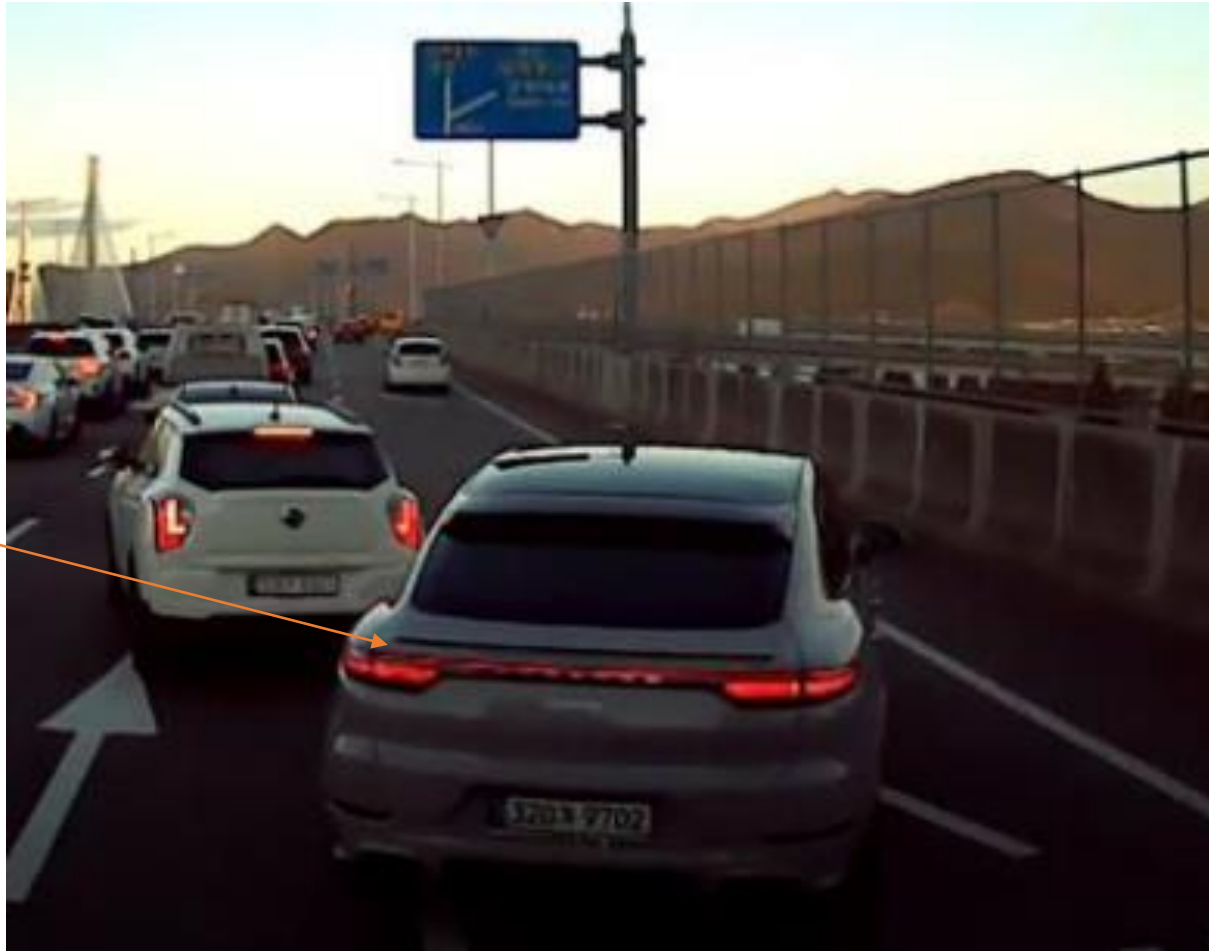
At about 0740 hrs, a product vehicle travelling on the second lane was passing a tunnel when the product vehicle driver attempted to switch to the 3rd lane in order for him to prepare for the right turn about 200 meters ahead. On the right side of the product vehicle(3rd lane) there was a 3rd party car who was traveling alongside the product vehicle truck. The product delivery driver failed to identify the existence of the 3rd party car and hit the 3rd party car while making a lane change to the right.

3<sup>rd</sup> party passenger  
car that was  
knocked into by  
product vehicle

- Drivers to check the mirror every 5-8 second interval; left and right are equally important – to identify the potential risk around the truck.
- Turn on directional signal early to indicate intention to switch lane

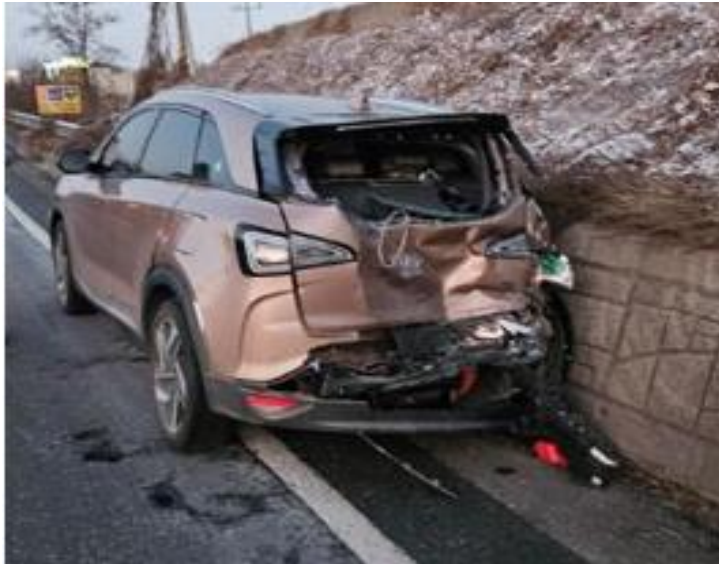
At about 0630hrs, when it was still dark, a product vehicle was travelling to facility plant for product pick-up. While passing the junction at a speed of about 67 km/hr, there was a parked 3<sup>rd</sup> party passenger car on the road shoulder which was involved in an earlier road accident. Parked 3<sup>rd</sup> party car did not have hazard light indicator switch on to alert other traffic. There was no street light for this stretch of road.

Damaged rear of 3<sup>rd</sup> party passenger car

- Driver should manage his safe speed and space while driving with poor visibility

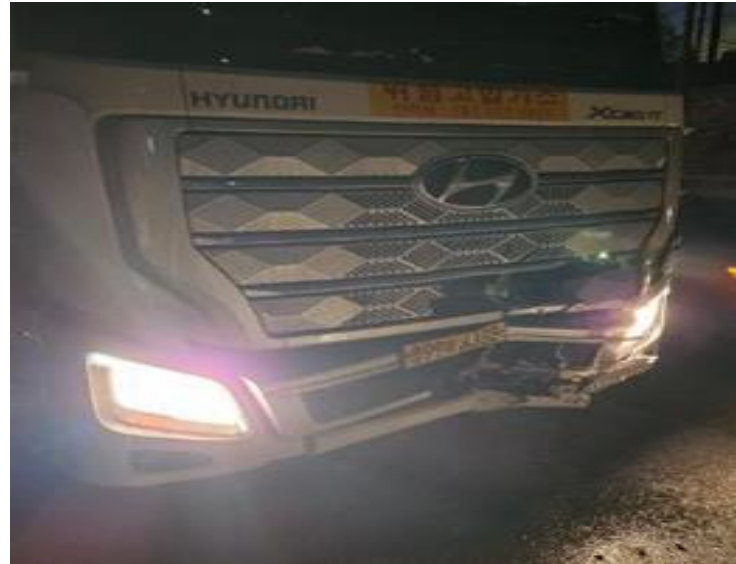
Product Vehicle Front Bumper

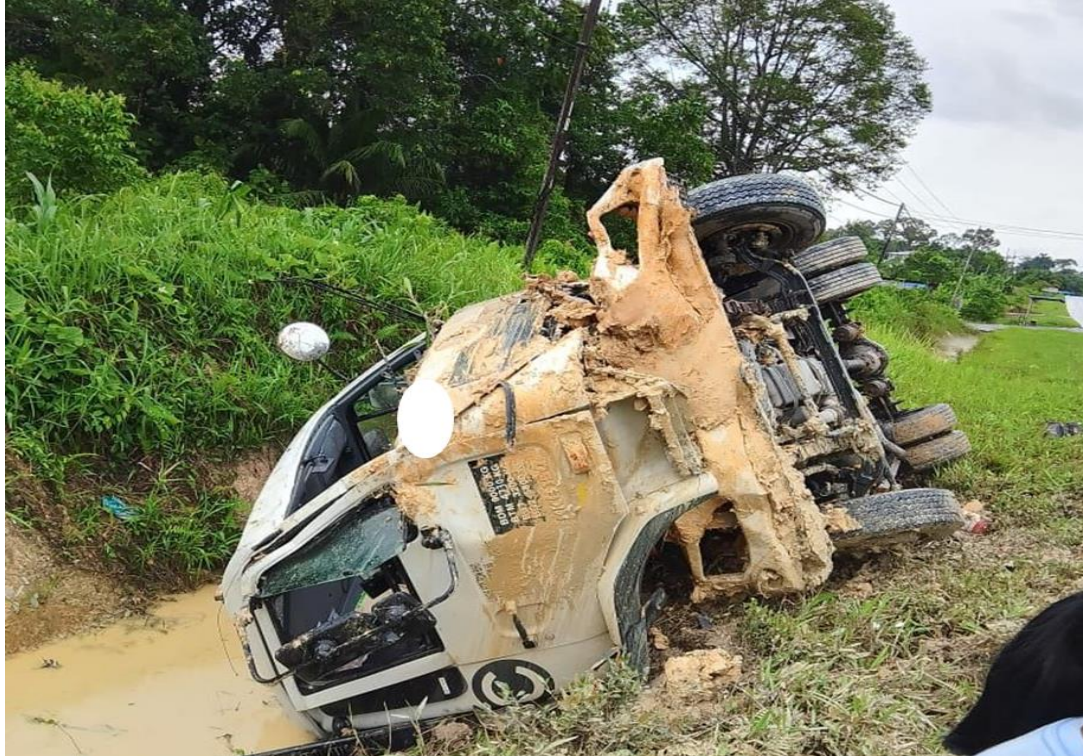
Driver and attendant were wearing seatbelts when the incident happened. The driver escaped with a minor cut on his scalp and no physical injury observed on the attendant. There was also no product release.

Rolled over cylinder truck on soft ground

**Driver not injured,**  
was wearing his seatbelt.

- Seat belts probably had prevented more serious injuries to driver and attendant.
- Reduce speed in adverse weather and on wet road condition
- Have proper weight distribution on cylinder truck as uneven weight distribution can affect center of gravity.

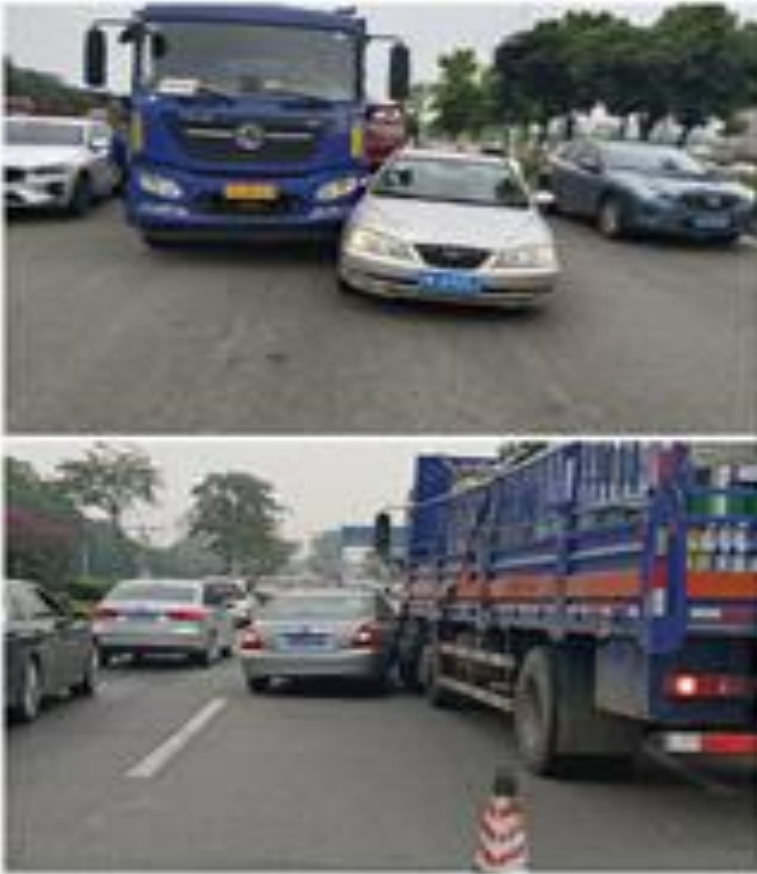
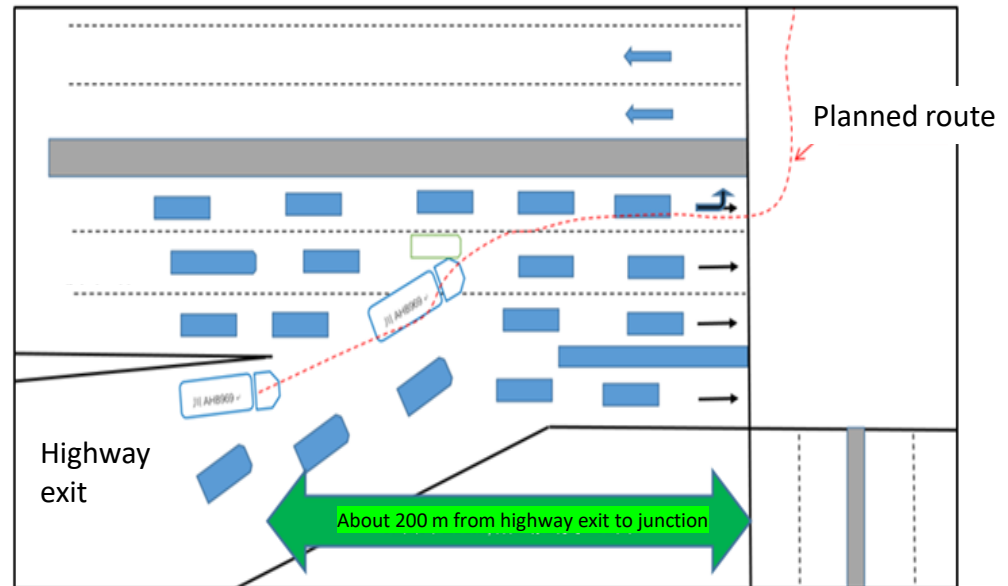
At about 0752 hrs a cylinder truck collided with a 3<sup>rd</sup> party passenger car after continuous lane changing in unsafe manner.

Cylinder truck colliding into 3<sup>rd</sup> party passenger car.

- Proper lane changing protocol was not applied. Reinforce adherence to defensive driving and proper lane changing protocol.

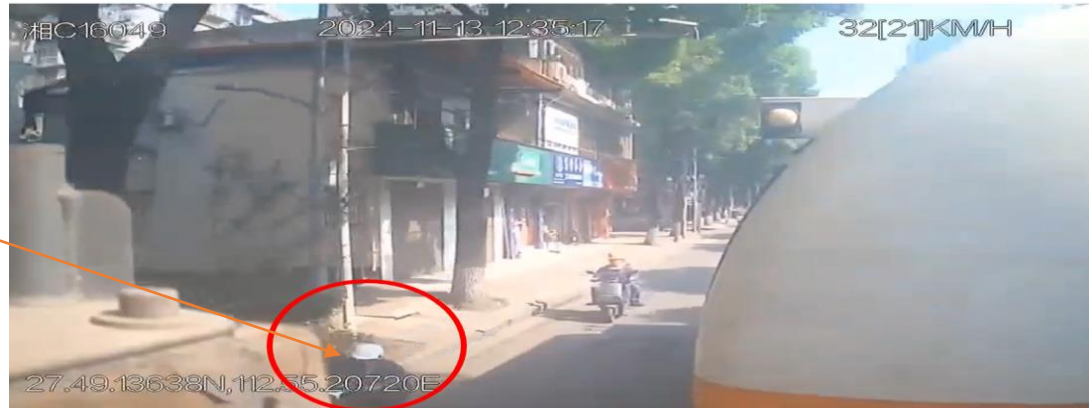
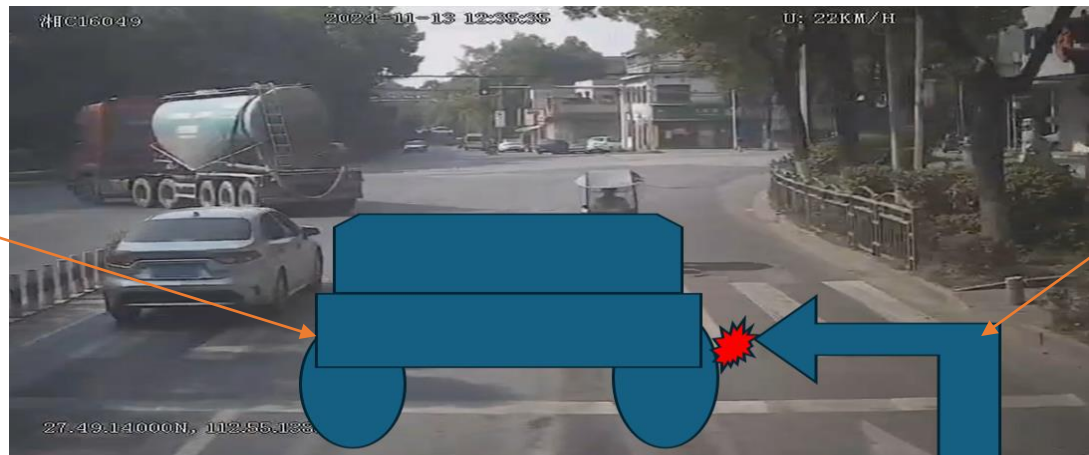
At about 1230 hrs, a product vehicle tanker was on way to the intersection of a road, when a two-wheeled electric bike was trying to turn left on the rightmost motor lane and scraped against the product vehicle vehicle in front of the right side. The electric bike rider (a 74-year-old male) fell down under the right front wheel. The driver stopped the vehicle immediately. The electric bike rider was taken to the hospital and was found to have soft tissue contusions around the left thigh, hip and knee joints after a CT examination.

Electric bike turning left brushed against the front wheel of product vehicle

- Driver failed to notice electric bike rider in the blind spot
- Emphasize that when turning, the escort should lower the window, assist in observing the road situation in the blind area on the right and alarm the 3rd party road user on the right.

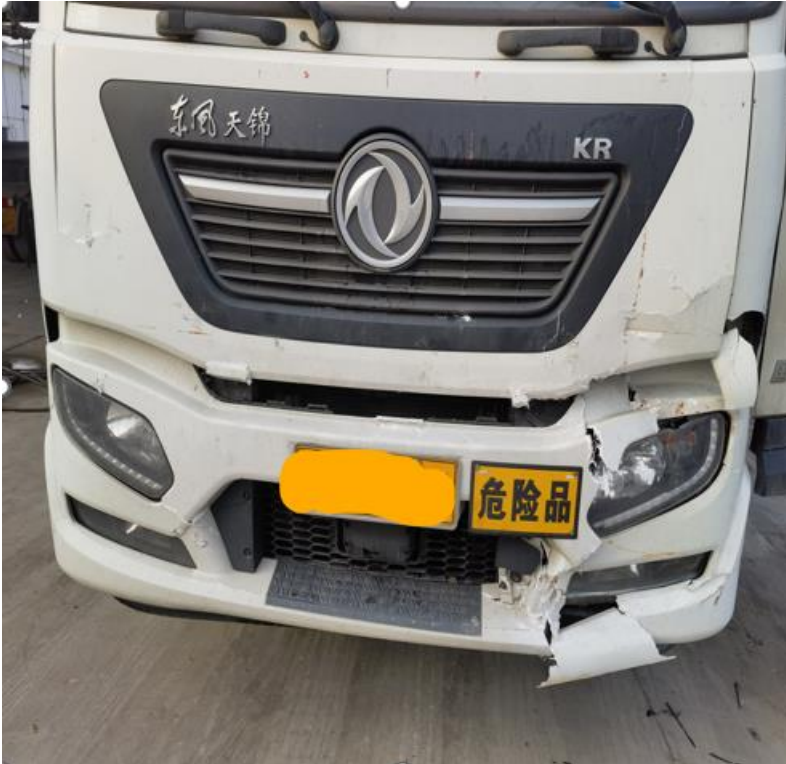
Damages on cylinder truck

- Keep a safe following distance from vehicle in front of your vehicle. Recommended safe following distance would be 6 seconds or more
- Increase the safe following distance when there is a big truck in front that blocking your front view

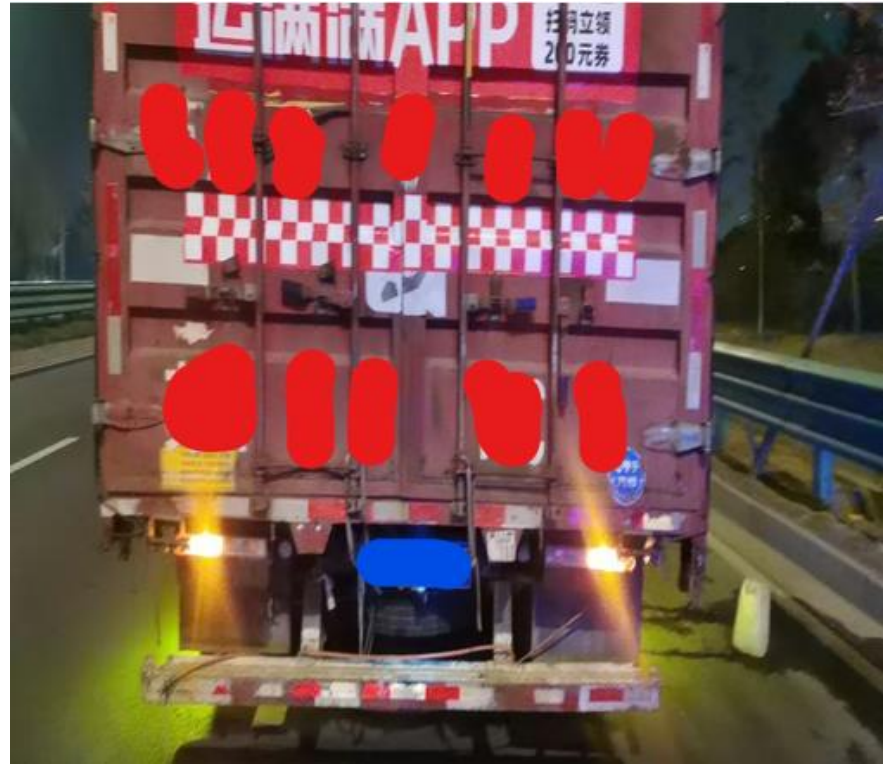
The rear of 3rd party light box truck

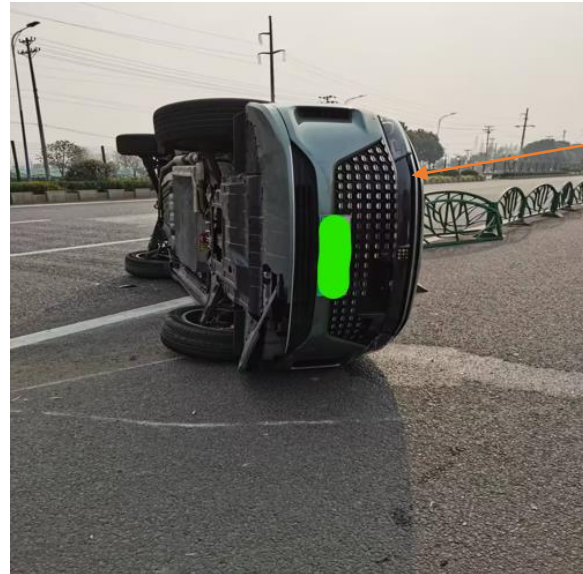
At around 1214 hrs a product vehicle departed from the factory for delivery. While driving on a certain non-highway road section at about 68km/hr, it collided with a small 3<sup>rd</sup> party passenger car entering into the product vehicle's legal lane from the same direction on the right side, causing damage to the left front wheel and bumper of the product vehicle truck, and the small car went into a rollover. There were no product leaks in the collision, but a passenger in the car received some injuries.

Product vehicle driver failed to perform adequate observation to anticipate the car from coming into product vehicle's lane.

Rolled over 3<sup>rd</sup> party passenger car

- Professional driver must be alert at all time and need to anticipate other drivers actions

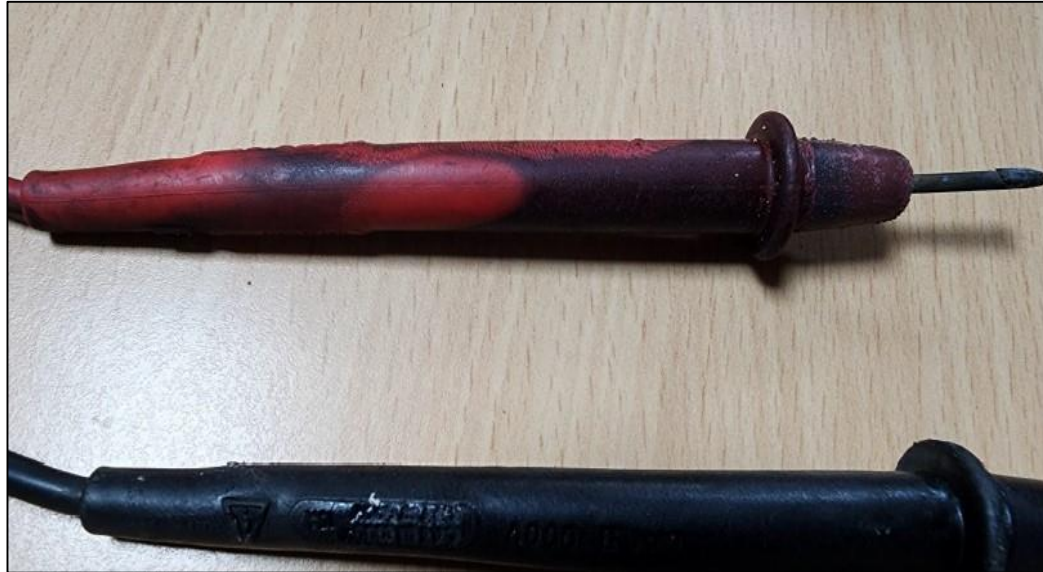
A Safe Work Permit (SWP) was issued for working on the pressure switch of the Gas Nitrogen compressor, work was completed on the pressure switch, then Lock Out Tag Out (LOTO) was removed to take the no load trial. Before the start of the motor, electrician turned on the power supply to the local electrical panel (415 Volt) and started to check between the component. At that time, an electric flash was observed (no one was near to the electrician) that caused burn injury to the hands of the electrician up to the forearm. During investigation it was observed that the Electrician did not perform the right electrical measurement before turning on the power supply. It was also found that there was a phase to phase short circuit between the primary terminals across the main and delta contactors what caused melting of the main contactor terminals and bolts as the resistance between cables R and Y found to be only 3.4 ohms. The low resistance indicates insulation was compromised between these two phases.

Burnt mark on electrical multimeter

- There is inconsistency between SOP & Training (Process of Electrical training was not followed)
- No temporary protection/cover (tarpaulin etc) provided for preservation of the electrical panel from dust and moisture was arranged

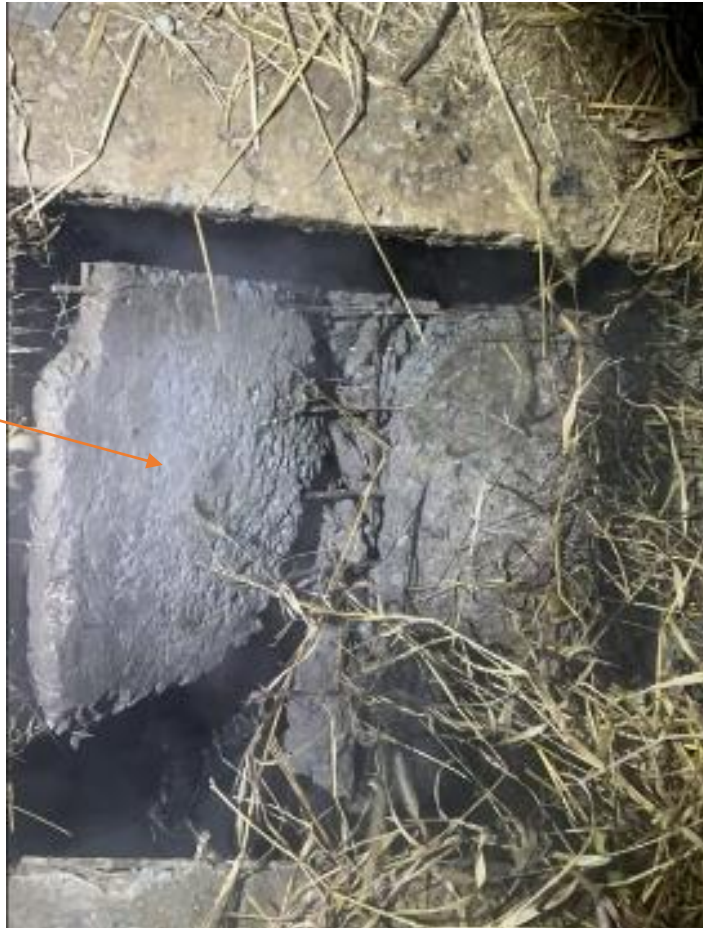
At about 1800hrs, a product vehicle driver was performing pre-filling inspection when the cement cover under the driver's feet suddenly broke, and the driver's left leg fell into the cement ditch. The wire in the broken cement cover cut the skin of the driver's left calf. The driver did a simple treatment at that time and returned to the terminal after unloading. Then he went to the hospital for examination, the wound was 4 centimetres long, the doctor stitched 6 stitches to the wound.

Broken cement cover

- Be aware of the road conditions and watch your step when walking.
- Identify slip/trip/fall hazard while walking

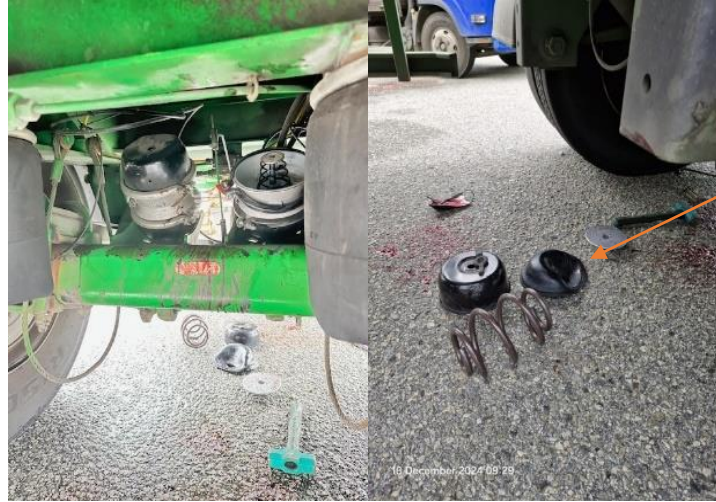
At about 0905 hrs, a 3rd party repair workshop send their mechanic to the plant to attend to a trailer brake problem. The mechanic intent to release the brakes on the trailer in order to haul the trailer back to the workshop to repair the leaking bellow on the axle. The leaking bellow on the axle cause the air pressure unable to build up in the air chamber, resulting in brake engagement. In order to haul the trailer to the workshop for repair, the mechanic will need to release the brakes on the trailer before hauling to workshop. At about 0920 hrs, the plant personnel was informed of the injury on the mechanic face, due to the brake chamber give way and the released chamber cover hit the mechanic face. The 3rd party mechanic was sent to the maintenance office before calling ambulance to convey him to the hospital via ambulance.

Chamber cover that hit the mechanic

- Did not identified hazard on compressed spring as stored energy
- Follow truck repair procedures and manage using Permit To Work System (PTW)
- Wear Proper PPE

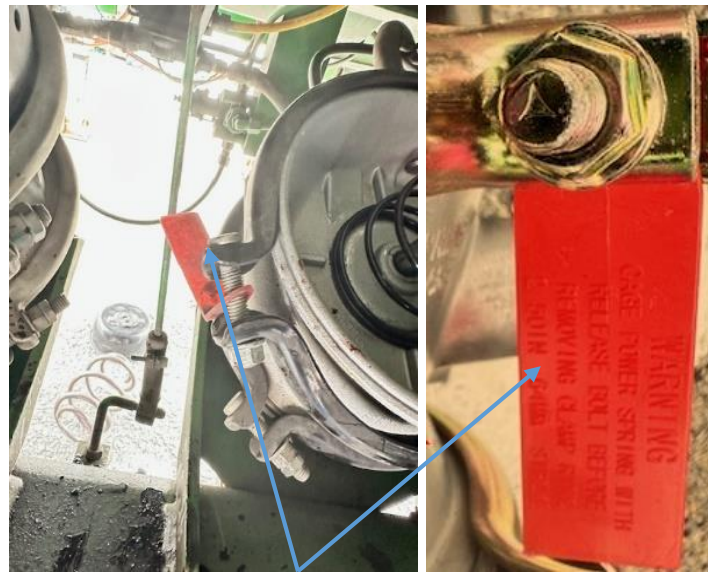
Warning label of stored energy in spring

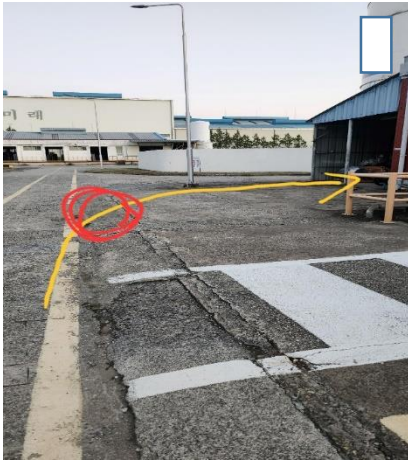
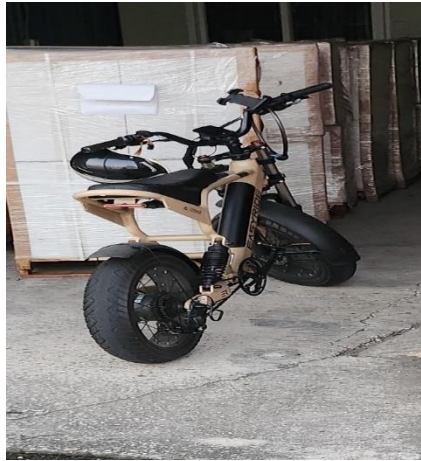
At 1450 hrs, a production team operator employee was commuting to work on an electric bicycle for her shift. While passing through the company's main gate and entering the passageway (slope section) in front of the public office building to park her electric bicycle, the front wheel of the bicycle slipped, due to losing her balance and step on her right foot. She felt uncomfortable on her right big toe and went to the hospital. She was diagnosed with a fractured toe and treated in brace and returned to work.

While passing through the company's main gate and entering the passageway (slope section) in front of the public office building to park her electric bicycle, the front wheel of the bicycle slipped, due to losing her balance and step on her right foot

- Refresh hazards recognition & dynamic risk assessment training for employees.
- Conduct bicycle Safe driving training for related employees.

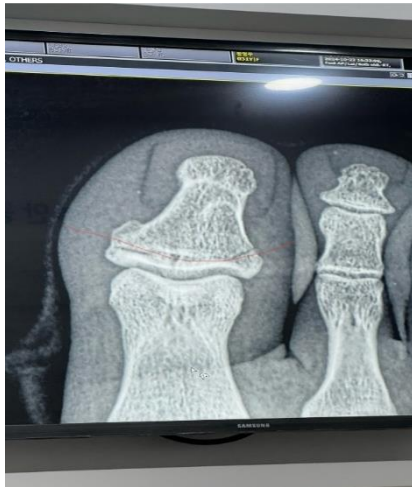
The operator was diagnosed with a fractured right big toe

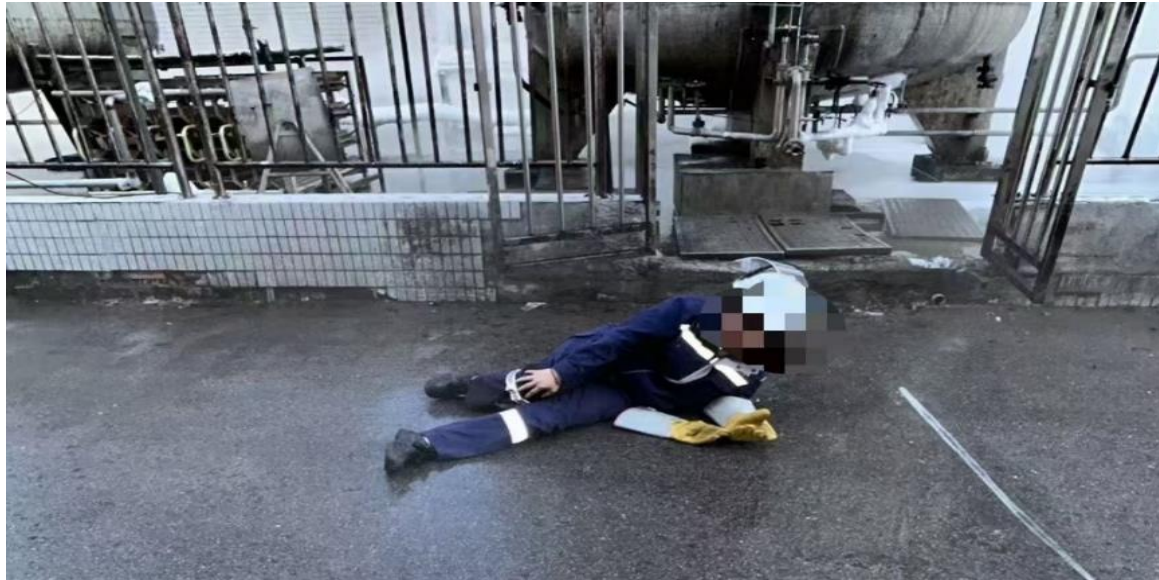
Due to the icy ground in the area and the fog at the site, the helper slipped and fell while walking. The helper was immediately sent to the hospital for an examination, which confirmed a comminuted fracture of the right patella and contusion of surrounding soft tissues.

The slipped helper

- Identify slip hazards and eliminate risks in the workplace.
- Avoid distraction and focus on the ground where you are walking
- Take smaller step when walking on slippery ground

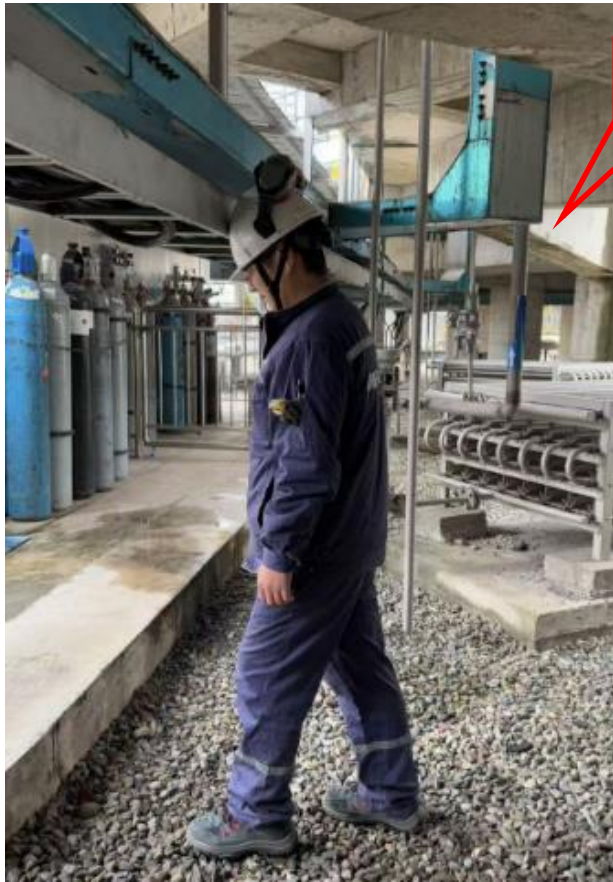
He was moving quickly in a low visibility and dark area while his helmet hit the cable tray

- Enhance the safe behavior – no rush
- Walk on designated walk path and do not take short cut at site

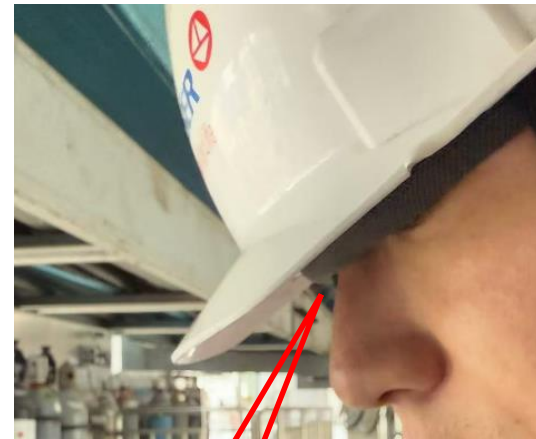
The operator suffered a minor fracture on his nose.

The cornice inside the helmet punch his nose

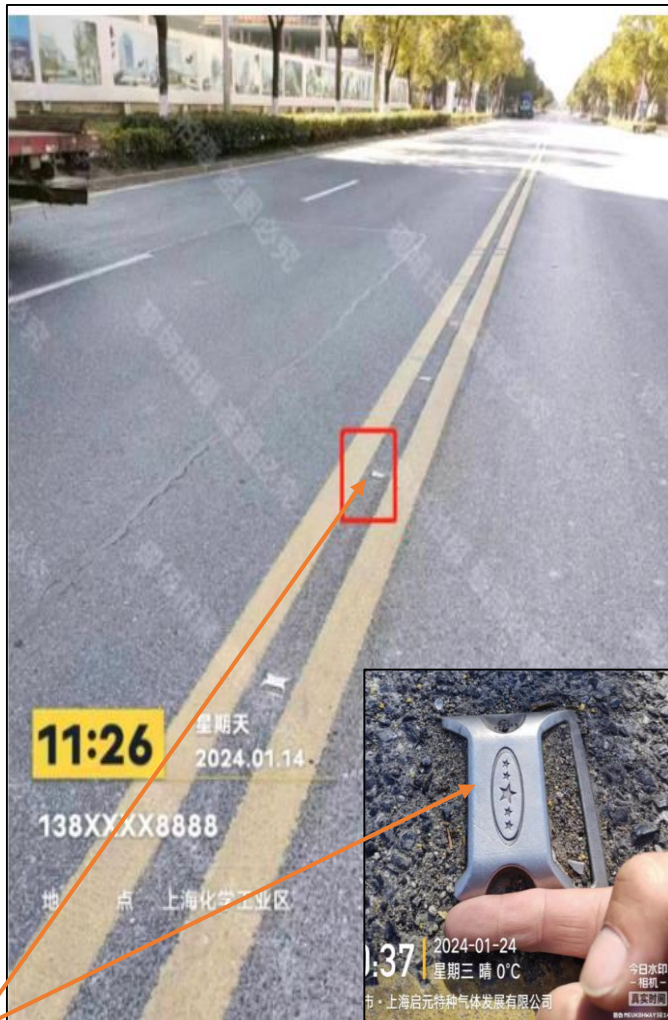
Raised reflective block

- Pay attention to the surrounding and road conditions while walking and crossing a road.
- Walking slowly and carefully, watching your step.

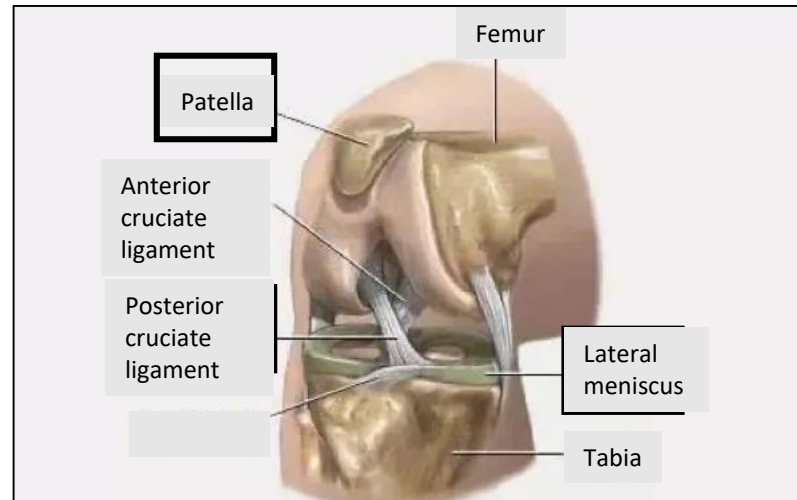
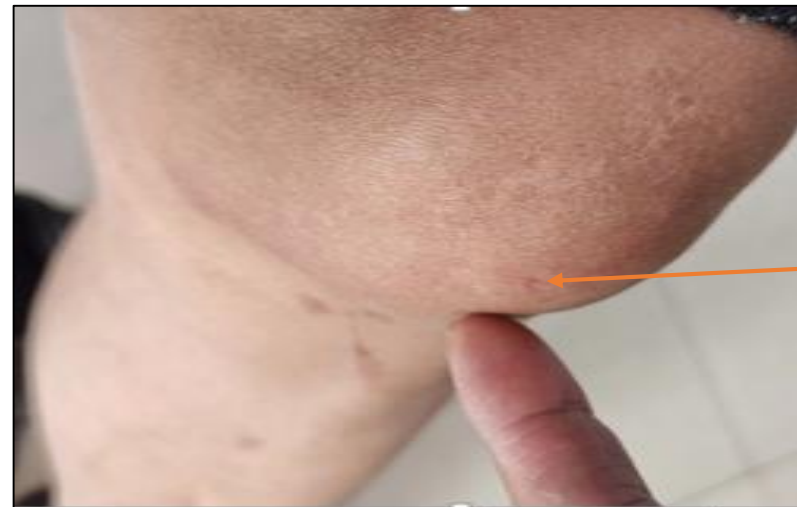
After finishing their deliveries for the day (around 10 pm), the helper went to a hospital for examination where the doctor advised him to rest and monitor for two days for healing. However, after resting for two days at home, the helper felt an increase in pain. The helper then went to another hospital for further examination where he was diagnosed with left knee fracture and tear on ligament.

Swollen knee
