# Recent (H2 of 2024) Safety Incidents in the Gases Industry in Asia

# Recent (H2 of Year 2024) Safety Incidents in the Gases Industry in Asia

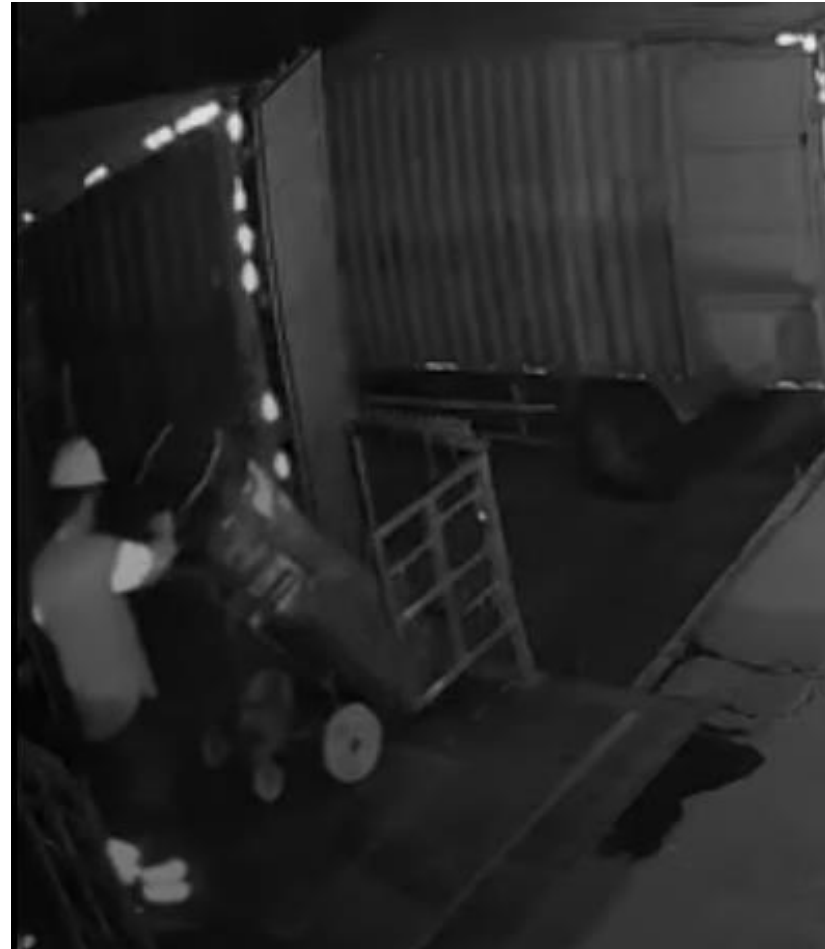
At 1841 hrs, a Packaged Gas (PG) driver was loading Liquid Gas Cylinders (LGC) at the supplier's site. When he was moving a full Liquid Oxygen LGC (165L) from the tailgate to the truck, the LGC suddenly fell off from the hook of the trolley. Under the influence of gravity, the LGC trolley pressed the driver's left thumb to the guardrail of the tailgate, causing the distal phalanx of the driver's left thumb to fracture. After treatment in the hospital, he was assigned temporary job at site work the next day.

Non-approved trolley

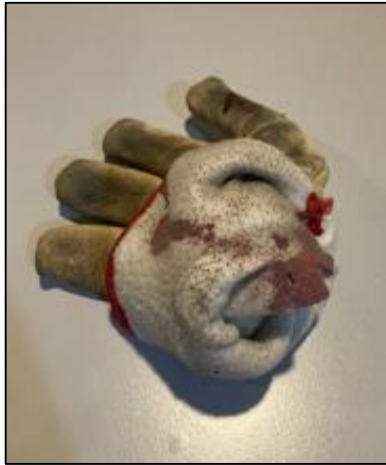
At about 1150 hrs., a Packaged Gas (PG) driver was at a customer's facility. He moved the cylinder onto the trolley and secured it with a metal chain. As he tilted the trolley, he heard a loud noise. He saw the cylinder slipped off from the trolley and fell to the floor. At the same time, the trolley was broken at 3 supporting points, the metal handle of the trolley struck his hand. He removed his gloves and found a cut injury on left hand. Customer provided cotton gauze and bandage for first aid. The plant manager arrived at the site and sent him to the hospital. X-ray revealed a hairline crack on his left hand. He was prescribed antibiotics, painkillers, and the 3 cm cut was stitched.

Blood stains of glove

- Periodic detail inspection and certification of fitness of use for trolley.
- The cylinder trolley broke and caused the cylinder to slip and hit driver's hand. Inspect cylinder trolley before use.

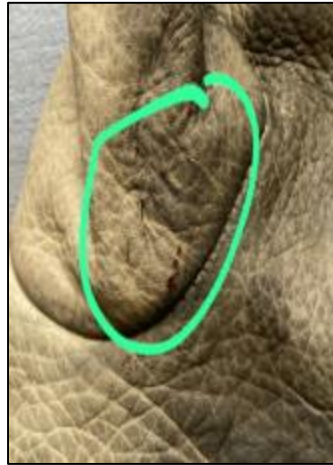
Cuts on the glove

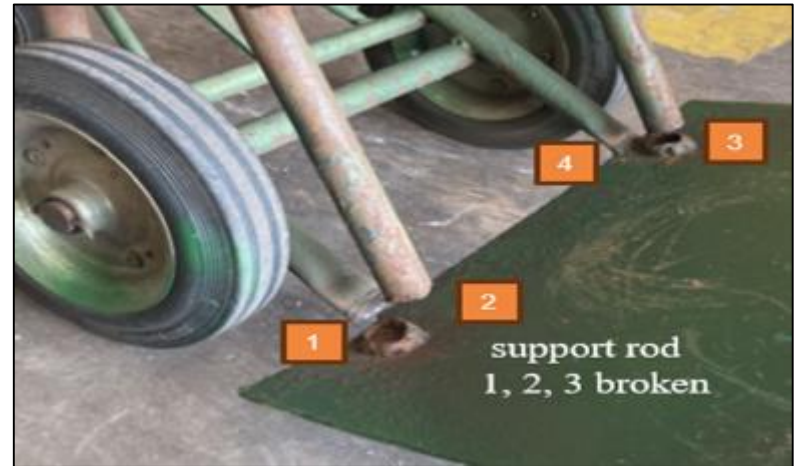
Support rods broken

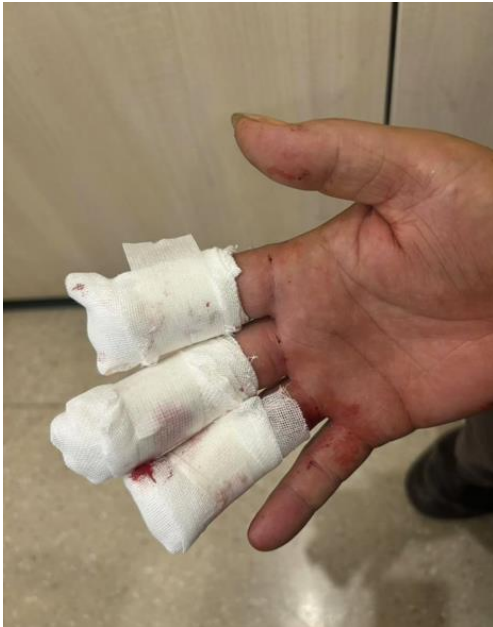
At about 1330 hrs., at a product transfill parking lot, a Packaged Gases (PG) escort was unloading a dewar cart from the tailgate of the PG truck. The dewar fell off the hook at the cart head. Our escort failed to drawback his right hand from the pinch point between the falling dewar and the hook. The supervisor accompanied him to the hospital where he was diagnosed with fracture on his right index finger, middle finger and was sutured. The ring finger was also sutured, and he was given a tetanus vaccination. The escort was discharged from the hospital before 1700 hrs.

Injured fingers

- Ensure that the trolley hook and dewar lift slot are fully engaged.
- Use only approved trolley
- Place hands on designated position of trolley

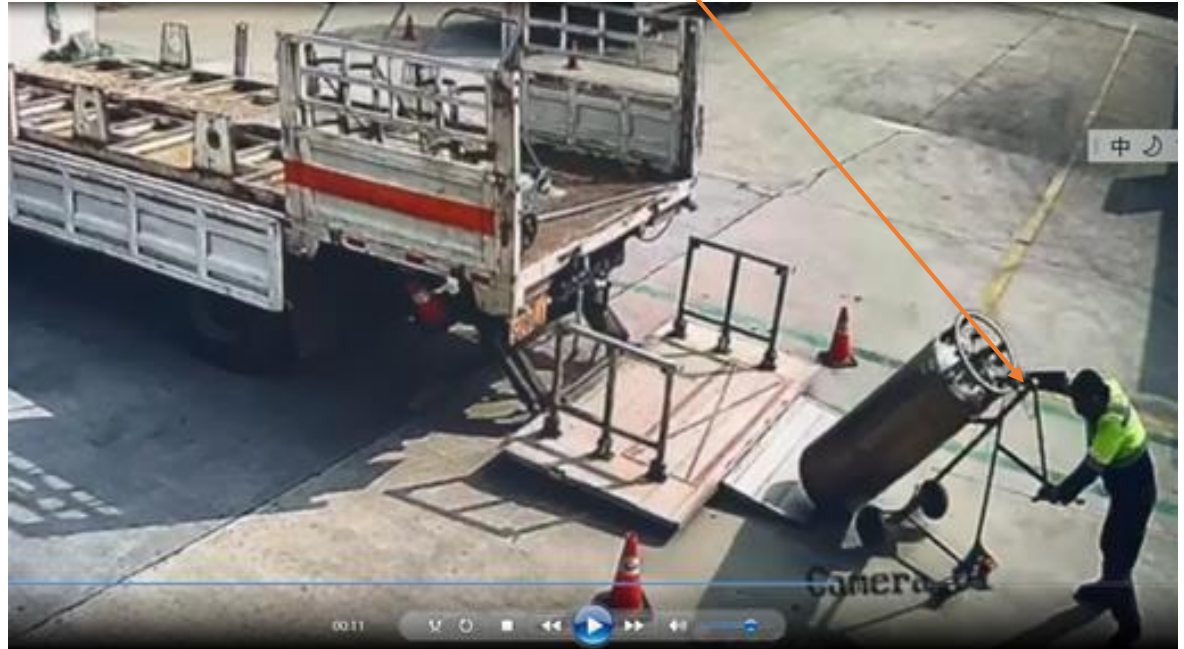
PG driver's hand placed wrongly on LGC

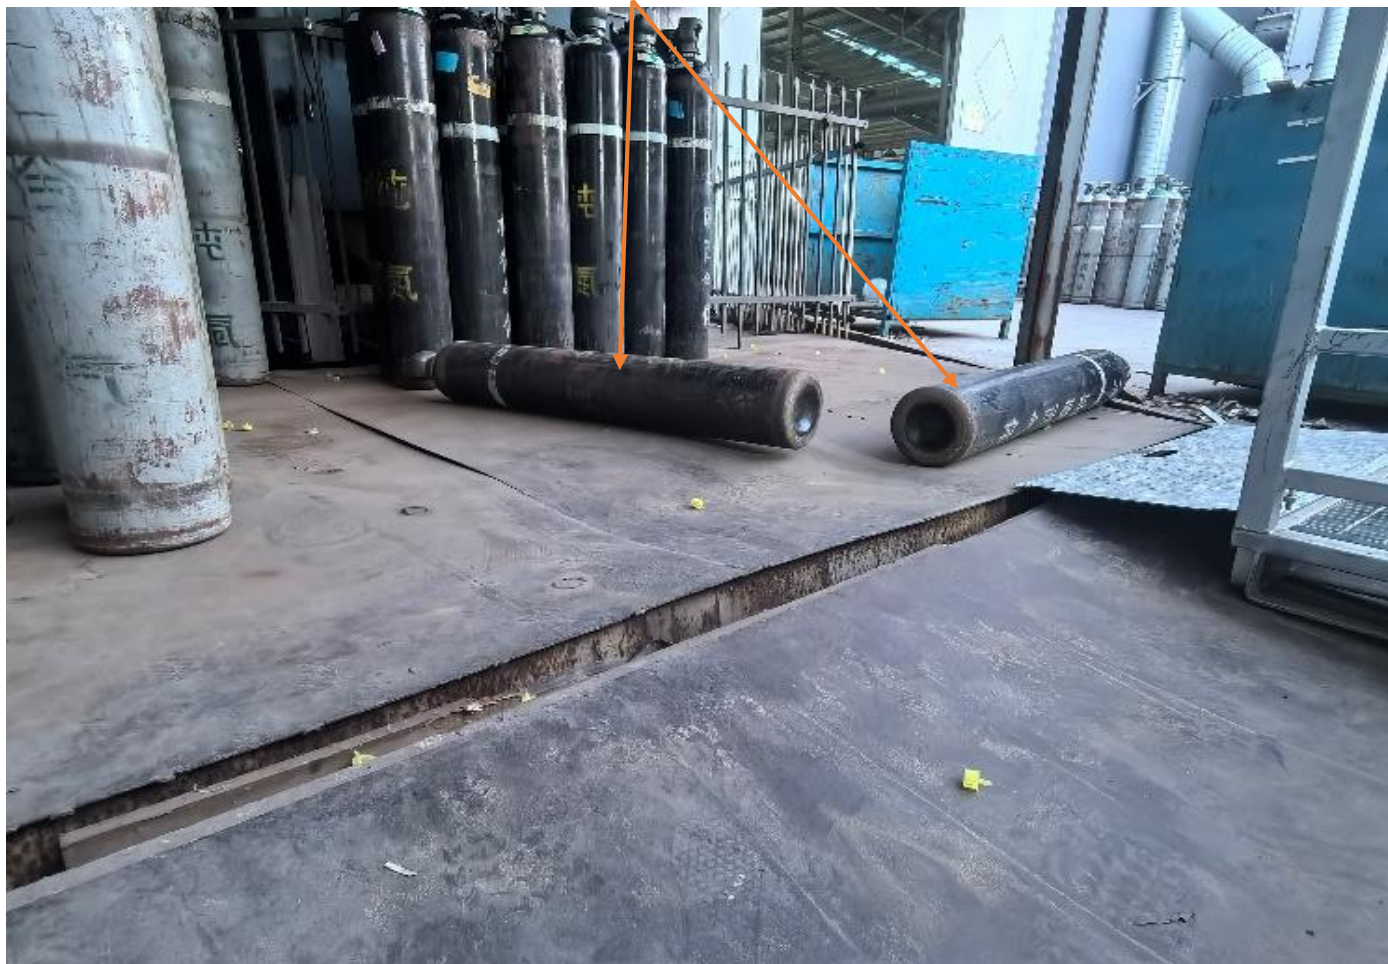
Fallen cylinders

- Do not try to catch a falling cylinder. Move out of harm's way
- Secure lone cylinder with chain to sturdy structure

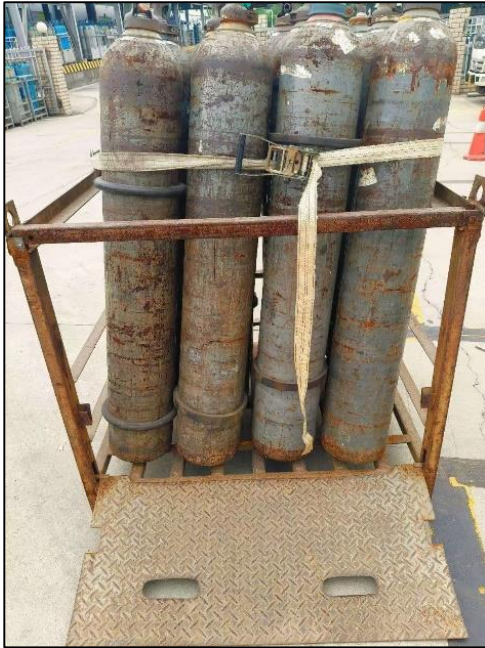
At about 1430 hrs, after unloading two bundles at the customer's site, the driver found that the gas cylinders inside one of the old cylinder rack in the carriage had already been tilted.

Cylinders strapped but tilted

- Use only approved cylinder rack.
- Secure the cylinders with strap to the cylinder rack frame.

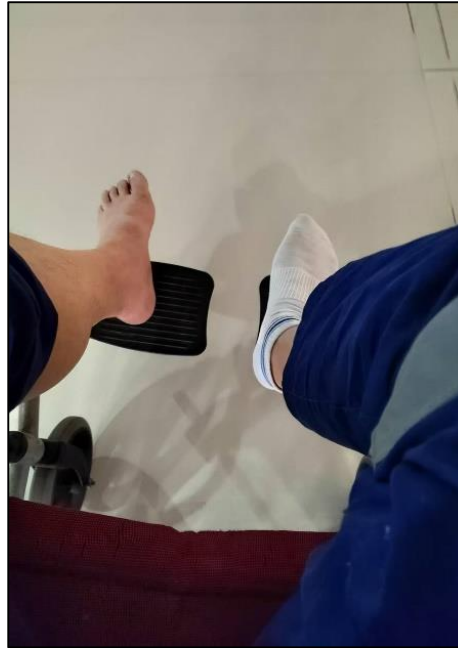
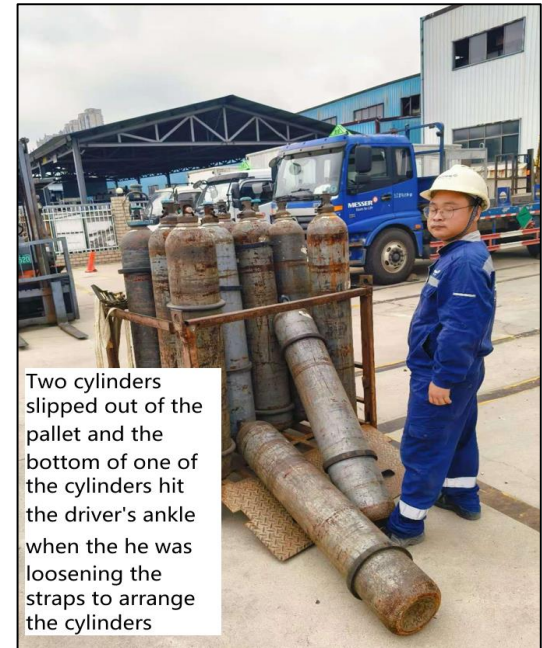
Then the driver loosened the cylinder straps and then sorted out the cylinders, in this process, two cylinders slipped out and the bottom of one of the cylinders touched and smashed the driver's ankle. The driver suffered a light injury on his ankle and certified fit for work by the doctor and back to the work in the next working day (Job transfer temporary).

Injured ankle

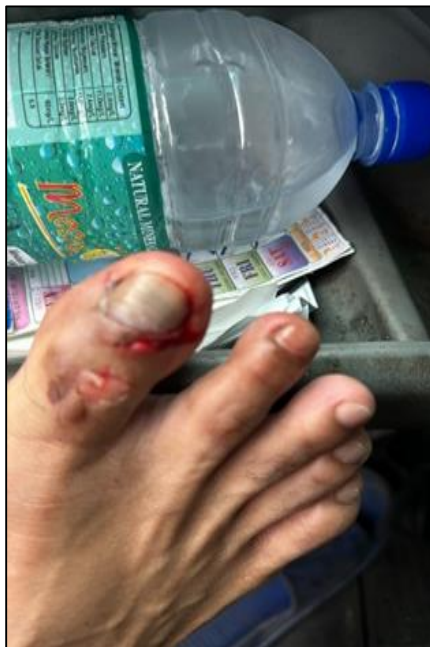
A cylinder delivery person took off safety shoes as it was not allowed at the Elderly Care Facility. He rolled the cylinder and it fell and hit the employee's right foot toe in front of the lift lobby where there was a slight slope. It was noted that:

Injured toe

- Use cylinder trolley and avoid rolling of cylinders
- Use appropriate PPE

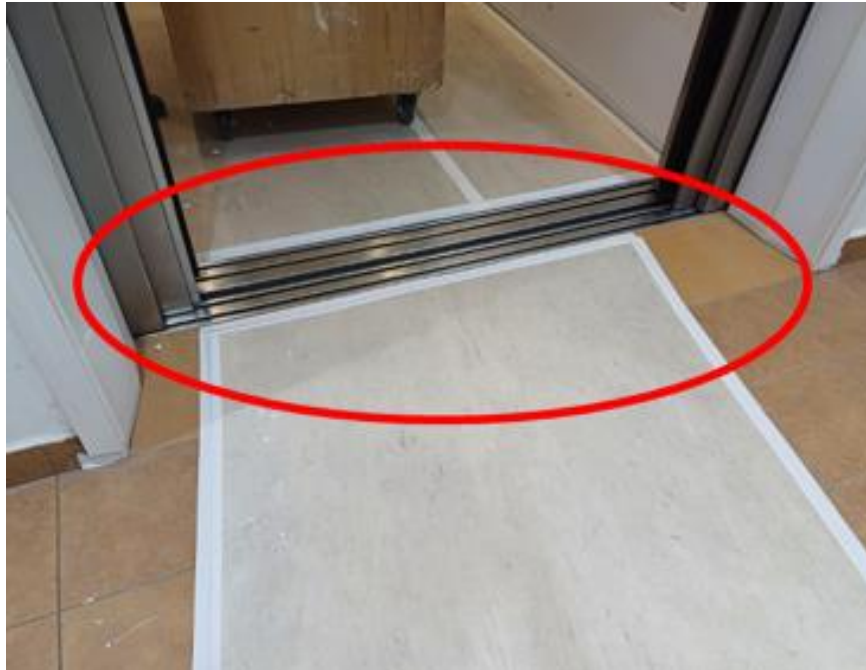
An Operator was pushing a trolley transporting 2 cylinders towards the cargo lift. One wheel got caught in the cargo lift doorway gap, causing the trolley to stand upright. This sudden upward movement and impact caused his left shoulder to be dislocated. The injured person had reported the incident to his supervisor. This incident resulted in a lost time injury where the injured person was granted 20 days medical leaves for dislocated shoulder.

- Using only one hand to push the cylinder trolley instead of two hands, caused person to lose control when wheel got caught in a gap.
- Improper assessment of the risk associated with uneven floor to the lift

Uneven floor height between cargo lift and floor

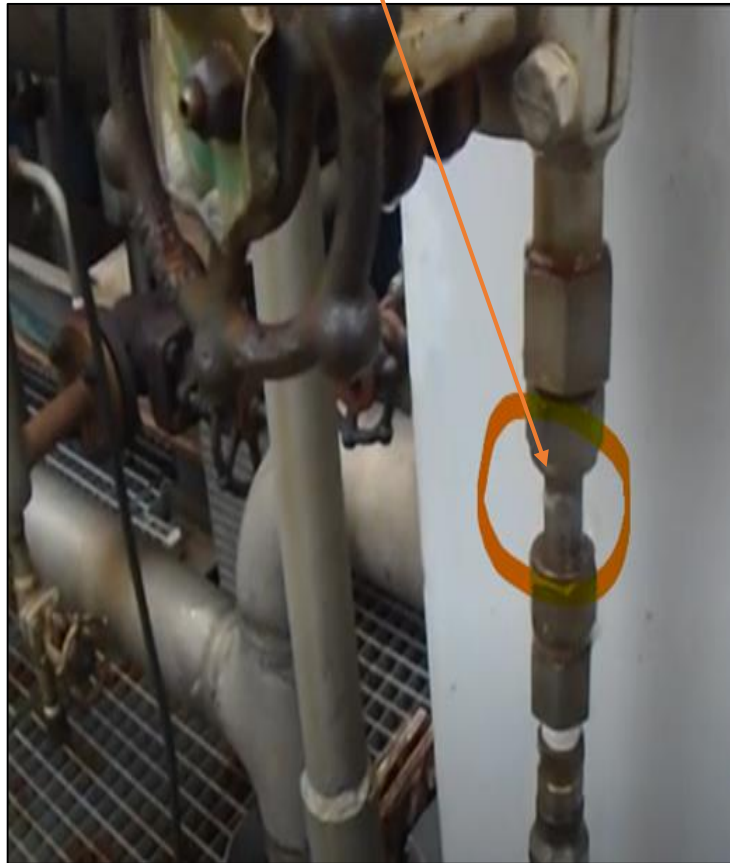
Syngas was leaking while operator was collecting the sample gas from a process gas outlet. The portable gas was reading over range of high alarm level at 1m away.

The leak point

- Review the sampling connection activity in maintenance strategy and identify the inspection/maintenance activity

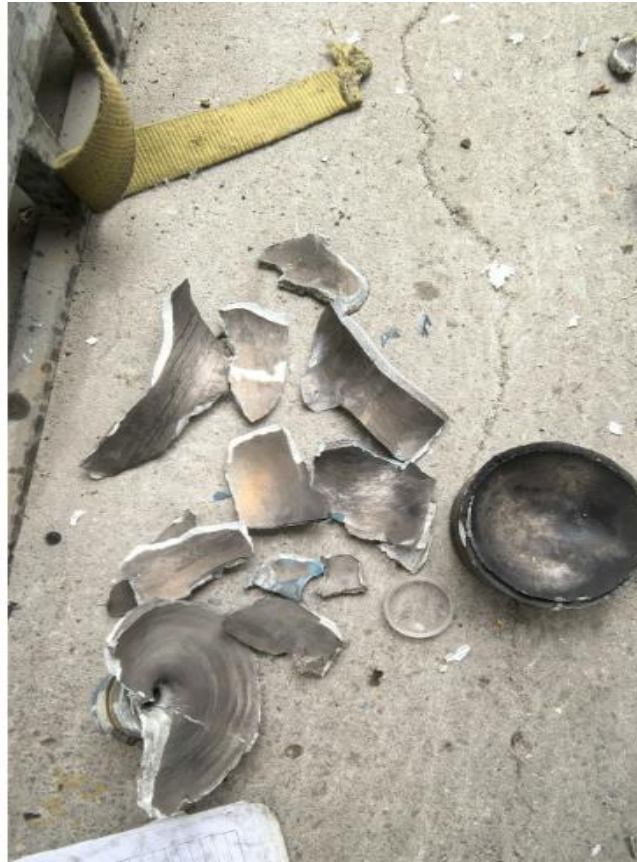
- Cross contamination from different products in the same venting panel.
- Cylinders of different product should not be connected to the same venting panel. Update the venting & purging SOP.

Broken pieces from ruptured cylinder

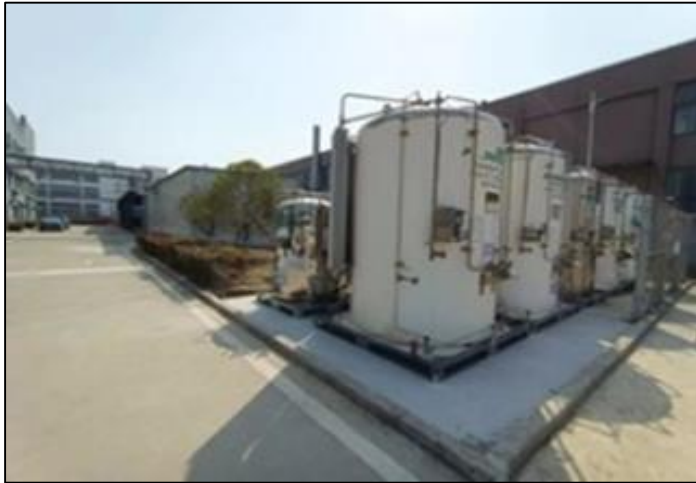
Some MB tanks interconnected together

- During an emergency, stop the leakage only when it is safe to do so. Do not put your body in the LINE OF FIRE
- 2 MB tanks interconnect together without check valves. Higher pressure from 1 MB tank flow to the other MB tank.
- EMOC is required for non-standard design.

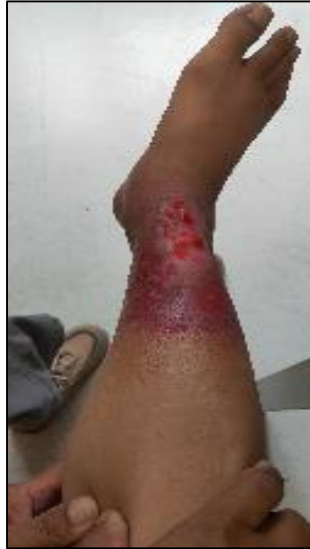
Cryogenic burn on leg

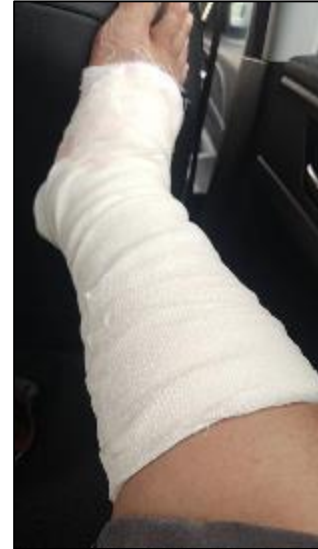
Injured leg in bandage

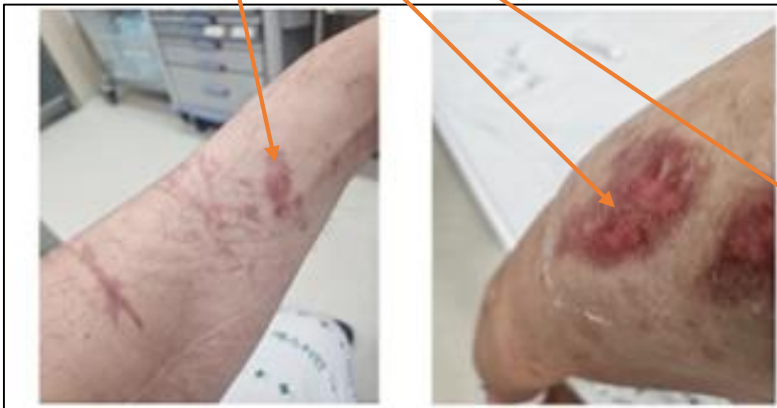
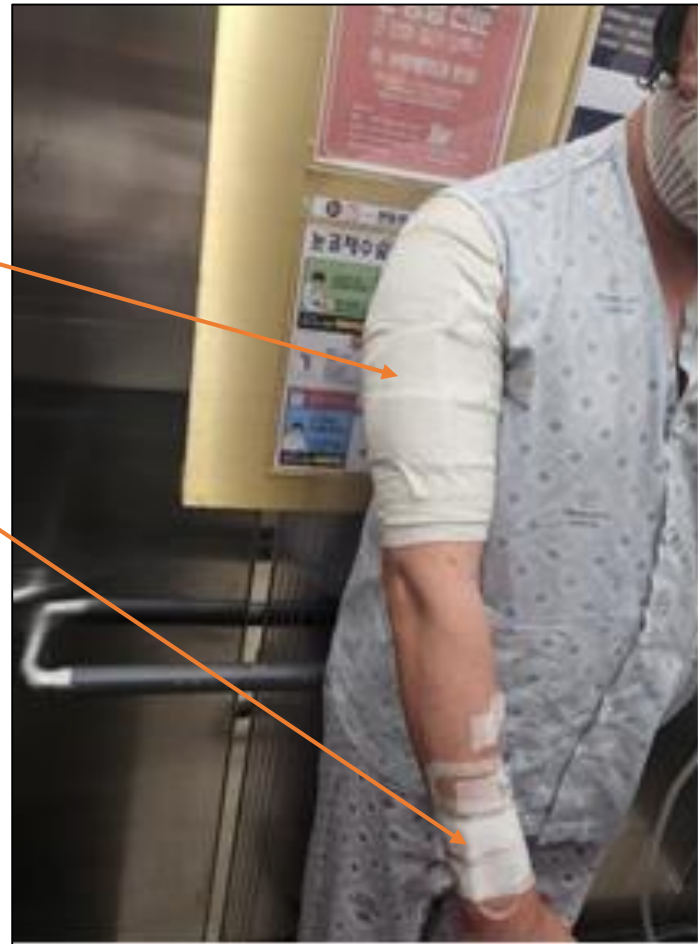
Hot burnt injuries to arm and hand

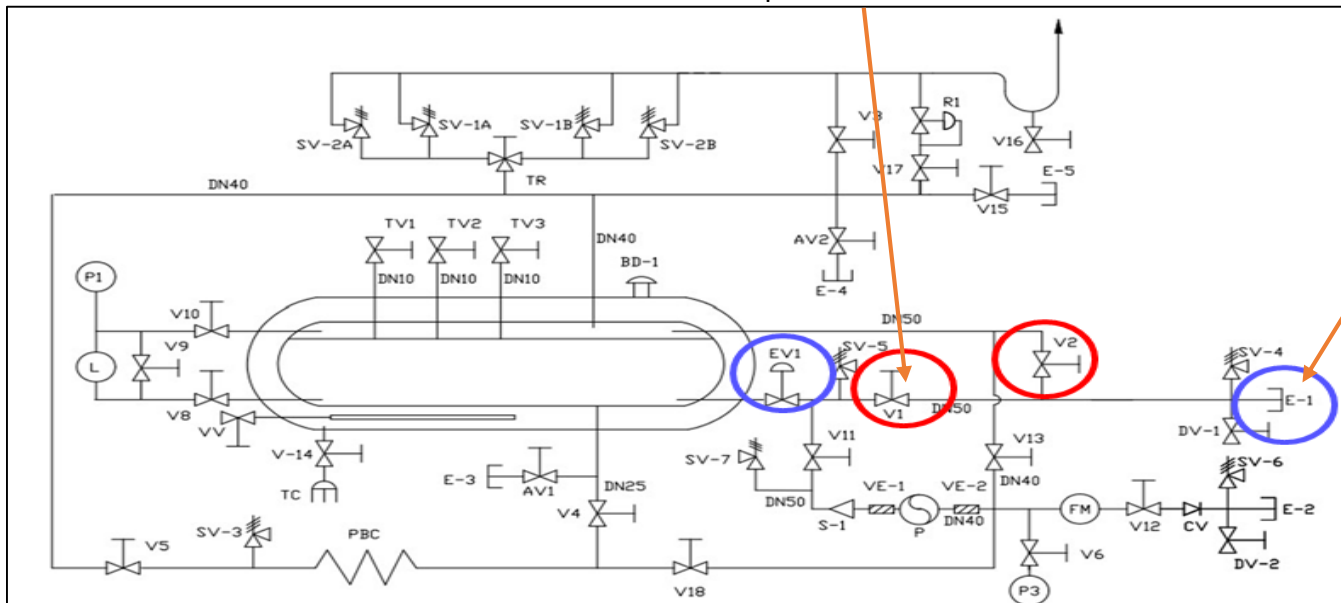
Valve was not close during unloading operation

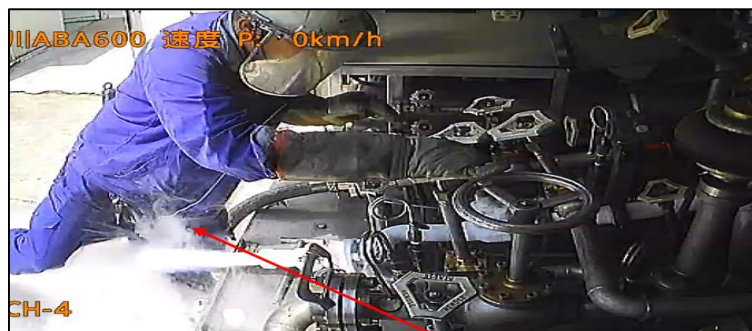
Fill port was not cap during unloading operation

The driver's left leg was facing the filling port when he was closing the liquid bottom Valve.

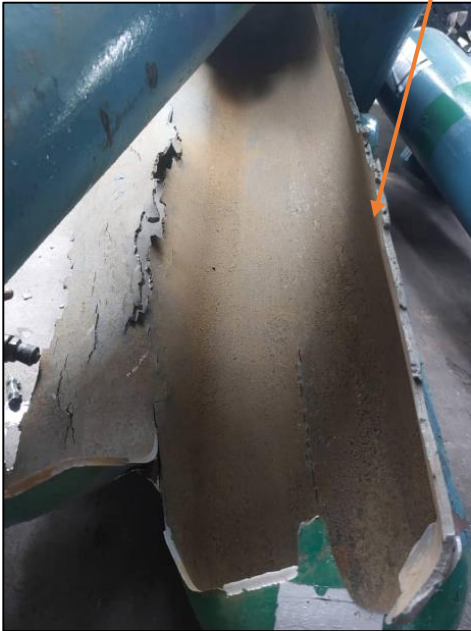
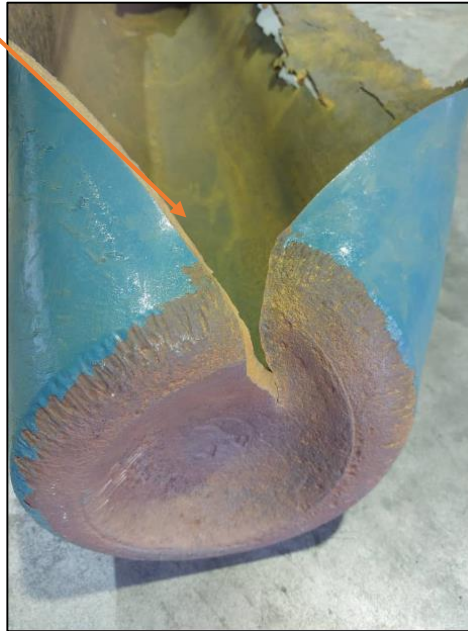
Ruptured cylinder

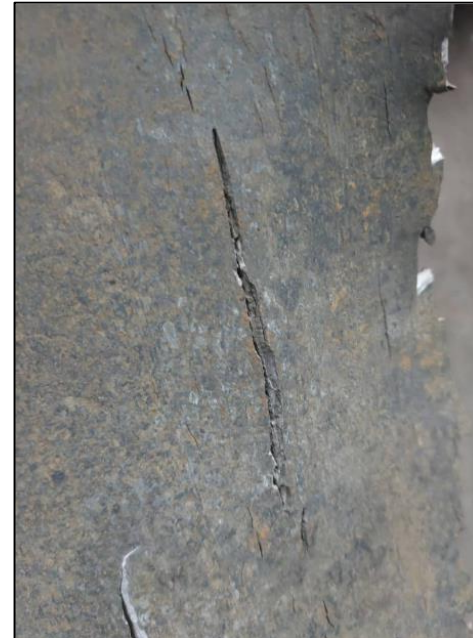
Defect on the inside of cylinder

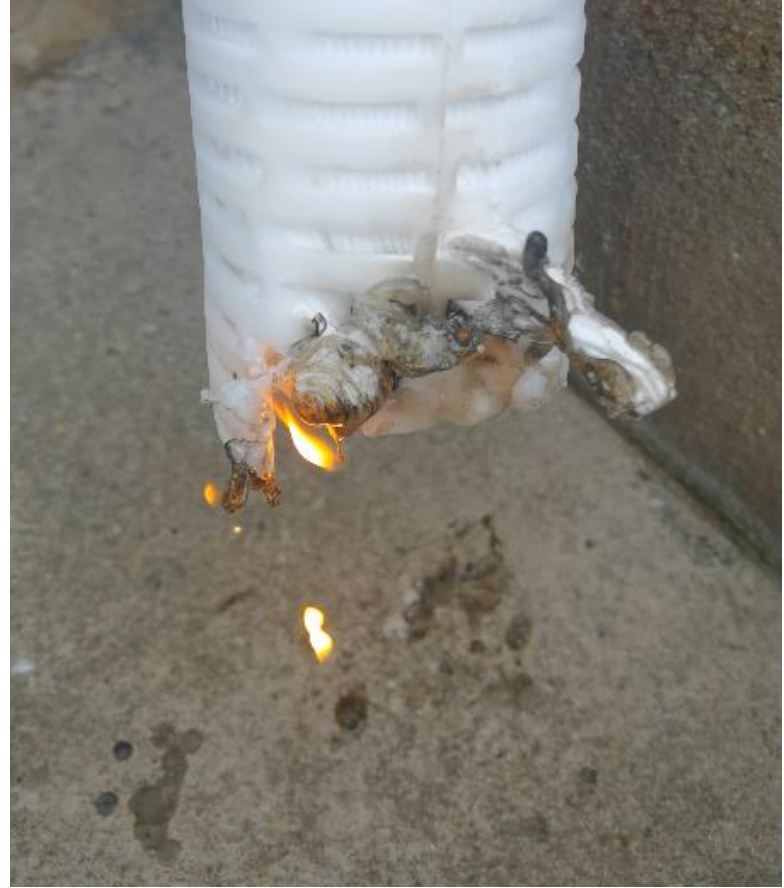
- Incompatible soft material for oxygen system
- Improve the control standards of oxygen-related non-metallic materials

Internal picture of the filter after the fire
