# **Recent (Year 2022) Safety Incidents in the Gases Industry in Asia**

# Agenda

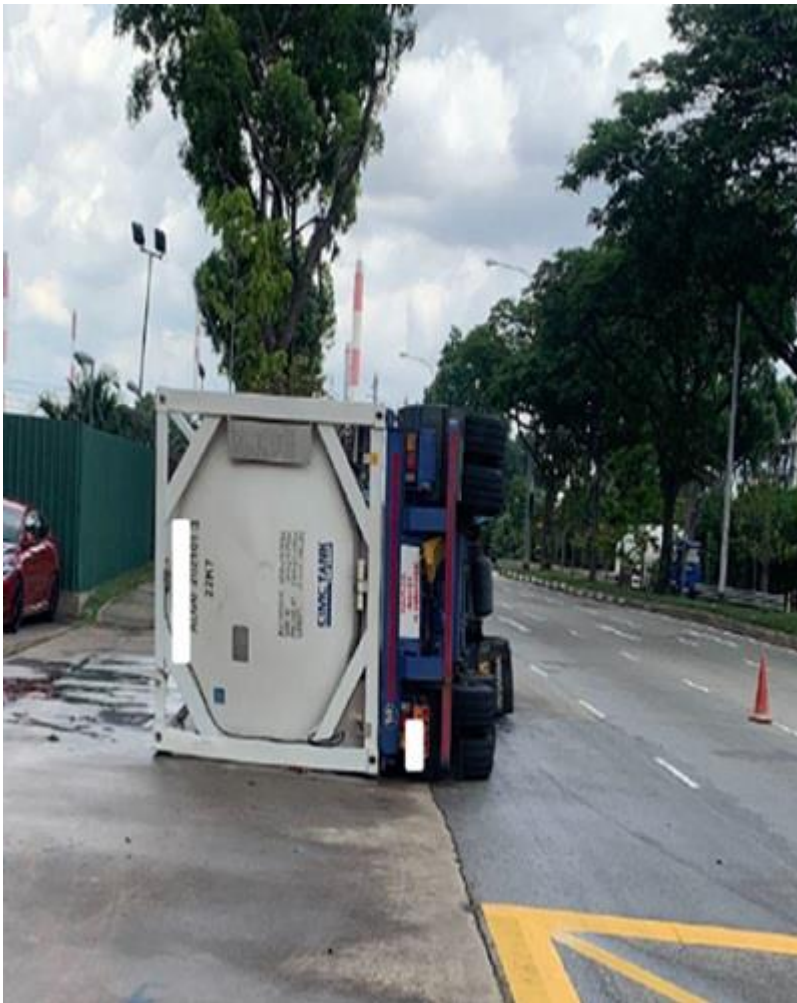
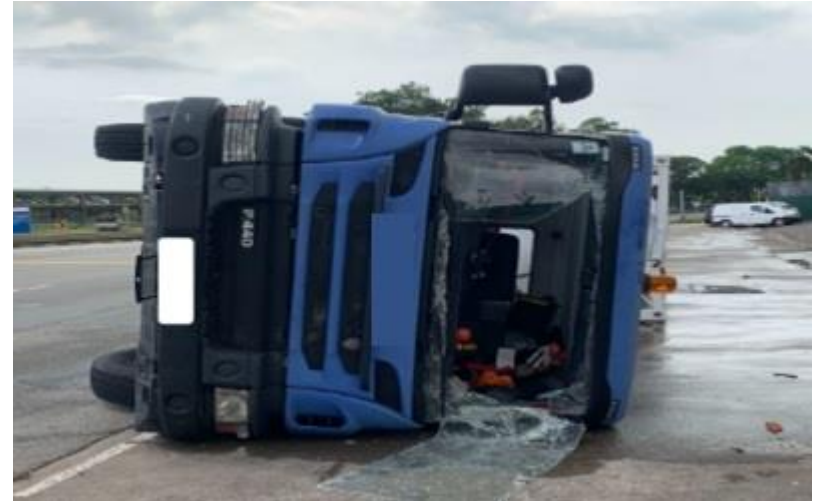
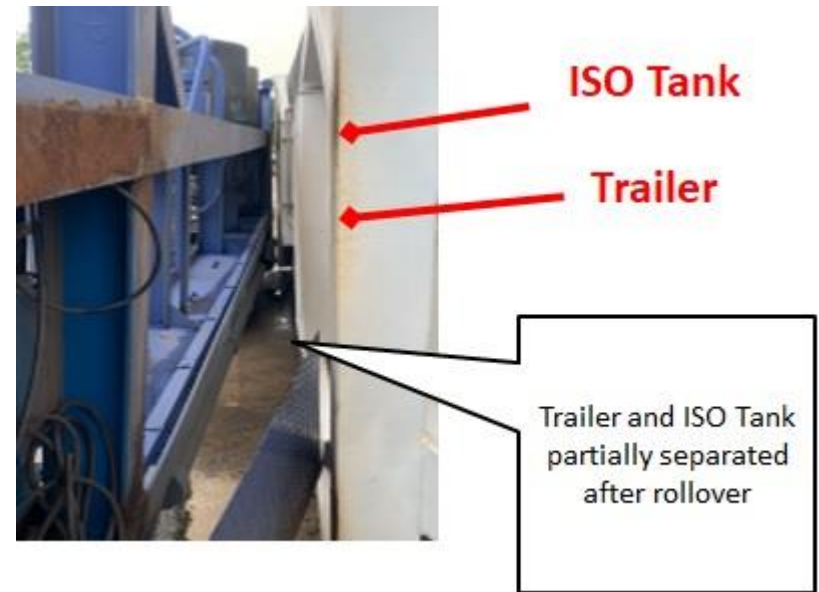
# High Severity Product Vehicle Accident

This incident happened at 10 30 am on a day when a bulk ISO tanker with LAR was taking a sharp U-turn at an intersection and rolled over. The road was dry when the rollover happened. There were no injuries sustained from this event. The ISO Tank was damaged but there was no leakage of products. The vehicle speed was **15 km/hr** when the driver made the U-turn. The vehicle was fitted with ESC and ABS.

Driver did not follow designated route. This was not the first time. Driver made the U-turn at a junction where there is no U-turn traffic sign.

- Stop before making a U turn
- Reduce driving speed accordingly when making a U-turn with ISO tankers (normally having a high Centre of Gravity).
- Fleet management to do periodic checks to identify illegal or unsafe driving.

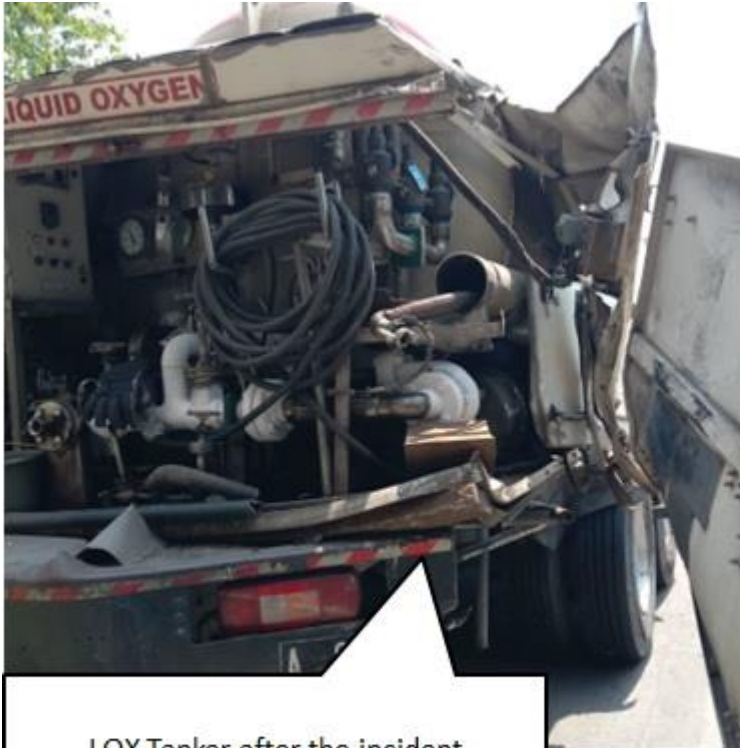
The ISO Tank valve box received significant damage but there was no leakage of products.

LOX Tanker after the incident

- To always set up breakdown triangle / cone at a sufficient distance behind stationary vehicle to warn other road users.
- To establish the criteria and educate drivers on how to determine whether a location is safe for stopping.

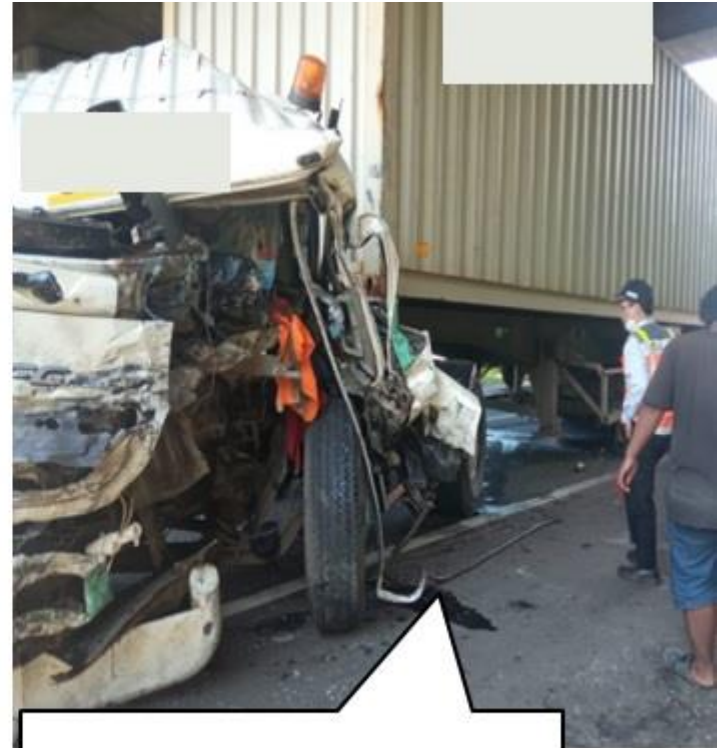
3rd Party Truck after the incident

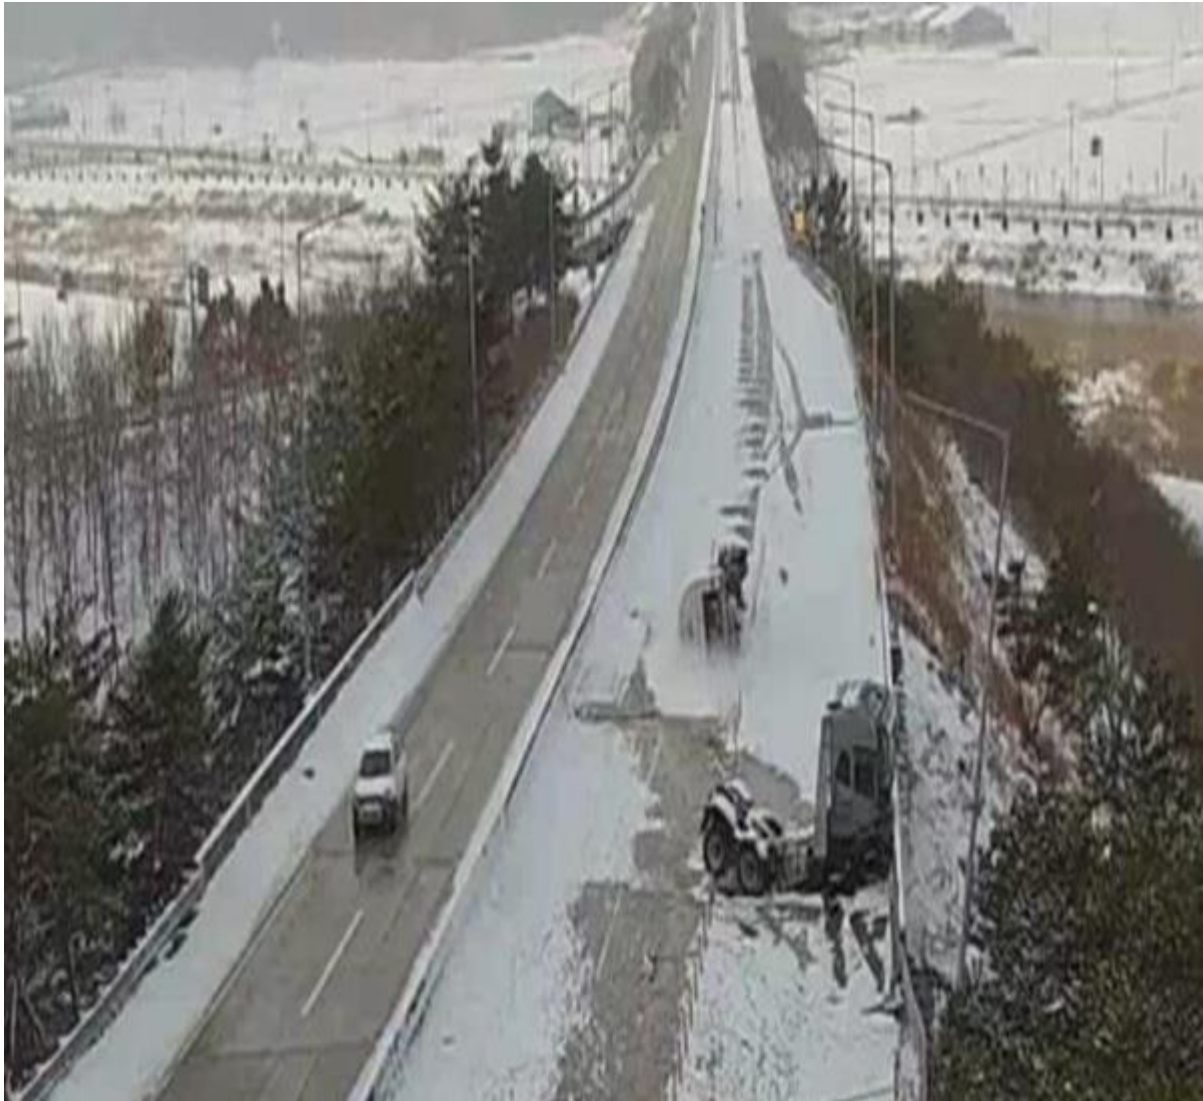
# High Severity Product Vehicle Accident

The driver received a hairline fracture on his spine. There was minor product release and significant damages on the tractor and trailer.

- Conduct refresher driver defensive driving and roll over training to all drivers.
- Measure the driver training effectiveness with road test.
- Conduct routine job safety observation and in cab footage review to rectify any unsafe behaviors.

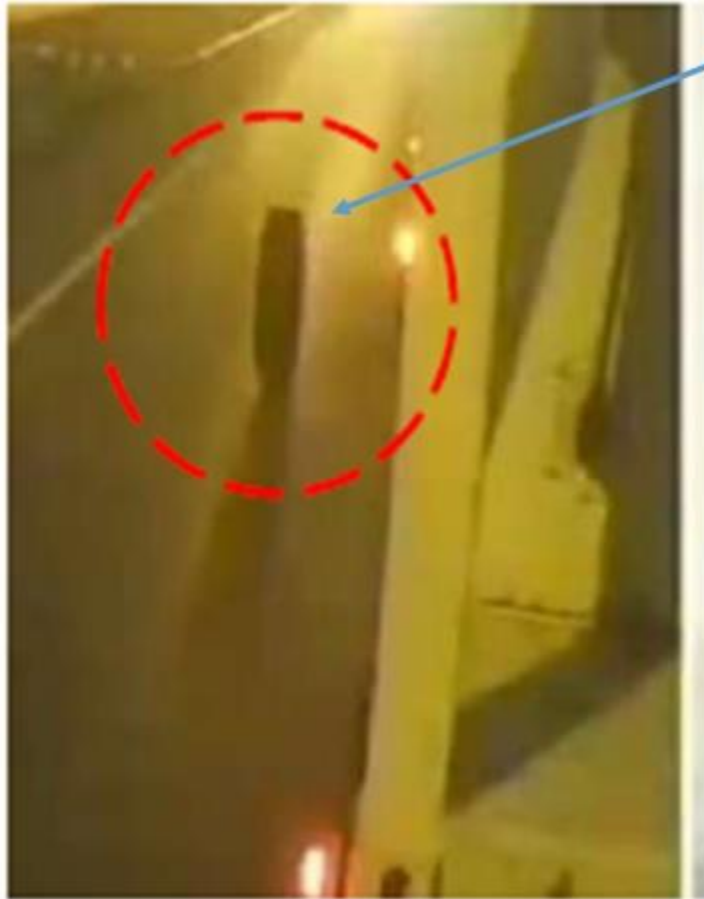
A driver completed pre-trip inspection process with no defect raised, and then started his journey. Approximately an hour later in the evening, the driver noticed on the right-side mirror that the wheel at front right trailer axle detached and rolled out from trailer. The driver immediately pulled over on the road shoulder, he found out the wheels at position no.13th and 14th disappeared, so he notified to supervisor. There was no third party involved.

Wheel moving away after separation from the truck

- Review and ensure suitable model of air impact wrench is available
- Conduct random observation of maintenance workshop
- Establish verification process on post maintenance inspections

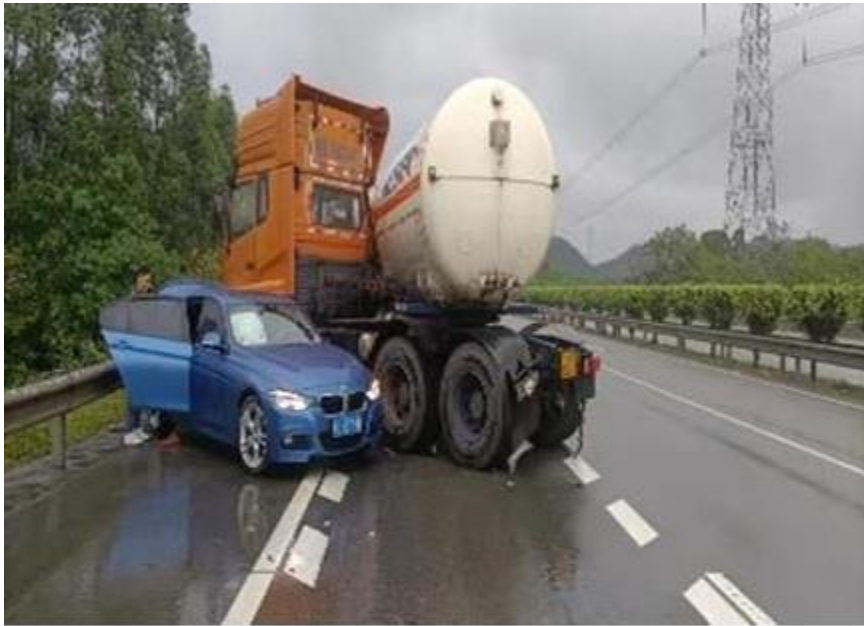
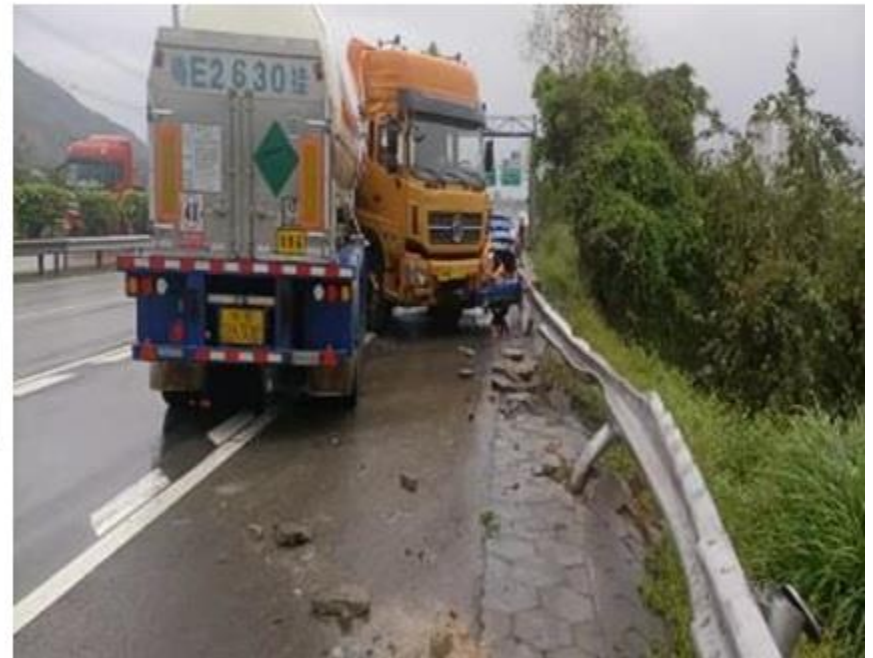
# High Severity Product Vehicle Accident

A road tanker was returning via expressway to base after delivering LOX. It was raining heavily when the incident happened at around 6 55 pm. A car driving in the same direction was on the overtaking lane. Though the vehicle was fitted with roll stability system but due to excessive speed and improper driving on the wet road, the car drifted out of control to the right lane and collided with the road tanker on the slow lane on the left side. This led to jack knife of the road tanker and also some damage to the car body.

- From the video footage, effect of aquaplaning was clearly noticed when the tires loose contact to the road. This leads to lose the control of the vehicle.
- Drivers to be careful and drive much slowly in heavy rainy day

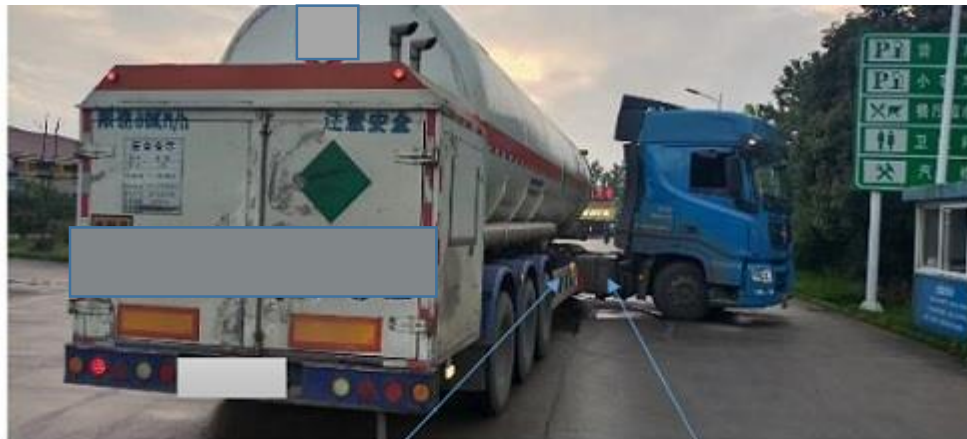
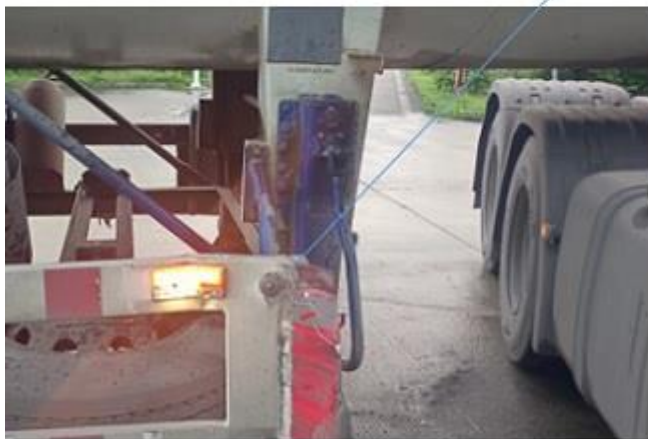
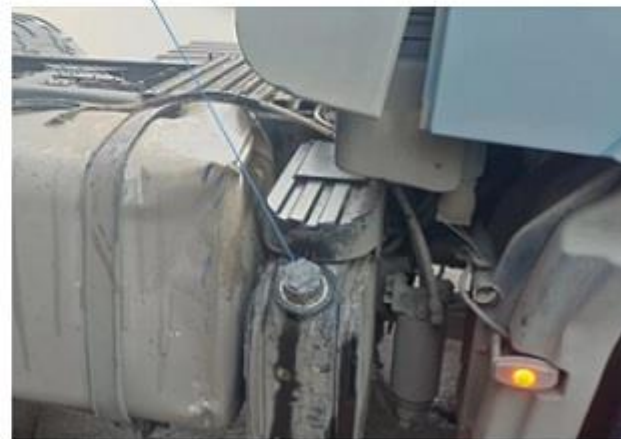
# High Severity Product Vehicle Accident

On a lightly raining day (slippery road surface) at around 7 pm a road tanker was turning to the parking lot of service area by the ramp of the expressway. But the driver was chose a wrong way to enter the car parking area. When the driver noticed the limited height sign ahead, he applied a sharp brake. A jack knife of road tanker followed. It caused damage to the right side of the tractor, rupture of the fuel tank and urea pot. The truck was fitted with Roll Stability Systems (RSS).

- All drivers need to slow down in advance according to Defensive Driving Training requirements when turning to the ramp.
- Reduce speed when driving under bad weather or road conditions.
- To have a program to identify high-risk behavior of drivers and ensure correction

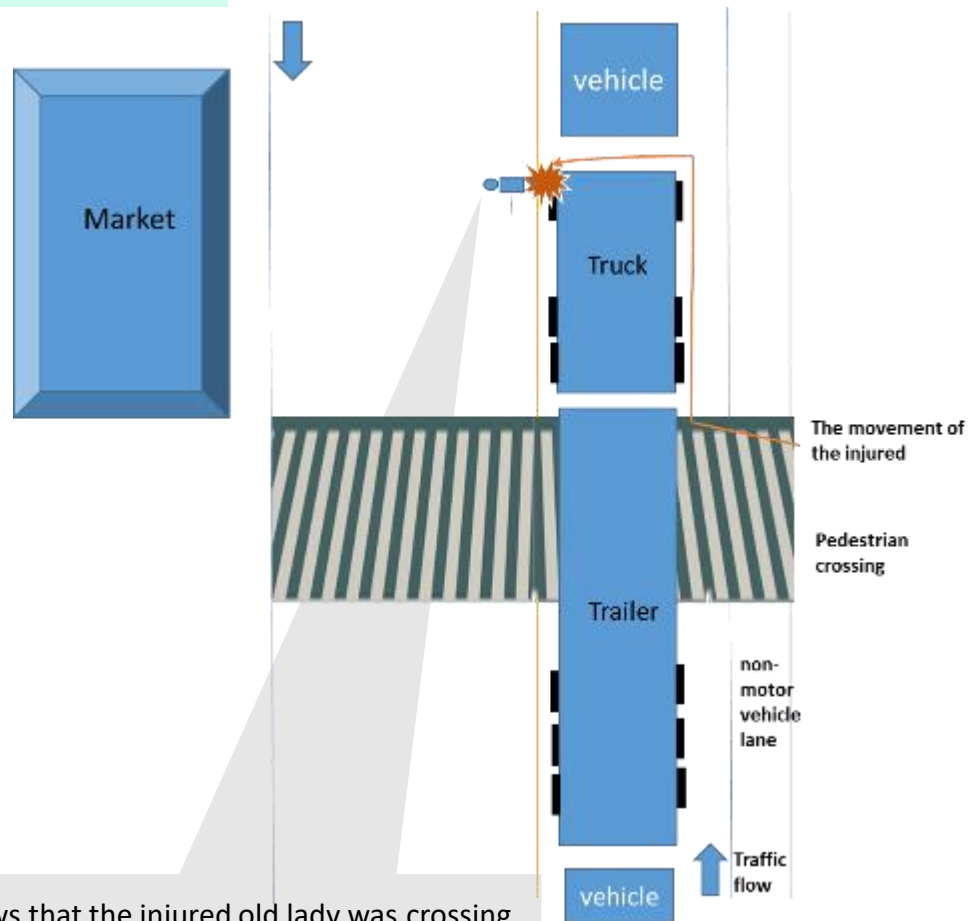
Traffic monitoring shows that the injured old lady was crossing the road from the right side of the road tanker, then she was walking along with the trailer and the truck as the red line shows. At last, she reached left front wheel of the truck (below the reflector) when the incident happened.

- Make sure the risk assessed was performed for distribution route.
- Specific and clear measures have been formulated for the risk points in the unavoidable high-risk road sections.
- Be sure, there is an annual training program for defensive driving for active drivers, which should be systematic and complete;
- Be sure for the new drivers, whether complete driver training and a certain length of internship assessment are carried out;

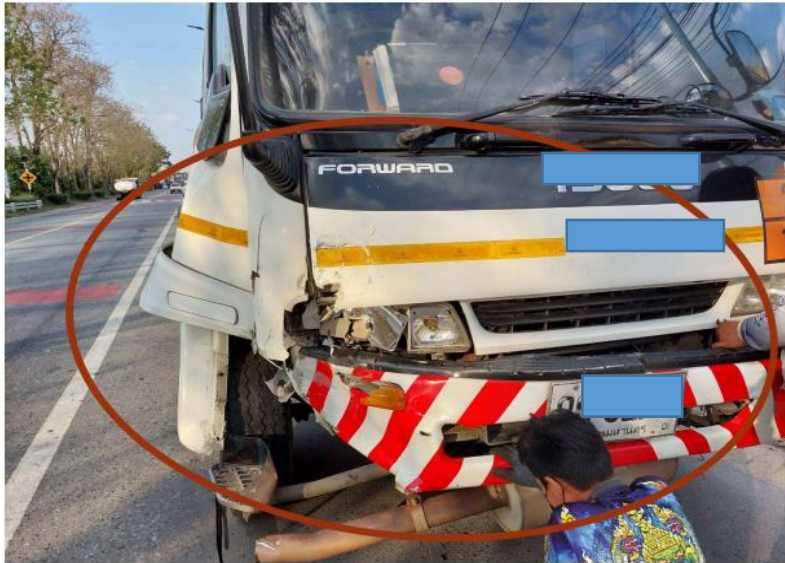
At around 1345hr on a day, a driver was assigned to deliver the Liquid Nitrogen to a customer. On way to the customer site, a pick-up truck that was in front of the LN2 tanker performed an emergency braking. The tanker driver did not get enough time to stop in time. As a result, the LIN tanker crashed into the back of the pick-up truck and was damaged. No injury was sustained arising from the accident.

Front of LN2 Tanker

- Supervisor to review the principles of safe distancing with training.
- Reviewed and emphasized the principle of keeping a safe distancing from the front vehicle by using the 4 seconds rule.

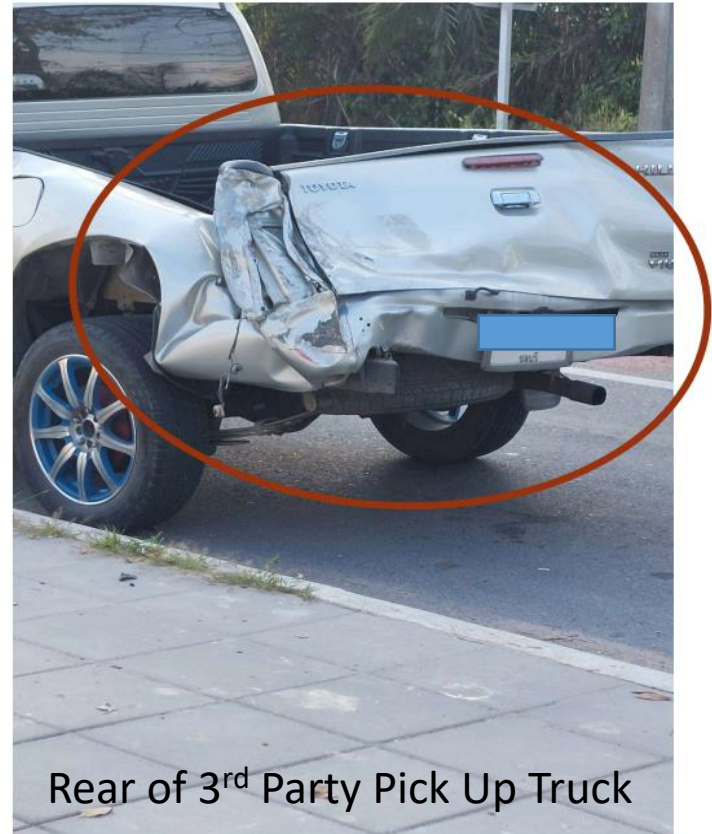
Rear of 3<sup>rd</sup> Party Pick Up Truck

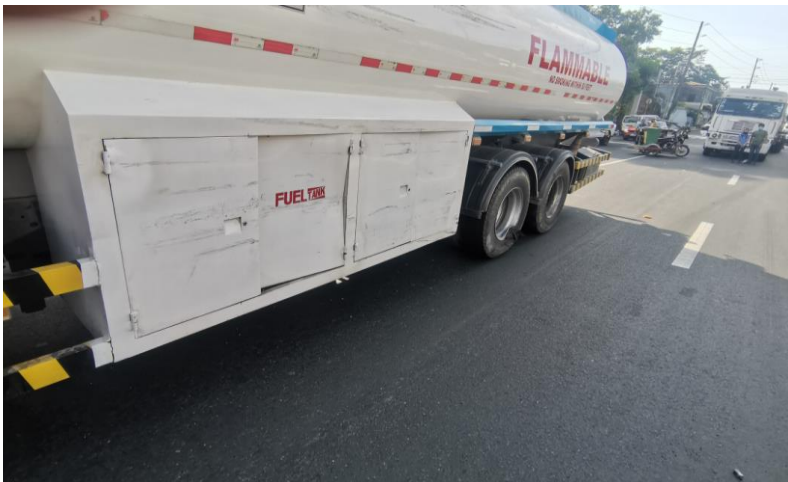
At 16:00hr, a Tractor was returning back to the production facility after product delivery. A red car in front of the tractor slowed down and signaled to turn left. The tractor driver in his effort to avoid collision with the car, tried to maneuver to the right. However a tanker carrying flammable goods was passing then and caused collision with the tractor. Left rear outer tire of the flammable tanker was hit by the tractor head causing the tire to burst while the front right bumper and fender of tractor head were damaged. No person reported injured in the accident.

Damage to 3<sup>rd</sup> party Flammable Liquid Tanker and Tyre

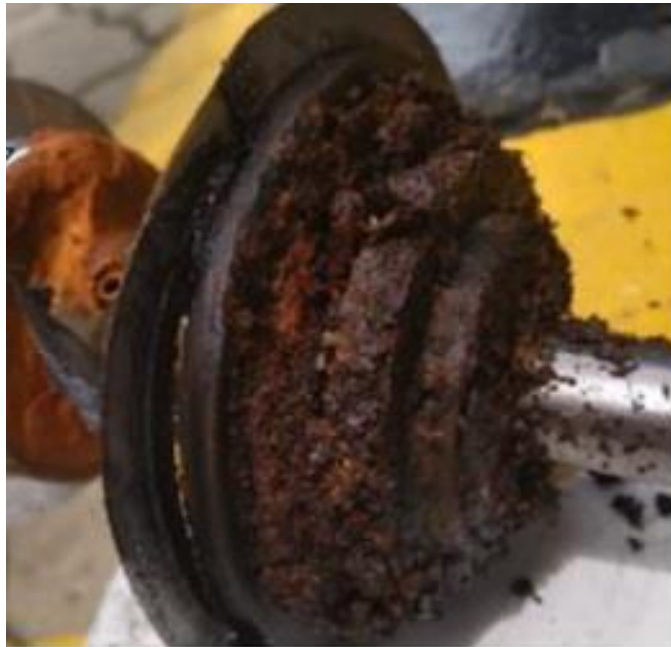
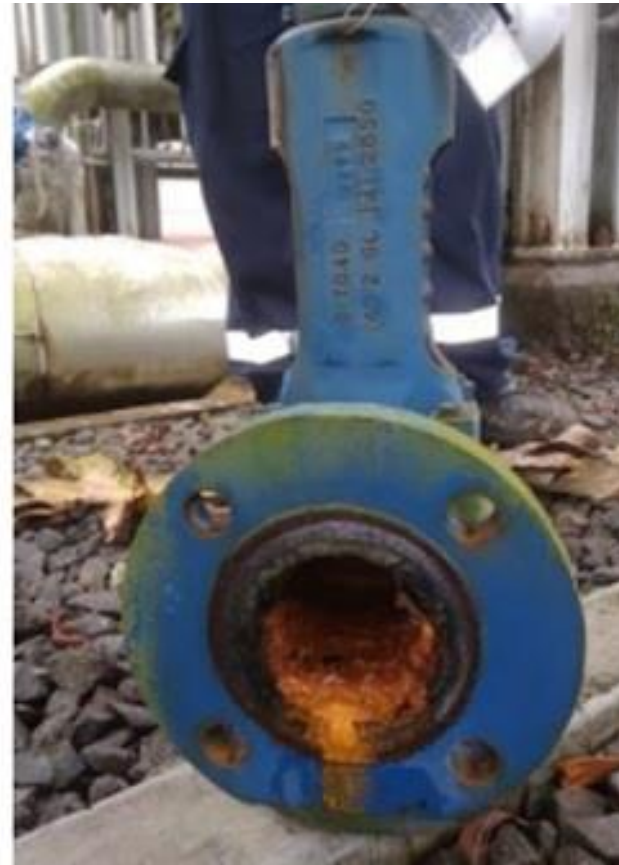
The Operations and Maintenance Team was performing calibration for two PSVs during a shutdown. The set pressure of the PSVs was 25 barg. However, both PSVs did not pop when pressure was increased until 25.5 barg. After further investigations, rust was found inside the both PSVs what did not allow the PSVs to pop.

- Maintenance not executed in accordance to the maintenance plan. PSVs not calibrated for 8 years (to be done once 5 years as per the maintenance plan)
- Improper design of outlet venting vaporizer. Moisture getting trapped in the line as outlet venting line design will not stop moisture entering from piping outlet.

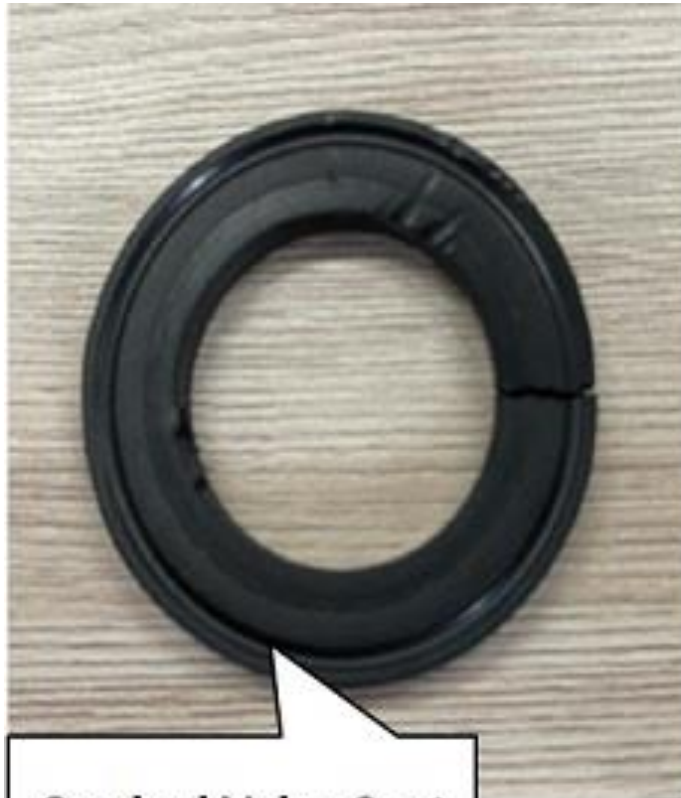
After topping up a Cryogenic storage tank at customer site, a liquid leakage and icing was seen at the outlet. The driver used water to defrost and depressurize the tanker and managed to tighten the outlet valve to stop the liquid from leaking. Minor gas leakage was still coming out from the outlet. After the next tank top up, liquid oxygen was flowing out of the outlet. Driver depressurized and decant to shut the outlet valve. Minor gas leakage was still observed. The tanker was subsequently sent back to site for investigation.

**Cracked Valve Seat**

- Ensure drivers are trained to handle leakage of all products which they are handling.
- Improve management of N+1 tanker qualification.

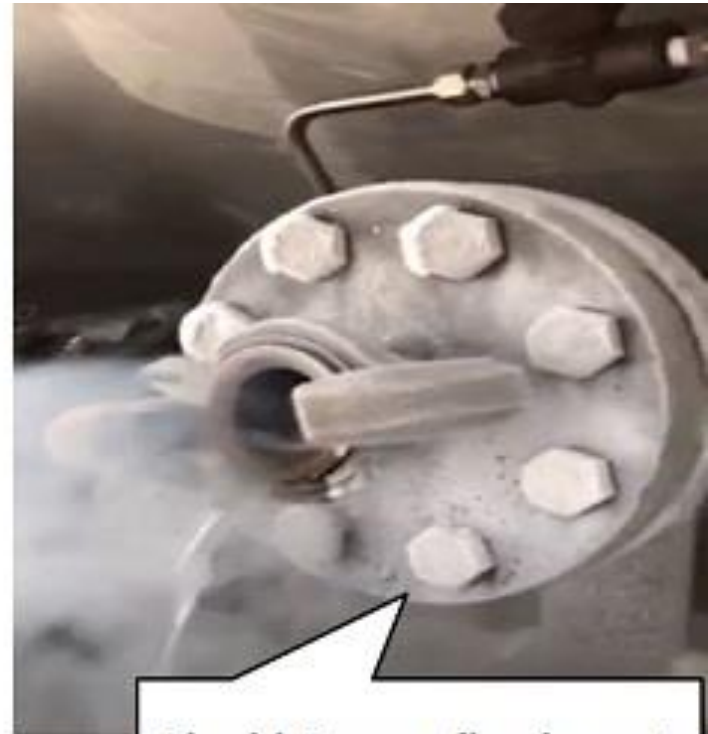
**Liquid Oxygen flowing out**

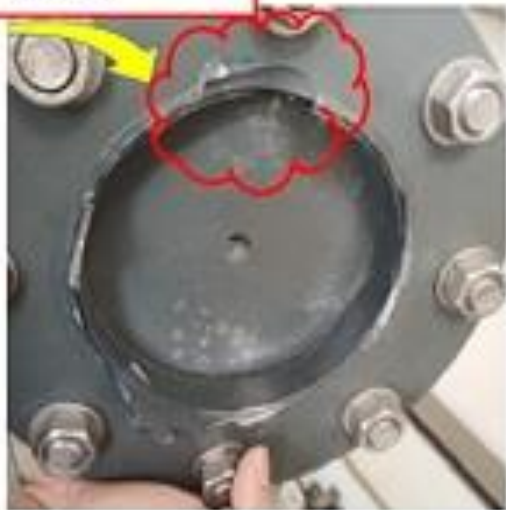
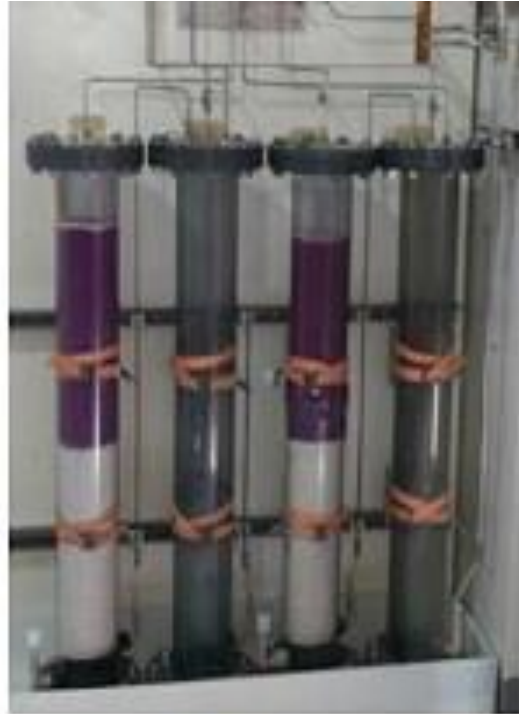
After checking, the Operator found that the flammable gas scrubber had burst. There was chemical release into the environment around the scrubber.

Top of chamber after  
burst

- Written processes need to be established for all work activities, with subsequent training and qualification provided to relevant personnel.
- Staff needs to be trained and aware of the hazards involved in their work.

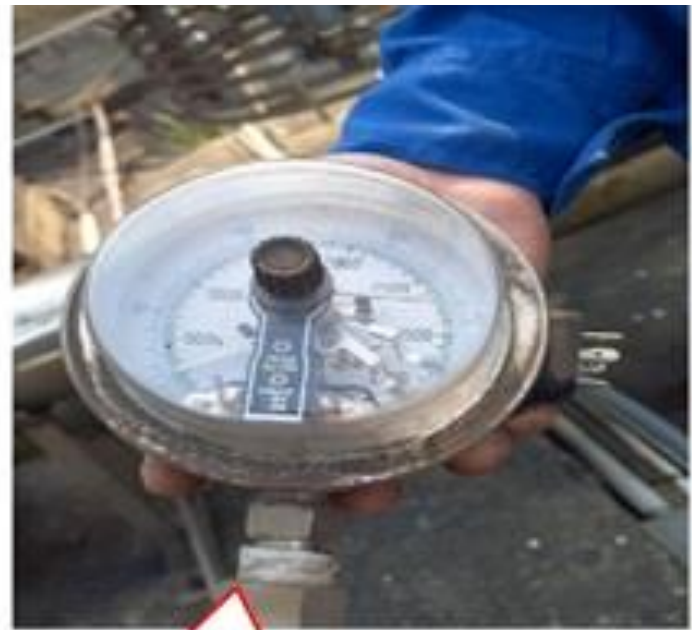
The filling station staff then informed the Maintenance Team about the situation. After investigations, the Pressure Switch was eventually replaced as it was found that the high pressure value set lever was broken.

**Old Pressure Switch**

- Maintenance Strategy of equipment essential for safe and reliable operations needs to be established.
- To establish periodic visual inspections as a minimum for equipment with no periodic maintenance planned.

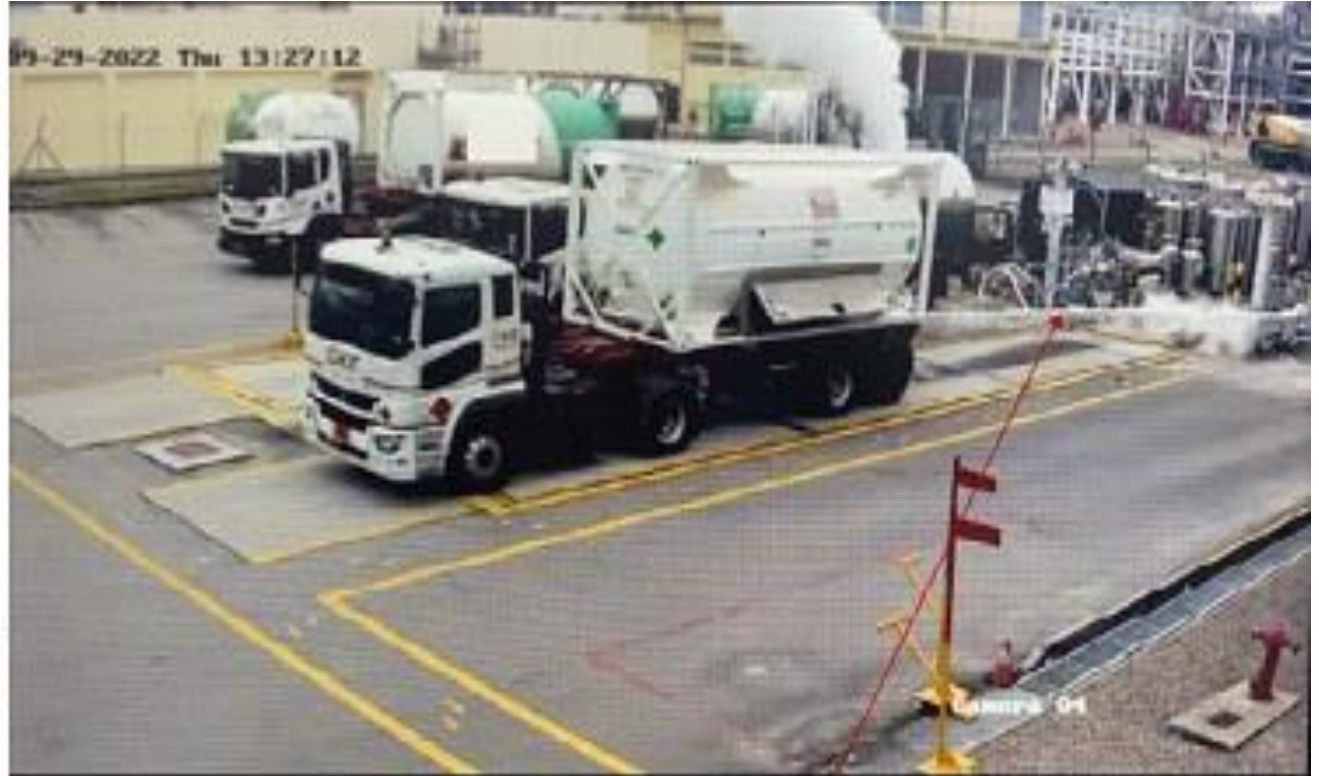
Hose being pulled

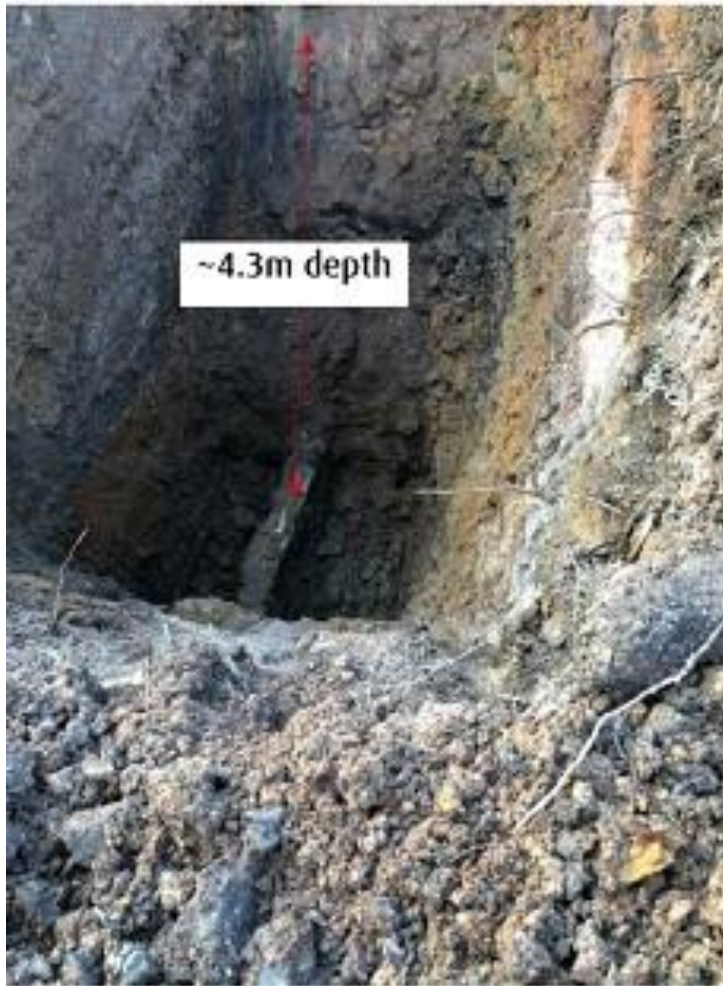
The nitrogen gas supply was isolated and approximately 2 meters length of nitrogen pipeline was damaged.

- Establish clear protocol on communication to utility contractors before any excavation works to occur near any gas pipeline.

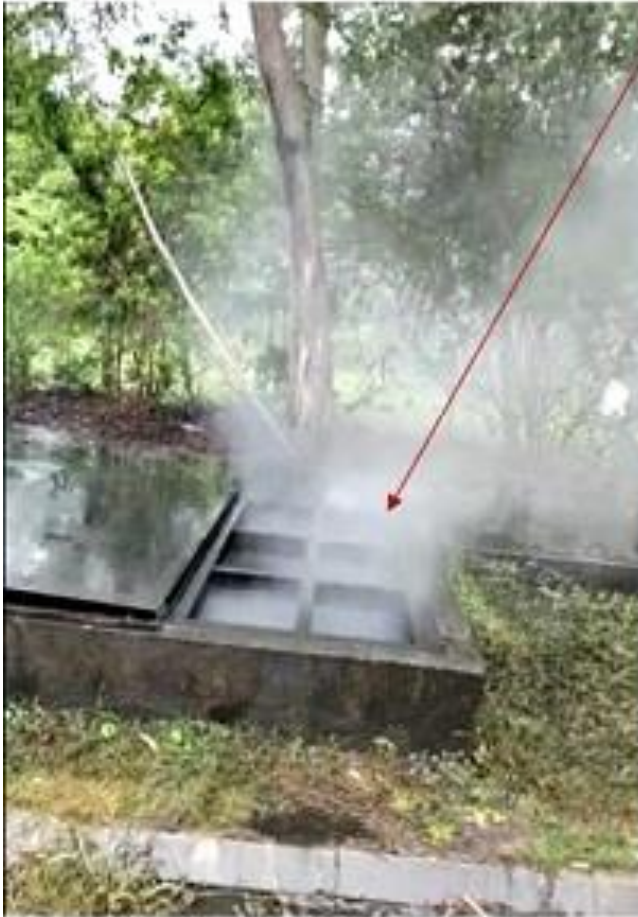
At 10.30am nitrogen gas leaked at valve pit located outside the customer's site. Team immediately reached site and barricaded the area to prevent personnel to access this area. The leak was noticed from a 4" spare valve inside the pit. The failed valve was removed and replaced with the blind flange, supply to customer was resumed at by the evening on the same day.

N2 coming out of the pit

- Review existing checklist to make it simple and easy to use at field.
- Train personnel on use of valve pits inspection and maintenance checklist.
- Modify/replace pit covers to prevent rain water ingress and improve water proofing
- Inspect all other valve pits to ensure correct bolt specs for carbon steel valve, corrosion and water leaks and take corrective actions
- Reinstate the cathodic protection at valve pit
- Review lessons learnt with Engineering team for revising existing practices for underground pipeline installation for future

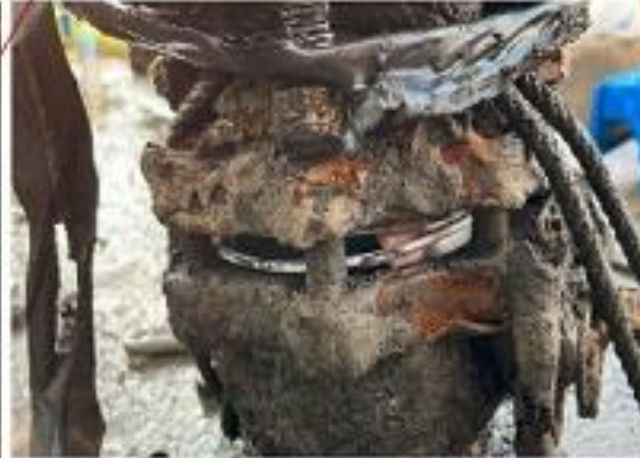
Failed valve

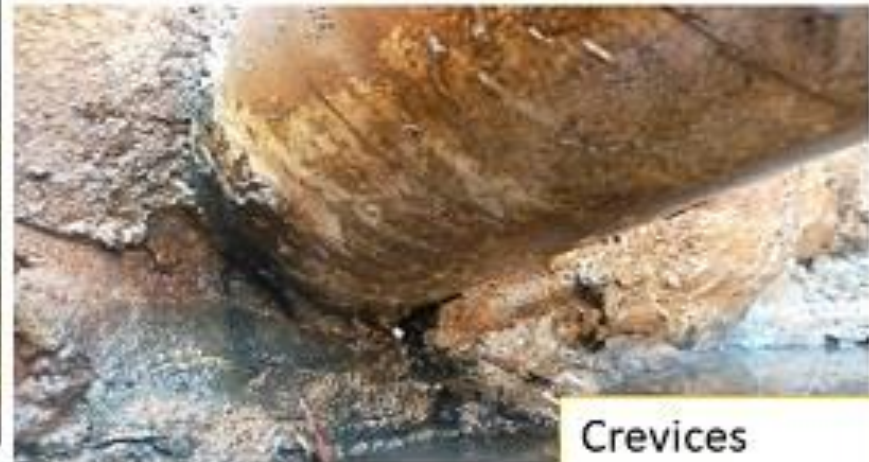
Crevices  
inside the pit

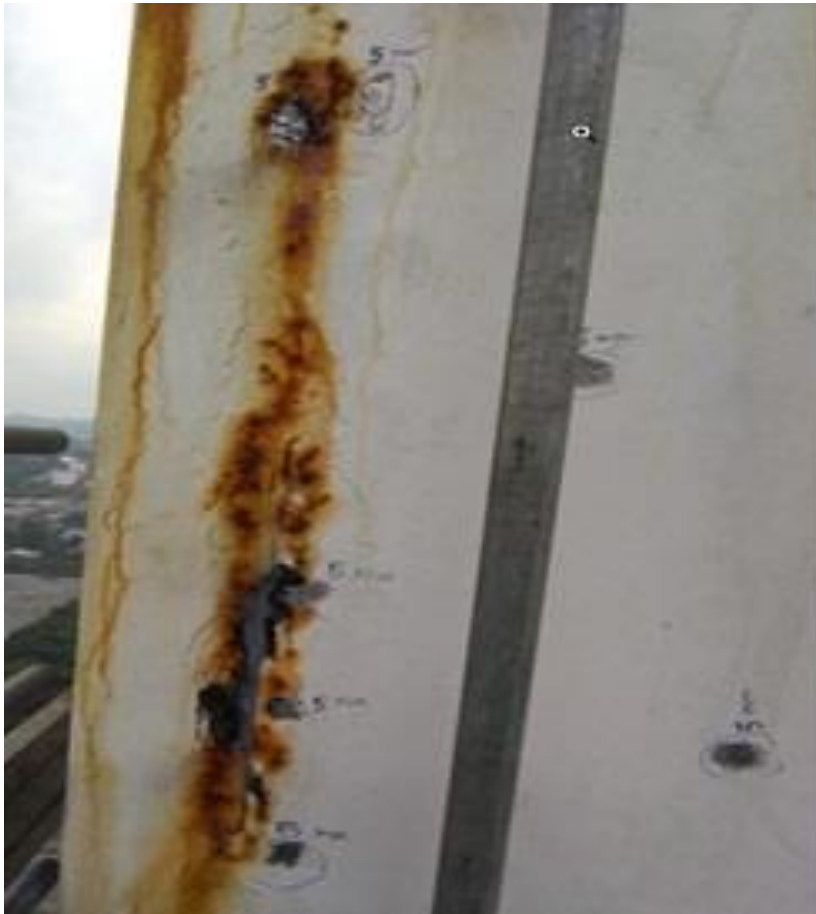
Around 1030am, a technician was performing weekly inspection of cold box when he found some perlite was released from corroded surface of a cold box top wall at 66 meters elevation. Approximately 2kg of perlite was released.

Corroded Casing

- Implementation of routine surface thickness measurement and high-quality painting program for process equipment and piping to prevent localized corrosion based on environmental conditions

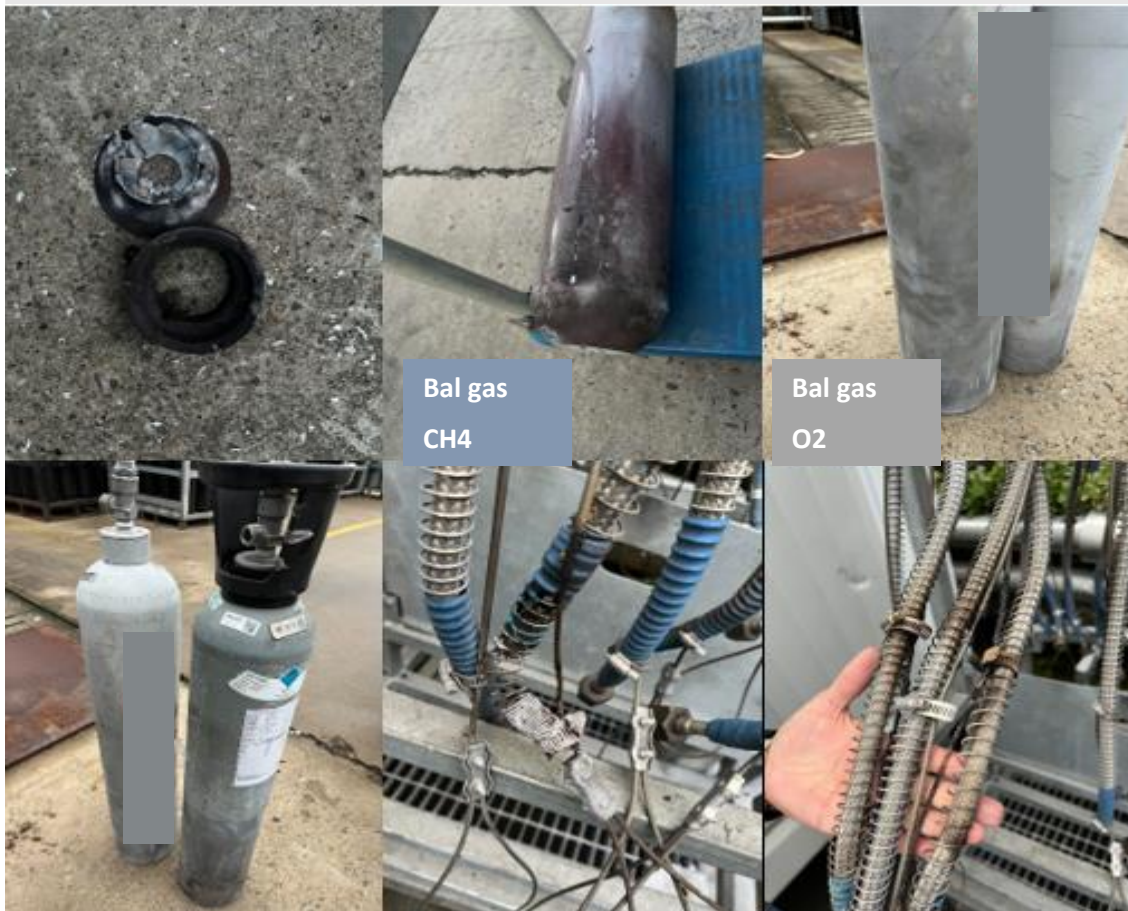
At about 15:03 pm, an employee was preparing calibration gas cylinder (8L aluminum cylinder) for heating and evacuation at outside (pretreatment steps before filling the steel cylinder). During the process, the operator connected the empty cylinder in the pallet with manifold for pretreatment. When opening the valves one by one for inspection, a flash explosion occurred what caused burns to the operator's legs and required hospitalization.

After verification, the cylinder containing CH<sub>4</sub> Bal gas is the diluted gas cylinder for the plant's own use. The cylinder body has no label and is mixed in the storage area where the returned cylinders to be processed. (The cylinder was not in the CTMS system)

- Reasonable classification and placement requirements for returning cylinders;
- For the replacement treatment of gas cylinders (i.e. heating, evacuation and replacement), the remaining gas of gas cylinders must be confirmed to have been discharged before connecting to the treatment system;
- Gas cylinders marked as combustible shall not be treated with cylinders of other gas types

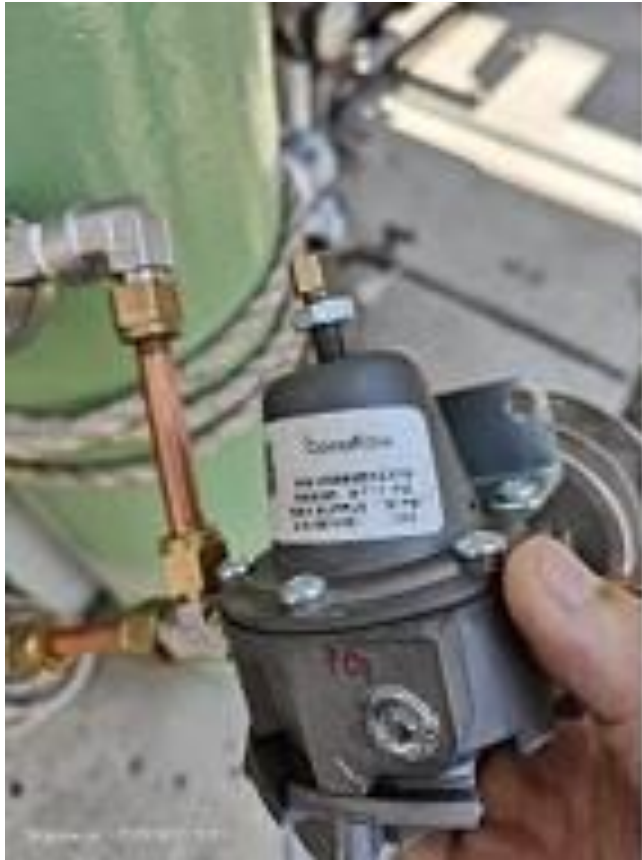
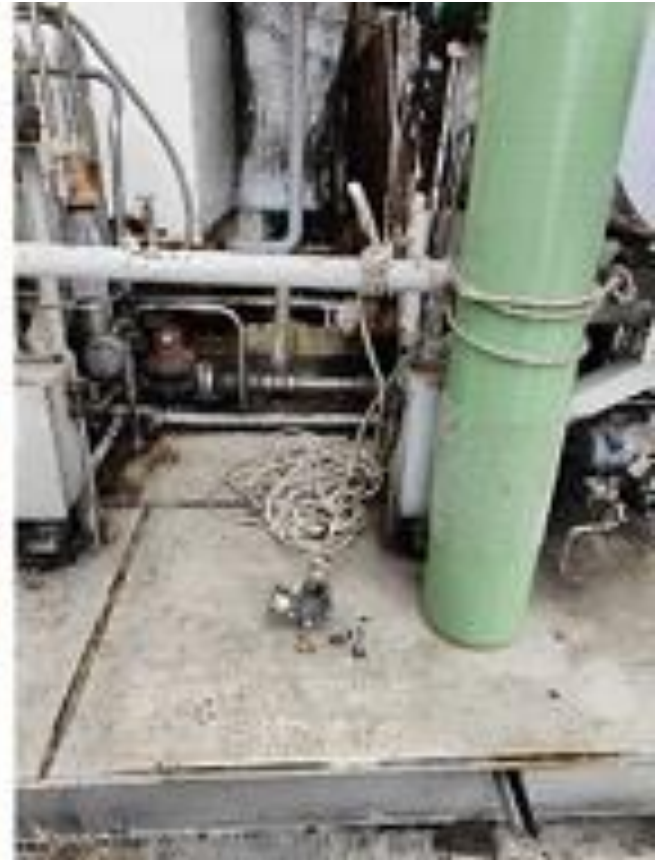
Around 13:00hrs, an E&I technician was setting up the regulator assembly at the Comander area with a nitrogen cylinder. After the preparation works were completed, he proceeded to test the setup by opening the cylinder valve. When doing so, the regulator ruptured causing a piece of foreign material to be embedded into his left forearm with a puncture wound. Immediately, he made his way back to control room and reported the incident to supervisor. Local team applied first aid and sent him to hospital for treatment using personal vehicle.

Incorrectly rated pressure regulator

- MOC to be raised for new work process
- WRA must be detailed to cover the entire scope of the process
- SWP Issuer and Receiver must communicate the detailed steps of the work activity

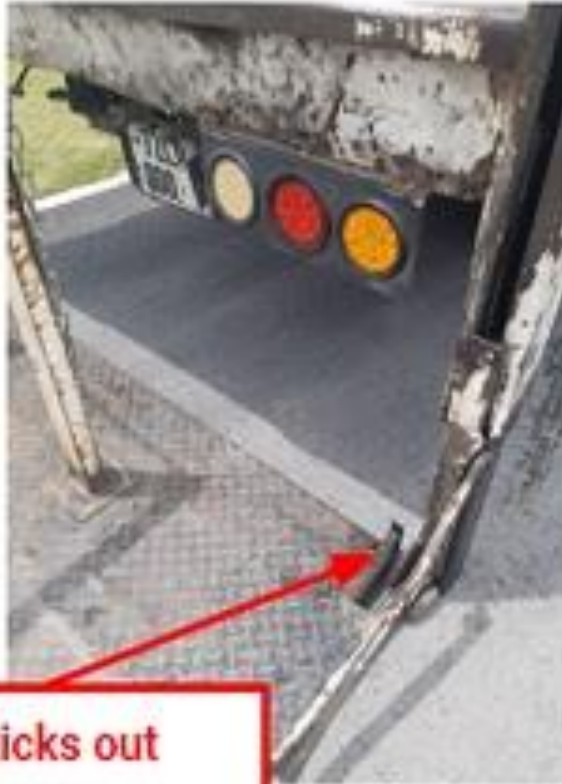
A truck assistant was standing on the truck tray bed to load loose cylinders. He used his left hand to operate the remote control to lift the tail lift, with his right hand resting on the loose cylinders. While lifting, the tail lift stalled. The truck assistant continued to press the remote to raise the tail lift. By doing so, the lifting hydraulic force caused too much pressure on the cable and caused the weld joint to fail, resulting in the tail lift dropping down.

Hook sticks out slightly

- Implement securing mechanism on the tail lift for cylinders.
- Job Hazard Analysis has to consider all tasks related to the job.

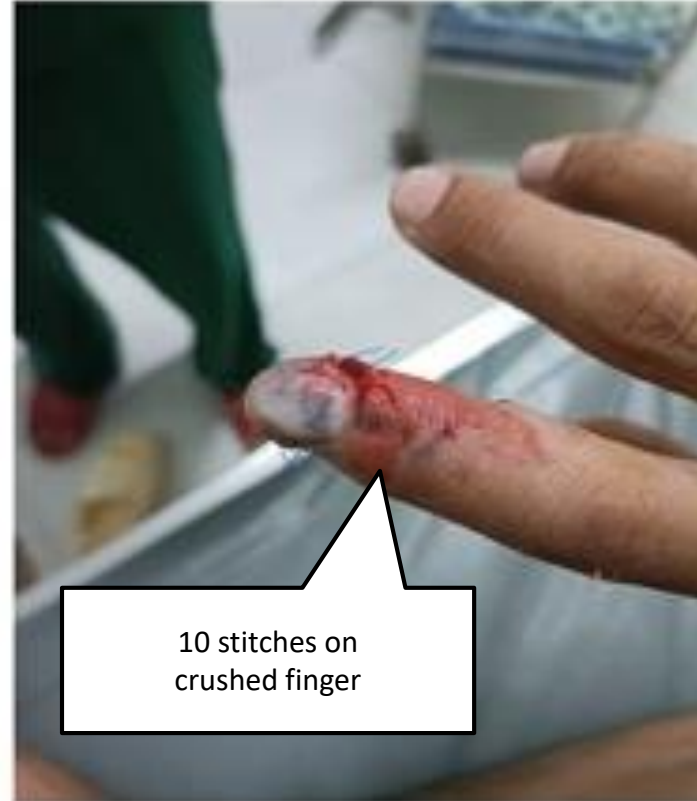
During the drop, the cylinders on the tail lift shook and the assistant's finger was wedged between two cylinders. The assistant was wearing full PPE, including gloves.

10 stitches on crushed finger
