# **Recent (Year 2022) Safety Incidents in the Gases Industry in Asia**

# Agenda

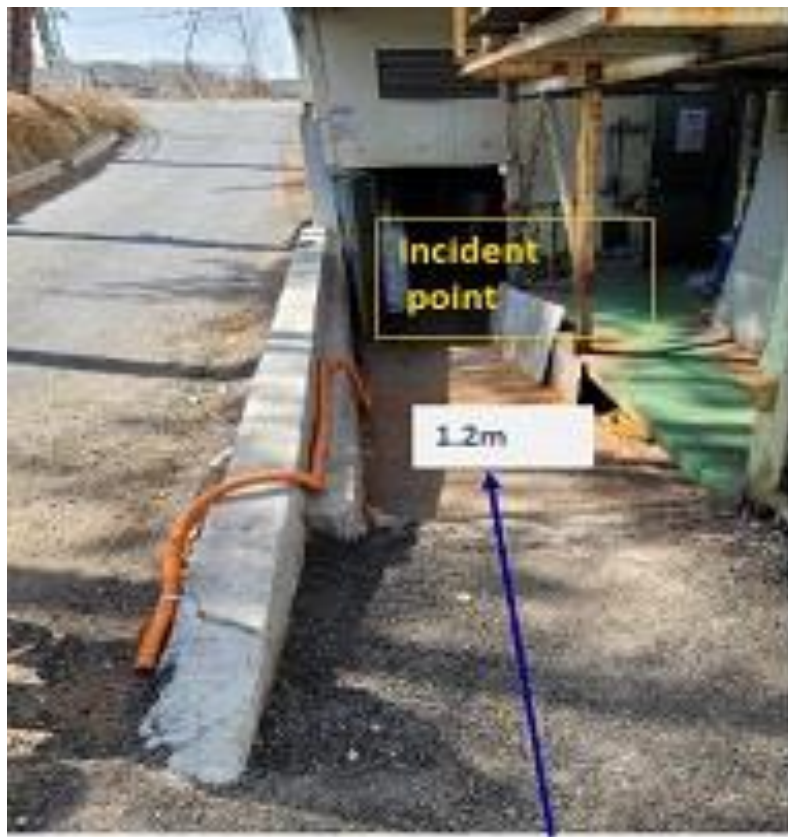
The road width is 1.2M and 6M long, a slope of about 10 degrees downward.

- Update manual handling training program and conduct refresh training
- Develop a plan to conduct customer site's safety assessment regarding safe access, loading/unloading, and moving to/from the storage area.
- Educate customers to make safe loading /unloading area and pathway.
- Do not try to catch a falling cylinder

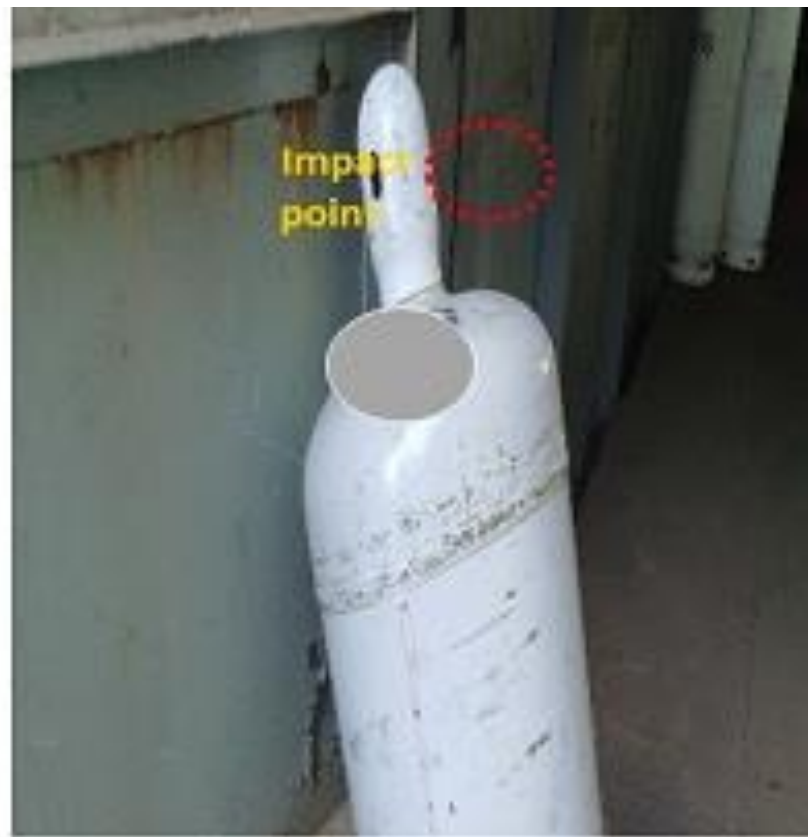
At 10:20AM, while a driver was moving a full 102-liter Ammonia cylinder(total weight 100Kg) to the customer warehouse. He lost control of the cylinder and tried to catch the falling cylinder. His left hand's middle finger was caught between the steel door and the falling cylinder. He was taken to a nearby hospital and received surgery on the fractured finger. There was no product release.

The middle finger was pinched between the cylinder and steel door.

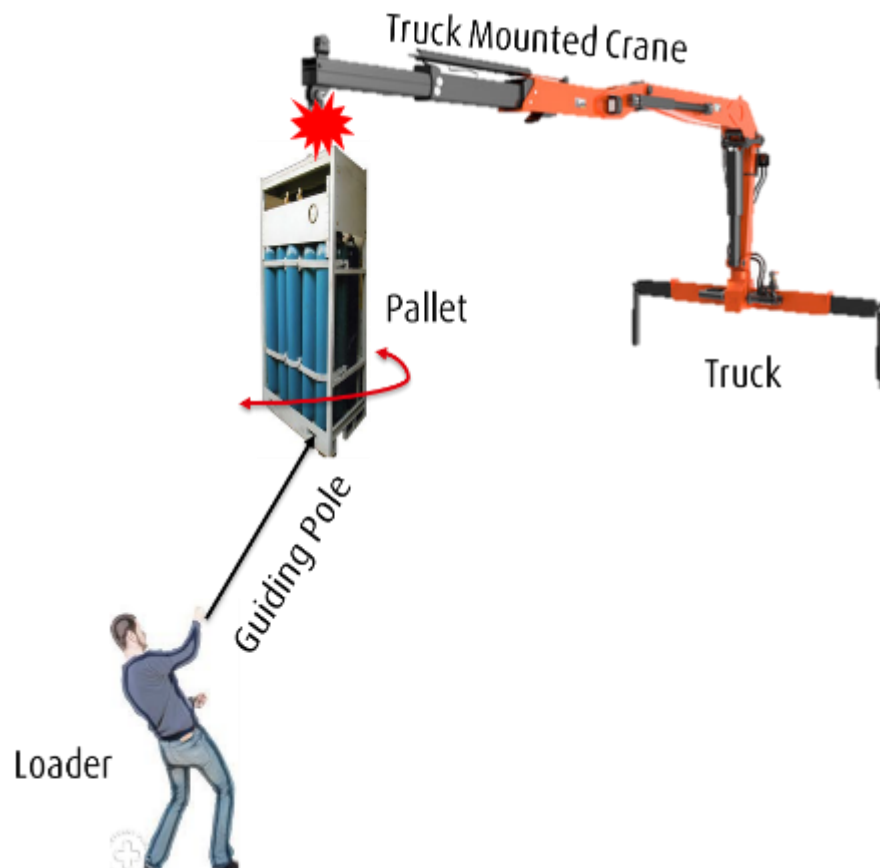
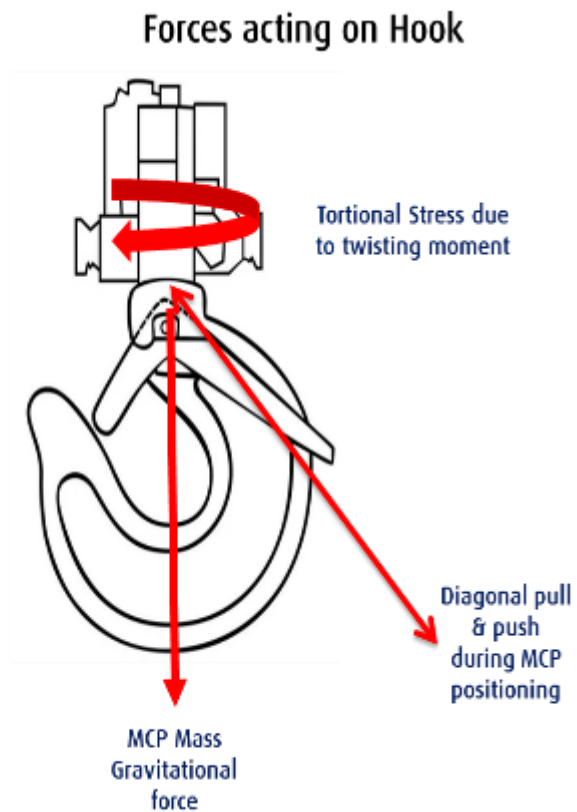
## Lifting Incident- Hook Failure

During unloading of a Manifolded Cylinder Pallet (MCP) using a crane, mounted on vehicle, the MCP fell from height (approx. 5') due to failure of hook attached to the parcel with crane. Hook holding MCP gave way from swiveled joint.

- Conduct crane handling safety review, identify and implement appropriate controls in work instructions
- Conduct routine job safety observations
- Review and standardize manifold layout e.g., linear vs cascade storage, safe distances between MCPs etc.,
- Implement controls to ensure critical safety commodity such as crane & its components purchases are monitored- vendor qualification, periodic evaluation and product certification

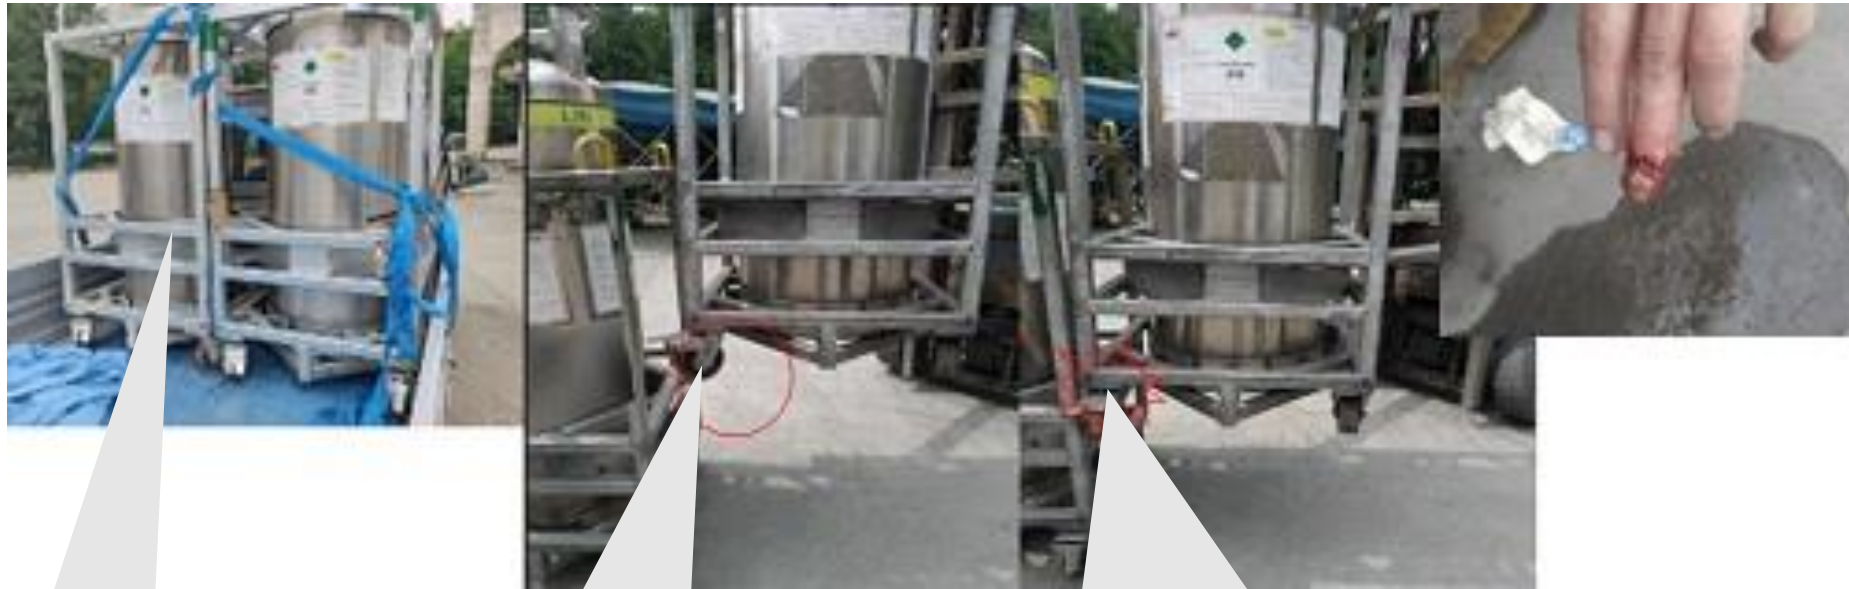
A customer was picking up the LIN dewar at a cylinder gas filling site when the operator was forking the second dewar onto the customer's truck. The customer wanted to adjust the dewar's wheel but plant operator failed to notice that. The frame of the dewar pinched the finger of the customer which resulted in a fracture on tip of his left middle finger.

The customer pick up two 196L LIN Dewars with non dangerous goods vehicle;

the two frames pinched the left hand of the customer.

- Be sure to conduct the safety training of the driver/customer before entrance.
- Gate inspection for the vehicle before entrance.
- Be sure there were risk analysis and corresponding SOP regarding the cylinder unloading/handling involvement of customer and their selected vehicle

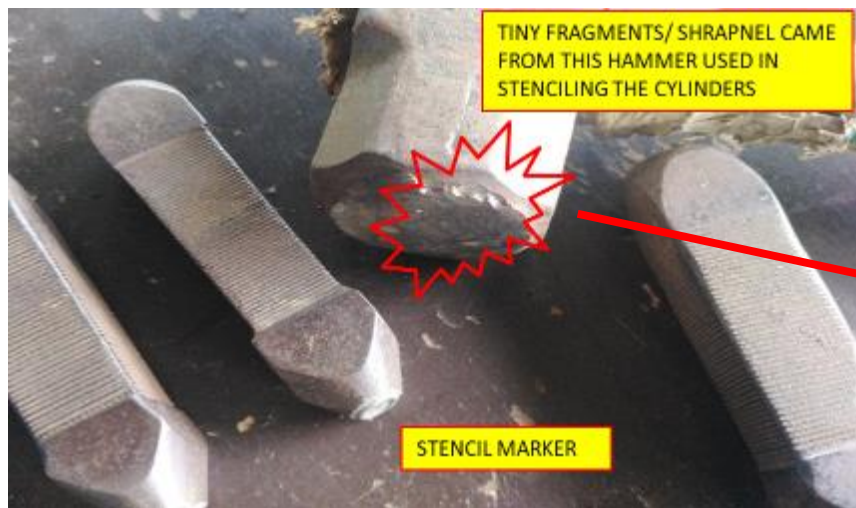
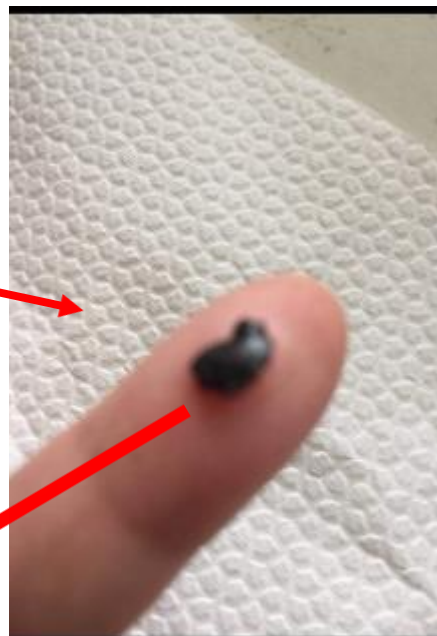
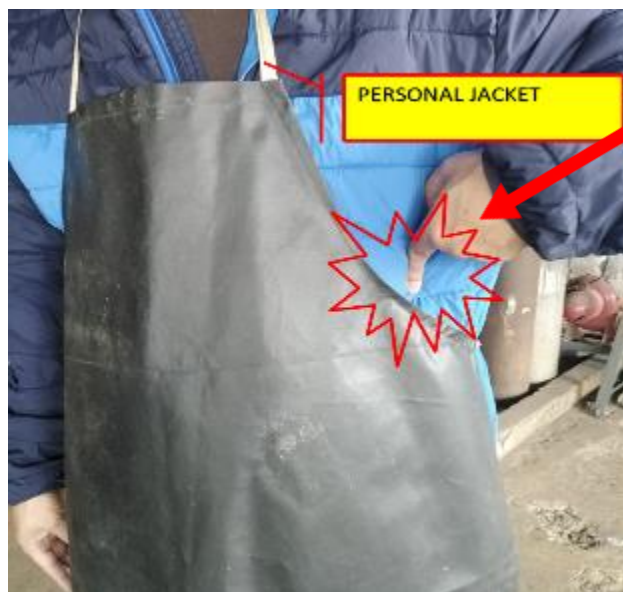
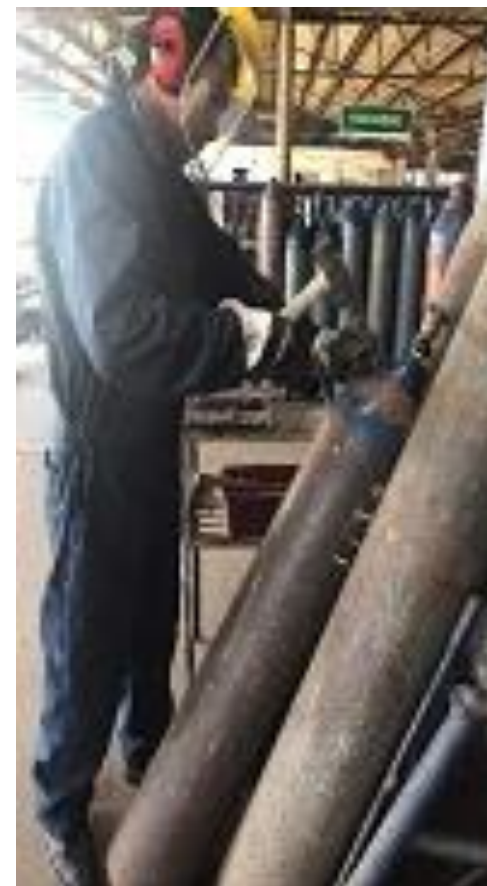
A cylinder maintenance technician was stenciling hydrotest date on the cylinder that passed the hydrostatic test. The Cylinder Maintenance Technician uses metal stencil marker and a mallet. When the mallet struck the metal stencil, a shrapnel from the mallet went astray and hit the right side below chest/abdomen of Cylinder Maintenance Technician, causing to bleed heavily. Another Cylinder Maintenance Technician administered first aid to stop the bleeding. Then rushed to the nearest hospital and based on the x-ray result, a tiny fragment from the mallet was pierce into his chest/abdomen. He was admitted to the hospital to remove the fragments by a surgeon.

- To wear thick body cover(apron) when doing the activity
- To reduce discomfort on the use of PPE, implement administrative controls such as work-rest method and use of electric fans to provide additional ventilation.

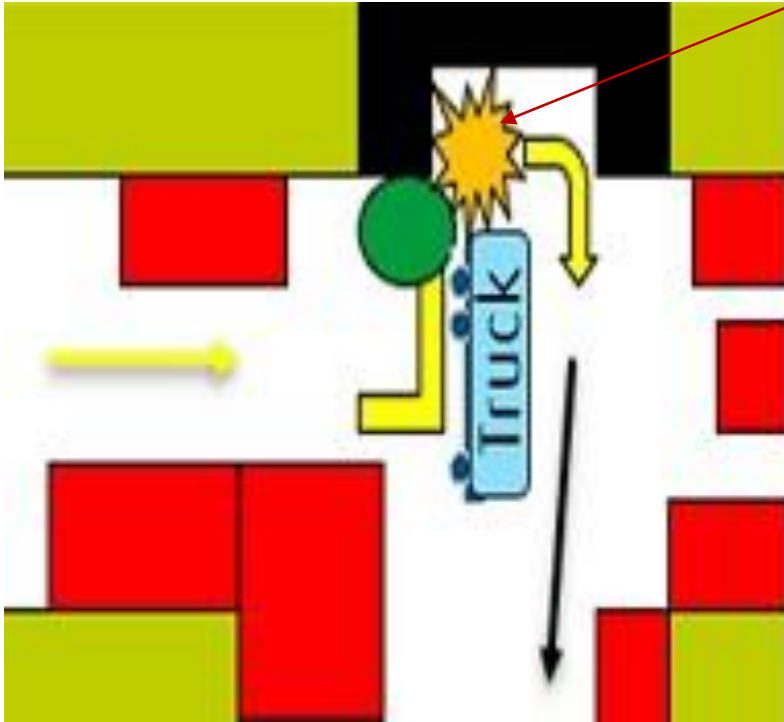
A product vehicle was maneuvering within a warehousing complex using an opened warehouse entrance to avoid parked cars in order to position for product fill at tank. The vehicle had stopped momentarily outside the warehouse door, when the helper moved to the rear of the vehicle to attempt to move a metal bucket. At that moment, the driver engaged the clutch to shift gear and the vehicle moved back 20-30 cm, and the helper's right forearm got caught between the vehicle and the workshop pillar. As a result, the helper received an avulsion fracture of right olecranon and underwent surgery to address bruising on his forearm tendon.

Position of the Helper

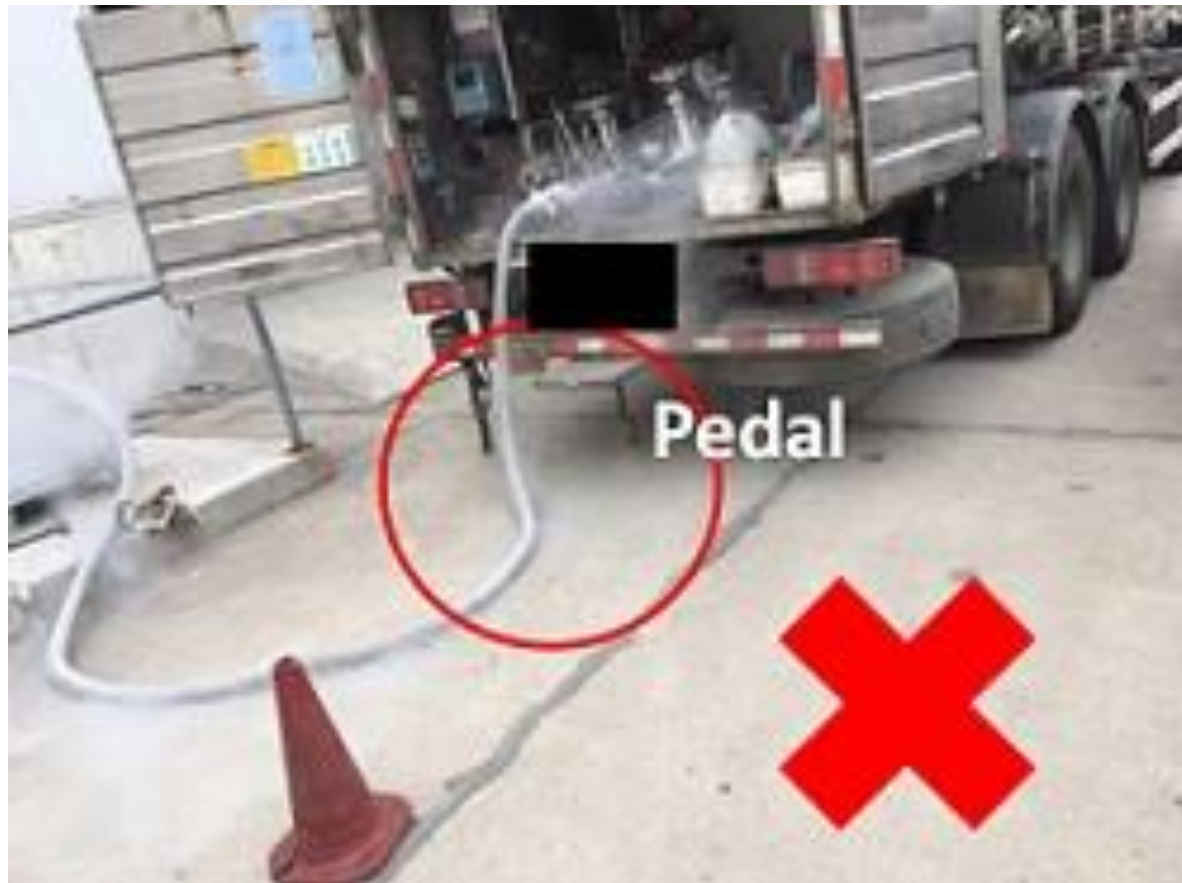
During product delivery at a customer site at 10 30 am in the morning, a driver was stepping down from an operating box pedal when his right foot stepped on the filling hose. As a result, he sprained his right ankle and had a fracture of the skeleton on his right foot.

- Clearly define the placement of hoses on site to be safe and reasonable.
- Strengthen on job observation, focusing on improving the implementation of three-point contact
- Review with the delivery personnel how to get on and off the vehicle correctly , up and down the pedals.

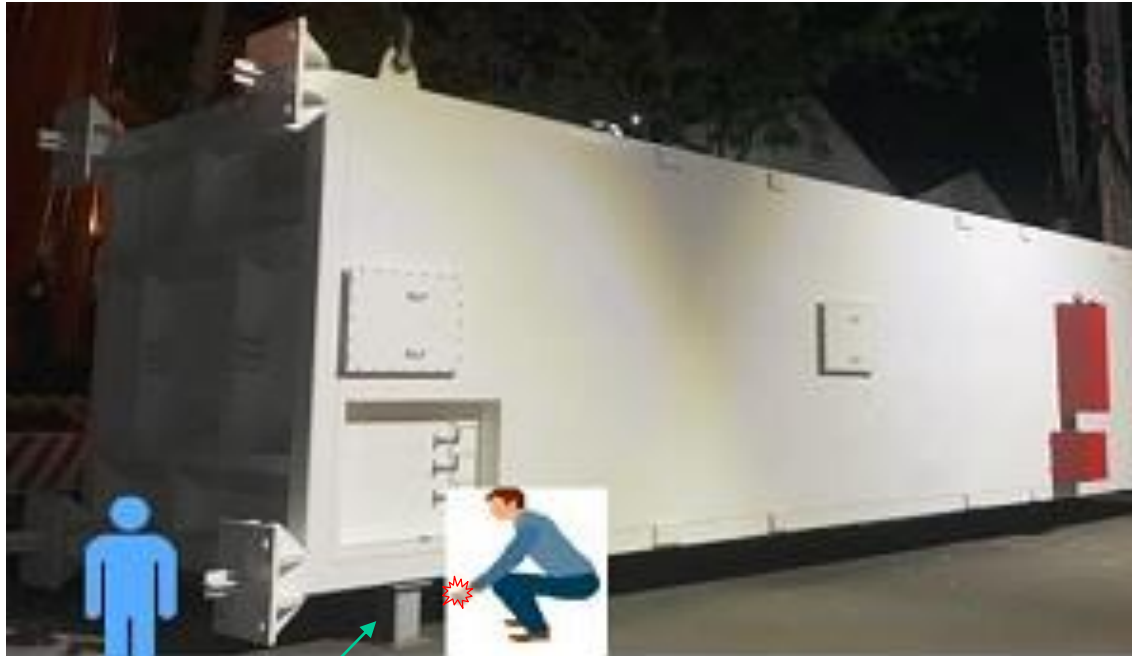
80 MT  
Crane

- Team must verify the declaration of competency of the Crane crews including signalman
- Ensure effective implementation harmonized PTW system including Lifting plan & method statement.
- Pre-job discussion (job specific hazard) must be conducted with all workmen involved in the job and documented.
- Establish proper communication system between all personnel involved in lifting
- Install suitable handle to adjust the stool.

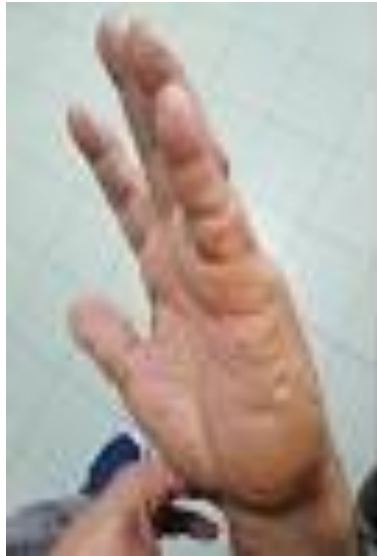
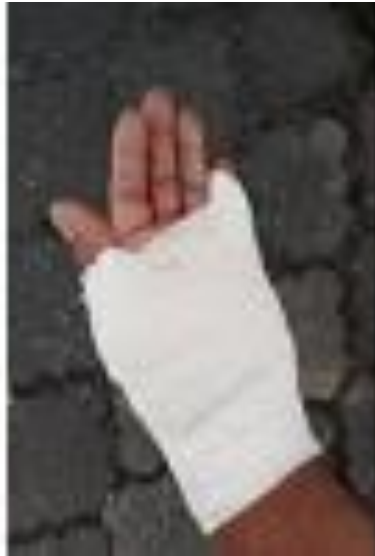
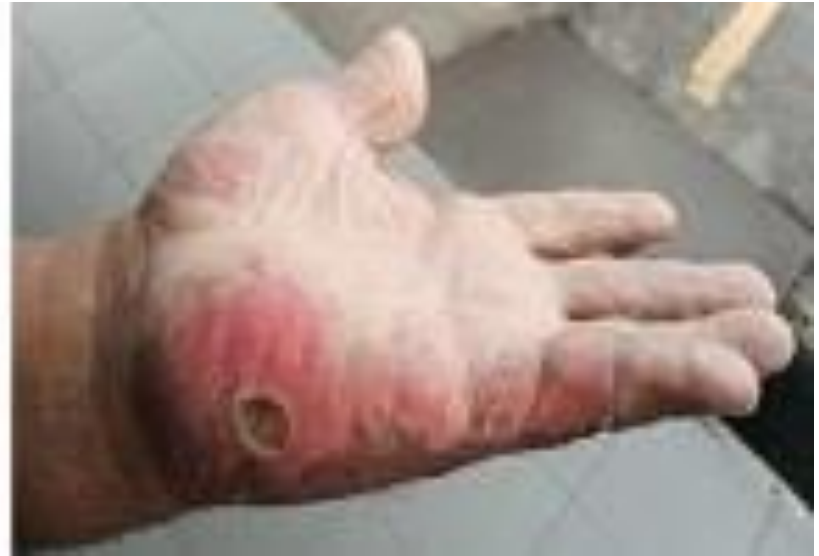
At around 07:30hrs, a bulk tanker driver informed the mechanic that the top fill valve cannot be fully closed. Mechanic arrived offsite to examine the defect. He consulted the senior mechanic, who advised him to replace the top fill valve topwork. Around 10:00hrs, mechanic vented down the tank pressure to 0 psi but there was still some vapour/liquid coming out from the bleed valve. While he was repairing the valve, liquid splashed onto his left hand and caused cryogenic burn. Fleet Supervisor and senior mechanic accompanied the mechanic to the hospital.

- Do not contact with cryogenic liquid even when wearing protective gloves
- Do not rush
- Follow safe work procedures

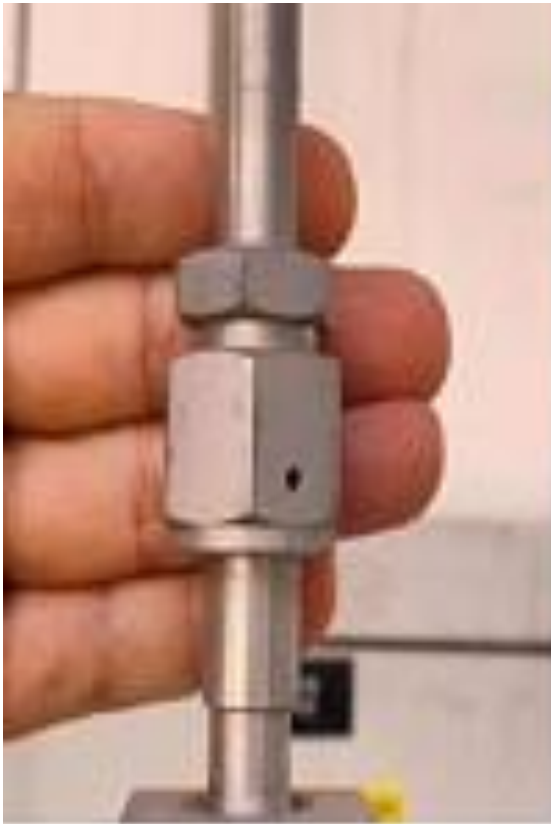
At around 16:40hrs, our operator stood on a ladder and used two adjustable wrenches to disassemble the joint of the analyser's sampling tube. Due to the tightness of the joint, the operator did not disassemble it with force the first time. The joint suddenly came loose on the second attempt, and the handle of the adjustable wrench in the operator's left hand hit him in the nose. The injured person took X-rays and CT scans at the hospital and confirmed the fracture of the nasal bone. Had surgery and being hospitalized due to nasal bone fractured.

- Keep clear from the Line of Fire while handling hand tools
- Limiting excessive force and overreach while working on ladder
- Select proper tool and apply proper technique when handling hand tools

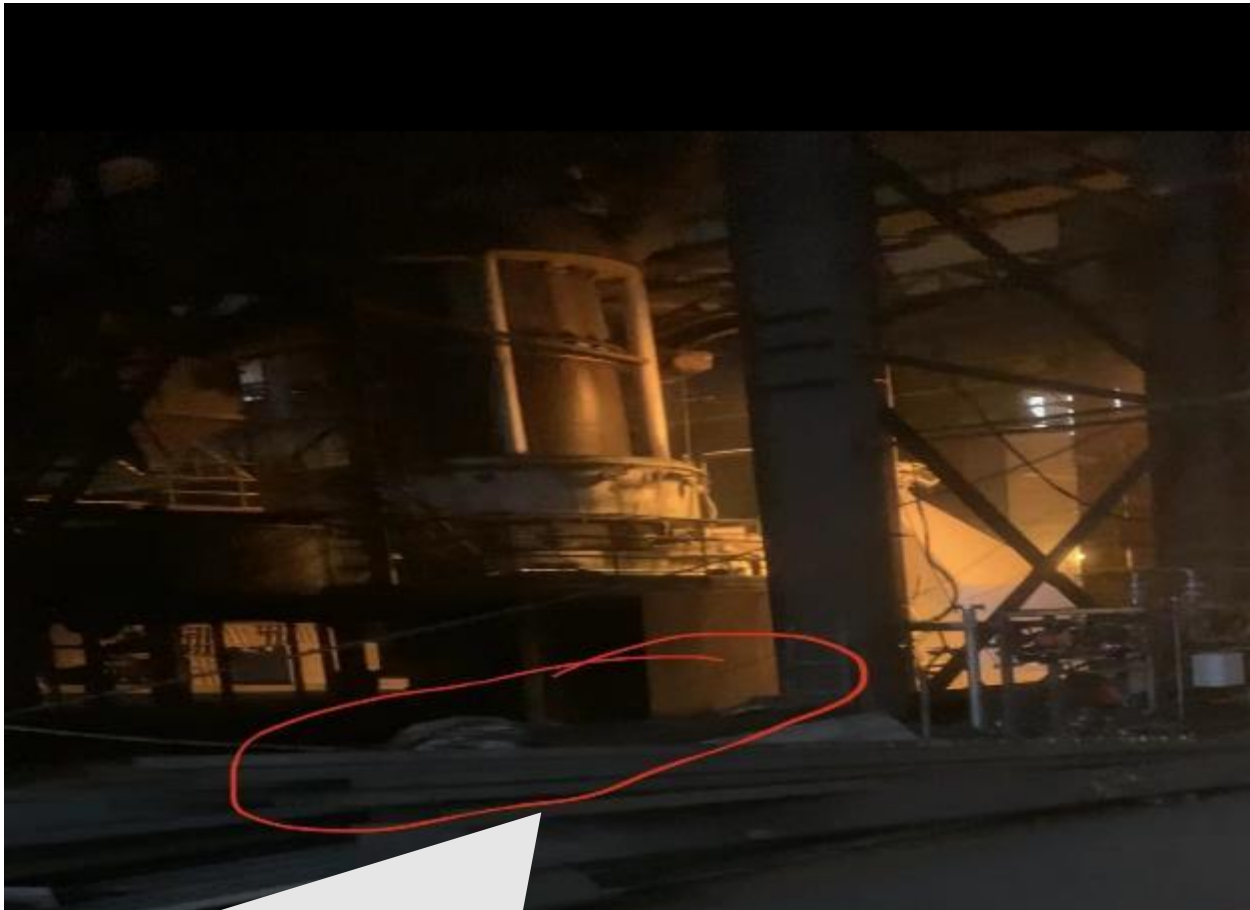
Customer site:

- The red circle shows the path with obstacles;

- Take time to prepare the risk assessment of customer site prior to visit or starting an activity
- Do not take or continue the work if you do not feel safe
- Always demonstrate safe behavior
