Training Package TP 25/20

# Recent (1Q & 2Q of 2019) Accidents/Incidents in the Gases Industry in Asia

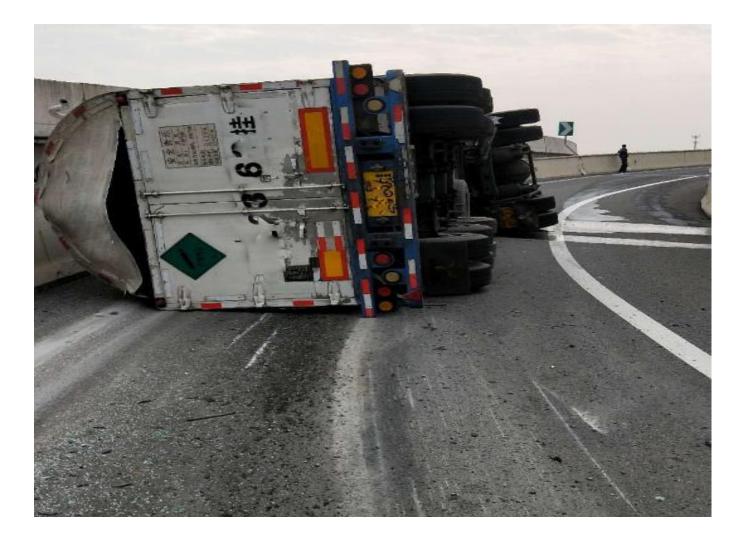
A LIN tanker rolled-over on the connecting curve of a city loop road and an expressway without involvement of any third party. The helper suffered a rib fracture and pulmonary contusion caused by the safety belt, and the driver suffered from a skin cuts/bruises plus soft tissue injury on his left elbow. The incident happened in the morning at around 10 am.

- High speed in the curve: ~ 70 km/h
- Careless driving

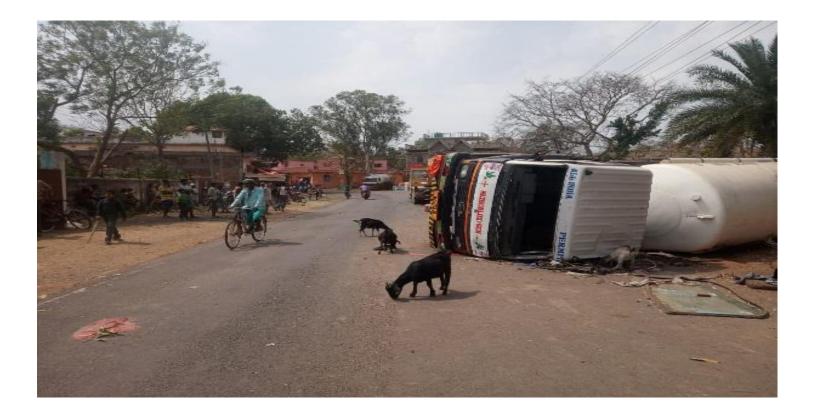
A contractor' truck carrying LOX was on the way to make a delivery. After turning a right hand curve road, the driver noticed a cyclist on the soft road shoulder; moving on the same direction. All of a sudden the cyclist swerved into the main lane in front of the contractor' truck. To prevent an accident, the contractor' driver moved to the right and tried to get back to the left lane. In this course of action the driver lost control and the truck rolled over. The driver was wearing seat belt, sustained minor injury and was treated with first aid. The truck cabin, tank, vaporizer and fleet chassis were damaged. Some product venting was required due to pressure rise.

- Driver did not observe and anticipate ahead while driving
- Driver did not adjust the speed to suit the road conditions

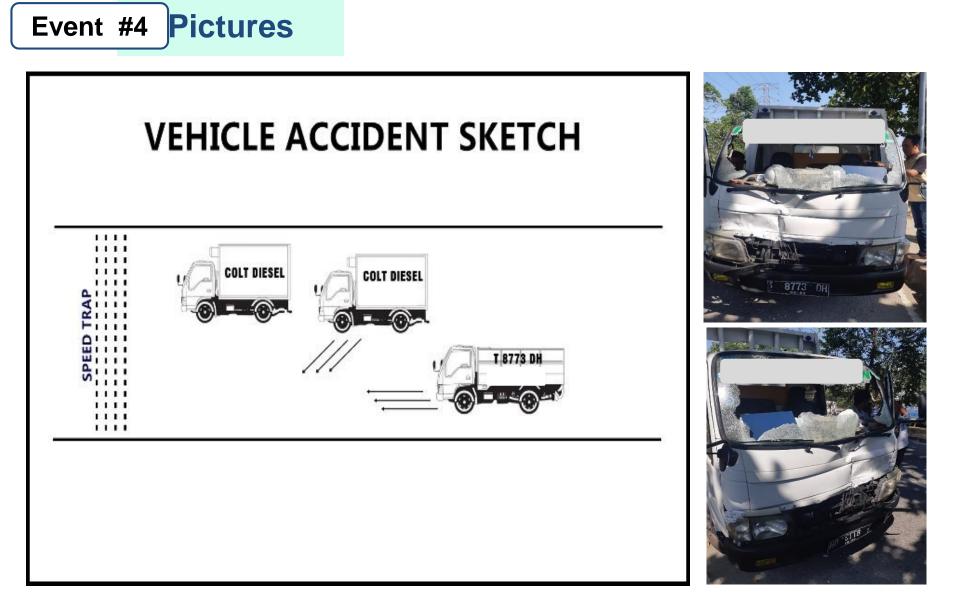
A cylinder truck crashed at the rear of a box truck after the box truck attempted to avoid a collision with another vehicle ahead by overtaking the cylinder truck while the other vehicle made forceful braking to pass a speed trap. Unfortunately, this effort failed because of inadequate space between cylinder truck and other vehicle. The cylinder truck speed was 30 Km/hr and the other truck around 50Km/hr when the incident happened. The third party driver received lost time injury, however the cylinder truck driver and co-driver had seatbelts and received no injury.

- Cylinder truck driver not following defensive driving
- No ABS for the truck

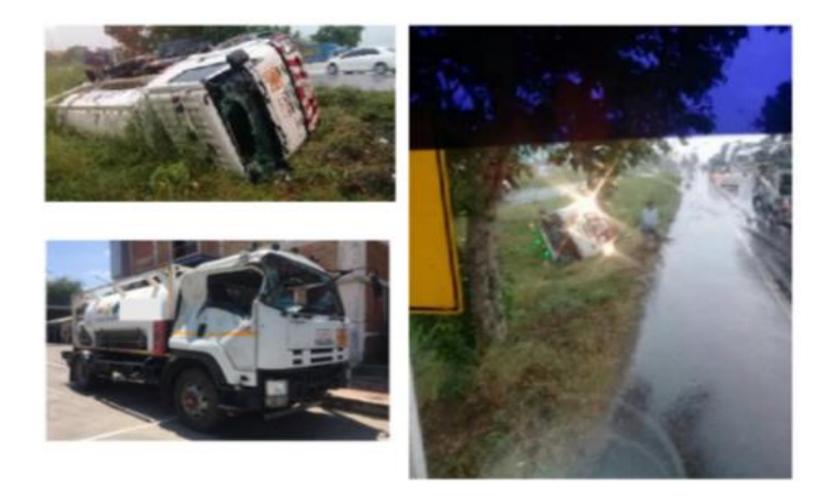
On way back after the delivery of Lox, a product vehicle driver arrived at a busy road where he intended to move to the left lane, but the traffic condition did not permit him to do so. As soon as he found an opportunity to switch lane, he tried to accelerate his speed to overtake a 10-wheel lorry which had occupied the left lane. At the same time, a car (on the right lane) braked in front of the driver and the driver naturally reacted by doing the same. In order to avoid collision, he steered the vehicle off the car, travelling at a speed of 50km/hr prior to the incident and the wet road made him lose balance, resulting in a rollover.

- Wrong overtaking procedure followed by the driver on a wet road
- Did not maintain enough space cushion from the car in front of him
- Driver was travelling at a high speed (50km/hr) on a busy road in bad weather
- The product vehicle was not installed with ABS, EBS or RSS

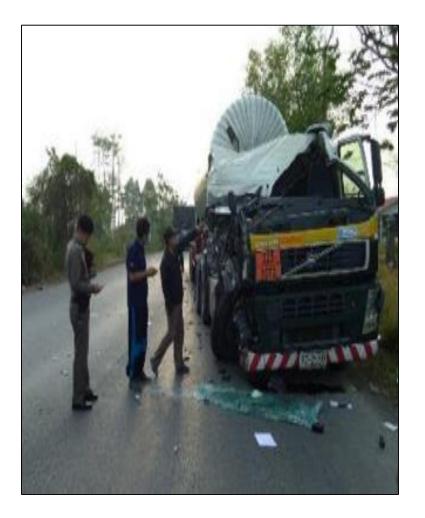
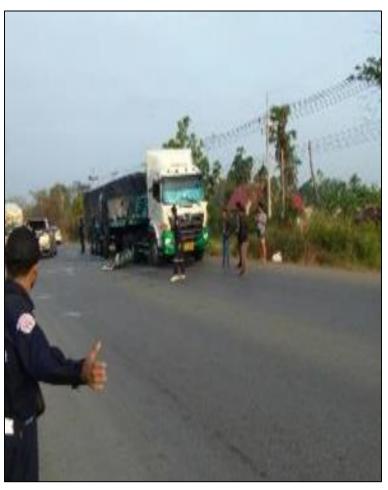
When returning to the depot, a LCO2 tanker hit the right side of an oncoming truck. Due to the impact, the tractor cabin was badly damaged but no product loss. The driver sustained head & right eyebrow injury and a fractured right wrist. There was no injury recorded for the 3<sup>rd</sup> party driver. The 3<sup>rd</sup> party driver contacted the emergency service and transferred the driver to the nearby hospital. Later the doctor refer him to another hospital for further treatment.

- Driver was found to be fatigued and had a micro sleep cumulative fatigue
- Driver did not apply brakes prior to the collision(GPS speed report)

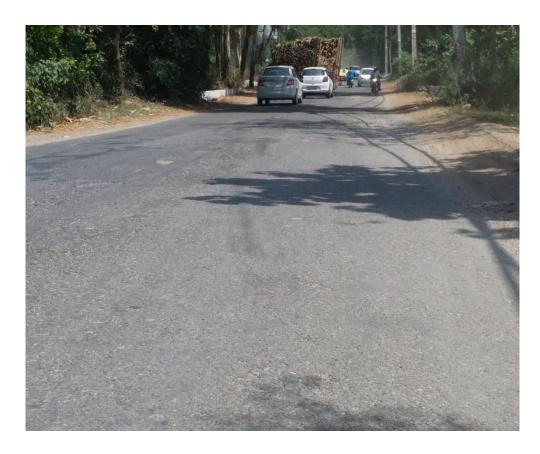
## Event #7 Pictures

- 21' double lane road without median
- Slow moving overloaded tractor trailer obstructing visibility
- Driver tried to overtake the tractor trailer
- Two wheeler with 2 pillion riders from opposite side tried overtaking another stationed two wheeler
- Two wheeler riders were without helmets

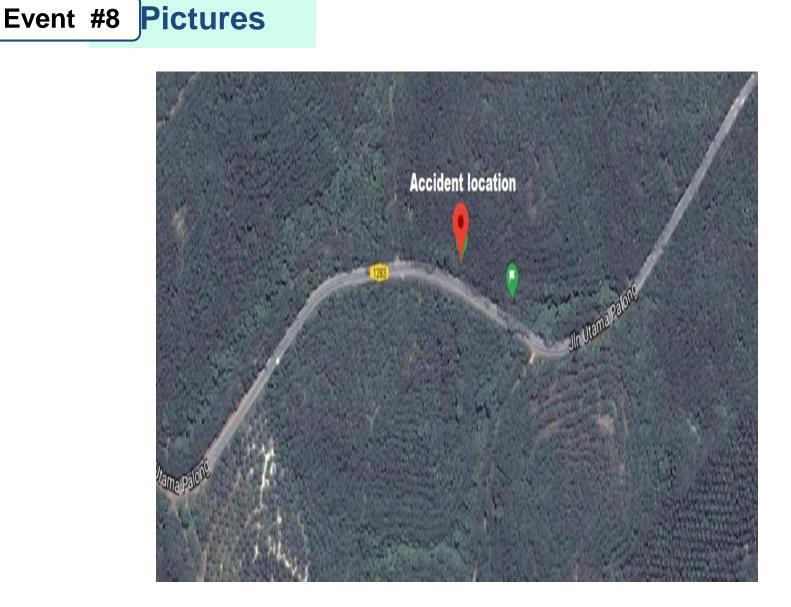
A LIN Tanker was on its way returning from a customer site to depot. At a curved section of the road, the tanker overtook a motorcycle and accidentally grazed onto it. The LIN Tanker driver was unaware of it until the police contacted on duty scheduler, based on eye-witnesses information. The motorcycle rider and his pillion suffered injuries (fractures). The male victim suffered 4 fractures on right rib bones and shoulder/collar bone. The female victim suffered 2 fractures on left wrist and hand.

Driver did not follow Defensive Driving. Overtook the motorcycle even though he did not have a clear view of sight.

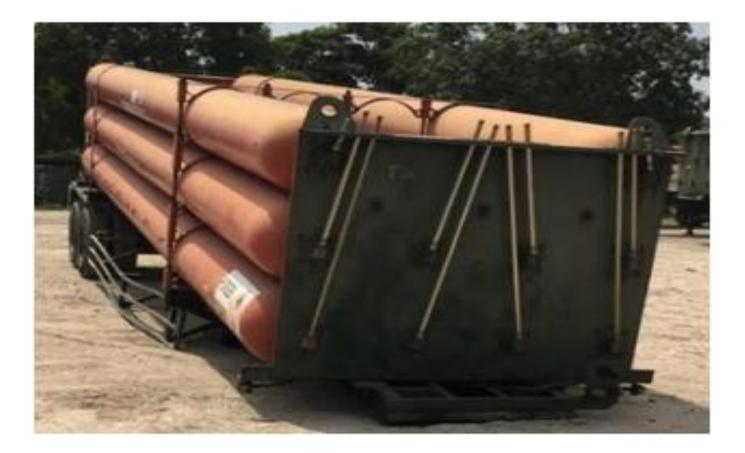
Driver prepared to send the H2 TT for treatment. Driver hooked trailer to the tractor head, came down from the prime mover and connected the sussie hose and electrical line. He later wind up the landing leg. Upon completed, the driver drove away from the parking lot. While making a 90 degree turn, the trailer was disconnected from the tractor head. There was no injury and product loss.

- Driver did not follow the correct trailer hooking procedure.
- Driver did not perform the tug test to ensure the lock jaw secured the king pin
- Driver did not check on the lock jaw and king pin position.

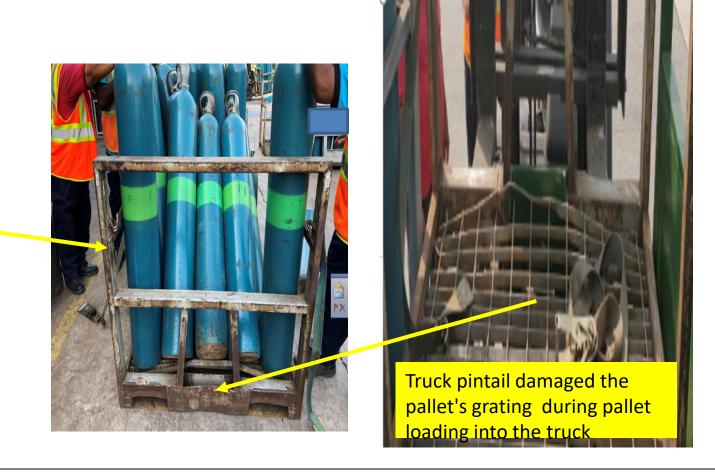
## Event #12 Pictures

- Pallet grating near pin tail damaged due to pallet grating hit by 'pintle' on truck whilst loaded in other depot.
- Improper movement during cylinder transfer attendant trapped in between loose pallets and unable to escape.
- Difference in the designs for the 'pin tail' for the pallet and the truck.

Cylinders fell on attendant

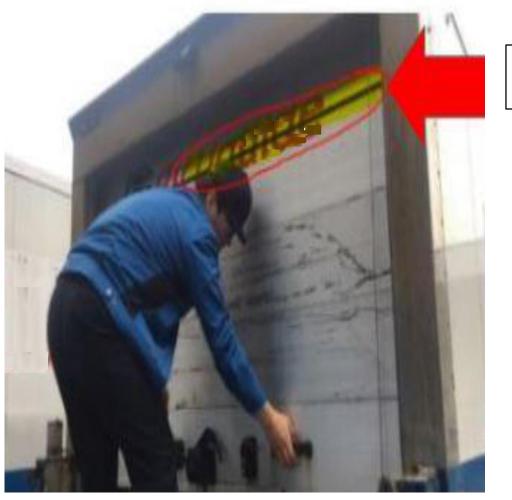
After unloading the cylinders from his truck, an employee tried to close the roll-up door (sliding rear door) by pulling it down. The door was not fully closed with first try. So he pushed the door down by foot instead of hand. At the same time, he unconsciously placed his fingers on the gap between the sliding door plates. He got his right fingers (3rd and 4th fingers) stuck between door plate as soon as the door is closed completely. He was transferred to the hospital and had a surgery.

Unsafe act: wrong method of closing door

Gap between door plate

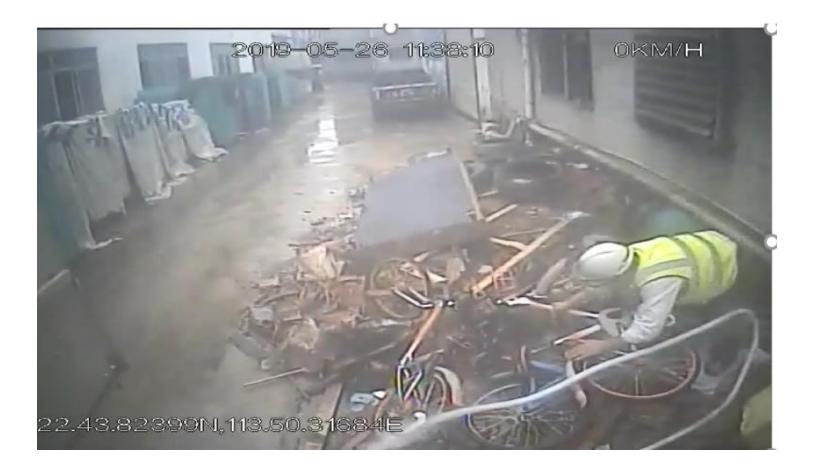
A MB driver completed unloading, when he was placing filling hose back to truck, he lost balance and fell due to stepped by construction trash pile with full occupied hands (copper hammer in right and filling hose in left) at that time, and his right chest hit on the tip protruding pedal of bike. He reported supervisor immediately and continuously finished rest of the work even he felt slight pain. Driver went to see a doctor. An X-Ray identified a minor fracture on the 7th rib.

- Loss the balance due to foot stepping on unstable debris with both hands occupied by hammer and loading hose.
- Normalize the deviations, working on the poor housekeeping area as usual.
- Loading access way was block by garbage pile.

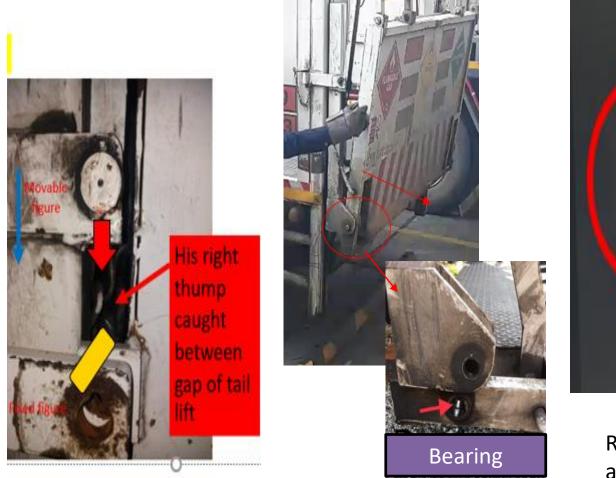
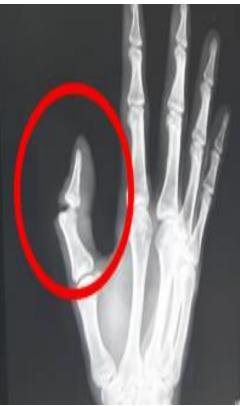
## Event #16 Pictures

- Not using a PPE: Lack of hazard awareness and hazard evaluation
- Failure to follow instruction from the driver to wait
- Lack of preventive maintenance for the tail lift

Right thumb joint and tendon injury

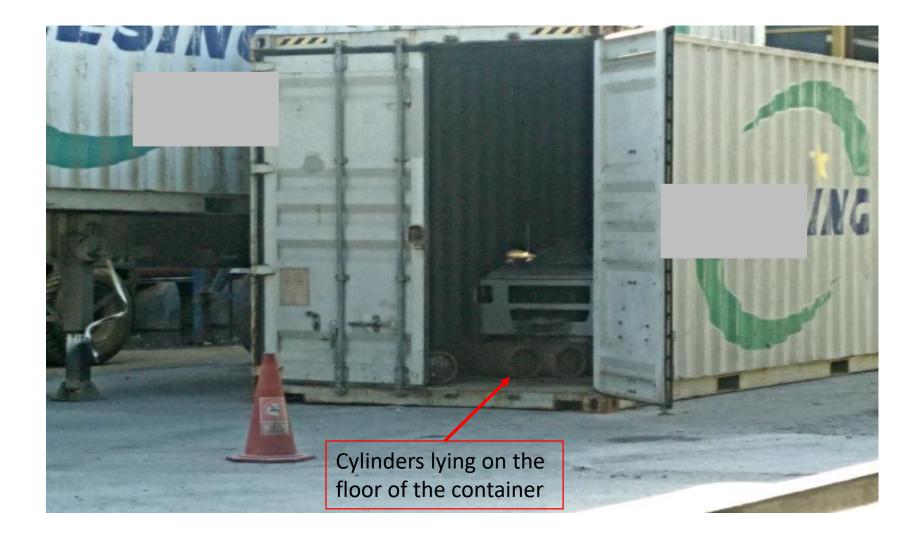
## Event #17 Pictures

A contract sorter detected acetylene smell coming out from an ISO container while performing un-stuffing of cylinders. Special precautions were taken by the sorter during the opening of the container door. Acetylene Cylinders were found in in horizontal position inside the ISO container.

The container was ventilated and subsequently the cylinders were removed safely. 3 cylinders found to be leaking at valve.

Not properly securing the cylinders/ Lack of supervision during loading of cylinders inside the container

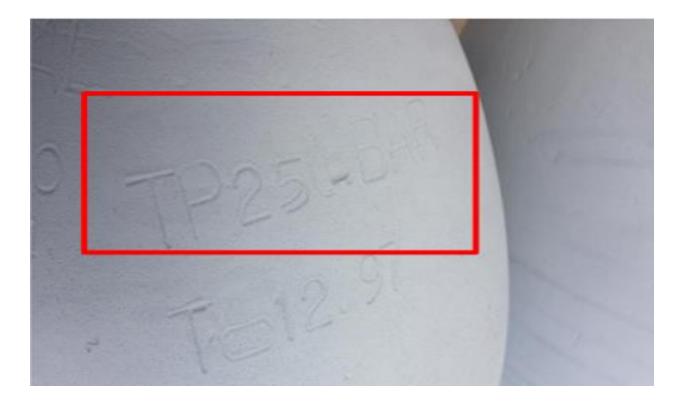
A hydrogen trailer consisting of 24 tubes went through hydrostatic test at 333 bar on December 2018. It was later discovered that 7 tubes has Test Pressure 250 bar stamped on the tube. The 17 other tubes have Test Pressure of 330 bar stamped on the tube. So, 7 tubes have been tested beyond their designed Test Pressure.

Professional Engineer based on last 2 test record and proceed to certify test at 333 bar.

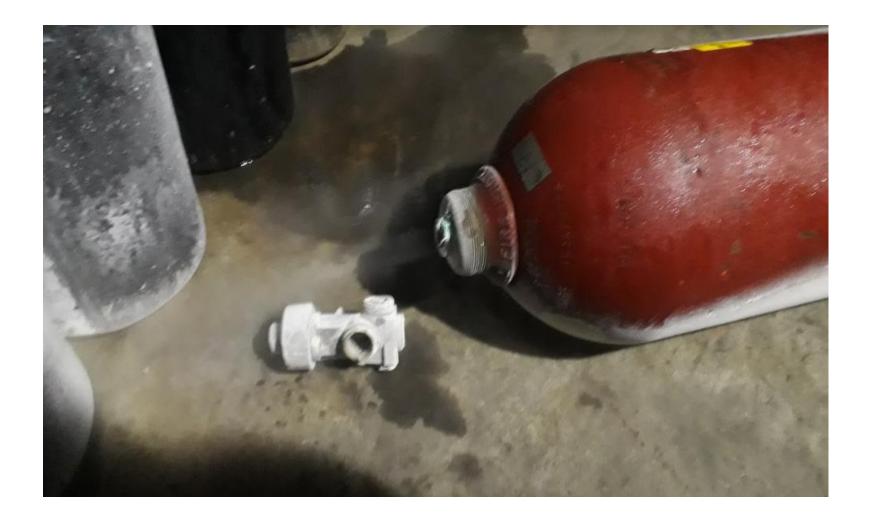
An operator was filling a customer owned CO2 cylinder and noticed that the valve was leaking. The operator aborted the filling and set aside the cylinder without cap and without strapping it. While setting up another cylinder, the cylinder that he had put aside was continuously leaking and fell to the ground due to high pressure. The valve broke, releases vapor cloud and the cylinder shoot forward. There was no injury to the operator.

Lack of Operational Discipline - Did not cap and strap the cylinder

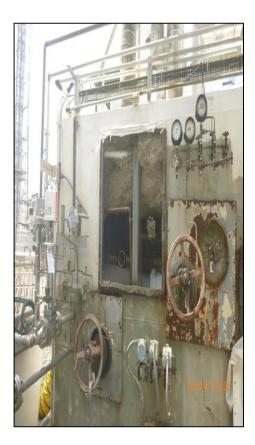
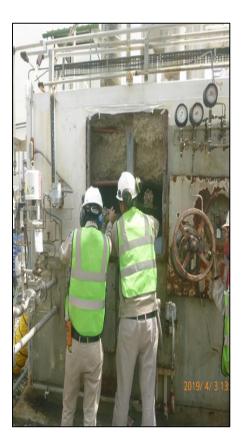
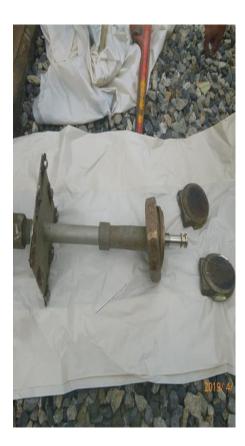
A permit to work was issued for removing a leaking cryogenic valve after isolating related valves. Two mechanic were removing the leaking valve but the system line still had residual pressure. Due to the residual pressure parts of the valve flew apart hitting both mechanic's face (they were wearing safety glasses). After administering first aid they were sent to hospital for further treatment where both received stitches.

- Residual pressure in downstream side from liquid and incompletely released pressure.
- Continue work permit approval even found pressure was passing from valves.
- Incomplete qualification program for operator and isolation knowledge of mechanic.

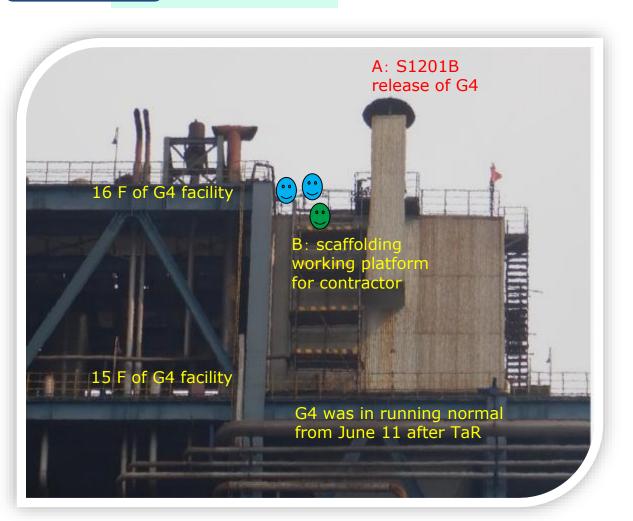
**Event #22 Pictures**

- The contractors working at a gas venting area during normal operating.
- Inadequate risk identification during SWP issuing.
- Inadequate hazardous area management ,lack of proper hazard warning and control for potential hazardous area.

- A: S1201B release of G4
  - DN 1000cm
  - atmosphere pressure after 5.0Mpa orifice
  - DN of orifice
  - 99.4% CO2 and 0.6% CO

B: scaffolding working platform for contractor

- scaffolding was erected on June 21
- acceptance inspected by safety inspector
- total 7.2m height with 4 layers
- Contractor (A) worked on scaffolding platform
- Contractor (B&C) stood on the 16 F inside of handrail

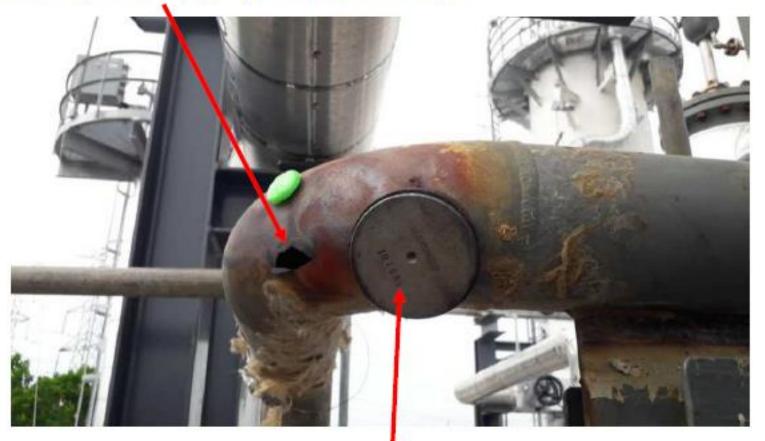
- Designer inadvertently picked carbon steel material pipe class while routing the line
- Missing verification in engineering checking and fabrication & skid checkout.

#### Approximately 1.5 inches size puncture hole at elbow

Piping material test with magnet, proof that it's carbon steel instead of Stainless Steel

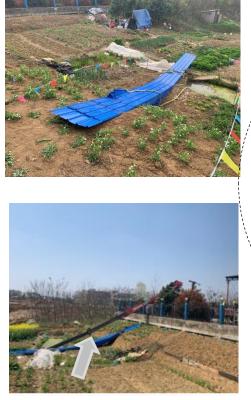
Crane topple position

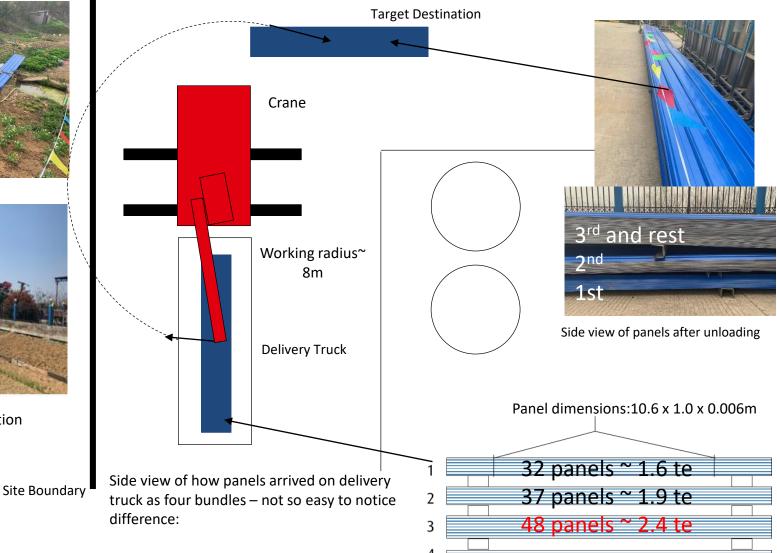
- The safe working load of the crane was exceeded by the Operator at the 3<sup>rd</sup> lift
- Crane operator admitted he didn't sufficiently reduce working radius before rotating boom.
- Lack of attention to critical detail / lifting management inadequacy by Supervisor
- Inadequate design The crane had no limiter / alarm warning for approach to unsafe loading

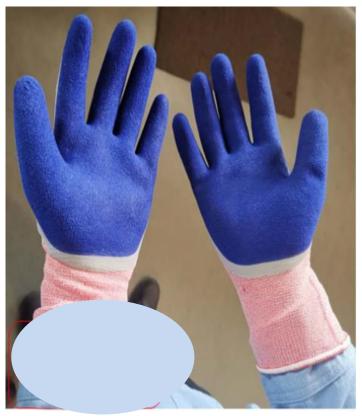
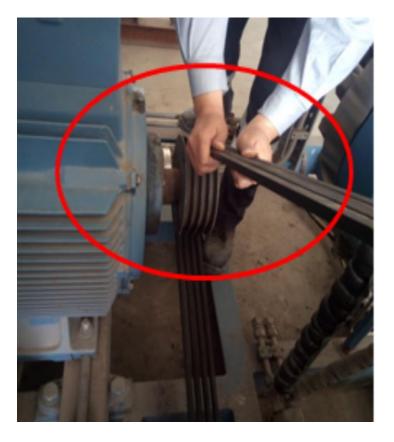
A mechanical engineer was performing a turning for compressor wheel by hand (manual barring). His glove got stuck between belt and the small pulley and he did not pull his hand out in time, which leads to the finger being stuck between belt and the small pulley. His right ring finger-end was fractured.

- The person did not anticipate the risk
- Finger crush injury risk was not identified when issuing work permit

Gloves worn during the incident
