# SAFETY BULLETIN 05/10

### ASIA INDUSTRIAL GASES ASSOCIATION

# Recent cases of asphyxiation in confined spaces in Asia

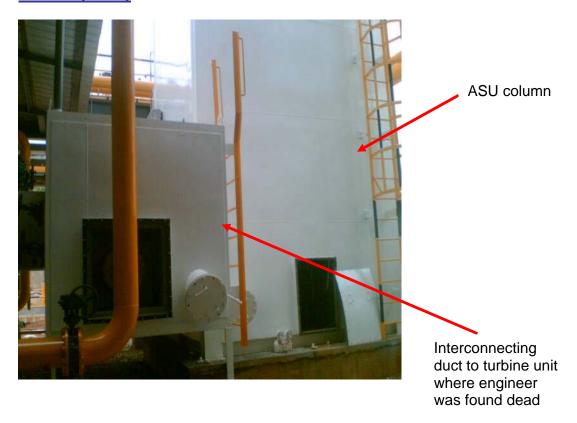
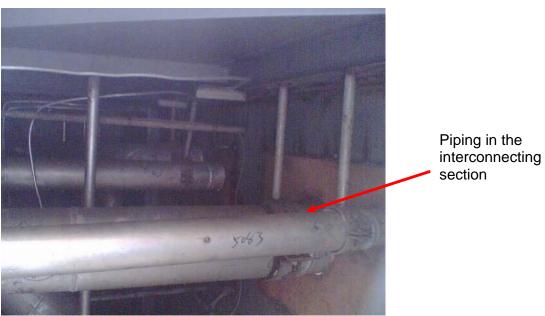
Engineer was found dead in the interconnecting duct between the ASU column and the turbine expander while carrying out a leak check on the piping works and equipment in the enclosure. The plant was undergoing cold test. Engineer was from Operations and was working with the engineering

- At 5.20 pm the shift engineer went on to the top of the interconnecting box where there is a manhole and saw a person lying inside. Two other operators were enlisted to pull the unconscious engineer out and he was sent to the hospital. He was ascertained to have died around 4 pm.

- The interconnecting section is 4m (length) x 1.5m (width) x 2m (height).

- Safe systems of work are required at all times.
- Confined space entry permits should be used for all vessel/enclosure entries.
- Avoid the use of nitrogen for pressure testing/purging/flushing unless under very specific and exceptional circumstances. Strict authorization requiring specific hazard controls has to be put in place before the use of nitrogen (or any inert gas) for such purposes is sanctioned. Hazardous Work Permit/Confined Space Entry system should be enforced. This appears to be lacking during the construction phase and also during the construction-commissioning interface.

- Gas check, personal atmospheric monitors are required when entry is necessary into enclosures where nitrogen is used or could become present inside the system.

- If an unsafe atmosphere is detected, steps should be taken to withdraw all personnel working inside such environment/atmosphere and detect and remove the hazard. A buddy system and self-contained breathing apparatus (SBA) should be utilized in areas where nitrogen leakage is detected (including any rescue situation)
