Training Package TP 22/17

Recent (2016) Accidents/Incidents in the Gases Industry in Asia

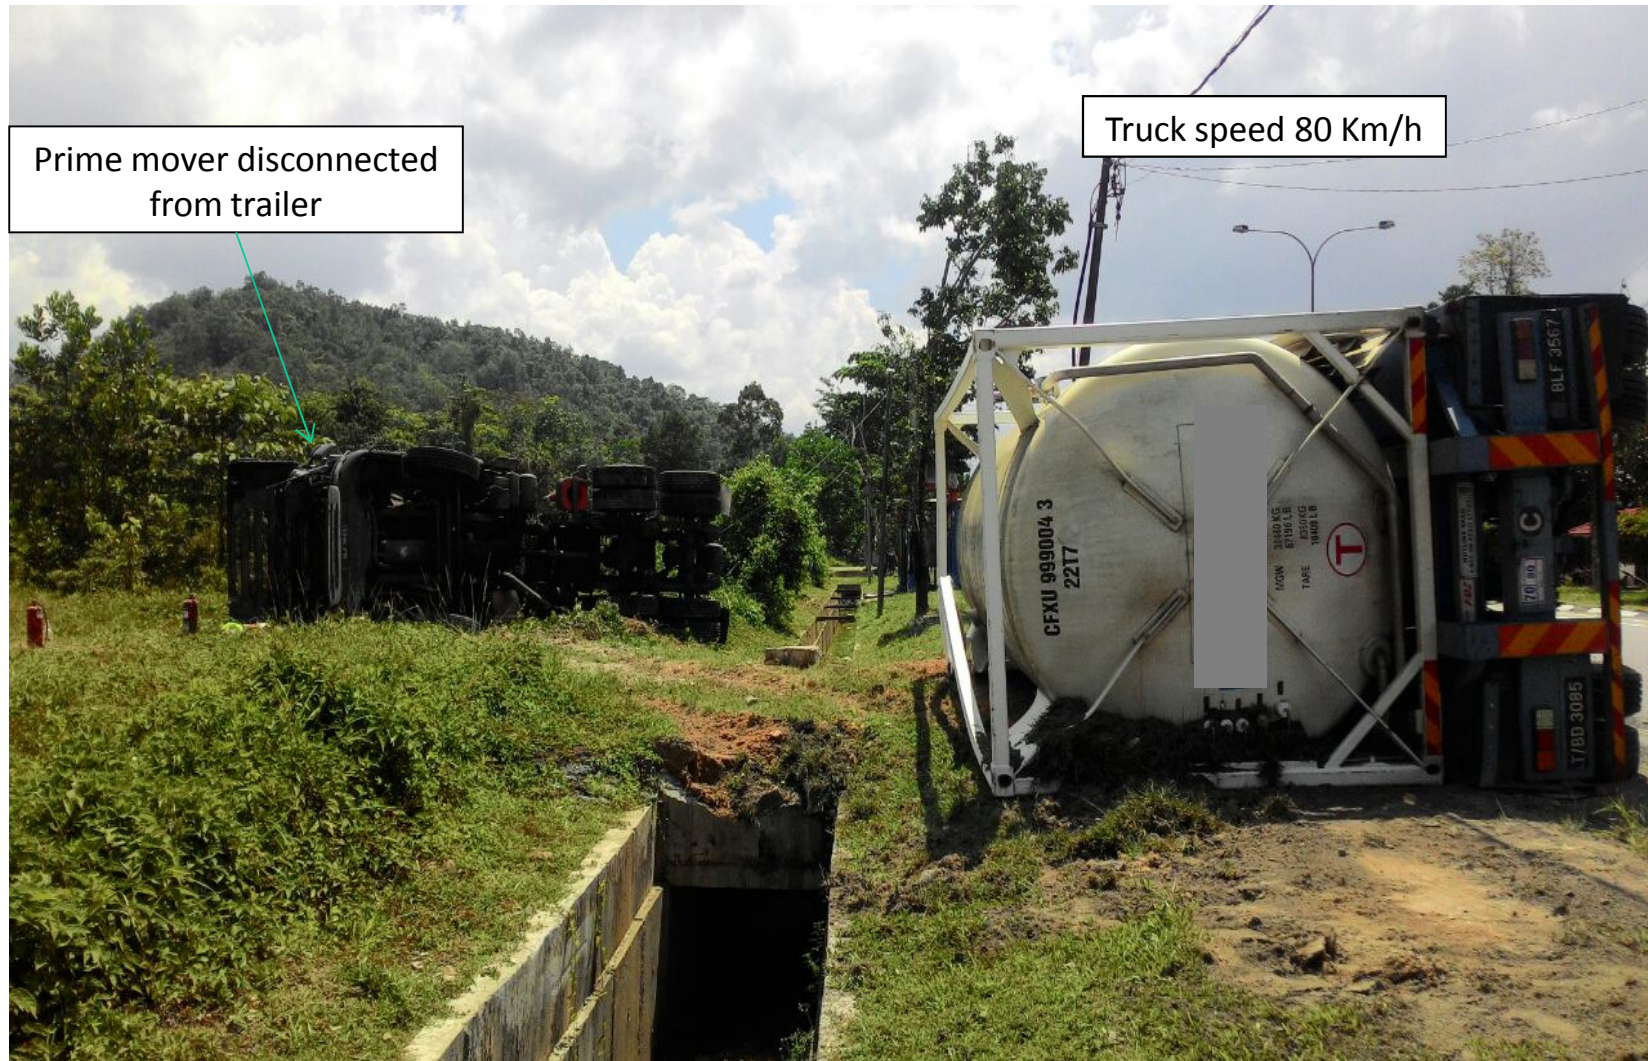
Event #2 Pictures

Product vehicle roll over due to over speed

A Lox ISO vehicle rolled over at a bend due to over speed (80 Km/h instead of 60 Km/h). The road and weather conditions were good and the incident happened around midday. There was no product spillage.

- Over speed (80 km/h instead of 60 km/h as allowed for the bend).
- Possible sleep inertia; the driver was driving for less than 5 minutes after waking from sleep in the sleeper berth.
- Failure of fifth wheel fixation, leading to prime mover disconnecting from trailer
- High centre of gravity of the ISO vessel

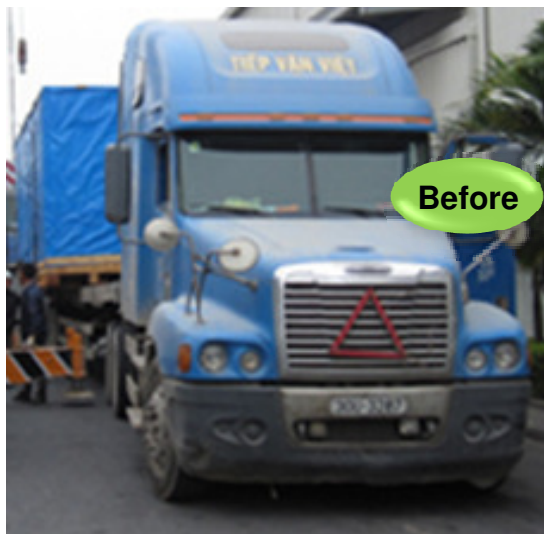
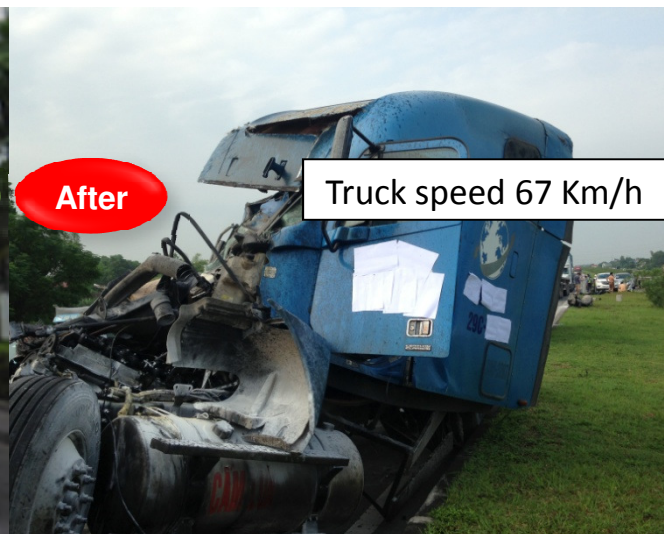
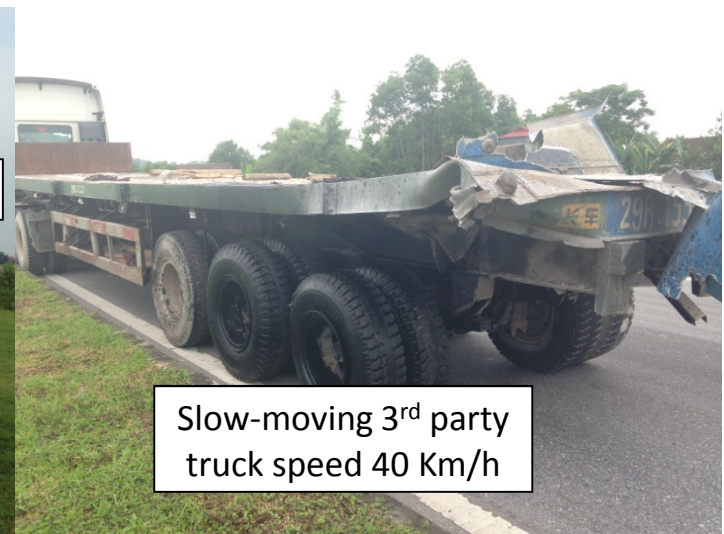
Event #3 Pictures

High severity product vehicle accident

At around 4:23 am, a truck accident happened on the highway while ISO Lin tanker was on the way to deliver to customer. The contractor driver was driving at 67 Km/h when he crashed onto a slow-moving truck (40 Km/h) transporting 5 cement pipes which was in front of him on the same lane. The contractor owned prime-mover received extensive damages at the cabin. Third party truck had slight damages in its tail. No damage to the Lin ISO tanker neither any product release. Contractor driver was tired, saw the truck at the last moment and tried to avoid the collision. He was wearing his seatbelt and sustained only minor cut in his nose (Recordable Injury).

- Driver fatigue. Driver saw the slow-moving truck at the last moment.
- Slow signaling by the 3rd party vehicle

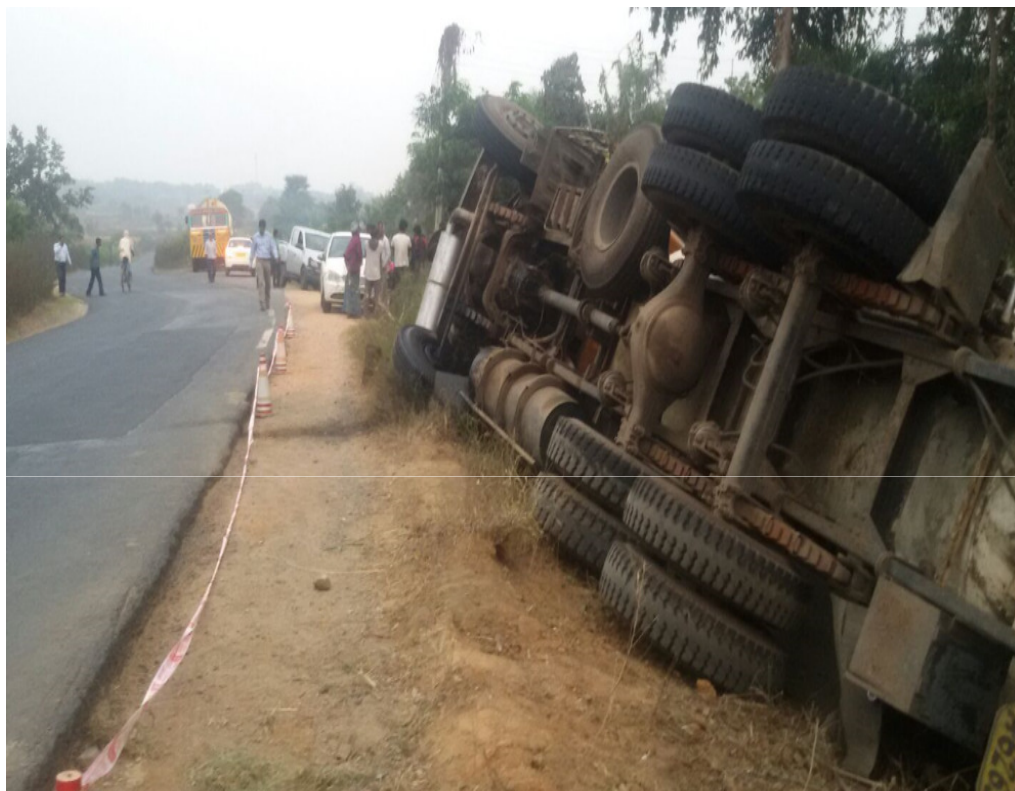
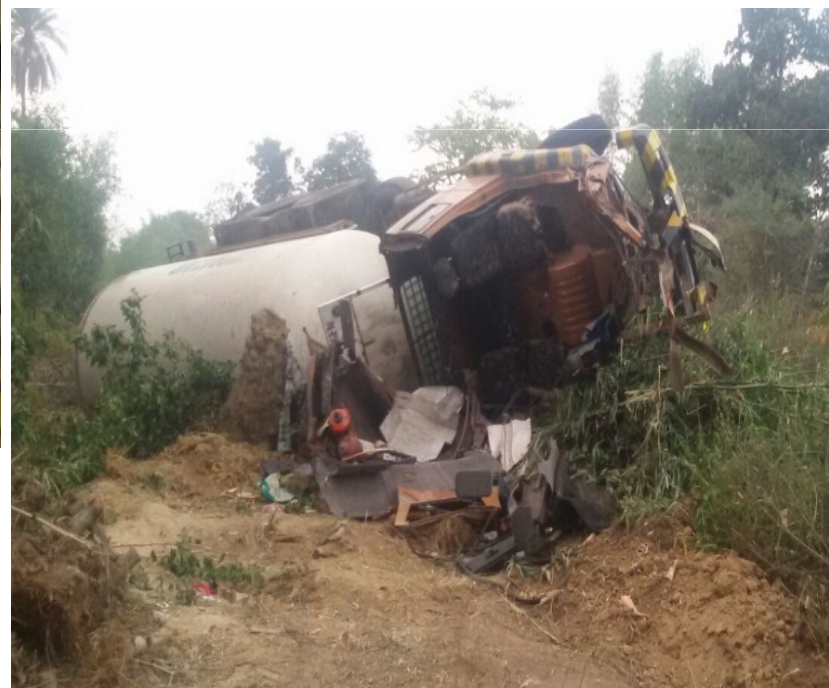
Event #4

Product vehicle roll over

Contractor owned & operated product vehicle while on its way to a customer rolled over by 90 degrees resulting in fatal injury to the seat belted driver (bamboo shrubs pierced the neck and skull). The vehicle cabin had to be cut open to extract the driver. Unfortunately the driver passed away on the way to the hospital

- Aggressive driving (Speed / Driving too close to road edge)
- Lack of practical roll over prevention training ; Route risk mitigation

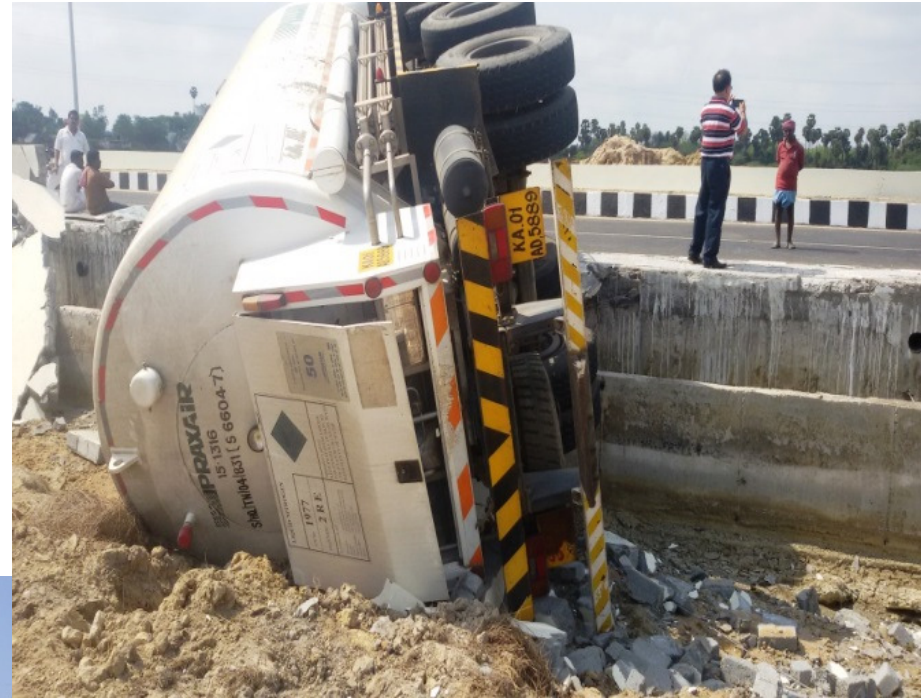
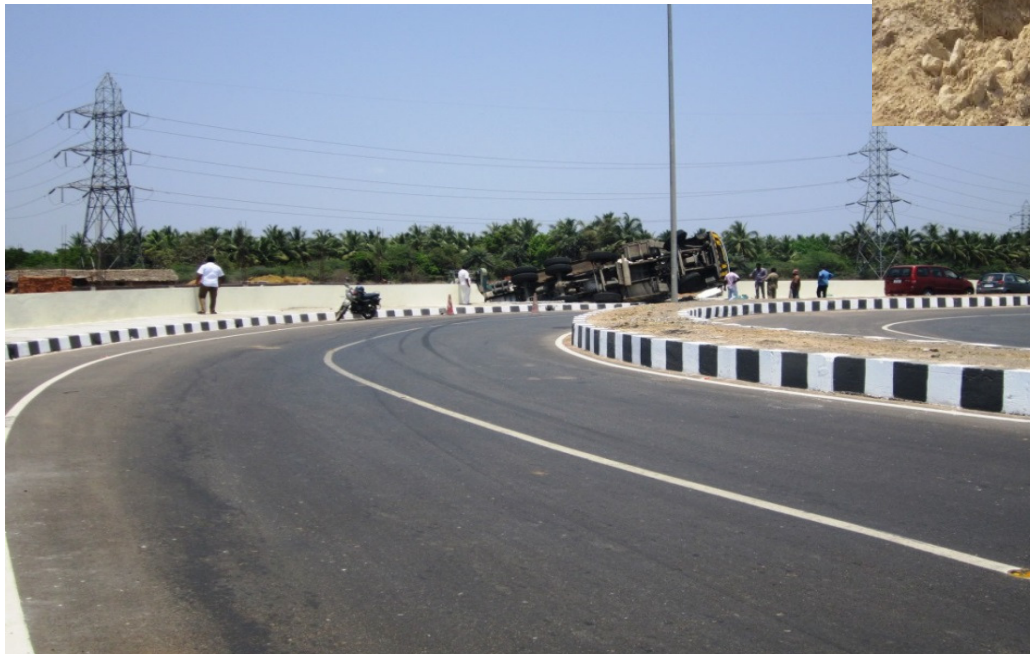
Event # 5

Product vehicle roll over

Contractor owned liquid nitrogen straight truck, rolled over by 90 degrees at approximately 10 kilometers from plant while on its way to a second customer after delivering to the first customer. The truck was carrying a partial load of 9 MT in tanker. The accident happened on a sharp curved section of the road where the driver lost control. No injuries to anyone and no product release.

- Excessive speed in the curve
- Hard braking

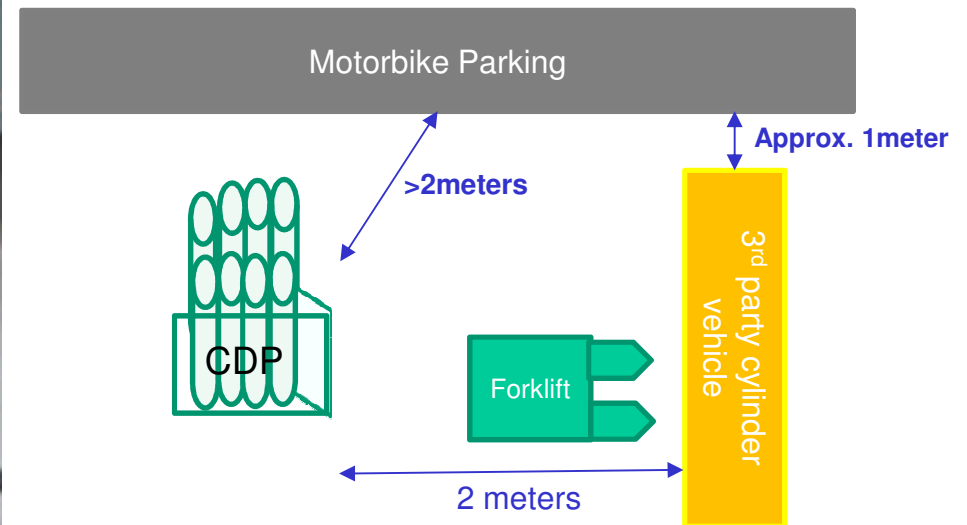
Event #10

Valve shearing off due to Argon cylinder fall

A customer driver removed 6 full Argon cylinders from Cylinder Delivery Pallet (CDP). The cylinders were left free standing next to his truck while waiting for forklift driver to load the cylinders into the truck. While reversing the forklift, he accidentally hit the CDP. As a result, the cylinders in the CDP fell and hit one of the free standing cylinders. The freestanding cylinder's valve sheared off and the cylinder ended underneath the truck with a release of 200bar of product, causing three motorcycles parked within 2 meters vicinity to collapse. There was no damage to the motorcycles and minor damages to the customer truck. No injuries were reported.

- Inadequate compliance with company SOPs and less than adequate risk assessments for unloading/ loading area

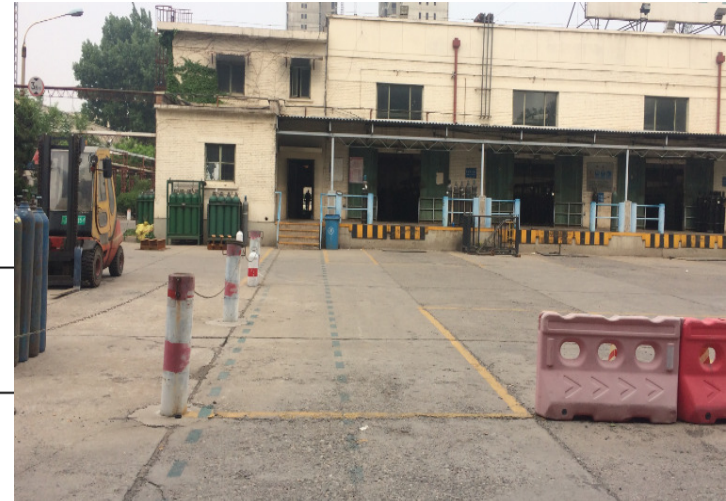
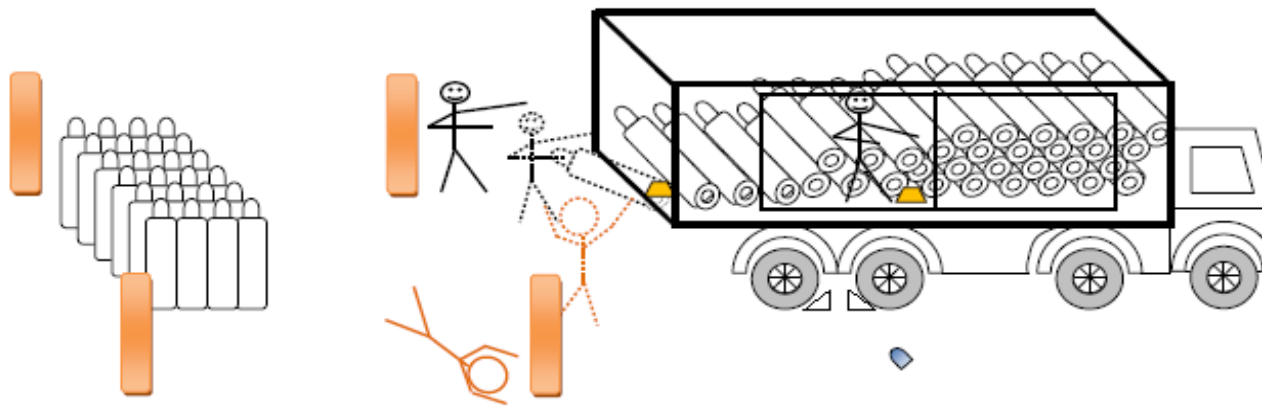
Event #11

Cylinder fall & driver injury

During unloading of empty cylinders from truck to ground, a high pressure Argon cylinder with residual pressure (200 bar) was rolling toward the end of truck compartment floor. Contractor driver attempted to stop the rolling cylinder from falling down the vehicle , failed and panicked leading to tripping and falling on the ground backwards resulting in fracture of the skull and leg. The cylinder fall resulted in the valve shearing off and ejecting the cylinder approximately to 18m away. The ejected cylinder / valve cap did not contact any individual.

- Inadequate procedure / implementation for horizontal cylinder handling
- Unreliable cylinder stopper mechanism
- Inadequate Contractor safety management

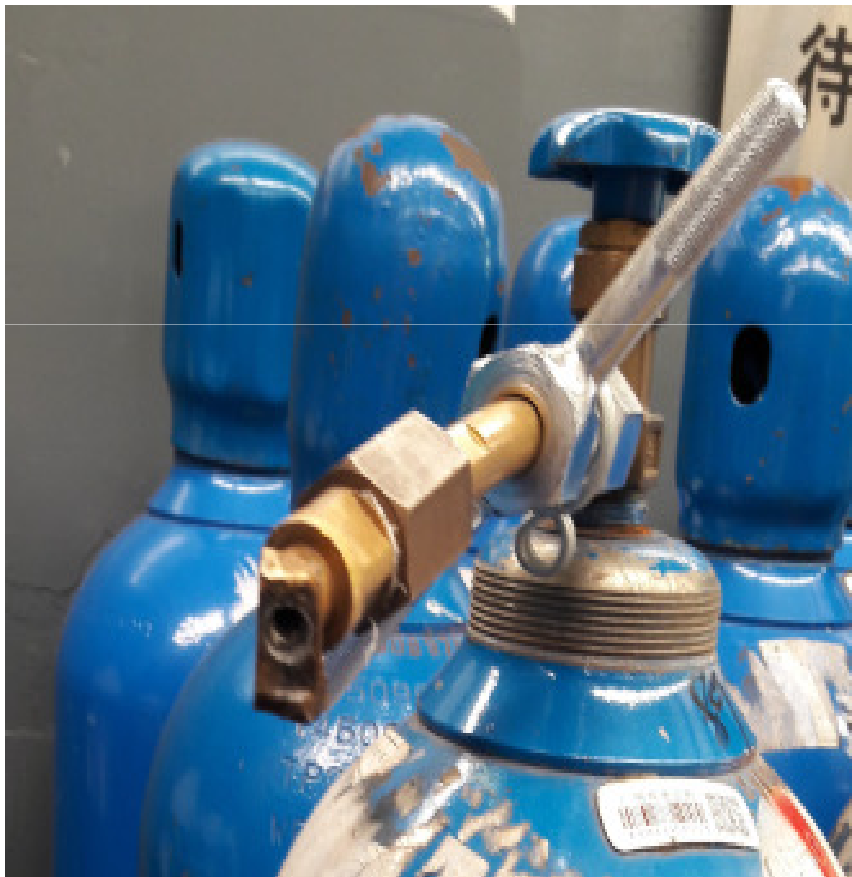
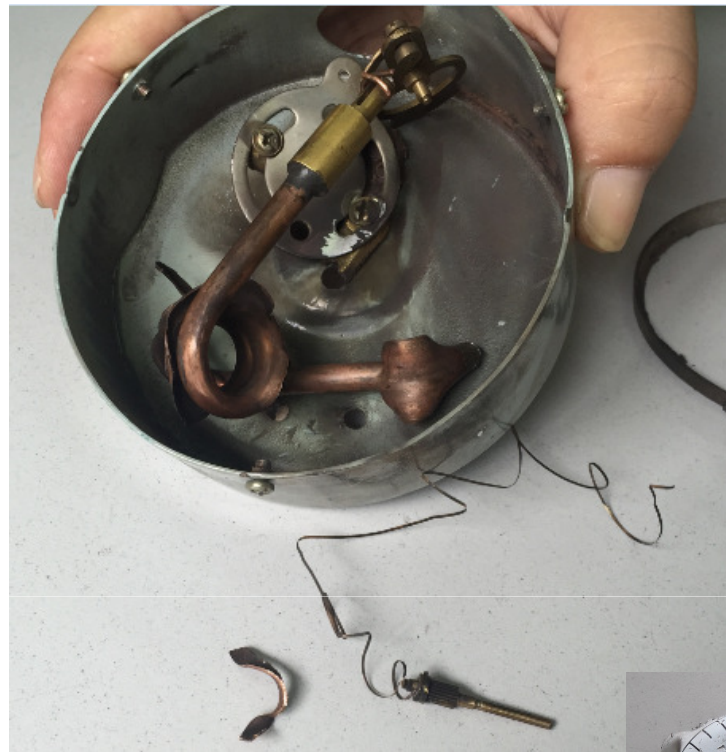
Event #12

Pressure gauge burst during cylinder pressure checking

An operator was injured when doing a pressure checking for medical oxygen cylinder . The incident took place when the operator tightened the screw, and opened cylinder valve slowly. While doing this , the gauge glass shattered injuring the operator on the right side of the chest. The operator was sent to the hospital immediately for treatment. The gauge that was used was not compatible for oxygen service.

- Non oxygen compatible gauge
- Use of portable gauges for pressure checking

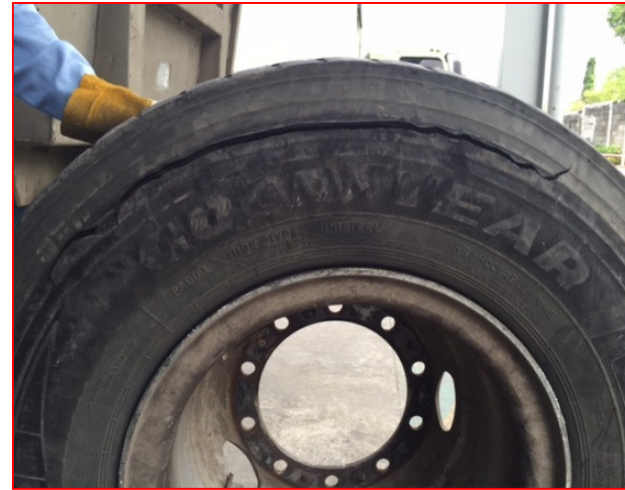
Event #15 Pictures

Tyre burst while inflating after on site repair

During pre-trip inspection of a vehicle, a driver found one flat tyre. The maintenance team dismantled the tyre and decided to fix it on-site. They found the tube flap nipple broken, which was then replaced with a new one. The mechanic squat on the tyre to hold the tyre inflator and his supervisor sat on the tyre to control the pressure then they started inflating the tyre. They hear a “krek” sound when the pressure reached 60 psi, they continued inflating the tyre and suddenly around 70 psi the tyre burst. Mechanic was thrown up and fell with his forehead touching the ground first, and his helmet got detached. He was injured on his fore head and lips (got 12 stitches), and his supervisor thrown to the side but not injured.

- Driver decided to run the vehicle with flat tire for long time the day before
- Mechanic's initiative to repair tire on-site
- Wrong method & tools to perform the task

Injury - forehead & lips
Contractor mechanic has been “ejected”
by the explosion.

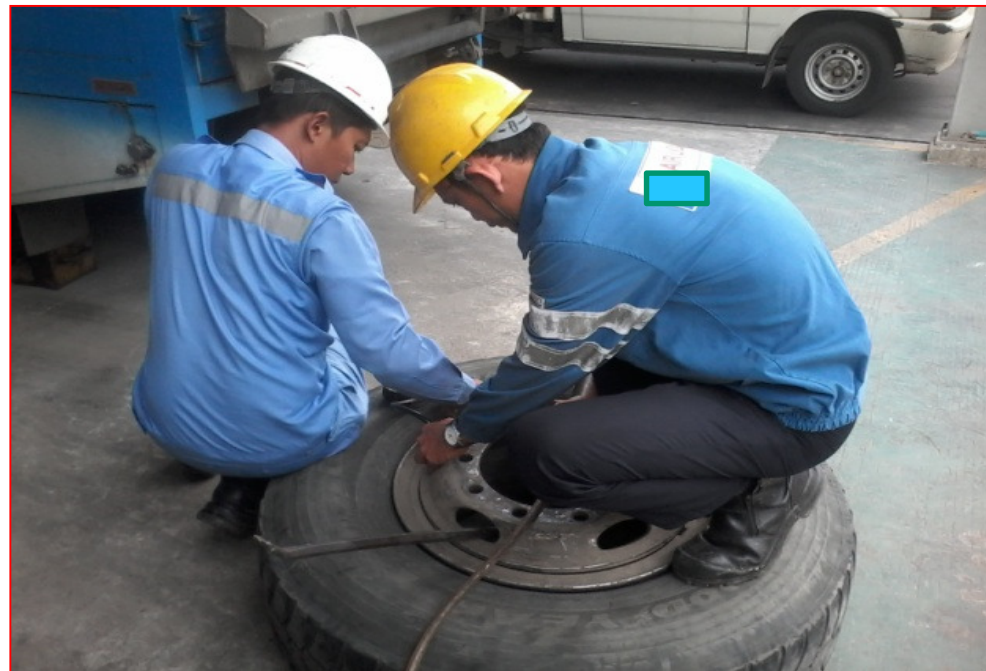
Truck's tyre burst after repair, while inflating

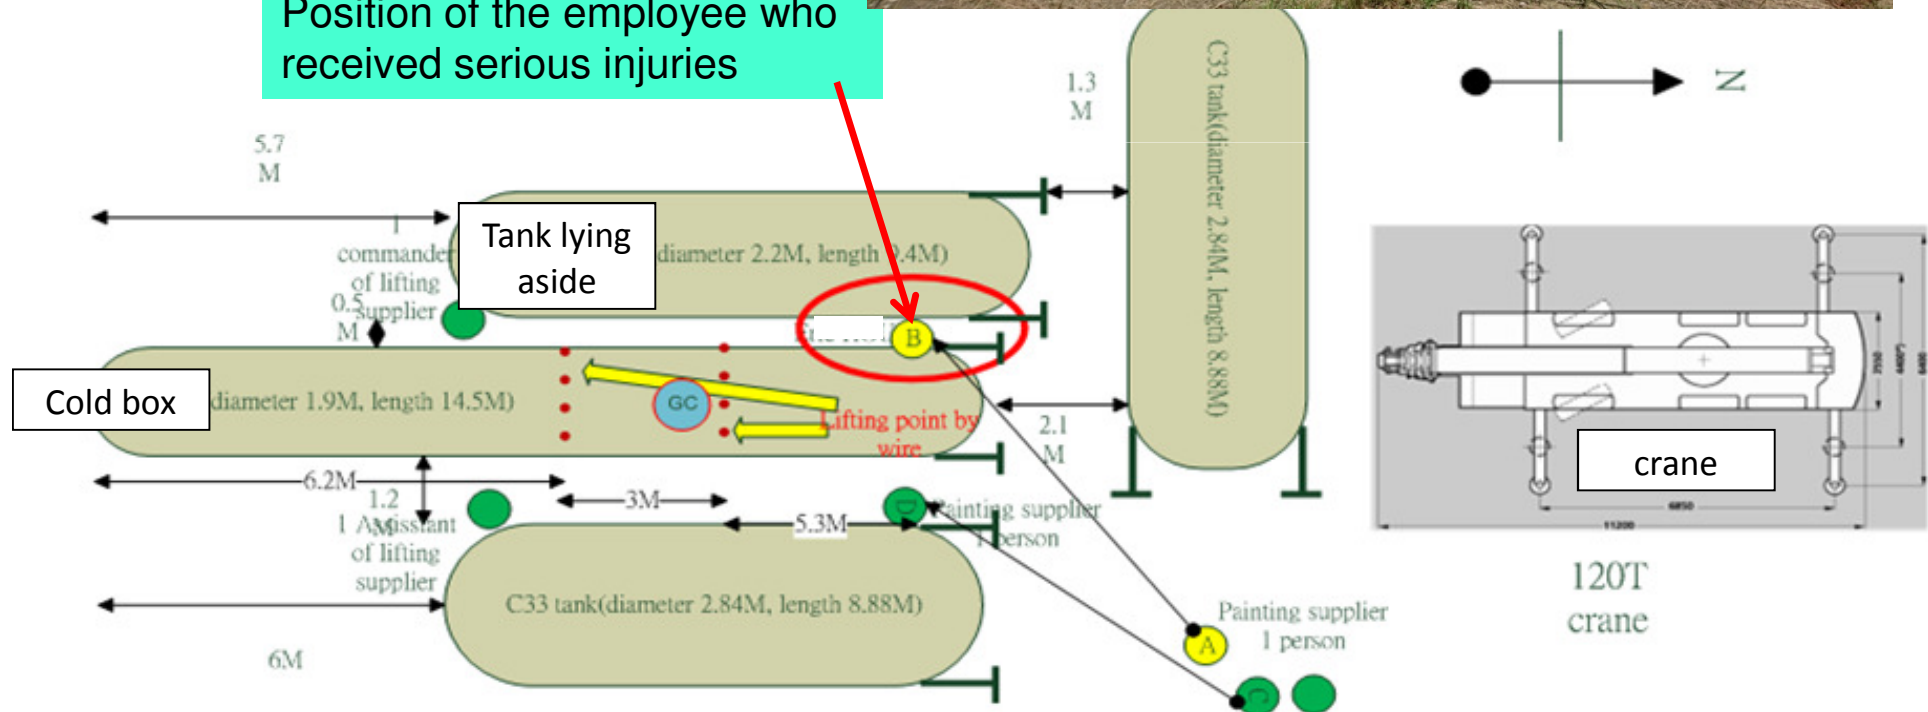
Position of the employee who received serious injuries

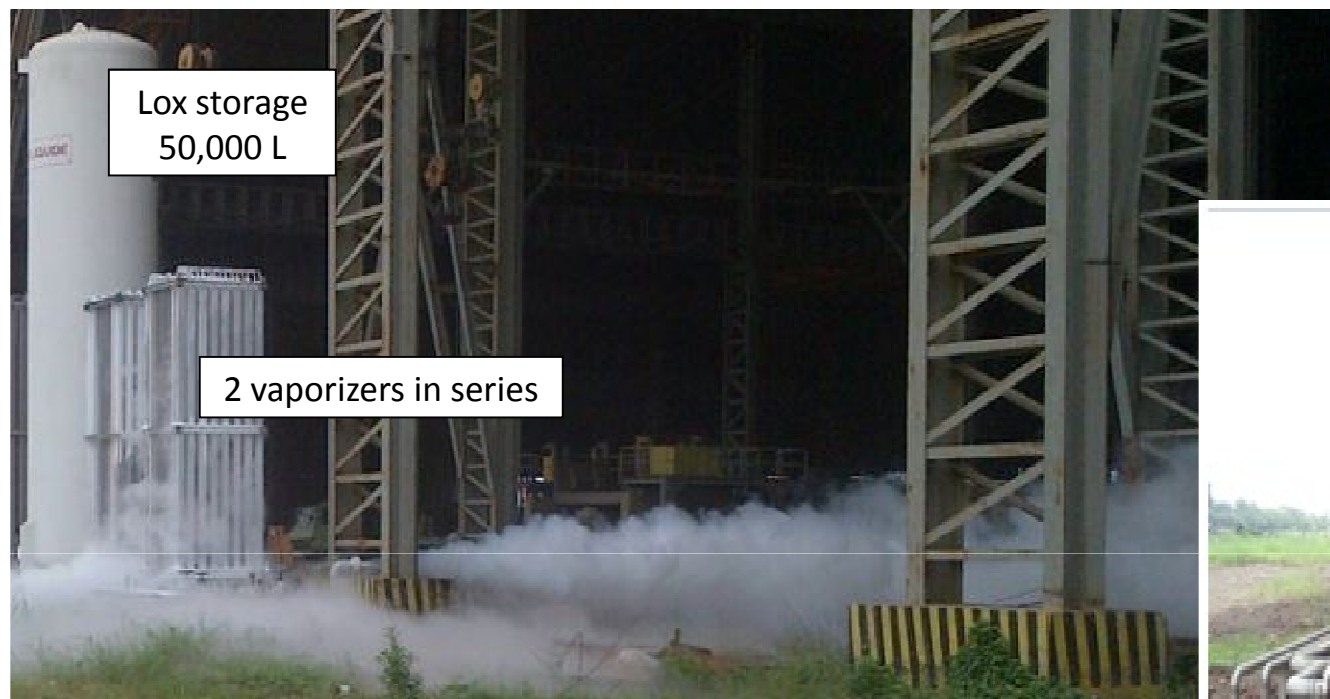
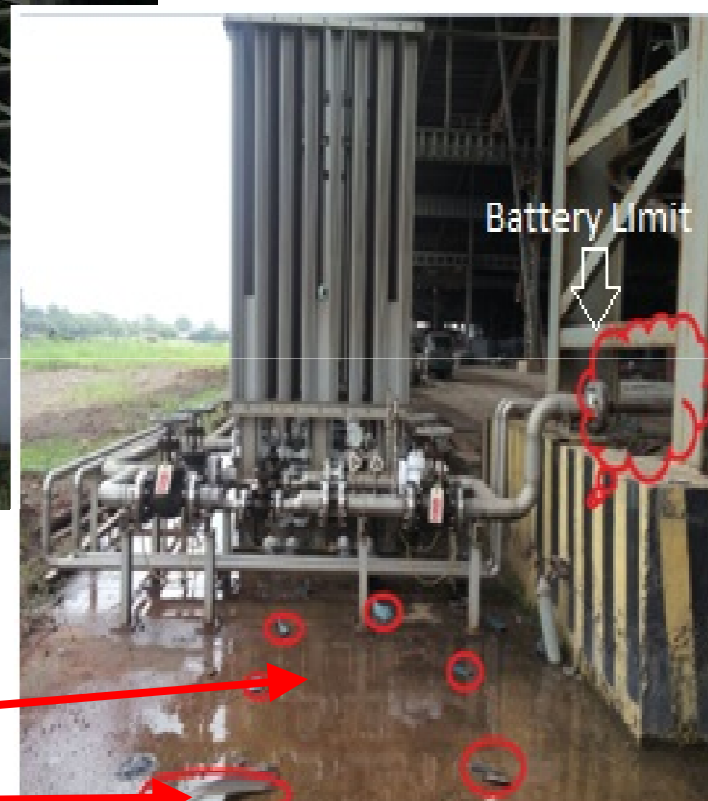
Event #18 Pictures

GOX Pipe line breakage due to Cold Embrittlement (CE)

Low temperature alarm downstream of Lox vaporisers got activated at around 8:00 am at a customer Installation which was not noticed/ignored. Temperature of oxygen gas continued to drop and at around 10:30 am cold embrittlement incident happened, this led to bursting of customer's carbon steel pipe (*20m long x 4" diameter*), interruption of customer's oxygen supply and release of liquid & gaseous O₂ for 10 min. Nobody was injured.

- Protection design : Insufficient CE protection (only alarm, no shut-off valve)
- Sudden increase of customer's consumption beyond vaporization design capacity
- Previous alarm (3 days prior) not properly escalated to HSE & management

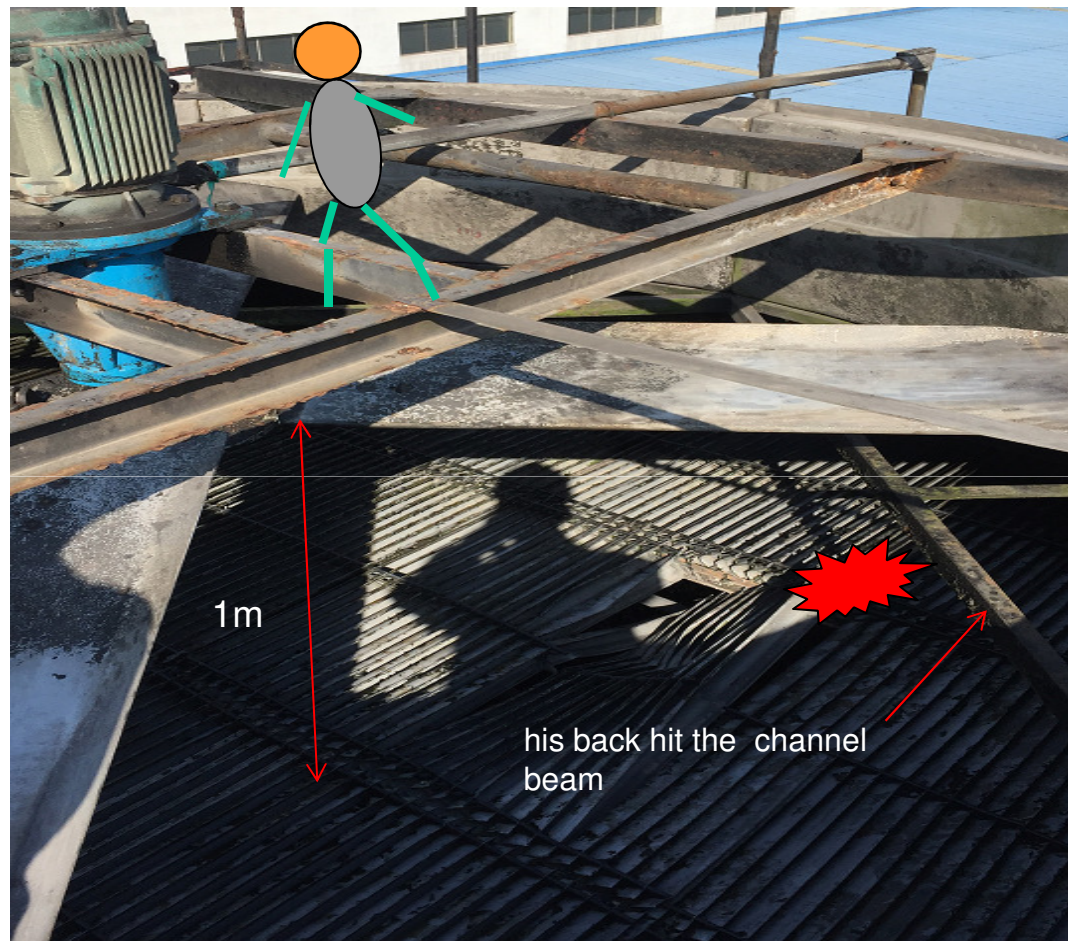
Event #20

Fall accident during maintenance work at height

Around 8:00 am, a maintenance team had finished the repair work on a transmission of a cooling tower fan. While climbing down, one worker slipped on the steel frame which is supporting the fan and fell down (height around 1 meter). His back knocked on the girder and caused a fracture of back rib.

- Lack of fall protection
- The mechanic's unsafe behavior
