Training Package TP 12/12

Recent Incidents in the Gases Industry in Asia

Asia Industrial Gases Association

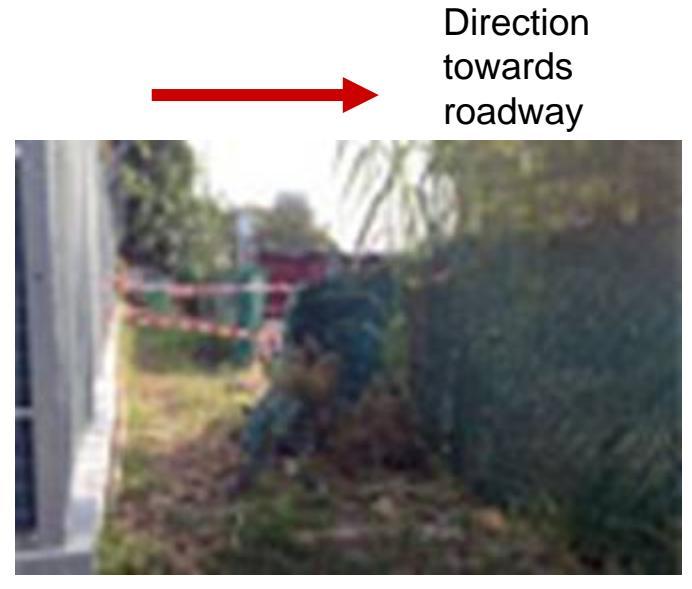
- On Sunday morning, there was apparently a sudden release of CO2 gas from the cylinder and it was ejected from the lorry onto the main road outside the premises.
- It hit and pierced through the side of a passing by double- decker bus and caused a glass window to break. A passenger on board suffered cuts from the glass splinters.

Cylinder shot through the fencing onto the road

The cylinder valve was found broken. A rupture disk failure could have resulted in a quick release of CO2 that caused the cylinder to take off like a projectile.

- Cylinder was heated under the sun.
- Cylinder was not properly secured on the lorry bed.
- [In some other cases that occurred in the past, safety device (rupture disk) was altered].

- That CO2 cylinders are always secured in a truck during storage or transfer.
- Valve caps are installed (fixed or removable). (The use of valve cap is recommended to prevent valve shredding).
- Repture disks are in good shape
- Cylinders are at temperatures below 52 deg C

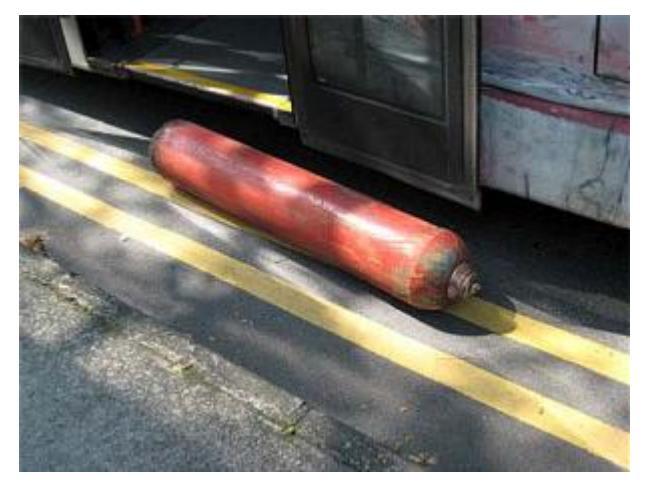
Cylinder lying besides the bus

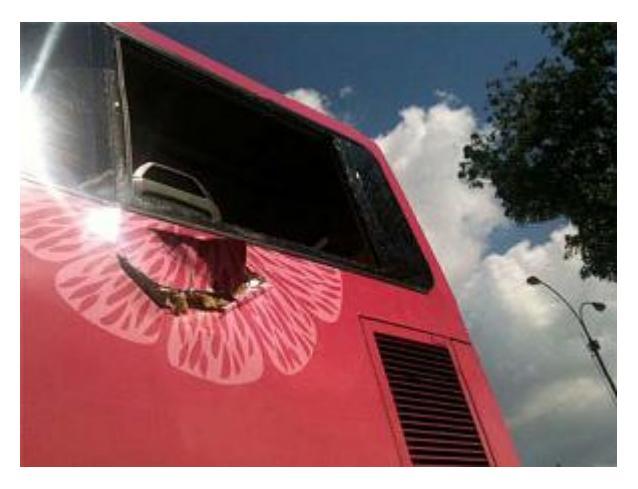
Point where it hit the bus

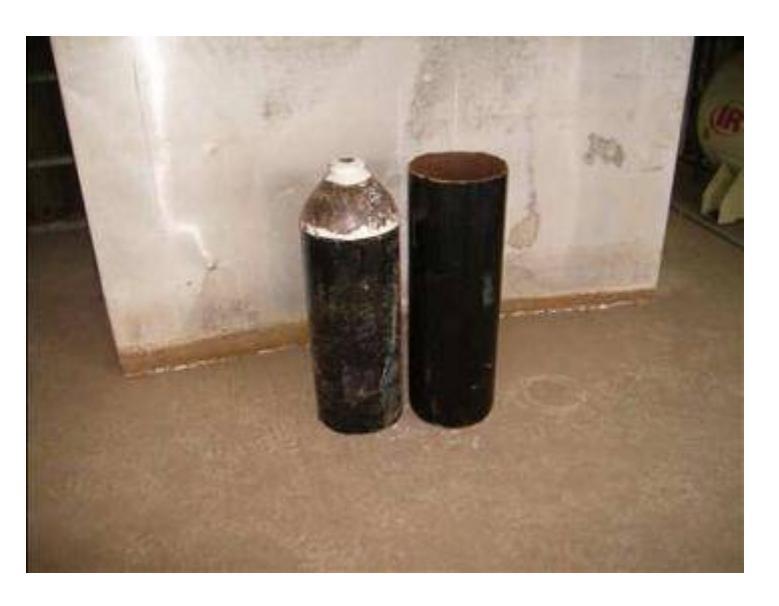
A customer-owned medical oxygen cylinder supposedly to be a DOT 3AA type with a 2015 psi (137 bars) working pressure split into two sections at the mid-point during a hydrostatic test.

It was found that the cylinder was a 'disguised' cylinder with a new top section welded onto the bottom section.

Cylinder split into 2 sections

- Sharing of incident with test shop staff
- Reiterate the need for critical pre-fill inspection
- Contact the owner to communicate the risk of such modification
- Work with authorities to stop such modifications

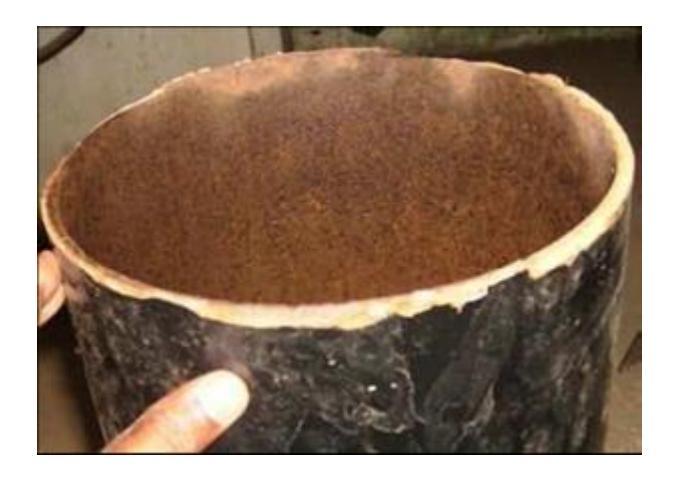
The bottom section of the cylinder showed severe signs of corrosion when compared to the top section.

- Unauthorised modification of the original cylinder by a third party. Such practices have been found in the particular country due to poor regulatory controls.
- A less than adequate visual inspection of the cylinder was done before passing onto hydro testing. Cylinder inspection procedures to check cylinder valve and body are critical.
 - To perform a good inspection, paint layers in the cylinder shall be minimum.

Lower half showing severe corrosion and bevelled edge

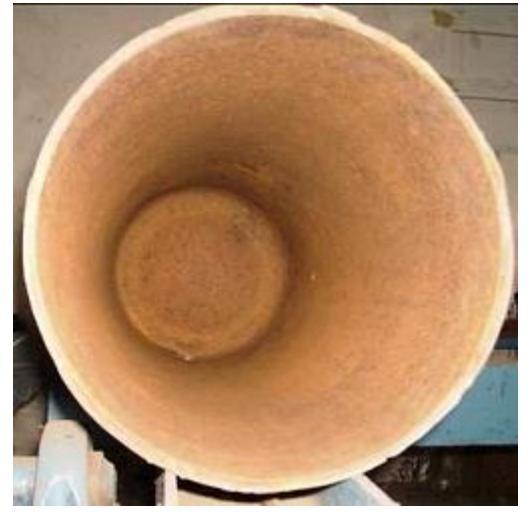
Top half showing less corrosion

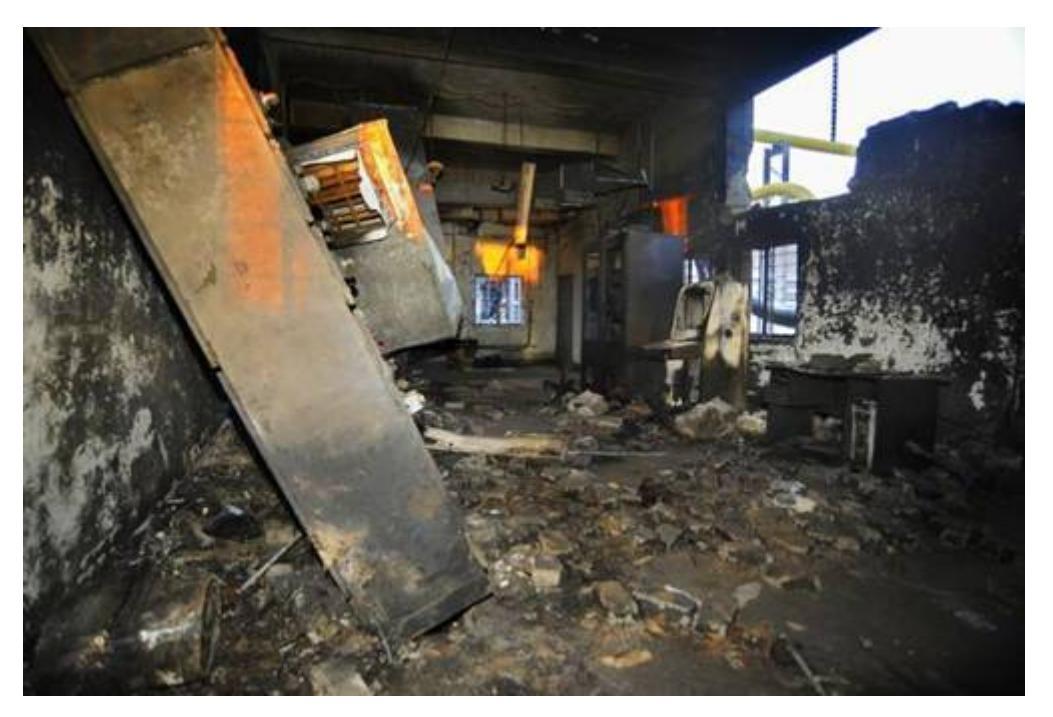
Fire and explosion broke out at a pressure reducing station on a new large oxygen supply pipeline at a steel mill during commissioning.

There were a large number of people (reported to be about 50) gathered at the control room at the time. The fire destroyed the control room and 19 people died from burns.

Picture shows damaged control room for pressure reducing station

- A partial blockage at the pressure reducing station (PRS) was indicated by inadequate flow of oxygen downstream of the station prior to the fire and explosion. Breakage of the filter element was found due to the high pressure drop across the filter.
- Trapped particles found in the filter at the PRS (after the fire) showed that particle impingement on the steel pipeline in the filter area could have occurred and resulted in ignition.
- Design practices to prevent excess oxygen velocity might not be properly followed.
- The presence of a large number of people which included those not associated with the operation of the PRS resulted in the high number of fatalities when the fire occurred.

- It would appear that there was inadequate preparation of the pipeline system for oxygen service.
- The operational problem/s that arose during commissioning was not addressed correctly.
- Too many non-operation staff had gathered on site at the Pressure Reducing Station (PRS) without recognising the potential catastrophe that could occur at the PRS.
- Strict application of standard in design and operation of oxygen system should be followed.

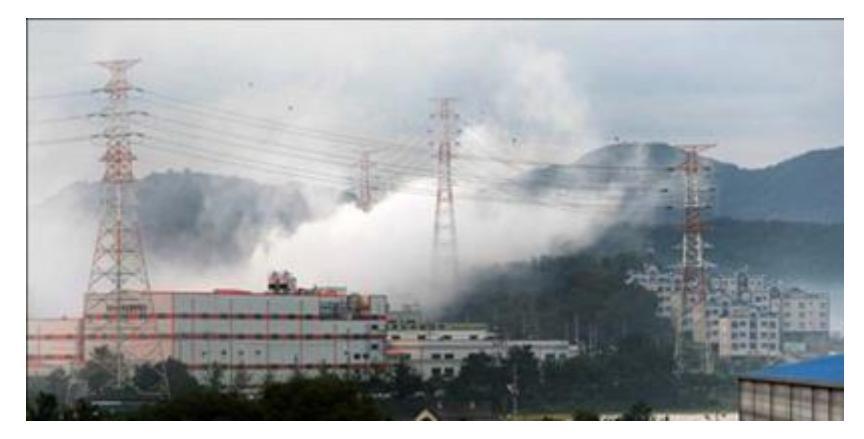
HF fumes seen from a distance

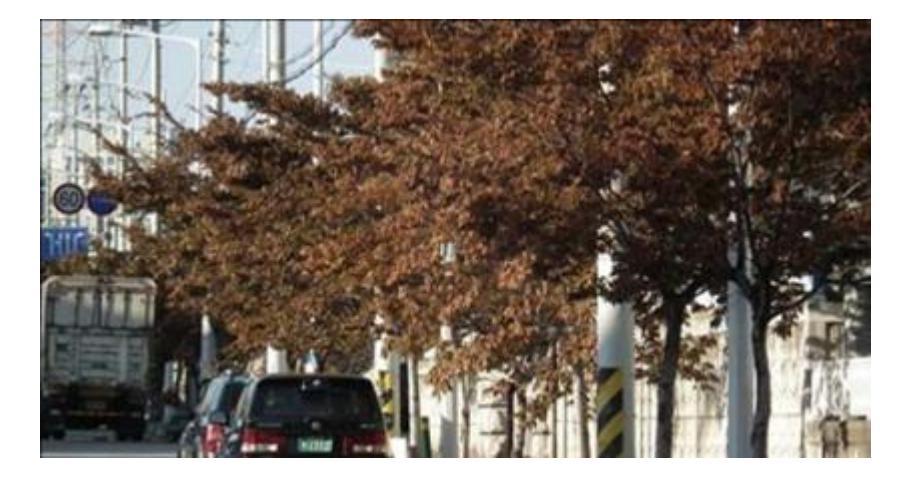
Trees turned brown by the HF fumes in the nearby area

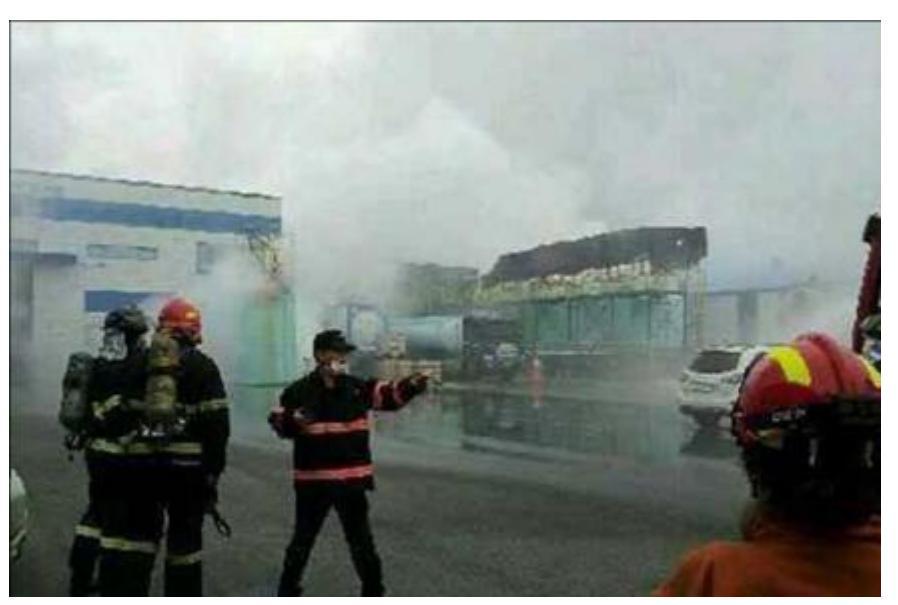
Fire department responders at the scene
