Training Package TP 08/11

Recent Incidents in the Gases Industry in Asia

Asia Industrial Gases Association

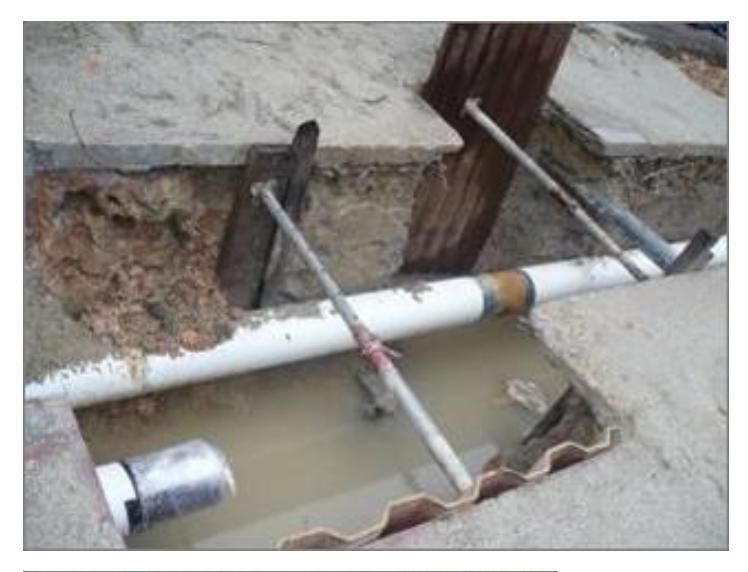
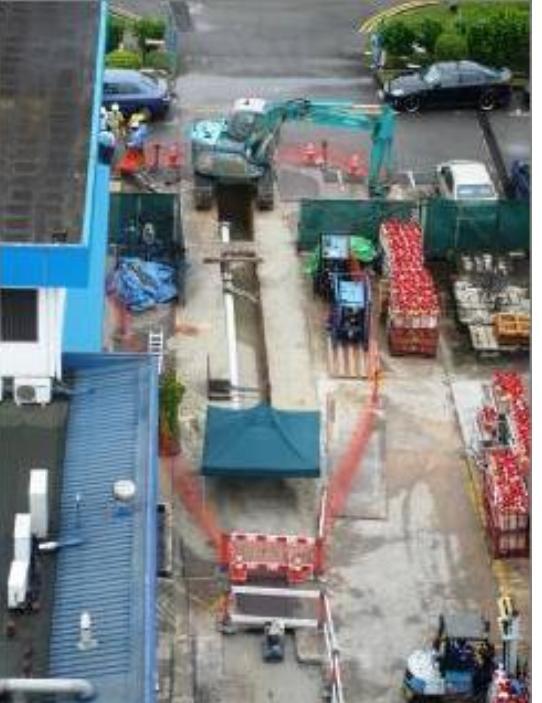
N2 pipeline cap and O2 pipeline

Pipeline and blank cap

The blank cap used to blind off the open-end of the pipeline uses a compressed rubber ring fitting design that is supposed to hold a pressure of up to 3 bar(g).

When the incident occurred the N2 pressure had probably risen to 7 bar (g) due to a malfunction of the pressure regulator used to regulate the pressure from the source.

• Blank cap design pressure exceeded

The blank cap used to seal off the open-end of the pipeline under construction was specified as *'to be able to hold a pressure of 3 bar'*. The pressure in the line was supposed to be maintained at 1 bar(g) Failure probably occurred when the pressure reached 7 bar (g).

No pressure relief protection was installed to prevent the pipeline from exceeding the intended pressure.

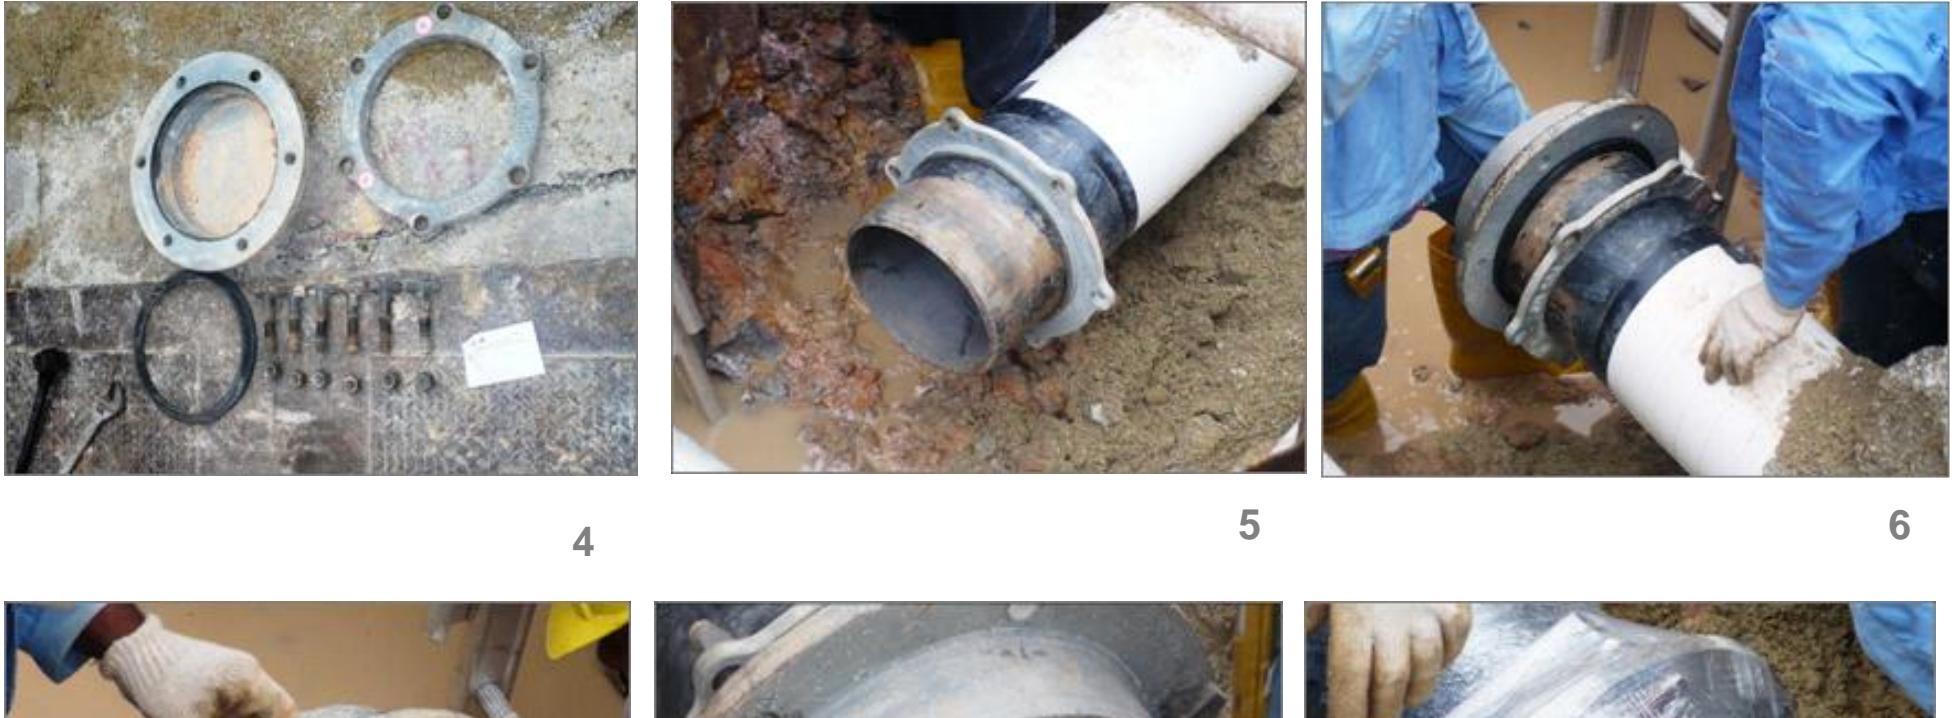
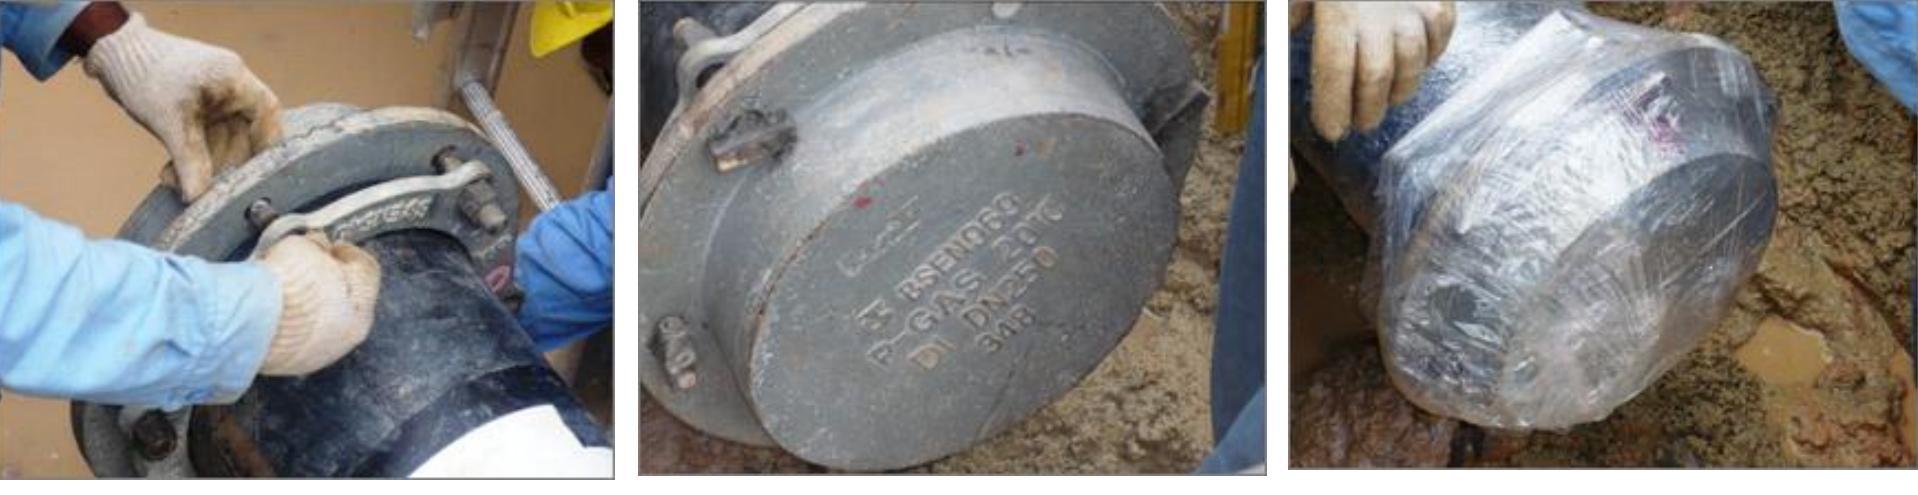
Pipeline Cap and Assembling Process

Note: Pictures taken after the accident

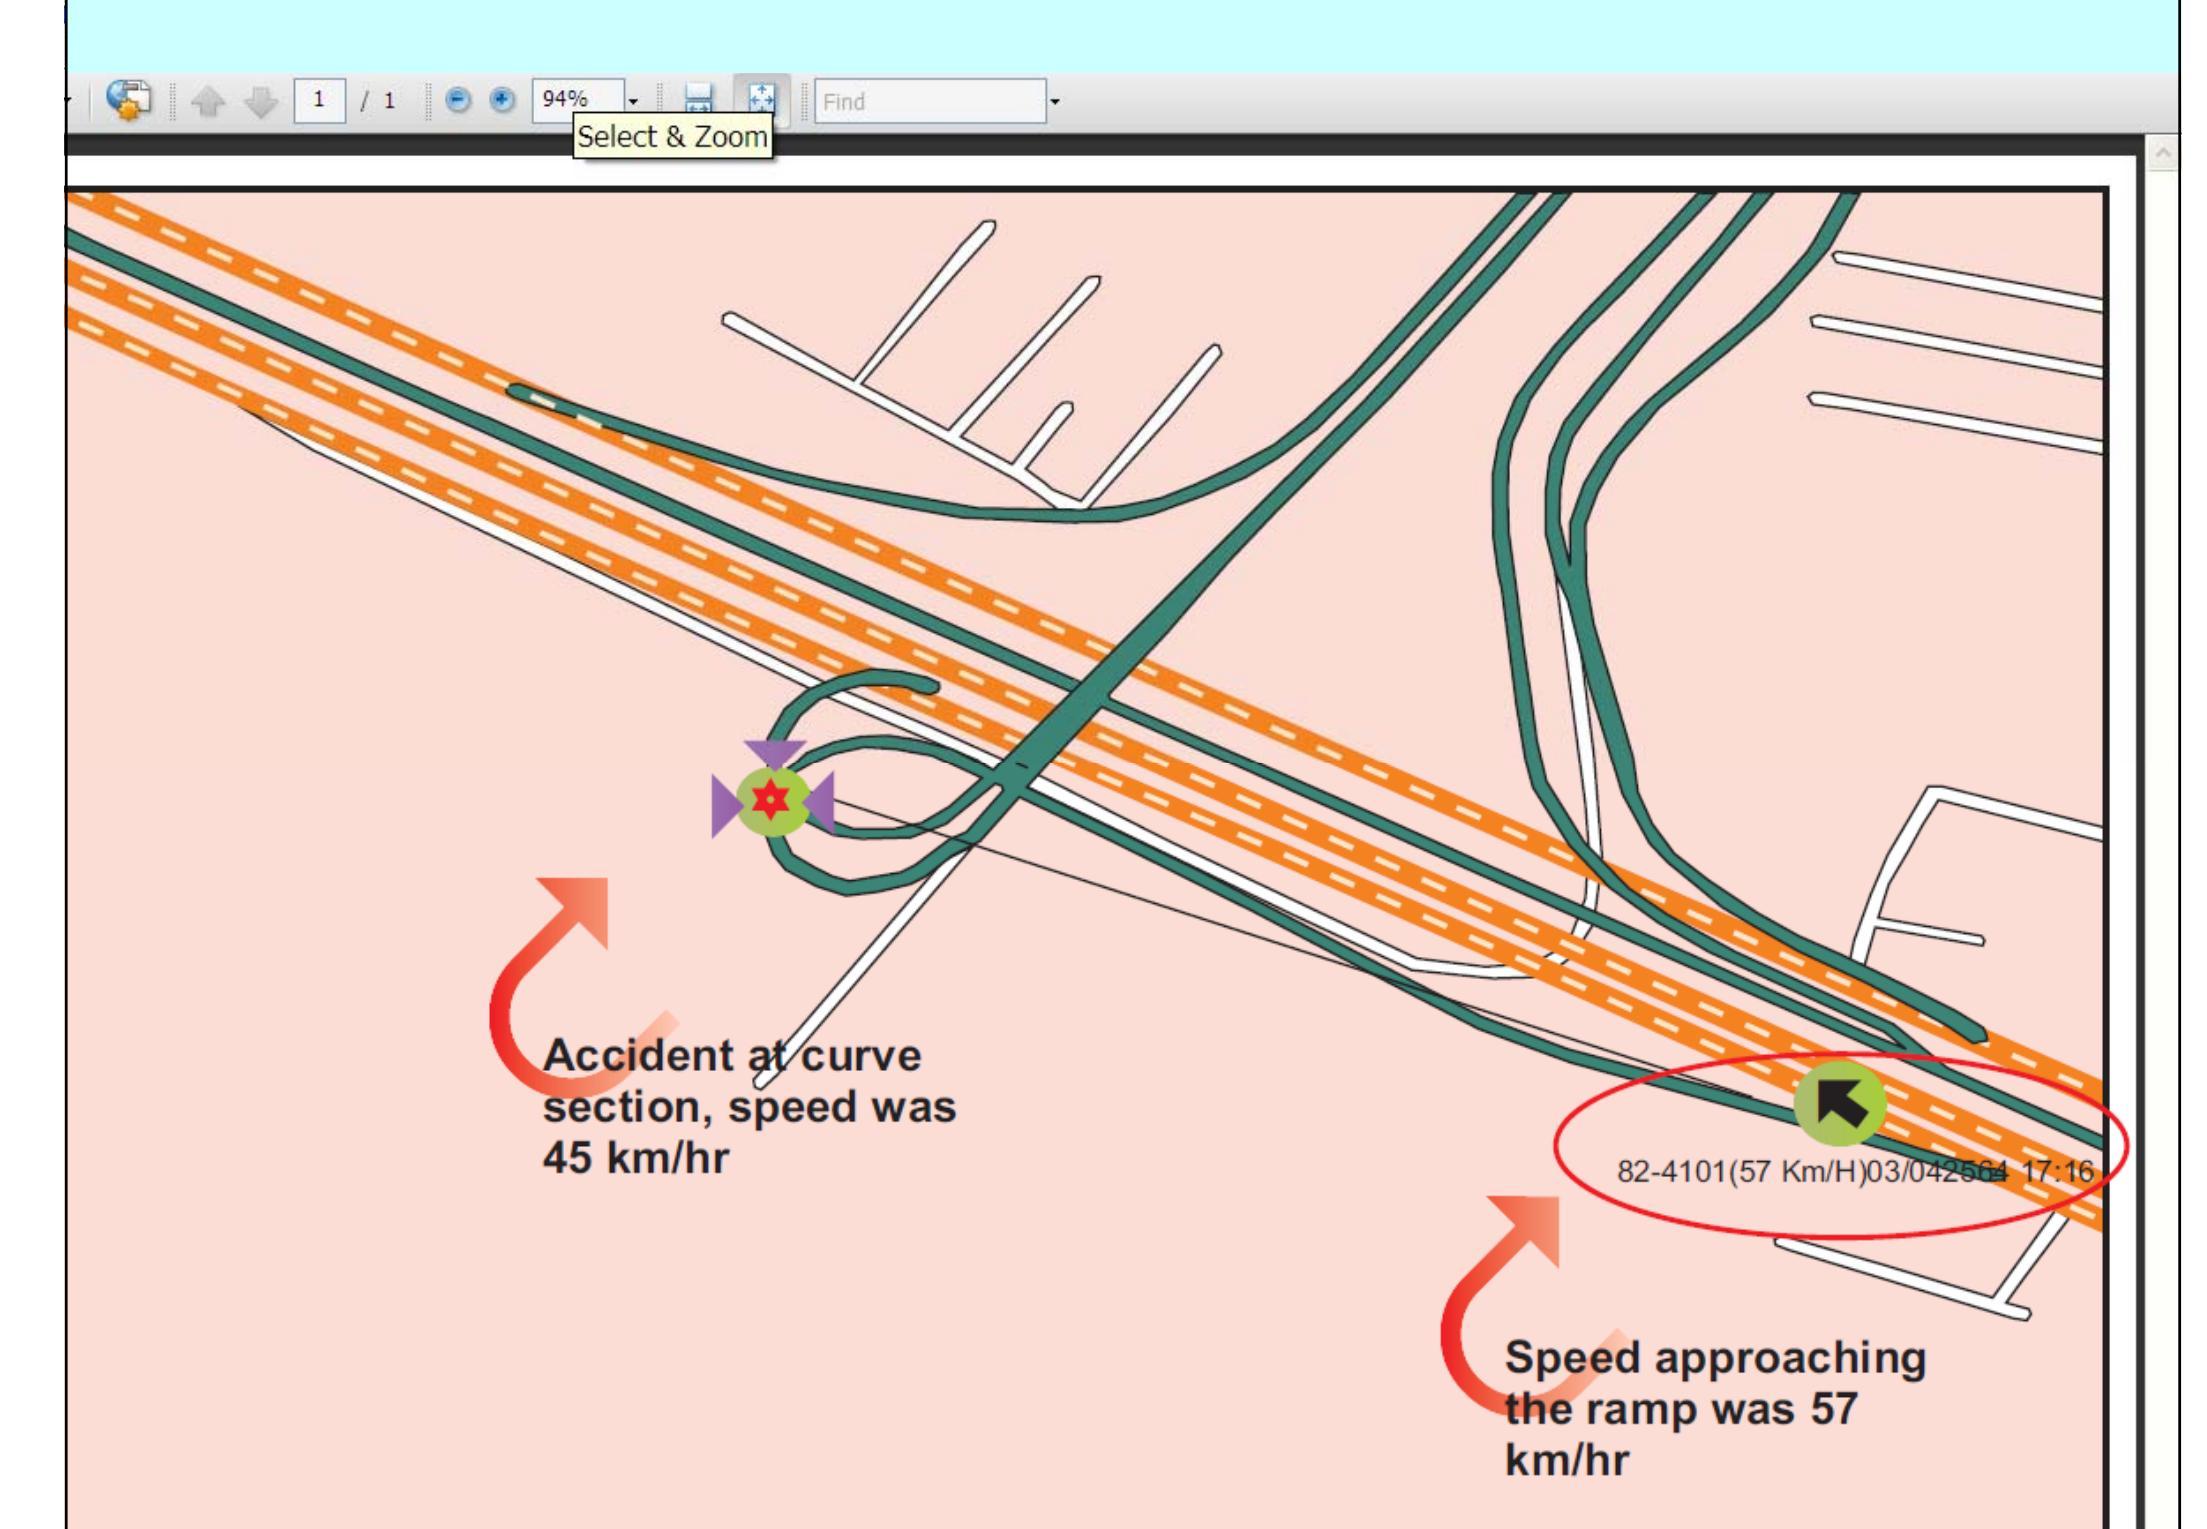
- A fully loaded liquid CO2 tank-trailer was on its way to deliver the product to the customer at around 5 pm on a Sunday. Traffic condition was light. The vehicle had approached the entrant ramp to an elevated road intersection at a speed of 57km/hr (as recorded by the GPS Black Box). At the curve section of the slip road to the ramp the speed was recorded as 45 km/hr. The driver suddenly lost control of the vehicle and the tank trailer rolled over and hit the roadside guard.

- Due to the impact, some portion of polyurethane insulation foam on the tank broke out and pushed against a gas valve handle (quick opening type valve). The valve was thus opened and resulted in some LCO2 release.

- Total liquid CO2 release around 3 tons.
- Estimated repair cost to tanker US\$ 42,000.

- Incident details are shared with drivers to highlight the data on the actual speeds in the incident and the speed limit which should be adhered to when negotiating a road curve.
- Drivers are reminded to keep to safe speed limit even when traffic condition is light and not to be over confident.
- Company to re-emphasize training for all drivers on the causes of rollover and the driving techniques to prevent it.
- Use of quick opening valves on liquid CO2 tanks should be reviewed as they tend to be opened when there is an impact on the handles in an accident.
- Useful link on rollover prevention:
