TAP WATER CORROSION OF COMPOSITES WITH AA 6061 LINERS

AIGA 073/13

Asia Industrial Gases Association

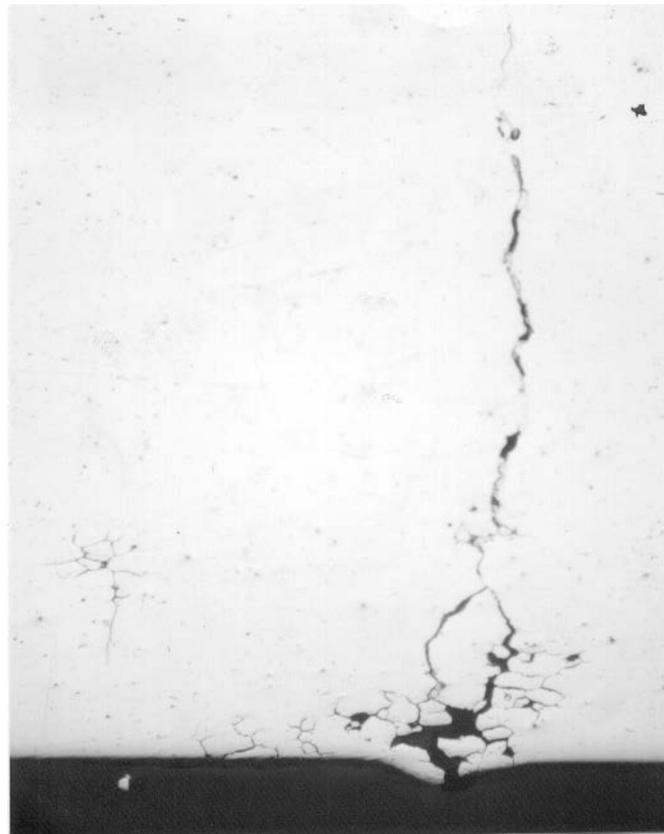
Figure 1 – HW Cylinders (AA 6061)
Fatigue crack initiated from a corrosion pit.
Magnification X 125

It is clear that a mechanism related to corrosion is in progress. Clear signs of intergranular corrosion were visible at the crack initiation sites for failed cylinders which have been metallographically examined, see Fig 1.

This would indicate that the intergranular corrosion created by the contaminants contained in the tap water introduced local stress raisers which led to premature cyclic loading failures. This intergranular corrosion promotes very high stresses during test pressure cyclic testing which effectively reduced the fatigue initiation process that usually provides the majority of the cycle life for aluminium alloys. The above can be explained by the following:-

- a) Residual chemicals, notably the chloride content, in the tap water, have created some pre-existing corrosion related defects due to the alloy's susceptibility, albeit small, to intergranular corrosion.
- b) The very much thinner wall thickness in a H-W composite AA6061 cylinder, compared to its seamless counterpart, means that the stress takes a lot less time to propagate the cracks to failure which have been initiated in a).

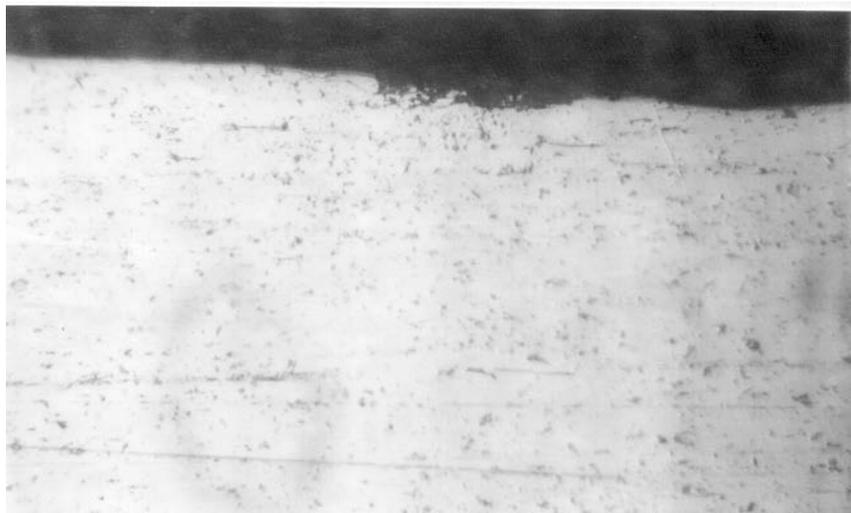
Figure 2 - AA 7060 Cylinder
Metallographic examination according to the intercrystalline test as per EN 1975.
Magnification X 300

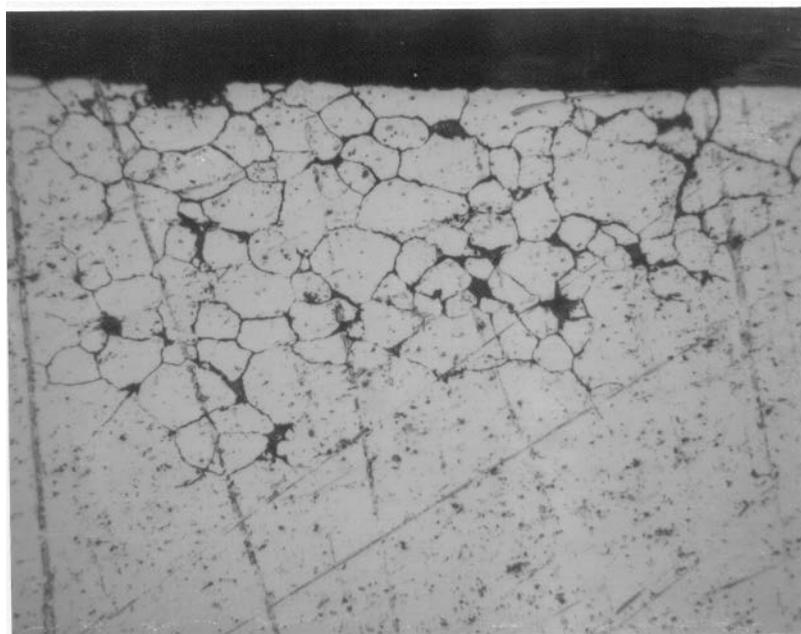
Figure 3 - HW AA 6061 Cylinder
Metallographic examination according to the intercrystalline test as per EN 1975.
Magnification X 300

cylinders of capacity from 0,5 litre up to 150 litre [4] and ISO 7866 Gas cylinders -- Refillable seamless aluminium alloy gas cylinders -- Design, construction and testing [5] standards dealing with seamless aluminium alloy cylinders, is a series of tests to check for an alloy's susceptibility to intercrystalline corrosion.
