ACETYLENE GAS SAFETY SEMINAR 2009

Acetylene Incidents

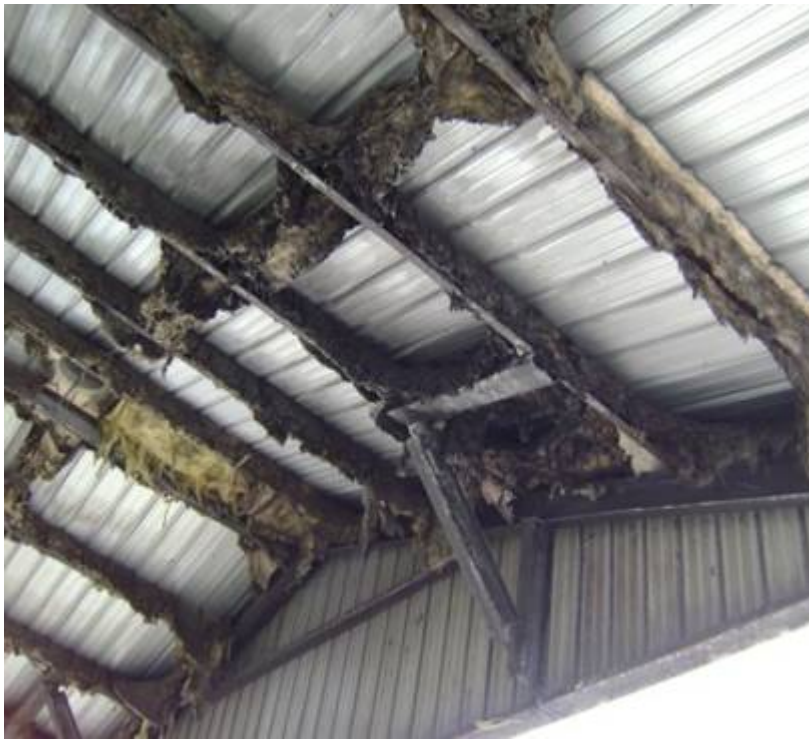
Acetylene Fire - Damage

- On 10.03.08, fillers were venting acetylene cylinders to atmosphere, not using the vent manifold, when an ignition occurred
- The fire quickly spread to other acetylene cylinders in the area
- The fillers unsuccessfully attempted to extinguish the fire
- The flammable filling operations were shut down and the facility evacuated
- The local fire department was called and extinguished the fire

- Minimal damage to the building in the area that the venting occurred
- One employee received a 1st degree burn to his face, a strained leg muscle and minor lacerations to the leg. He was treated and released from the local hospital
- Loss of 406 cylinders - \$35000(USD)
- Lost Revenue \$62000(USD)
- Actual or Potential Litigation / Prosecution Matters

Building damaged

- ✓ **Flammable Atmosphere was created by acetylene cylinders venting directly to atmosphere**
- ✓ **Ignition Source not determined**
- ✓ **Employees attempted to fight fire exposing themselves to excessive heat**

- ✓ **There was a backlog of cylinders to be vented as a result of an increase in reject rate in the 2 weeks prior to the incident that was not identified**
- ✓ **Site Emergency Action Plan instructs employees to fight small fires if possible but does not define small**
- ✓ **No fire protection system covered the area**

- **Employees vented cylinders to atmosphere in violation of Company policy**
- **Employees attempted to control fire instead of following emergency fire protocol**

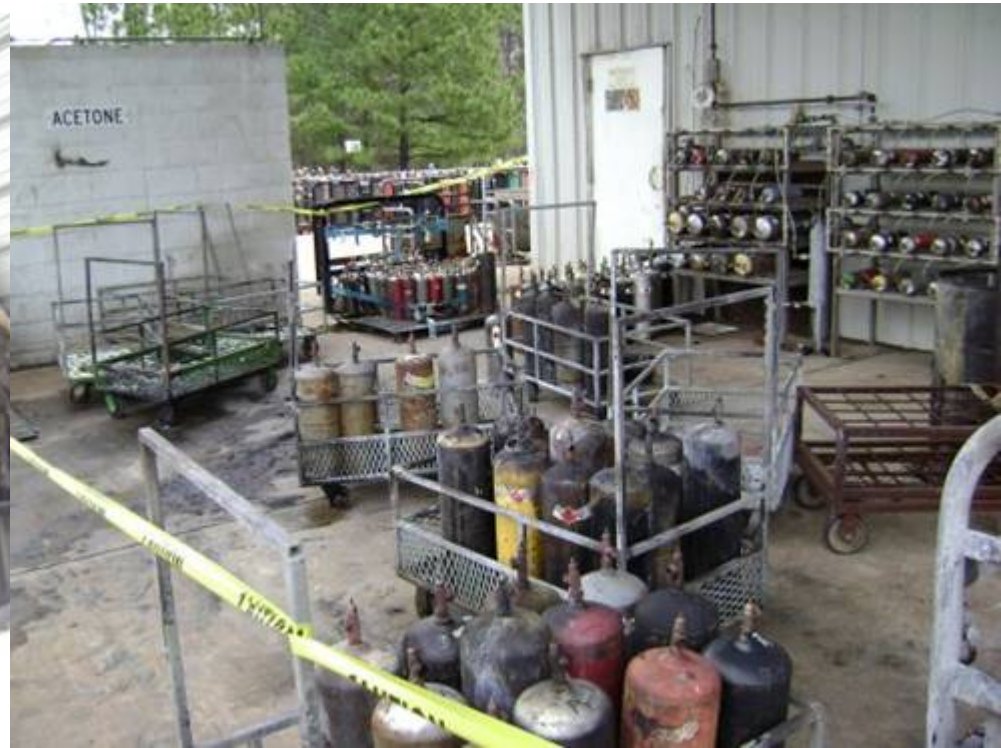
Cylinders damaged in fire

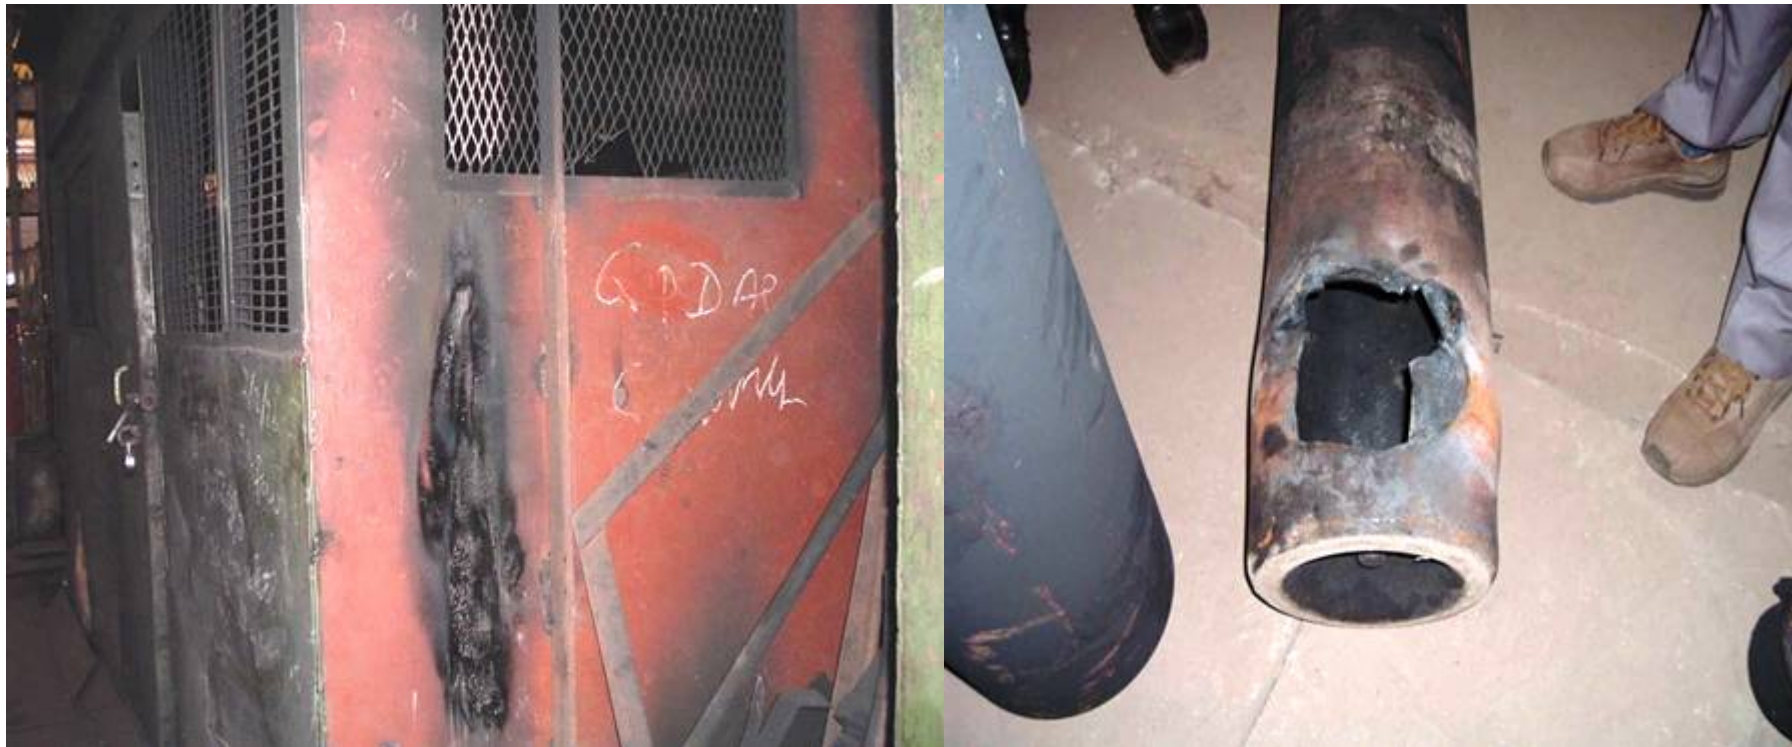
Cylinder Fire & Explosion - Damage

- Three DA cylinders were kept inside a steel cubicle located in the middle of a railway workshop.
- The customer's employees noticed smoke and fire in the cubicle and withdrew to a safe distance.
- The fire continued for about 20 minutes, at which point some employees approached the cubicle.
- One person knocked one of the cylinders over on to the ground and it exploded, killing him.
- Five men suffered burn injuries and two of them later died in the hospital.

Steel Cubicle

- **Hot acetylene cylinders can spontaneously explode. Do not approach, move or knock them.**
- **People who handle acetylene cylinders must be fully informed of and understand hot cylinder procedures.**

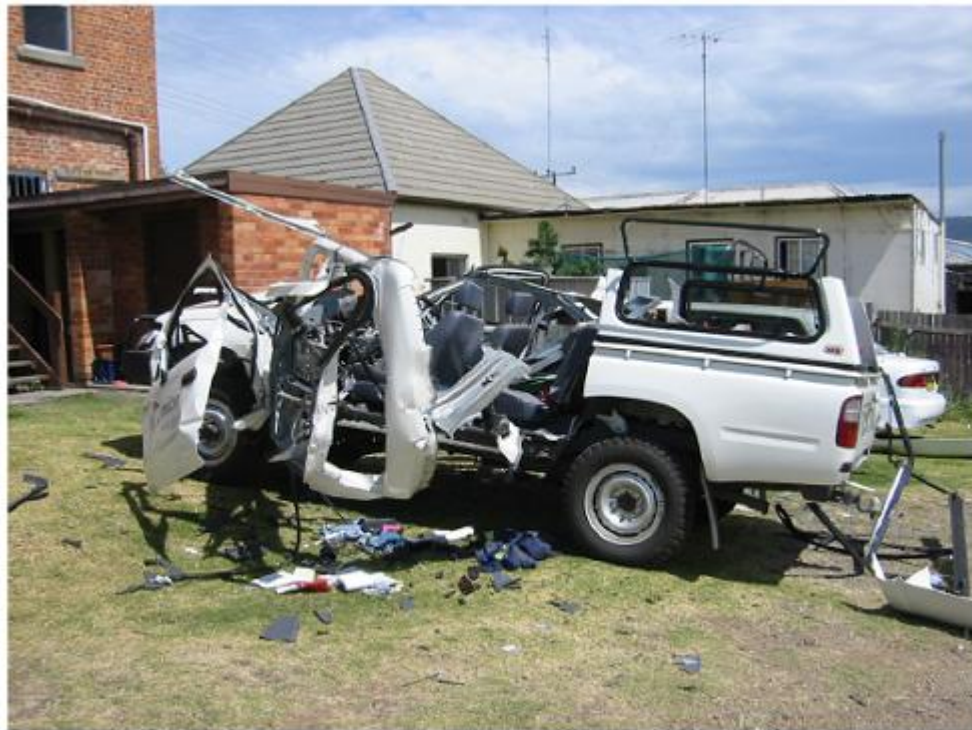
- A fitter with a work van left a DA cylinder on the back seat of Toyota dual cab over the week end.
- Acetylene cylinder valve was not fully closed and a leak occurred.
- Acetylene accumulated in the van.
- On Monday morning, as soon as the fitter opened the door, a large explosion took place.
- Ignition may have been caused by either:
 - internal light circulatory
 - automatic door control
 - mobile phone which was on the front seat
 - lighting a cigarette. The fitter was a smoker.

Cab badly damaged

- The fitter has damage to his ear drums & injuries on the face.
- The cab was badly damaged

- Never store cylinders in an enclosed vehicle or area

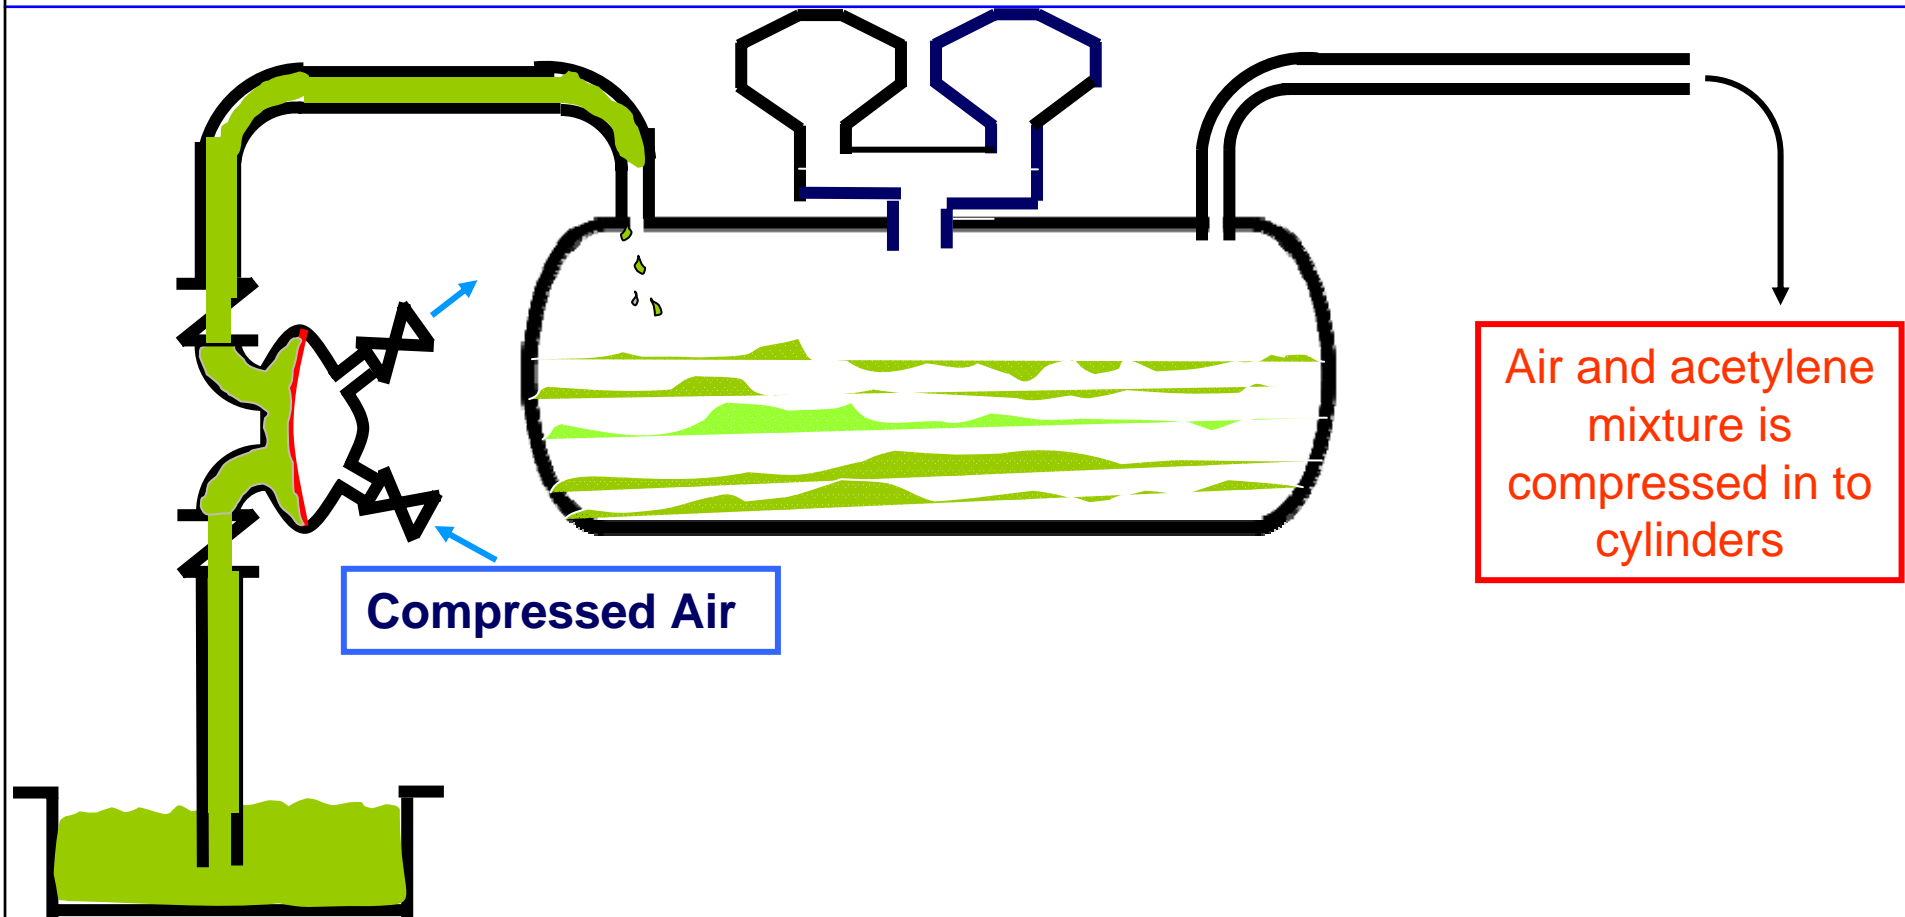
Air Acetylene Mixture

- An air driven diaphragm pump on the generator water system failed, resulting in the ingress of air
- The air got filled into several racks of DA cylinders resulting in a mixture of 80/20% acetylene/air
 - ✓ Some of the cylinders were dispatched to customers

- **Management of change procedures**
 - Experience of local engineering & management staff
 - Incorrect design of pump selected
 - HAZOP and risk assessment
 - Review of design by competent persons
- **Staff knowledge of plant, processes and operations**
 - Diagnostic skills
 - Acetylene purity testing

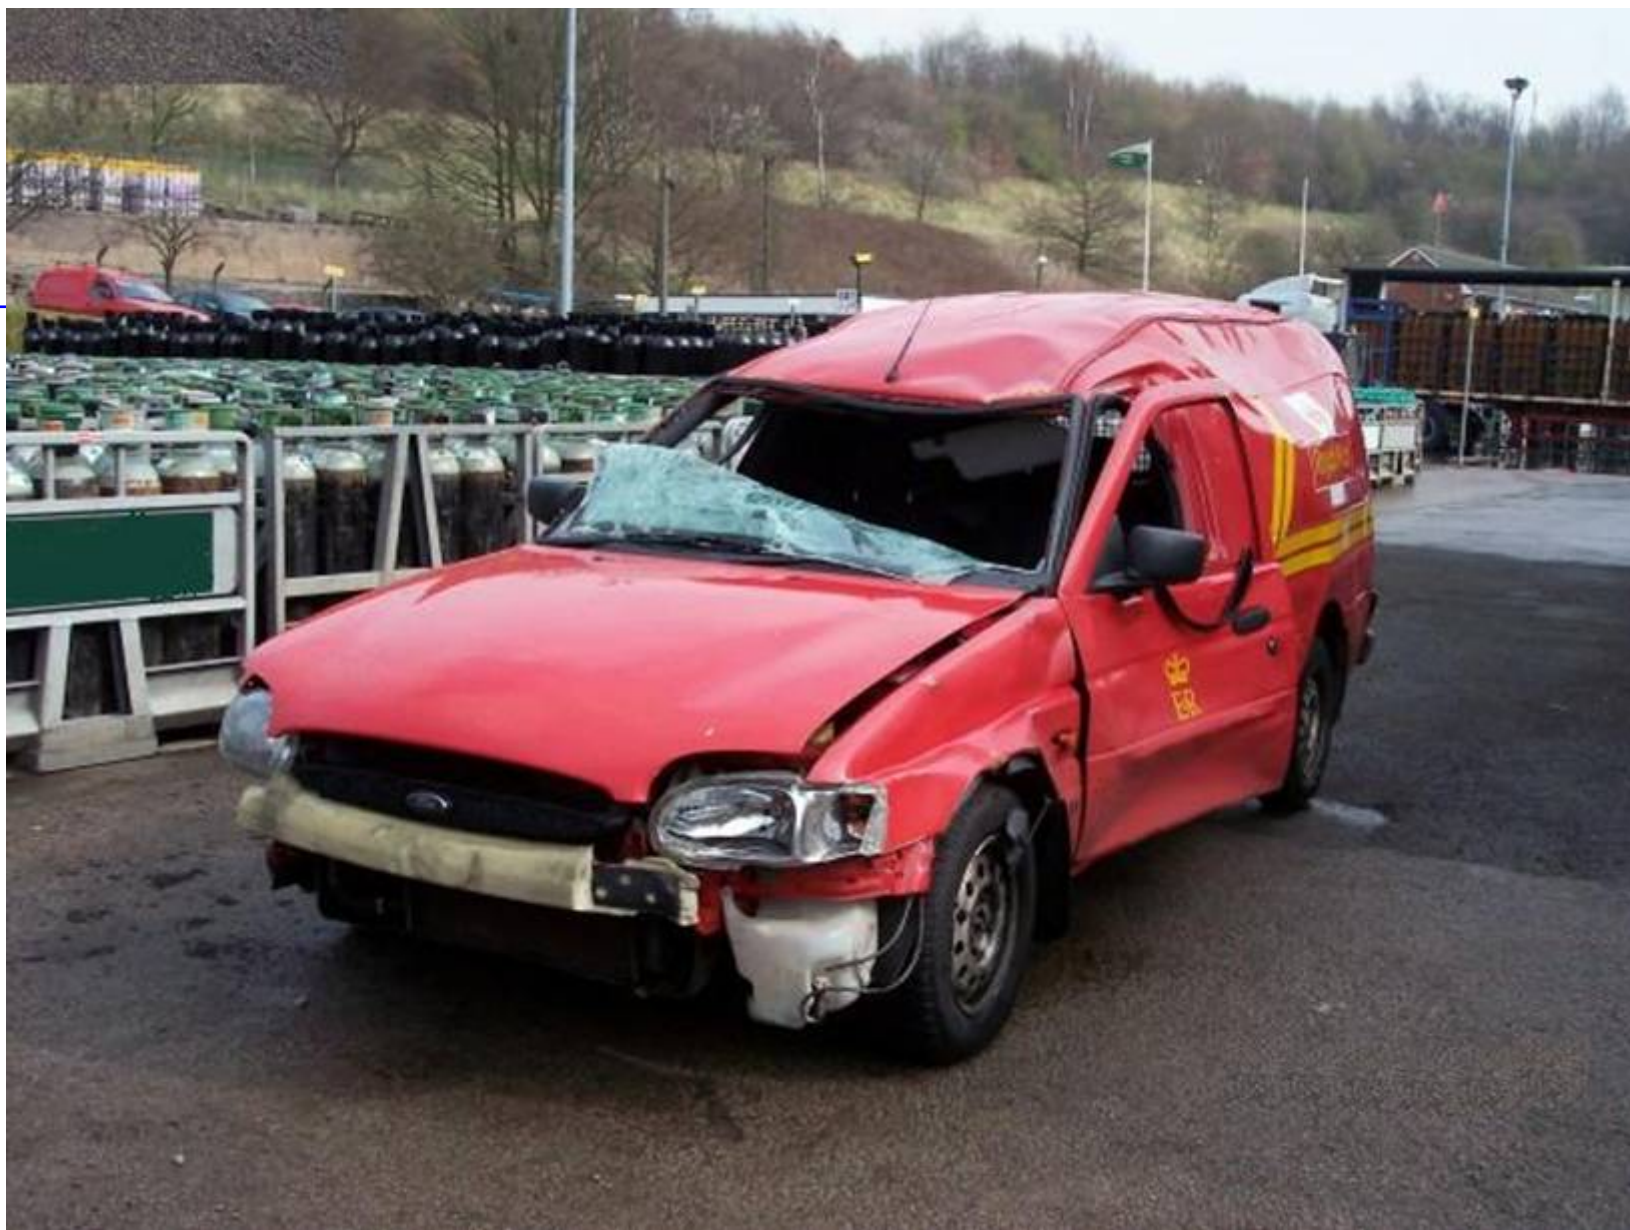
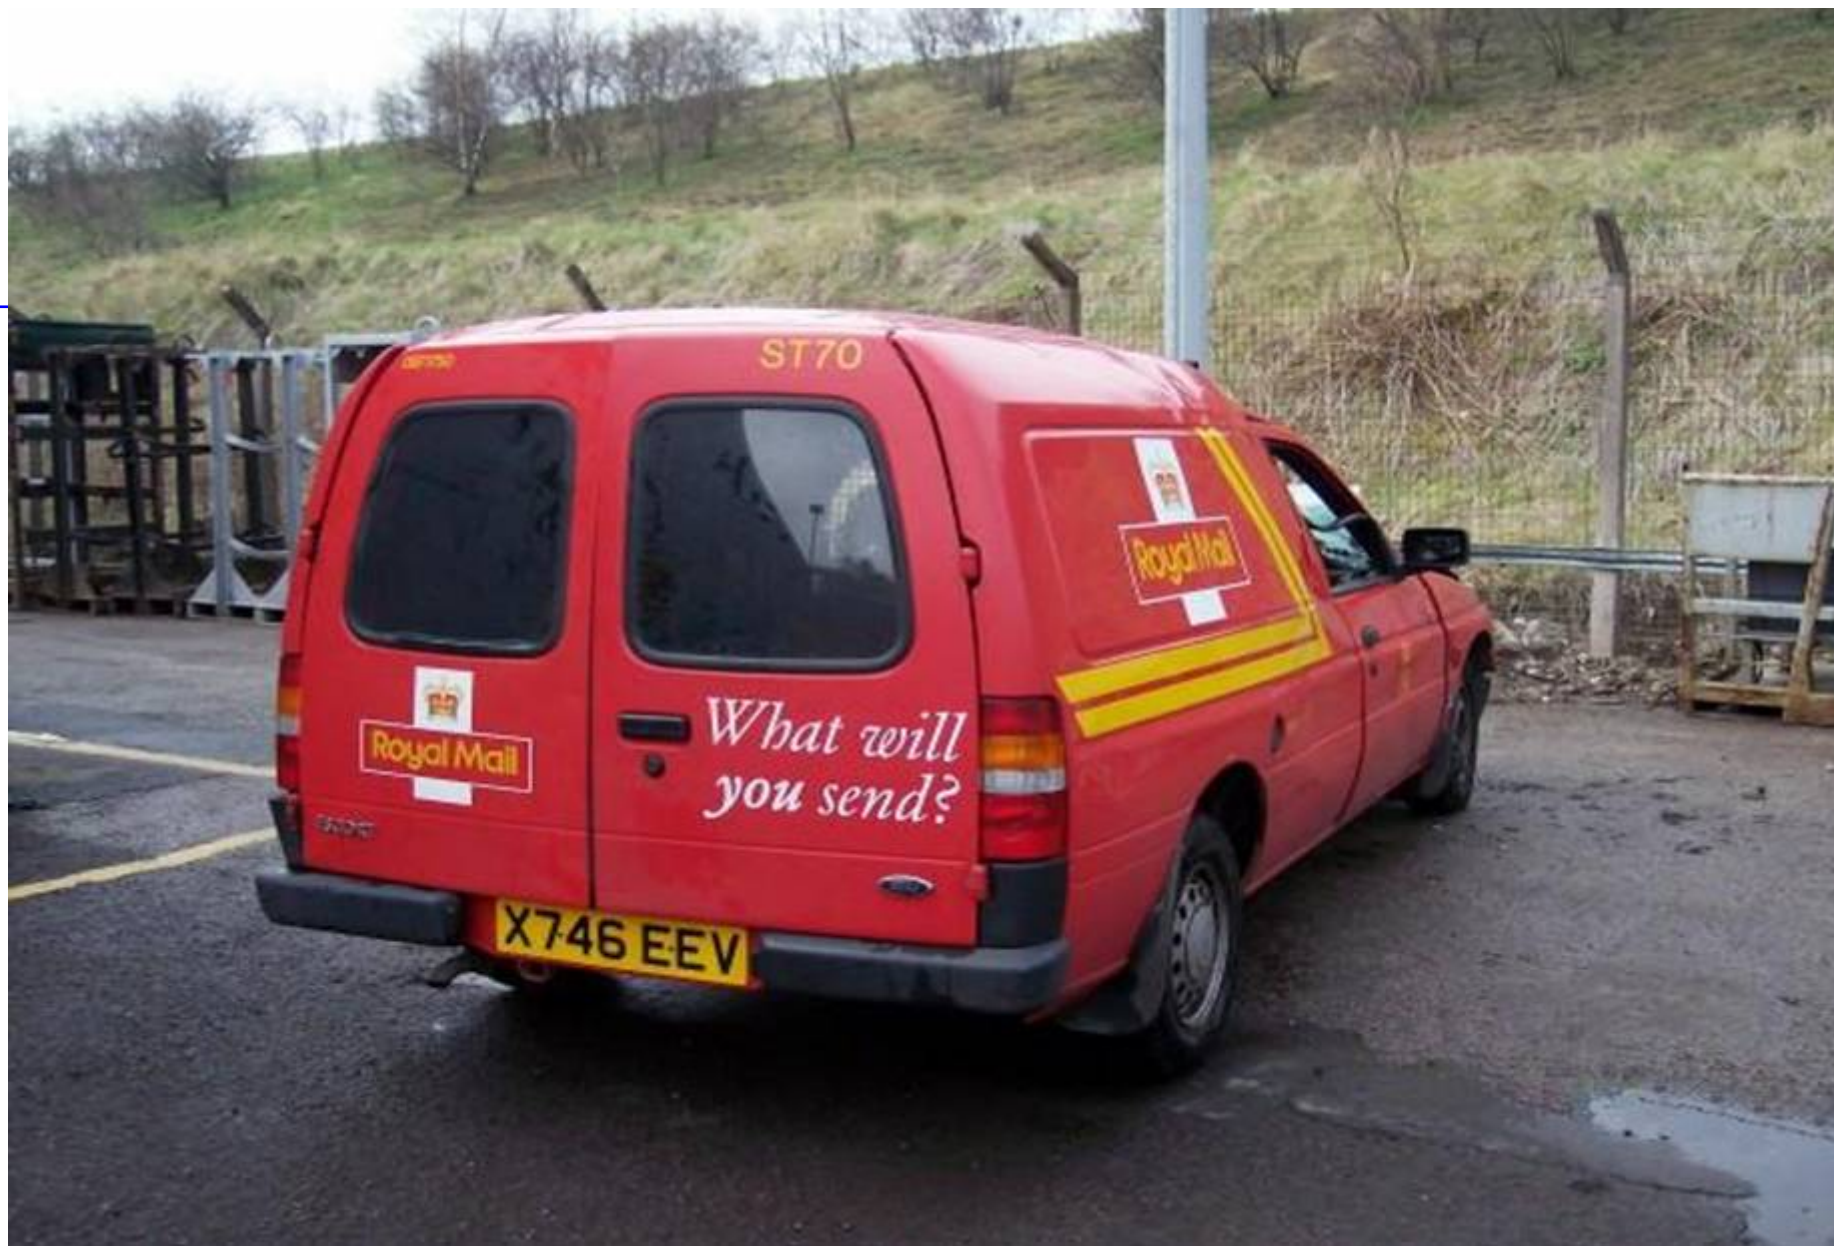
- ◆ Acetylene cylinders were vented to atmosphere in the yard
- ◆ A postman parked his van close by
- ◆ Upon returning, the postman got into the van & started the engine, igniting the gas cloud
- ◆ Large explosion

**Never vent DA cylinders to atmosphere**
-

**Acetylene from a cylinder contains acetone – the mixture is heavier than air**
-

**This type of incident has happened many times in the past**

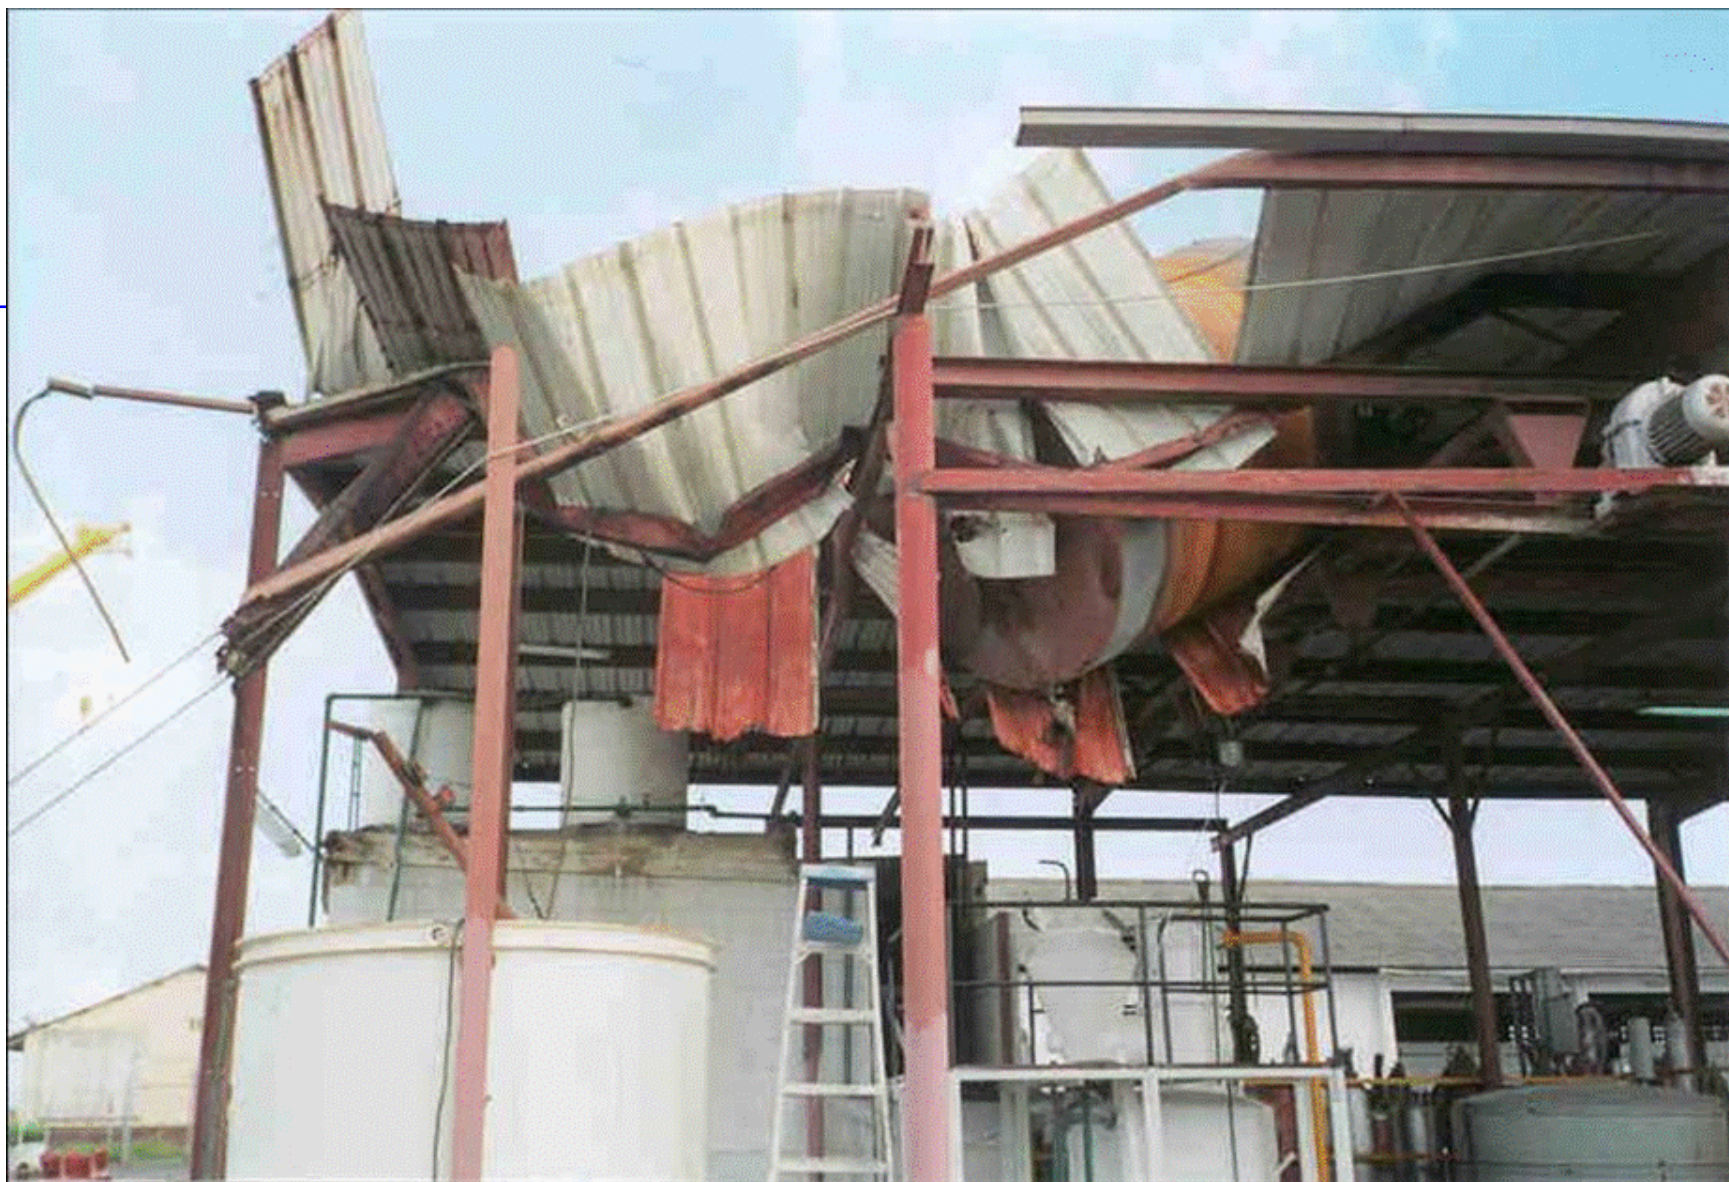
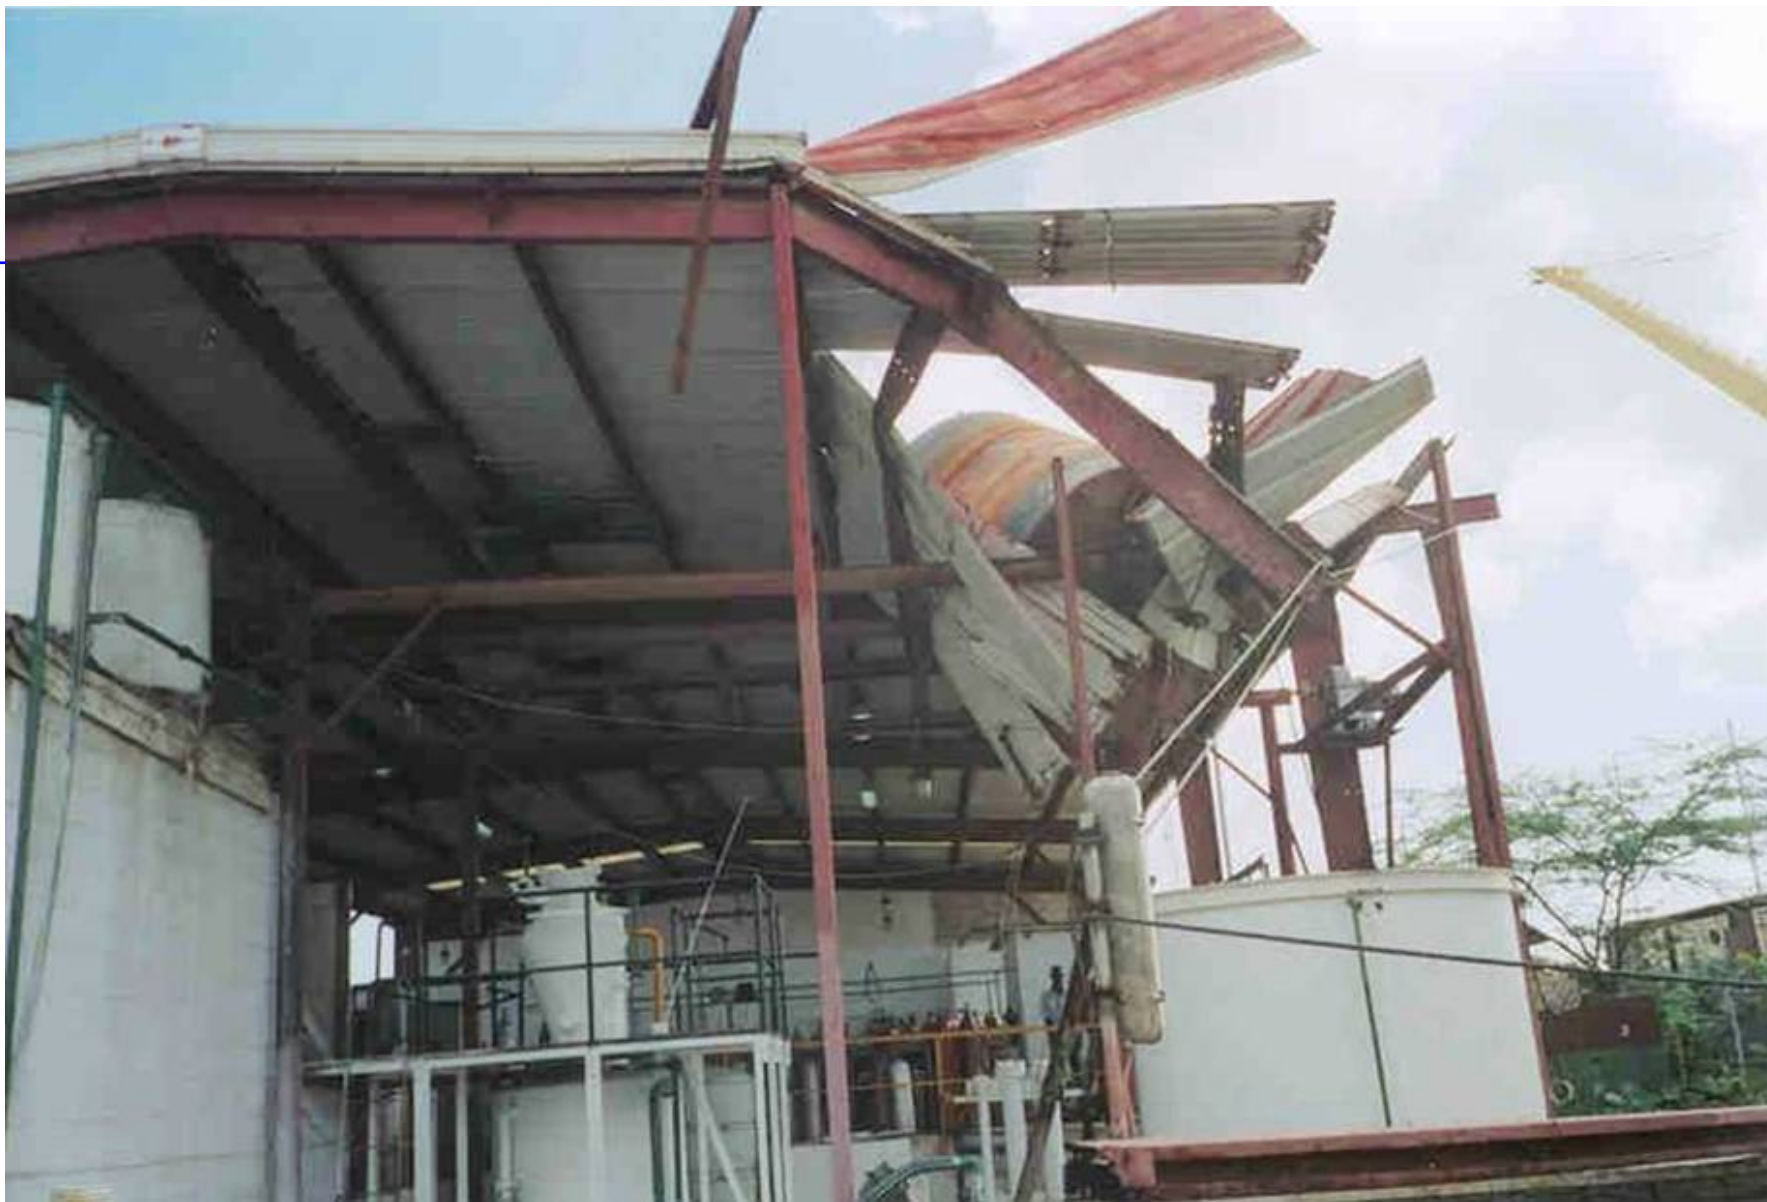
- Broken support bracket on gasholder dome required repairing
- Plant shut down, system purged with nitrogen for 4 days
- Permit-to-Work issued after testing for acetylene in the gasholder
- Welding started - there was an instant explosion
- The gasholder dome shot up into the air
- The welder fell from his ladder - not hurt

- **Pellistor* sensors require the presence of air and acetylene to function**
 - ✓ they cannot detect acetylene in nitrogen
- **Acetylene dissolves in water in gasholders**
 - ✓ it may be released if the temperature rises or the pressure drops
