ACETYLENE GAS SAFETY SEMINAR 2009

Acetylene Cylinder Fire Incident at Industrial Gases Plant

Acetylene Plant Background

Incident Background

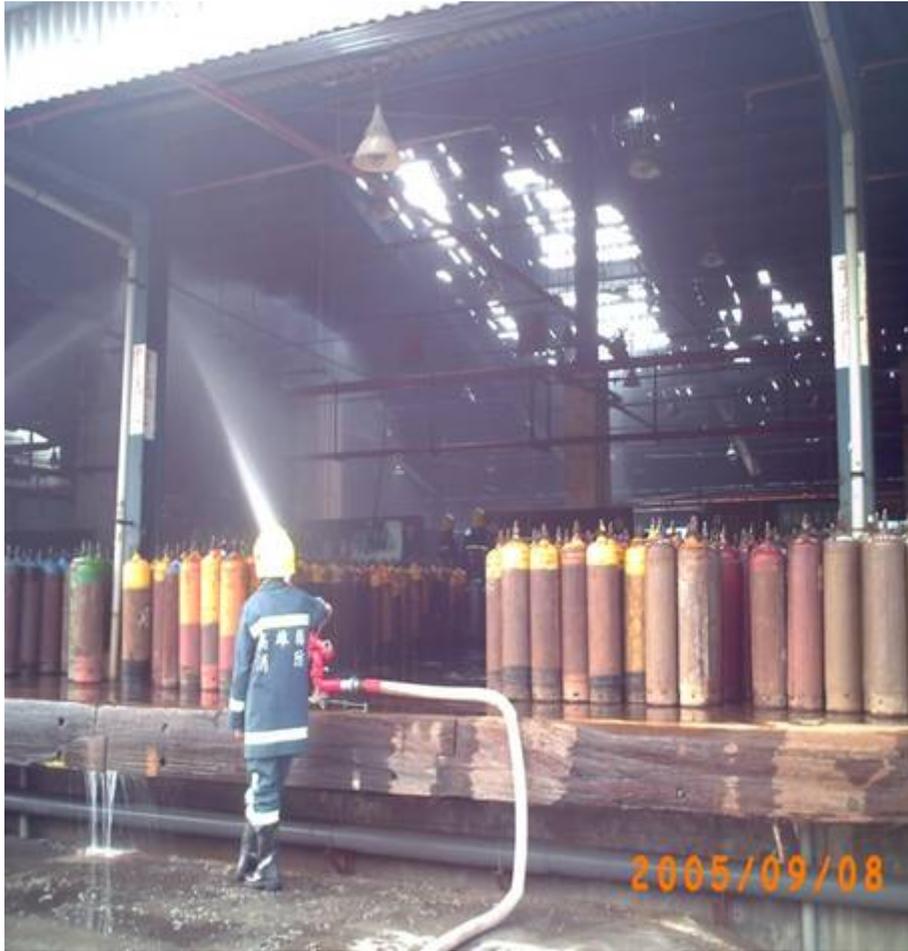
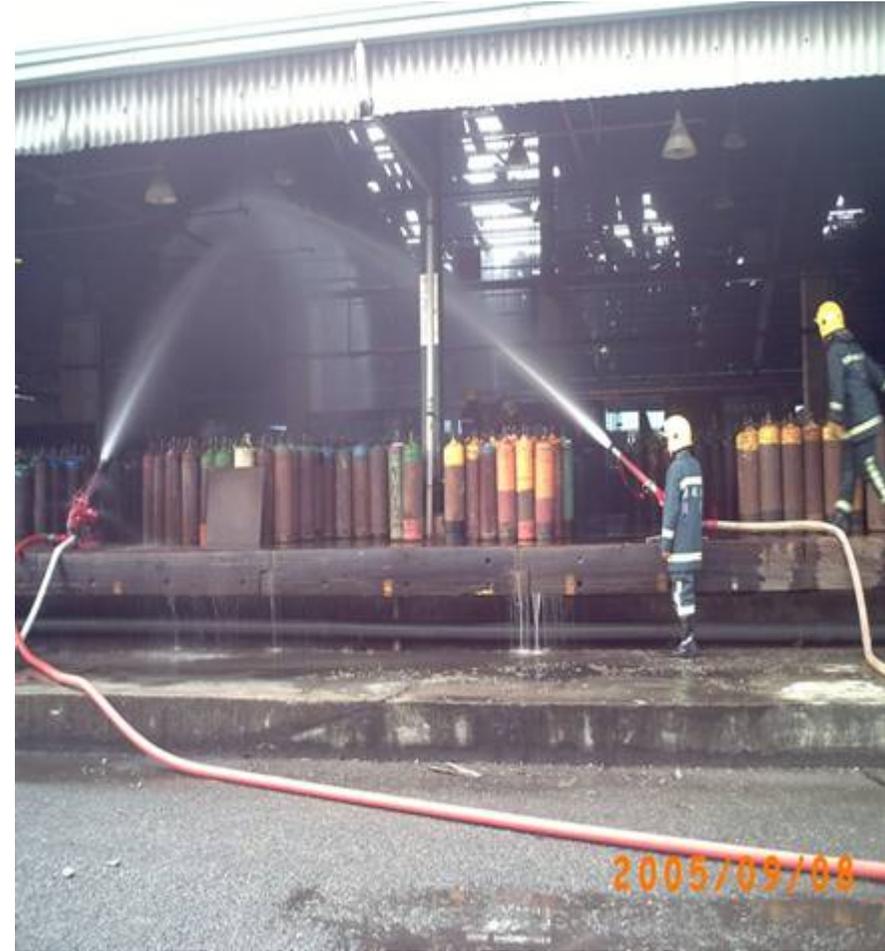
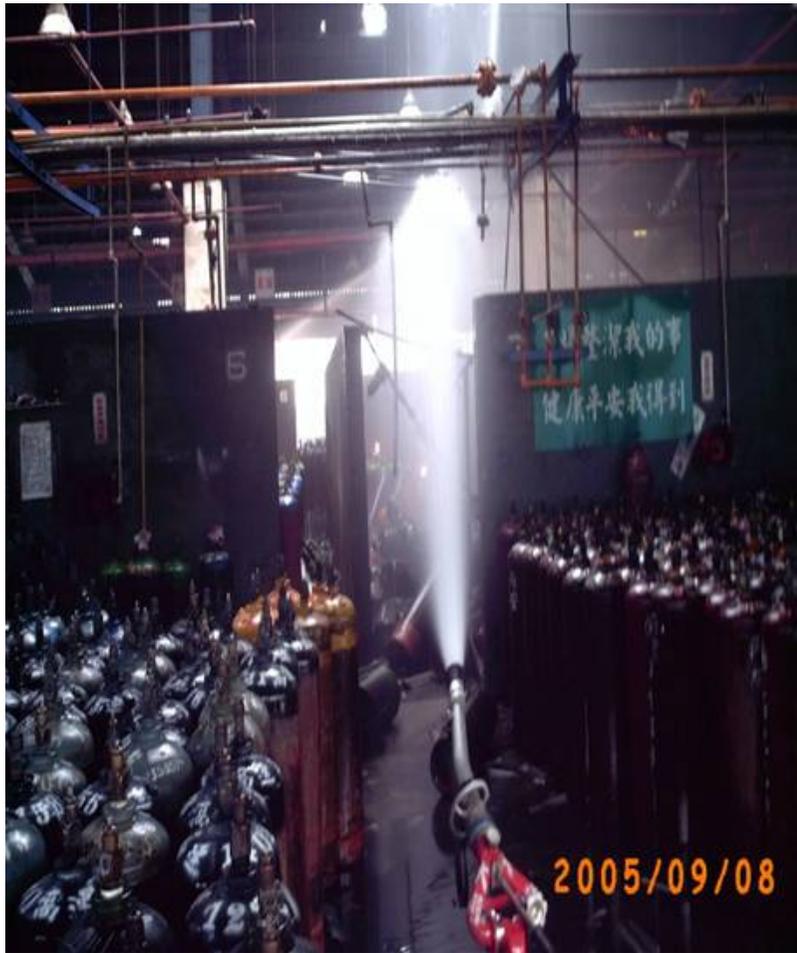
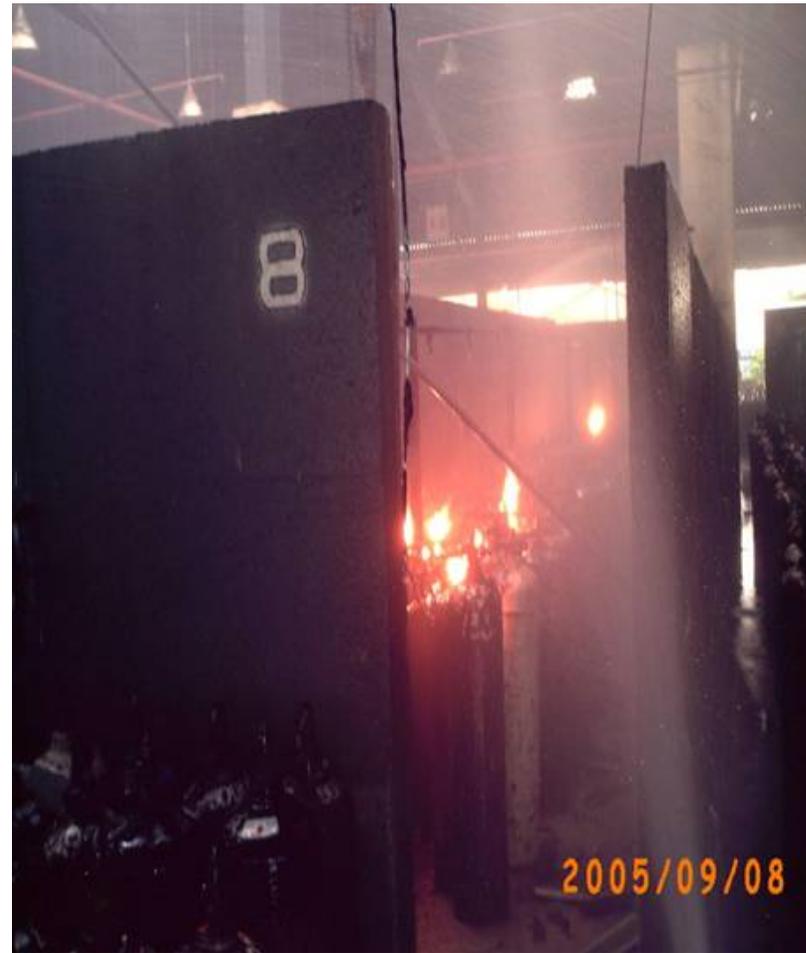
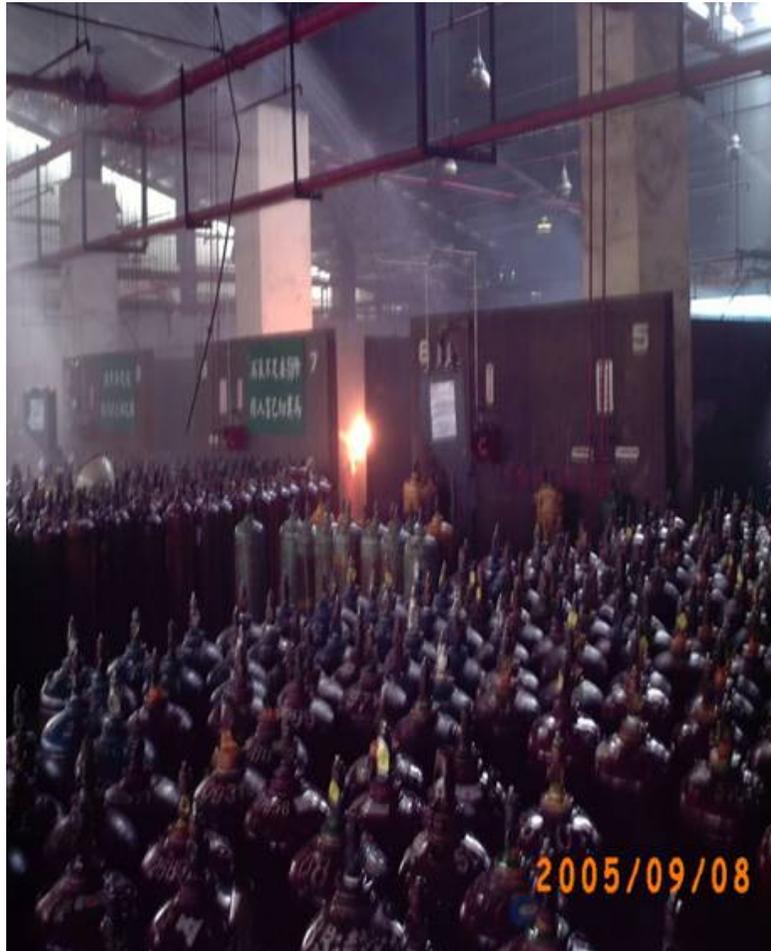
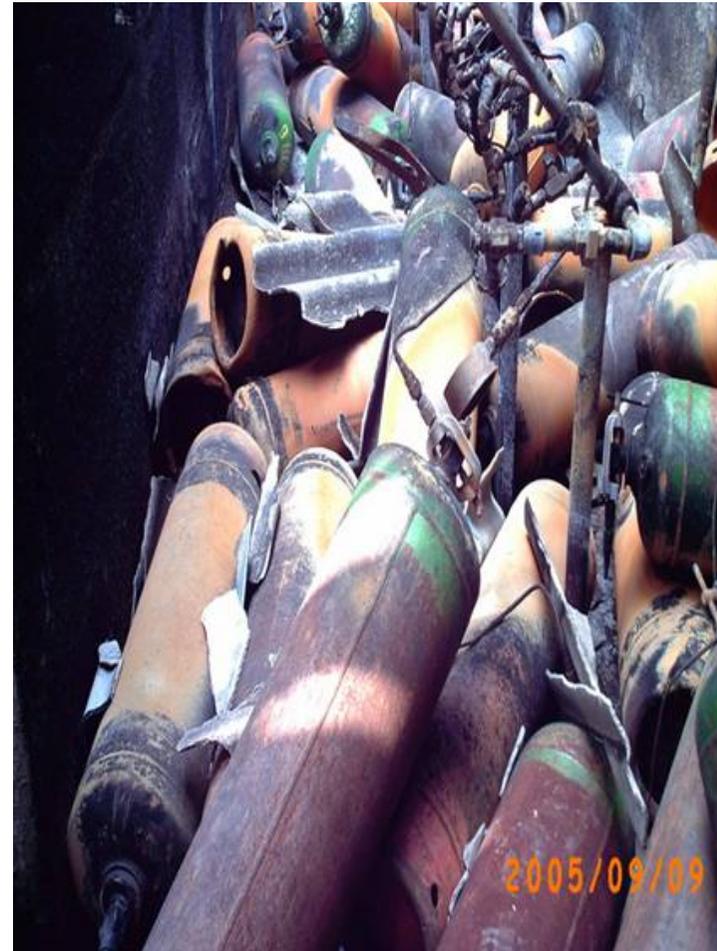
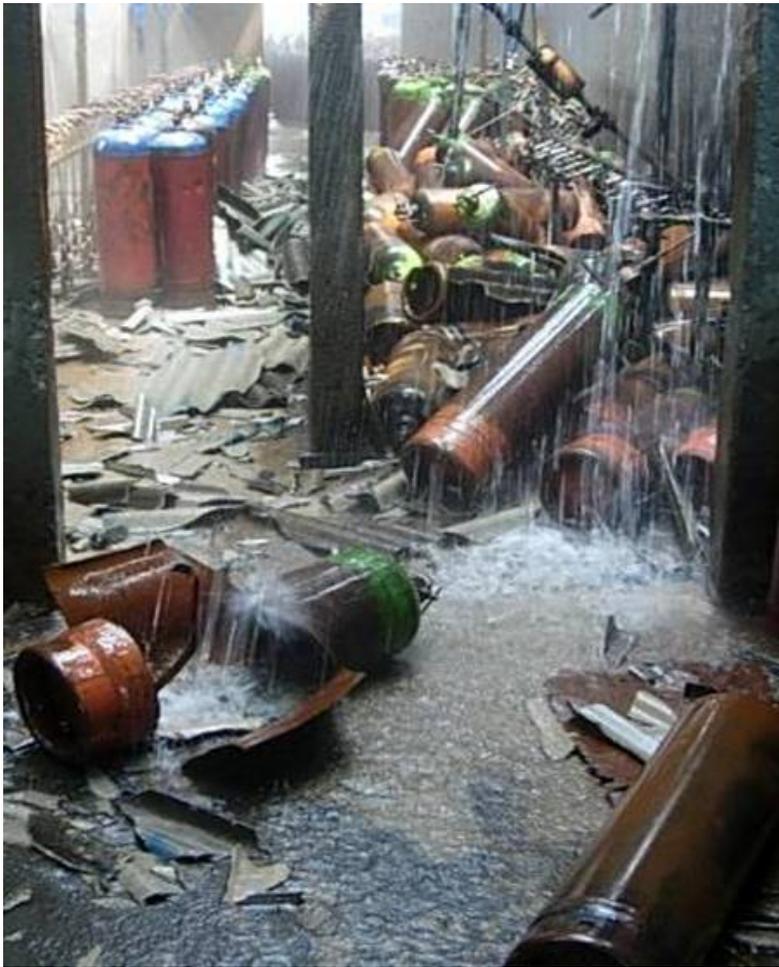
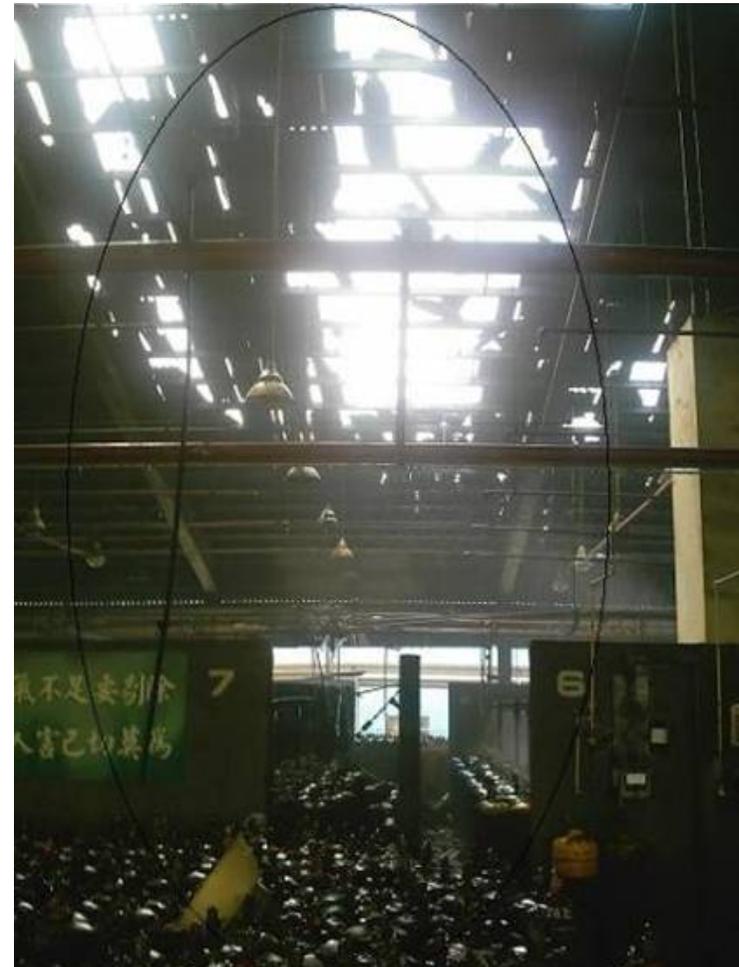
1. No personnel injury ◦
2. #7 filling rack totally damaged , #8 filling rack partially damaged.
3. 90 cylinders affected by fire , 8 cylinders exploded.
4. Damages to: Chill water system 、 test equipment piping, ex-proof lightings, factory roof.
5. Plant stopped for 19 days ◦

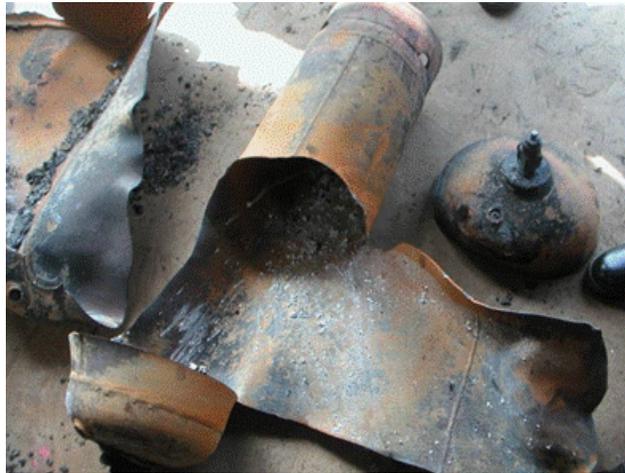
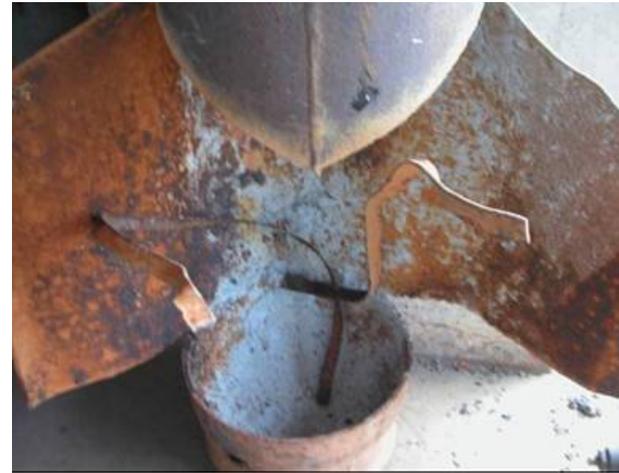
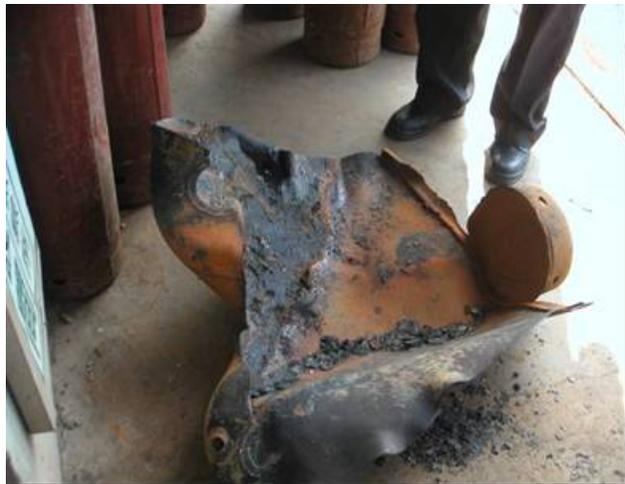
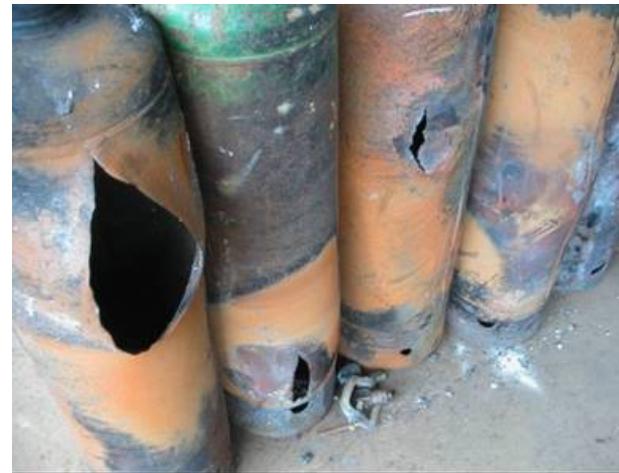
8 cylinders - exploded

- Excessive gaps in the cylinder mass.
- Acetone topping up done incorrectly.
- Other factors:
 - poor residual gas measurement to determine acetone shortage
 - ineffective high pressure drying
- Deluge system saved the plant, enabling it to get quickly back in to operation.

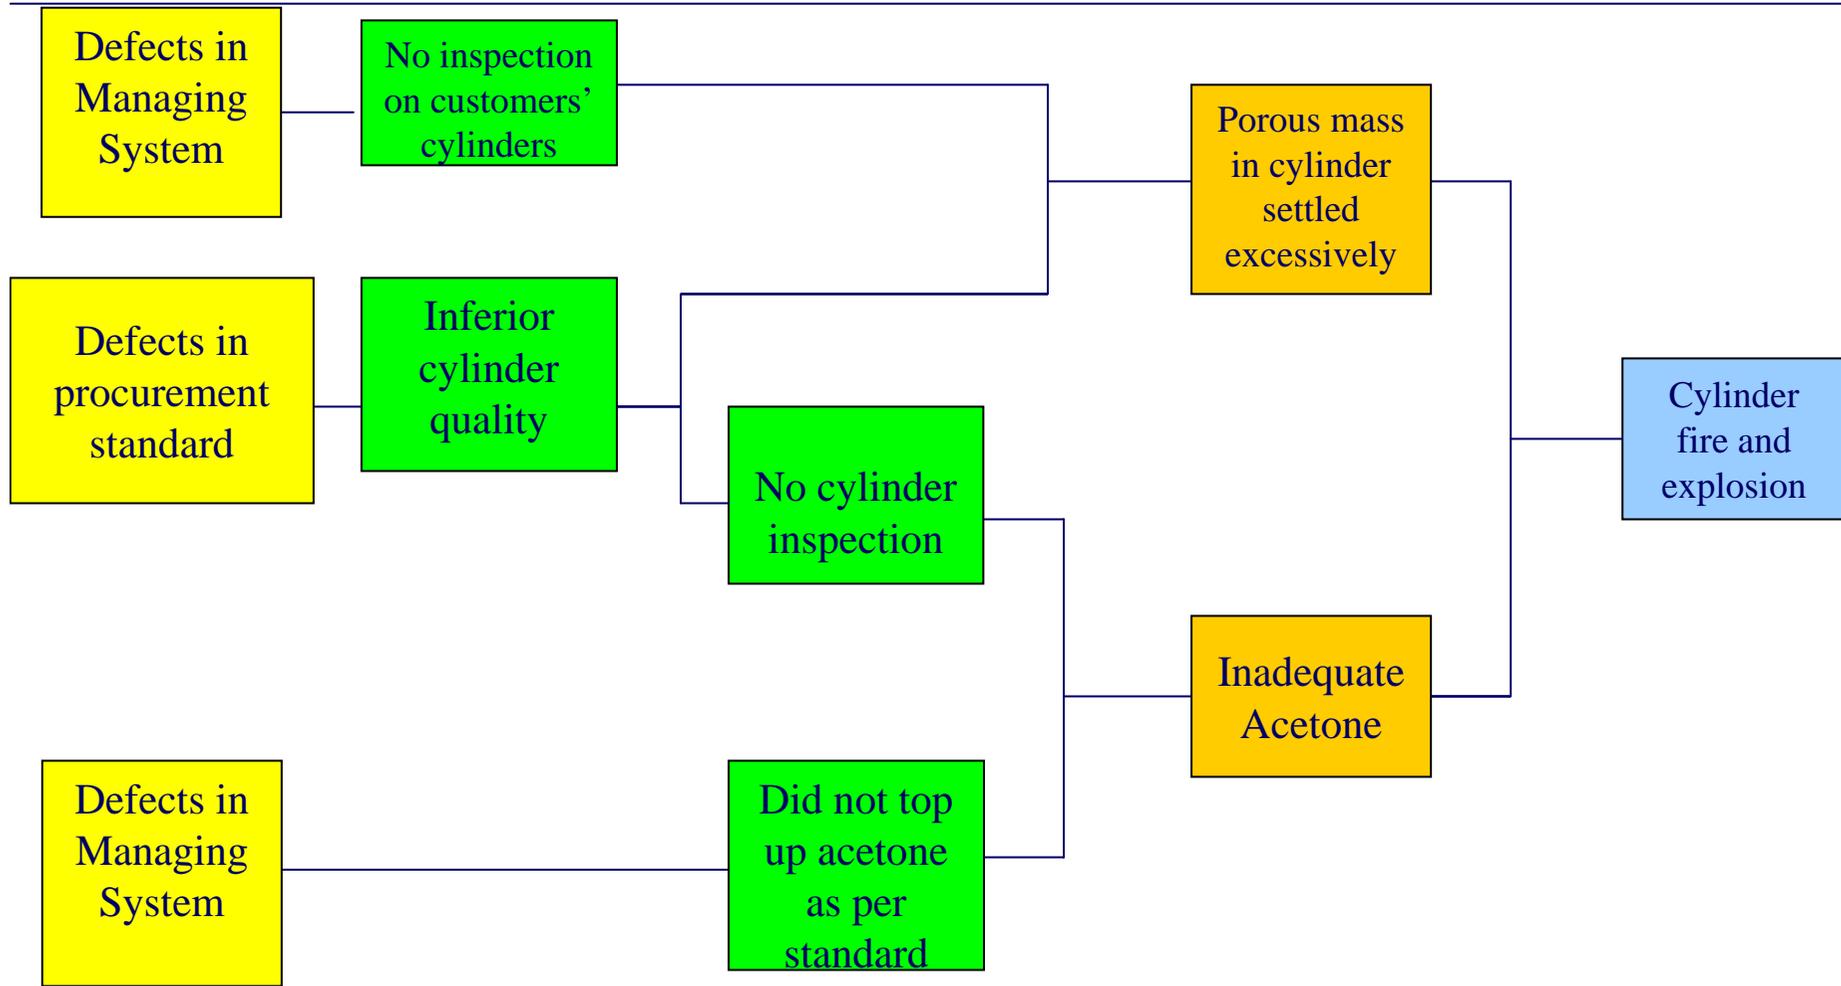
Causal Tree Analysis

管理的不足 Lack of Control	基本原因 Basic Causes	直接原因 Immediate Causes	事件 Incident
--	------------------------------------	--	------------------------------
