**Training Package
TP 14/15**

Recent (2014) Incidents in the Gases Industry in Asia

Asia Industrial Gases Association

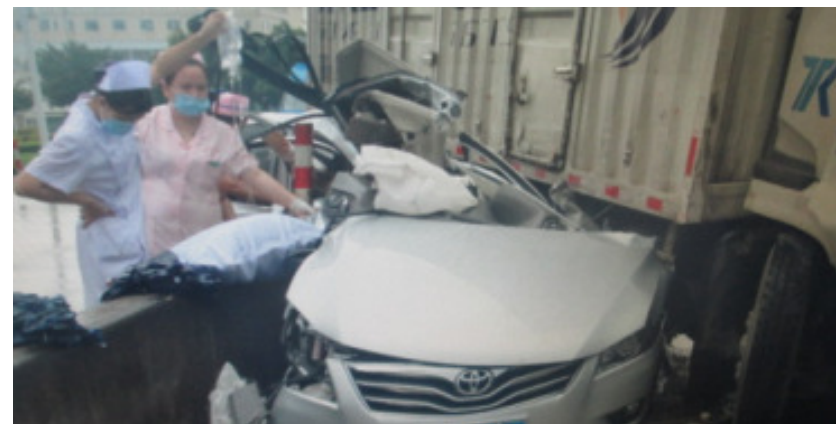
Incident Pictures

- While making a “U” turn (legal one) from the right lane, by cutting across the lane to extreme left. The service car was impacted by a truck. 2 employees were seriously injured.

- Vehicle invaded/obstructed the right of way of the truck.
- Less Than Adequate identification of the risk performing the maneuver.
- Making the "U" turn not as per traffic regulations ("U"-turn is only allowed from the left side)
- Inadequate driving experience

- Employee was not experienced enough in driving.
- Minimize "U" turns or any other maneuver in which road lanes might be obstructed, only making them in places where is expressly allowed by traffic lights or road signals.

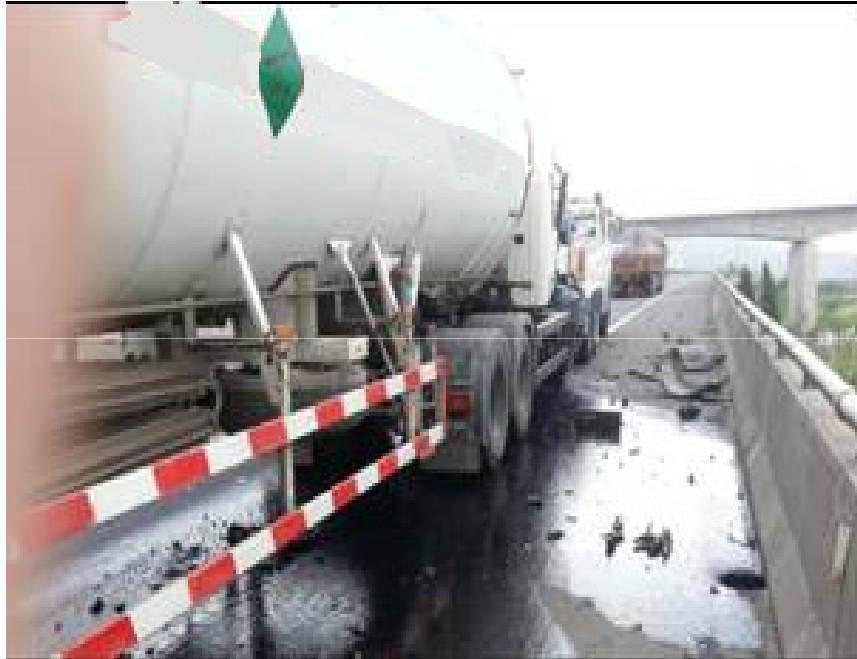
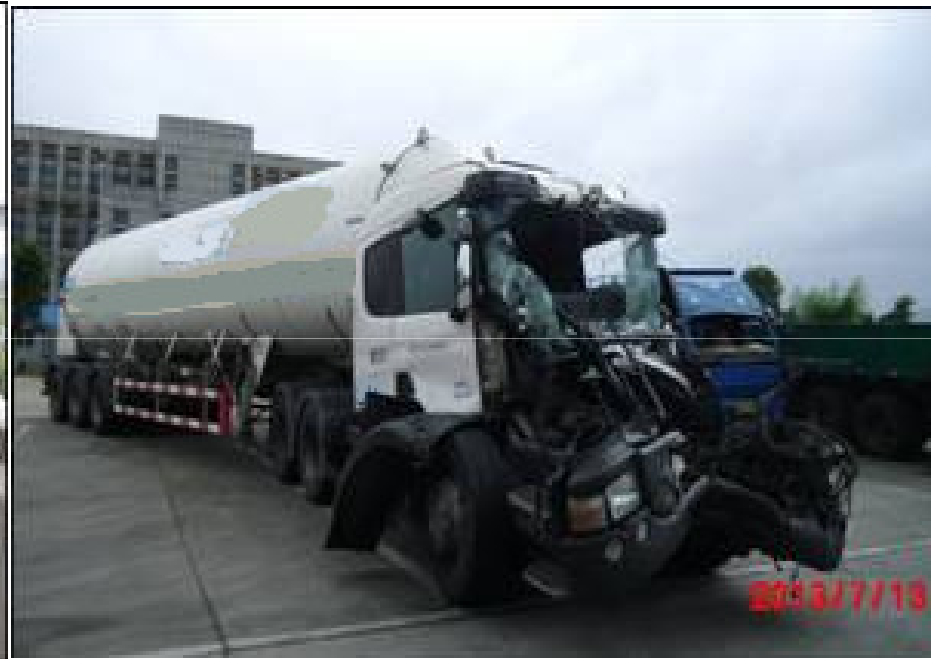
Incident Pictures

- A company owned bulk product vehicle rear ended a third party truck on the motorway. The driver of the product vehicle died from injuries and the helper suffered a collarbone fracture. Also the driver cabin of the truck received extensive damage.

- Inadequate driver fatigue management
- Less than adequate management control. The planned trip time was much longer than actual due to route change as a result of route diversion .

- Improved monitoring of rest breaks and work hours.
- Discipline on non-compliance with policy
- Adjust planned route to reflect actual route.

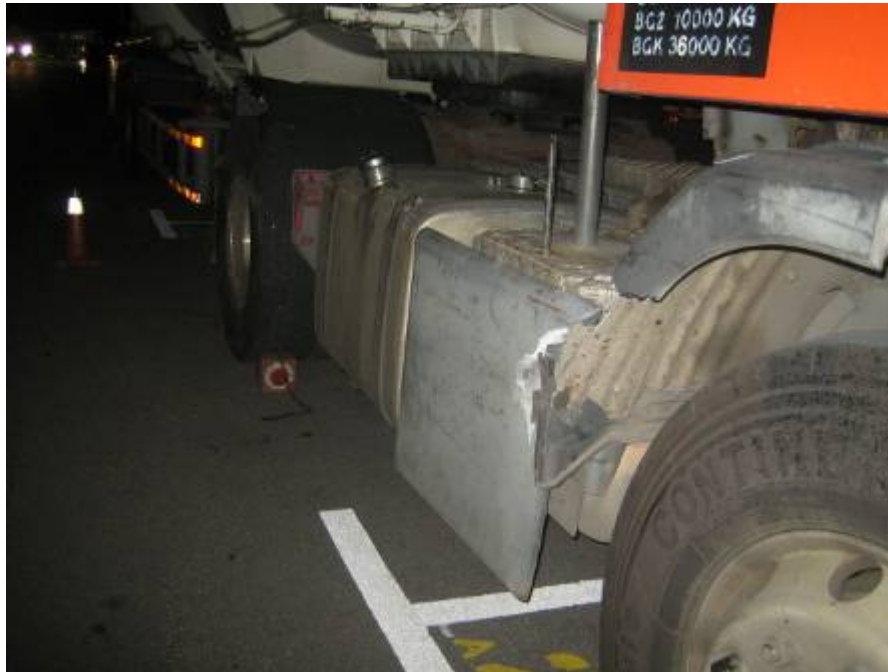
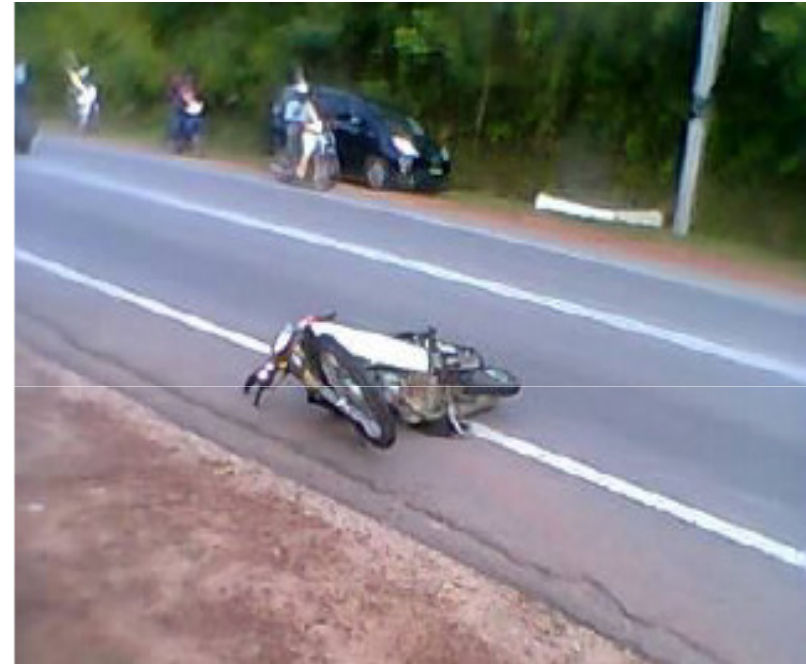
Incident 1 Pictures

- A fully loaded Liquid Nitrogen tanker had a side on collision with a motorcycle that was overtaking a passenger car from the opposite direction on a two way road. The motorcyclist fell and sustained fatal head injuries and passed away at the scene. The driver was wearing his seat belt and escaped without any injury. Motor cyclist was wearing crash helmet.

- Driver error in Judging the situation
- Motorcyclist misjudged the speed of the passenger car he overtook and the speed of the oncoming truck
- Driver took evasive action by moving on to the opposite lane

- To share with all drivers the importance of seeing & being seen by motorcyclist/road users and drive adjusting to the road condition and traffic
- Improve visibility of truck e.g. LED light on Cabin & body, reflective stickers.
- Re-emphasis on route risk analysis and communicate the risk of the routes to drivers and anticipating unsafe behavior of 3rd party road users
- Ensure driver drive at an appropriate speed based on stated limit and reviewing of trip information.

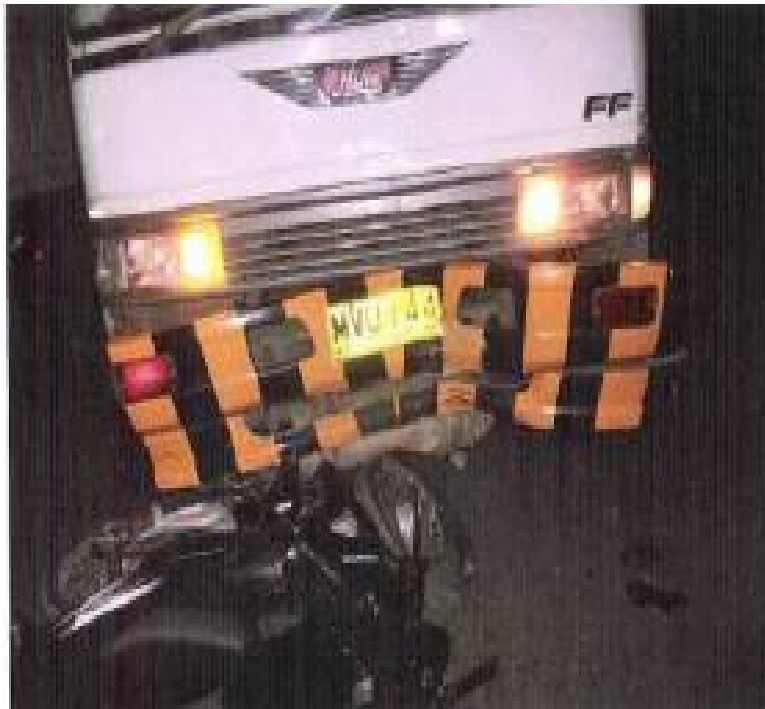
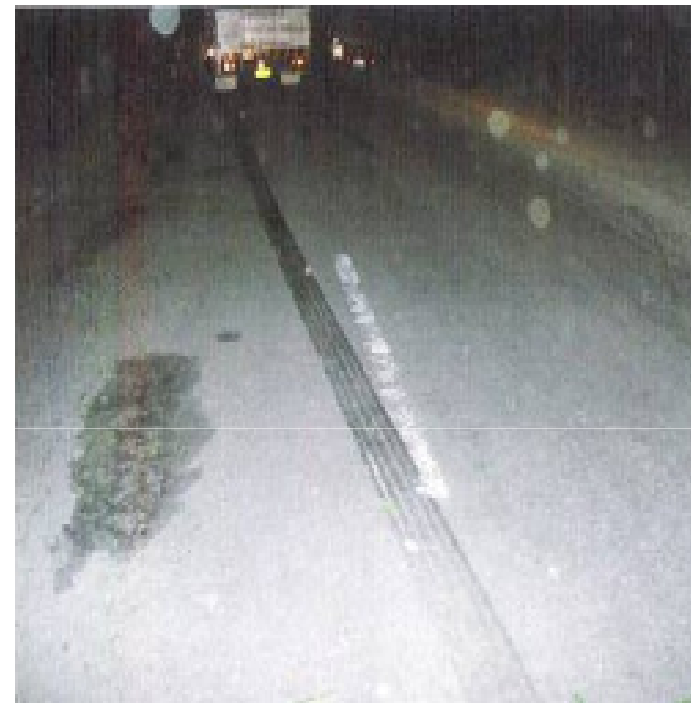
Incident 2 Pictures

- A cylinder delivery vehicle travelling on two-lane road was involved in a head-on collision with a motorcyclist. Initial reports indicate that motorcyclist was travelling in the wrong lane, both vehicles took avoiding action which was unsuccessful and collided head-on. The motorcyclist was not wearing a crash helmet and was fatally injured.

- Cyl Truck driver failed to apply Defensive Driving techniques by not looking ahead and anticipate oncoming vehicles and motorcyclist
- Cylinder truck was driving at a speed than the road condition – poor lit roads
- Motorcyclist was under the influence of alcohol (Incident 2)

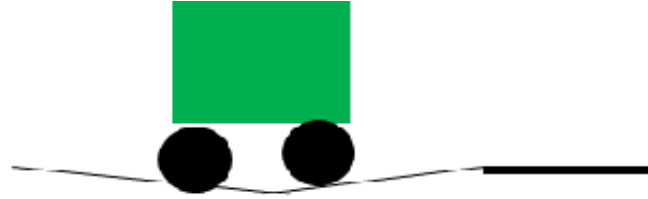
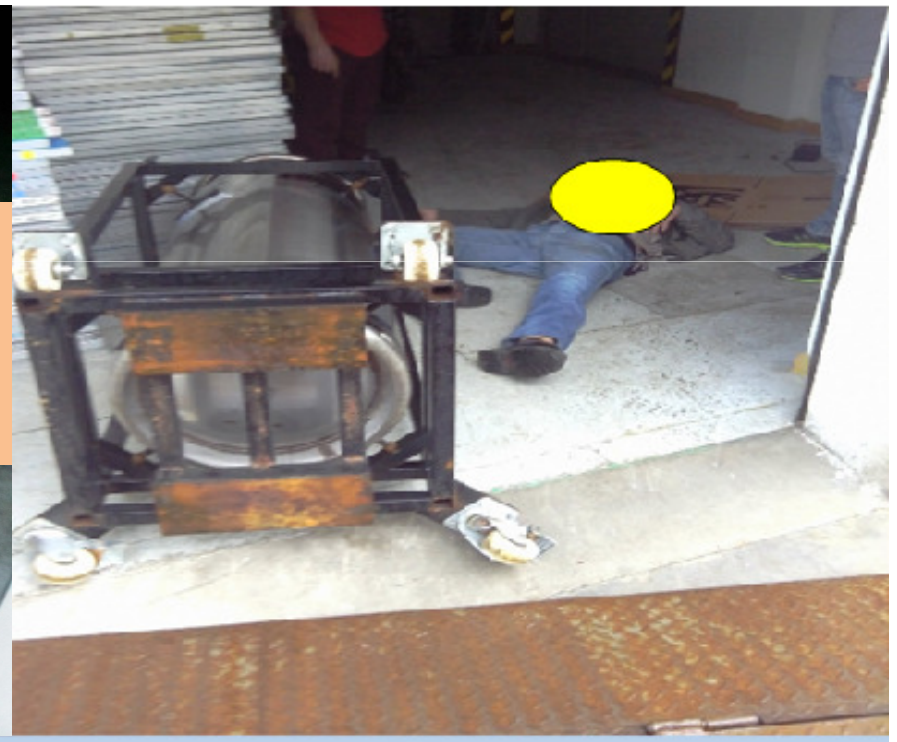
Incident Pictures – case 1

- On a rainy day at a customer site, an escort fell down laying on the ground in pain as he jumped backwards to evade a falling 210kg O2 liquid cylinder that he was unloading on a uneven surface.

- Hazard at the customer site - uneven flooring
- Inadequate safety review before performing a task
- Incorrect actions and decisions

- Never attempt to catch a falling liquid cylinders or a gas cylinder – serious injury can occur
- Conditions at customer sites may change – evaluate the hazards in advance and take appropriate action to perform the job safely
- The equipment used to transport the liquid cylinders must be appropriate for the conditions at the customer site
- If in doubt “stop the job” and get assistance
- Ref to AIGA TP 11/12

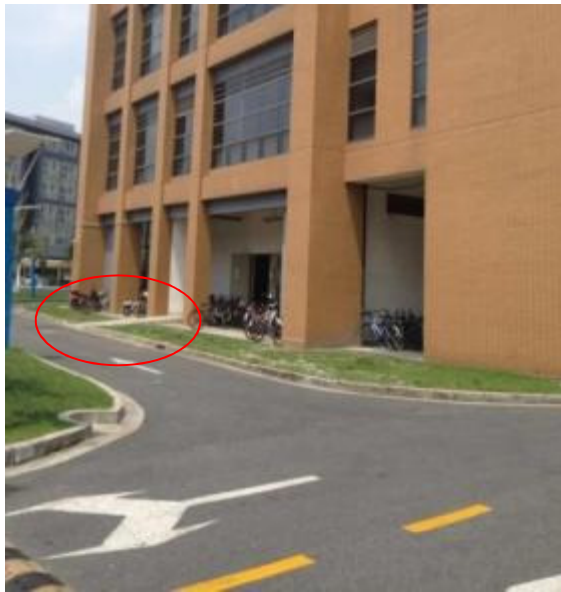
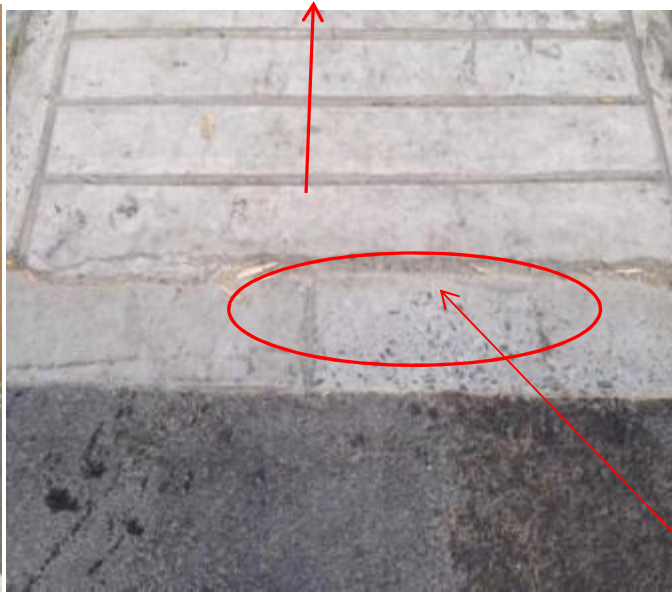
Incident Pictures – case 2

- Wheels on the liquid cylinder cart stopped rolling due to change in surface condition and the liquid cylinder tips over.
- Person attempting to catch a falling liquid cylinder .

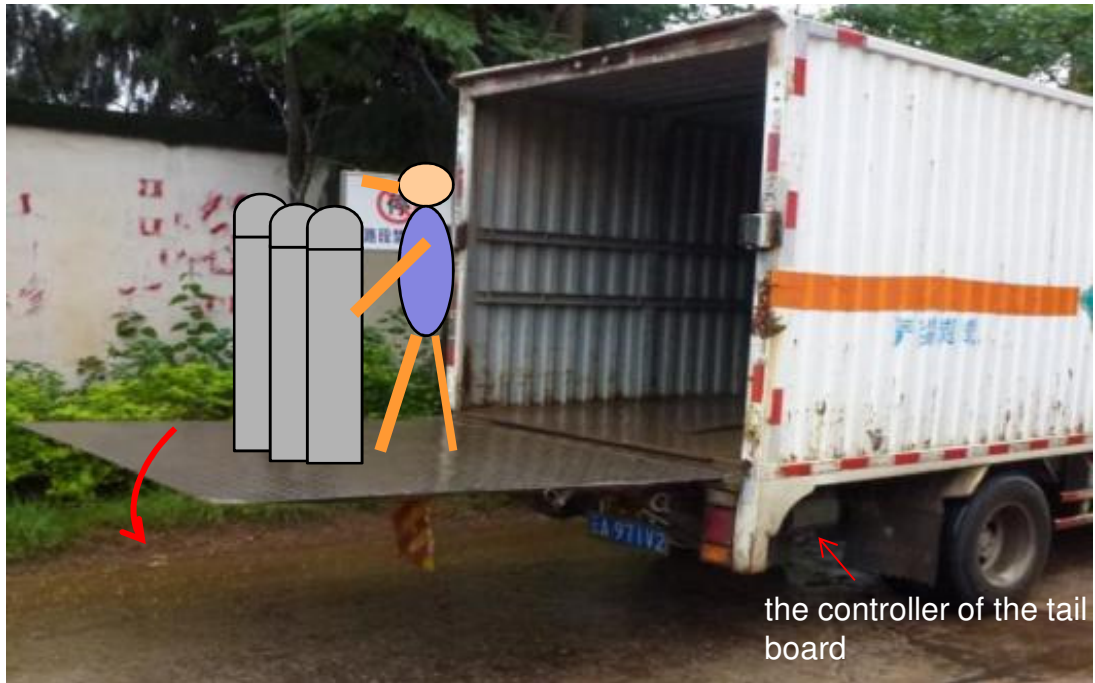
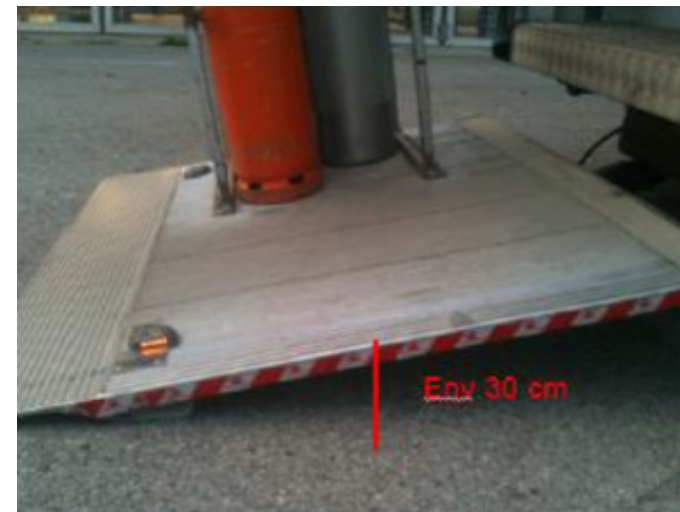
Incident Pictures

- Around 14:30, a loader was hit by two falling down cylinders at a customer site. The helper by mistake tilted the lift board instead of lowering straight. This caused the loader and the cylinders to topple and fall to the ground. Two cylinders hit the loader's left leg and caused the injury. His left tibia and fibula were broken

- Helper's mistake
- Absence of fixture or arrangement to secure the cylinders on the tail board during lowering and unloading of cylinders

- Improve the design of the truck, viz the fall protection rail and early-warning for the tilting operation
- Use special truck where available.
- Ensure that cylinders are secured on the platform to prevent cylinders from falling
- Enhance job observation to timely eliminate unsafe behavior
- Enhanced communication
