# ACETYLENE GAS SAFETY SEMINAR 2010 MALAYSIA

# Learning from Acetylene Incidents

# DA Incidents

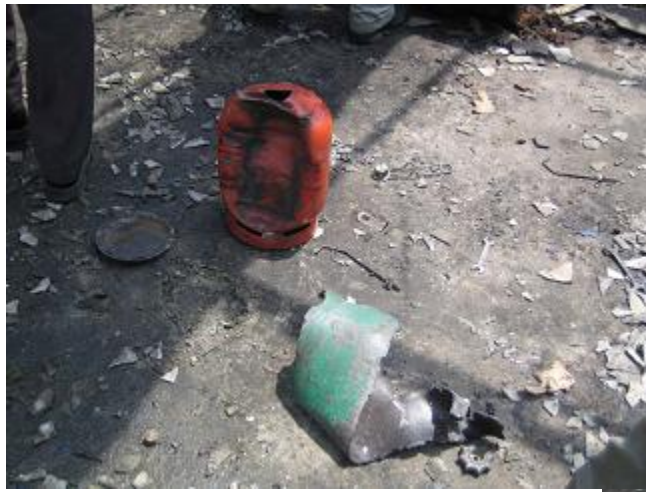
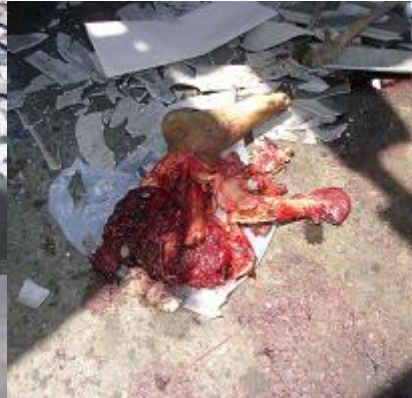
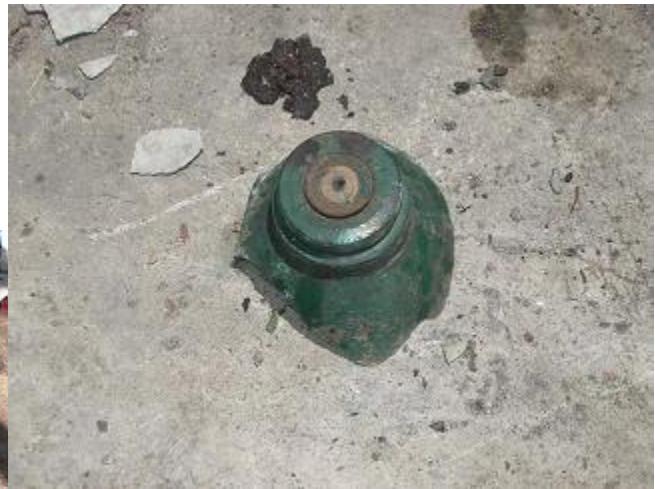
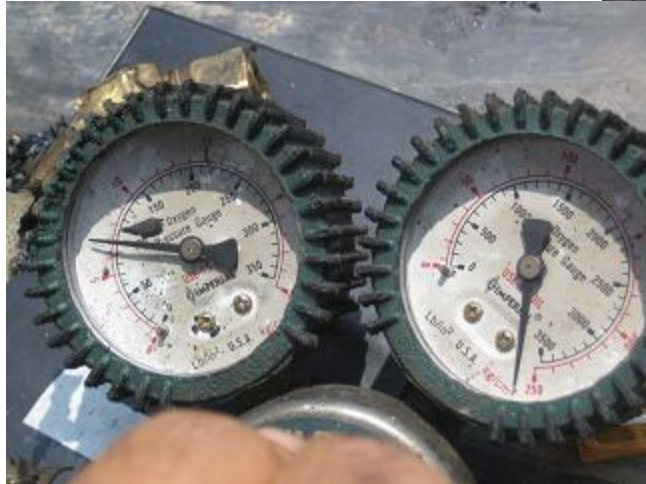
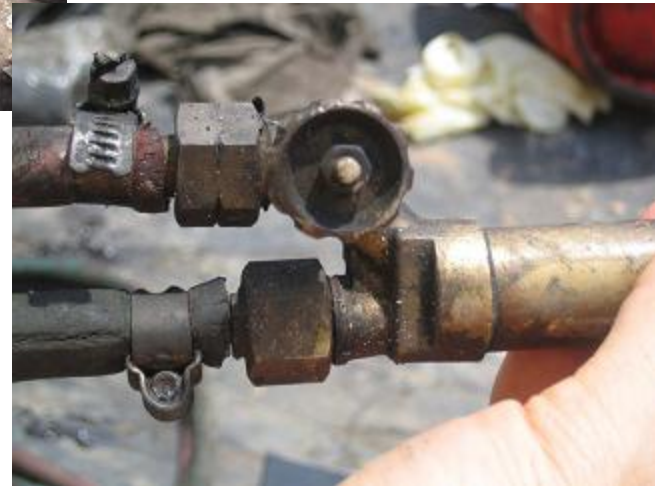
# What can happen if Flashback Arrestors are not used

(LPG + O<sub>2</sub> in this case)

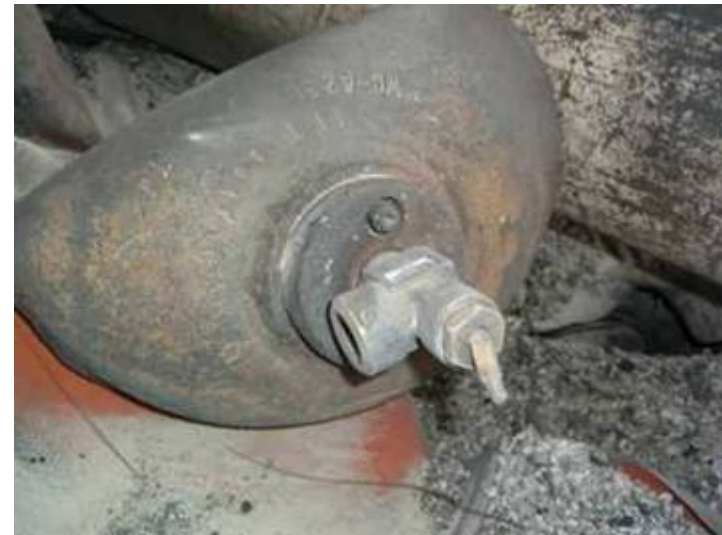
Cylinder no : 156307  
Cylinder spec: DOT-8  
Manufacturer : Coyne Cylinder Company, Huntsville, Alabama.  
Process : Cold forming of 2 seamless shells, joined by a circumferential seam weld.  
Mass : lime silica with porosity 88-92 %  
Manufactured in : Nov 1995  
Valve detail: BBB Neriki G11 3.94, side outlet, hand wheel  
TW : 53.5  
WC : 2.5L

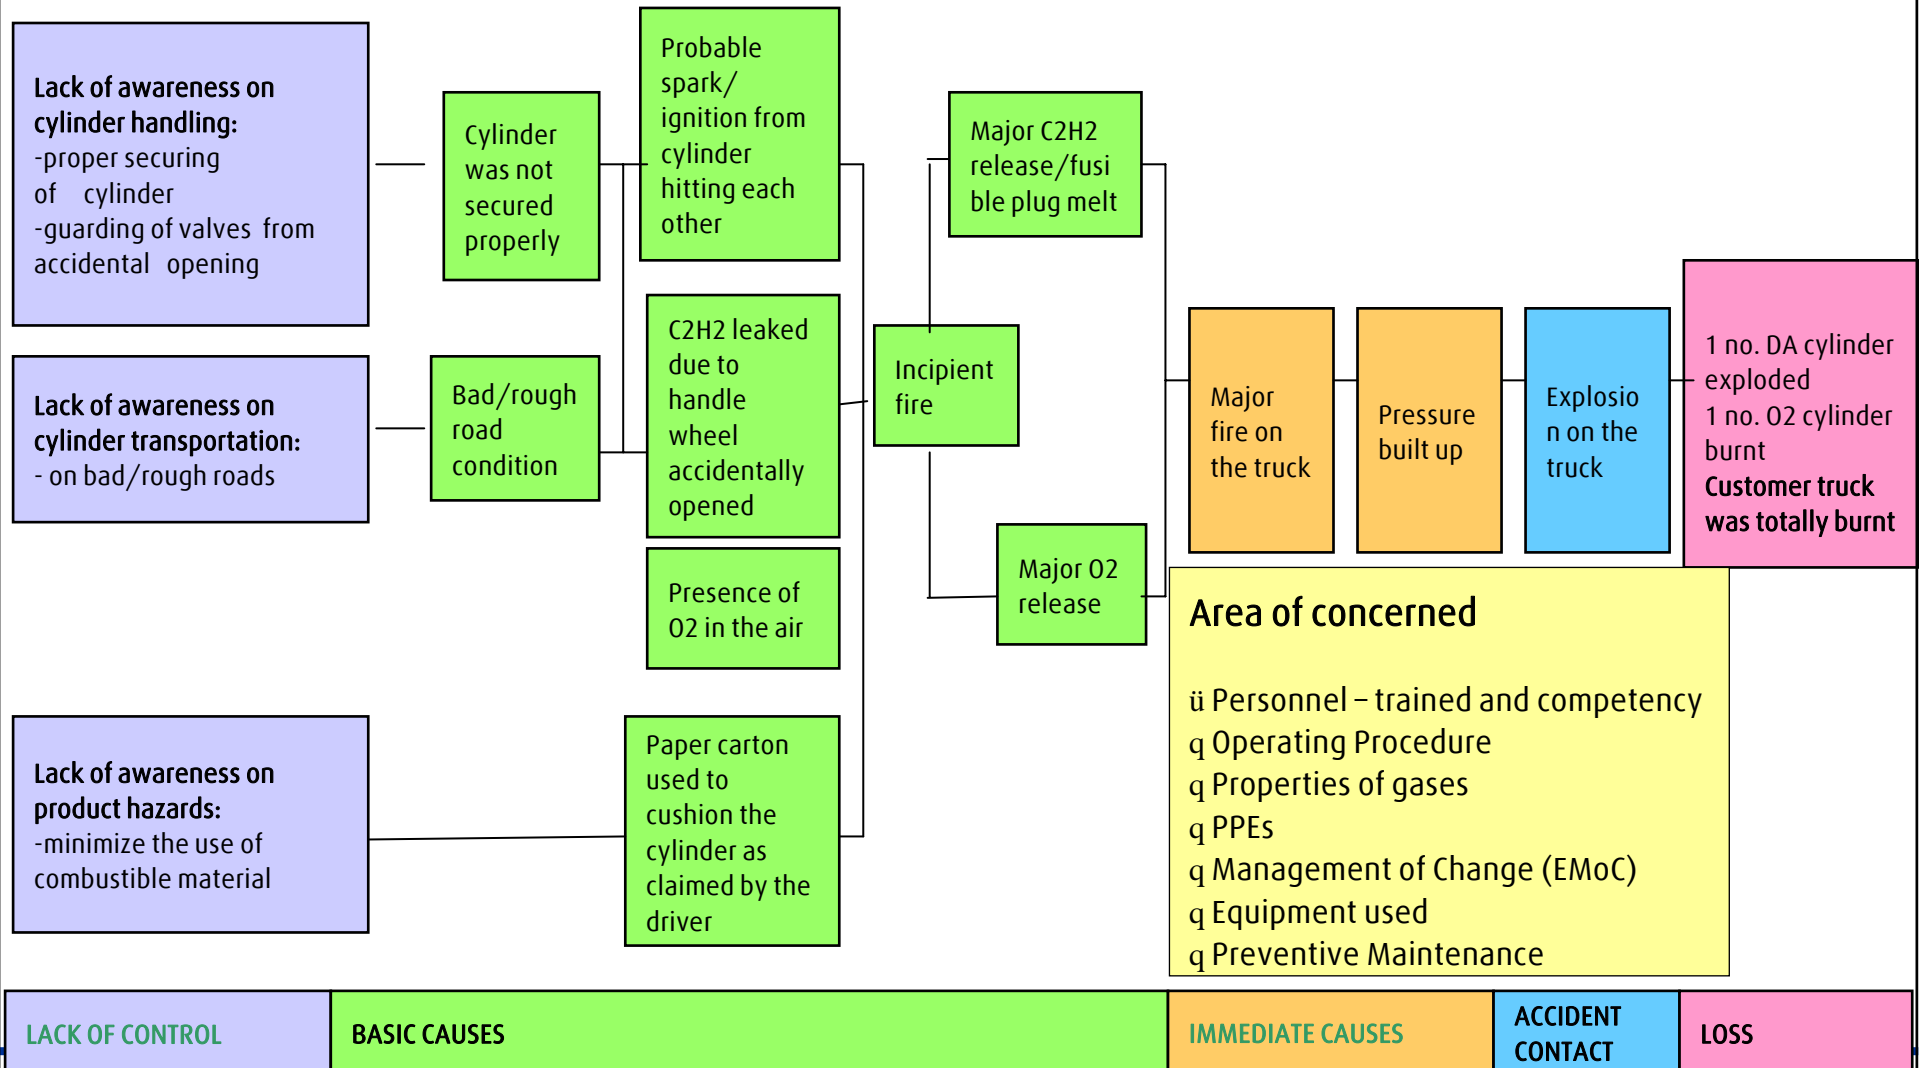
### 3. Causal Tree Analysis

The cylinders were transported on a pick-up truck. The two cylinders were lying diagonally on the pickup bed tied with nylon string. The size of the pickup bed was just sufficient to allow the taller O2 cylinders to be laid in this diagonal position. (Friction between nylon string and cylinders may cause electrostatic charges)

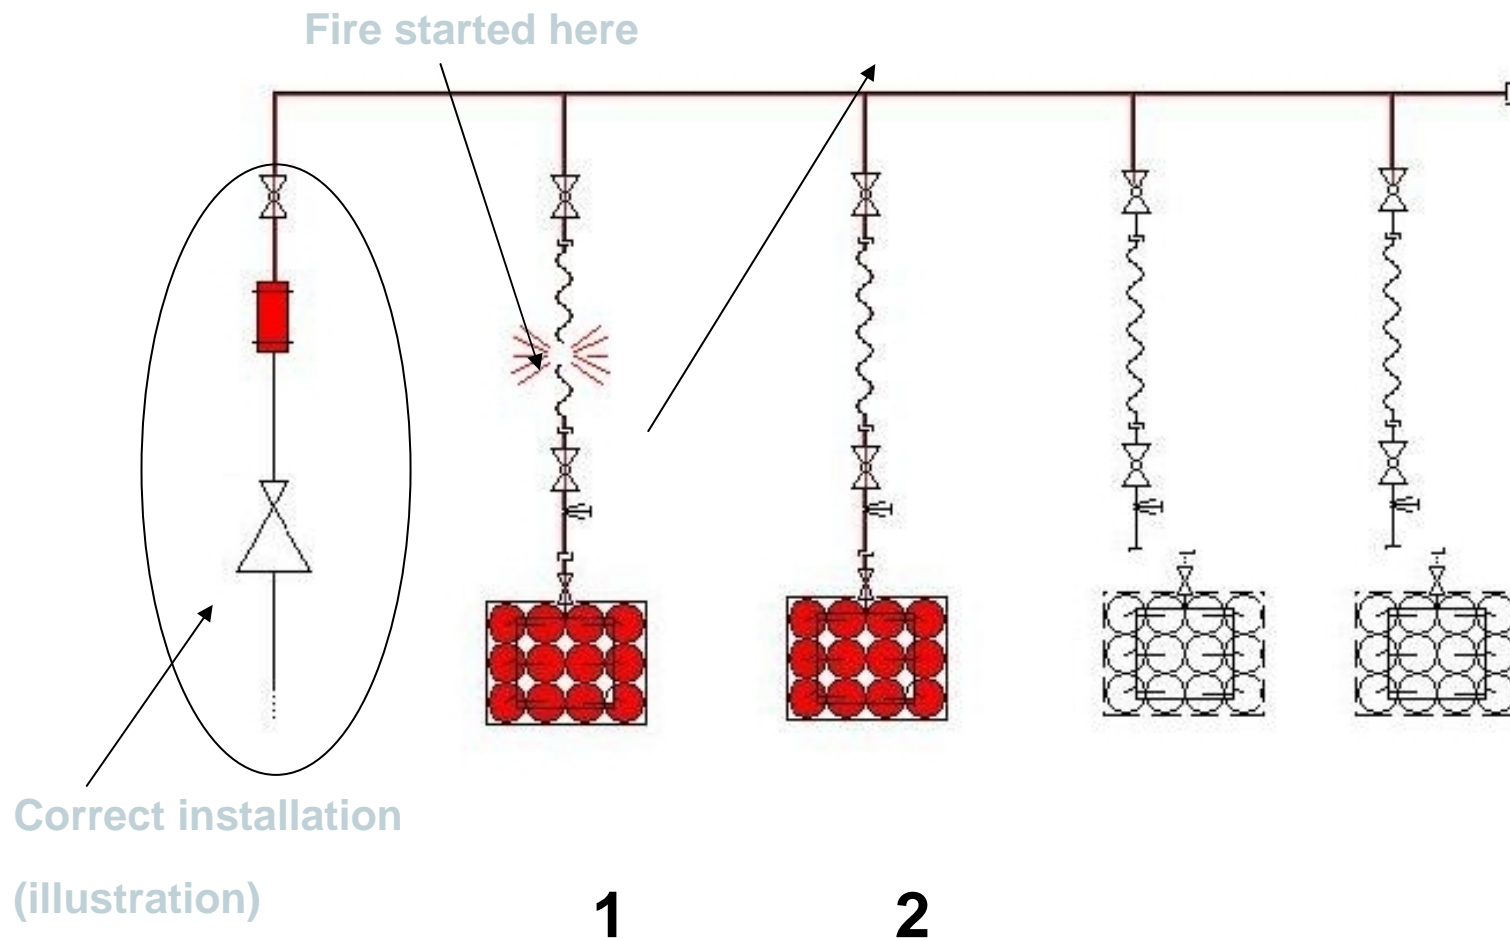
## QUIZ: Situation at time of ignition

## Connection design to the manifold used in the fire that burned down the entire station
