**Training Package
TP 13/13**

Recent Incidents in the Gases Industry in Asia

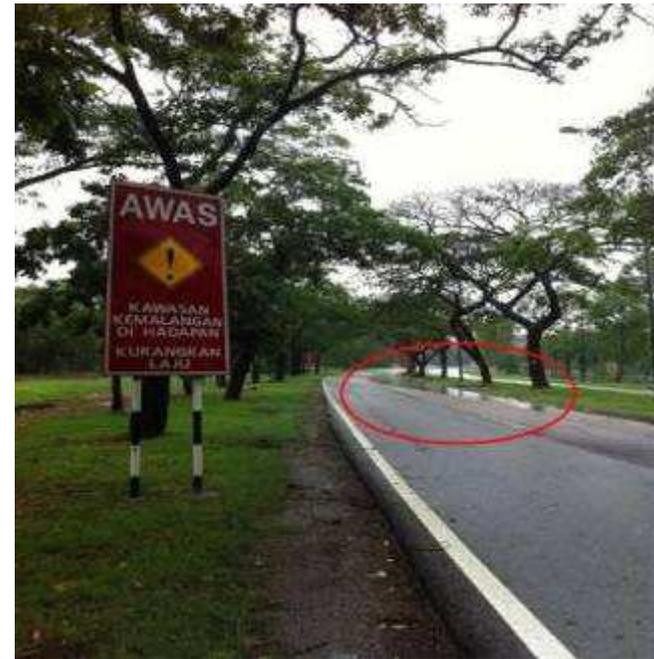
A fully loaded liquid oxygen skid tank being hauled by a prime-mover on a trailer by an temporary contract driver was involved in **a single vehicle incident** in dark and wet conditions.

From investigation, the driver was trying to avoid collision with a car that had suddenly changed lane and cut in front of the prime-mover. The car was apparently trying to avoid a pool of water on the road. This caused the prime-mover driver to lose control of the vehicle which then skidded and rolled over.

The driver who was wearing seat belt avoided injury. However, cab door and windscreen of the prime-mover were damaged.

Location of incident as seen during day time.
