Training Package TP 19/16

Recent (2015) Incidents in the Gases Industry in Asia

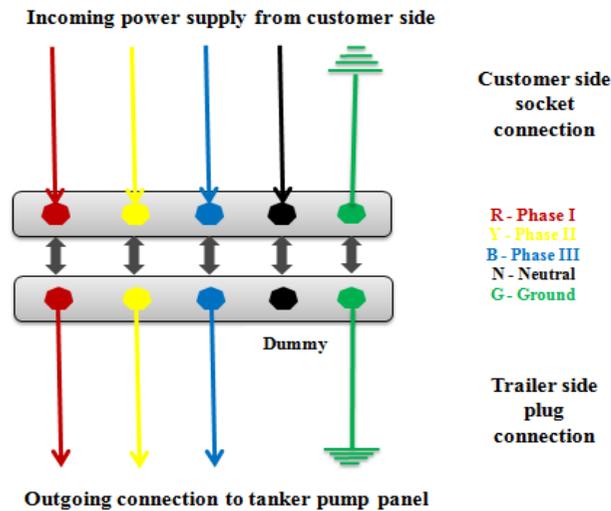
Connection: As found

- The accident happened at customer site when a tractor trailer was getting prepared for product delivery. The contractor driver was electrocuted thereby suffering a fatal injury.
- Investigation team identified wrong wiring at female and male sockets (male socket altered by some other customer) which caused the tanker pump body and piping system to be electrically energised.
- Driver was informed of the abnormal condition but decided to continue with his activities.
