Recent (H2 of 2023) Safety Incidents in the Gases Industry in Asia

© AIGA 2024- Asia Industrial Gases Association. All rights reserved.

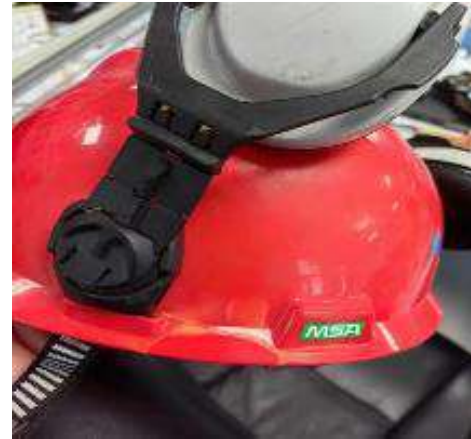
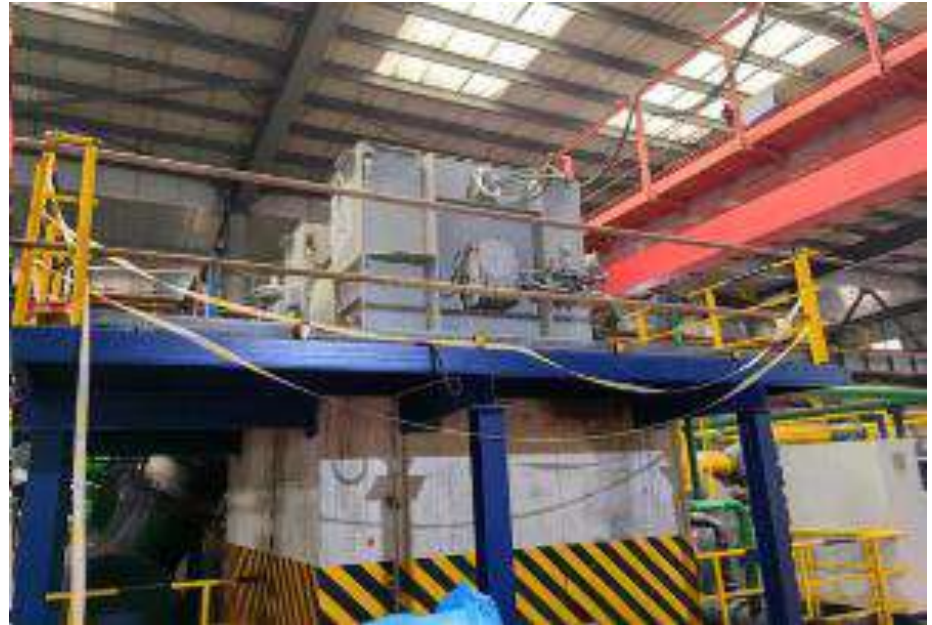
Guard rail was temporarily removed

Contractor not wearing fall prevention
equipment

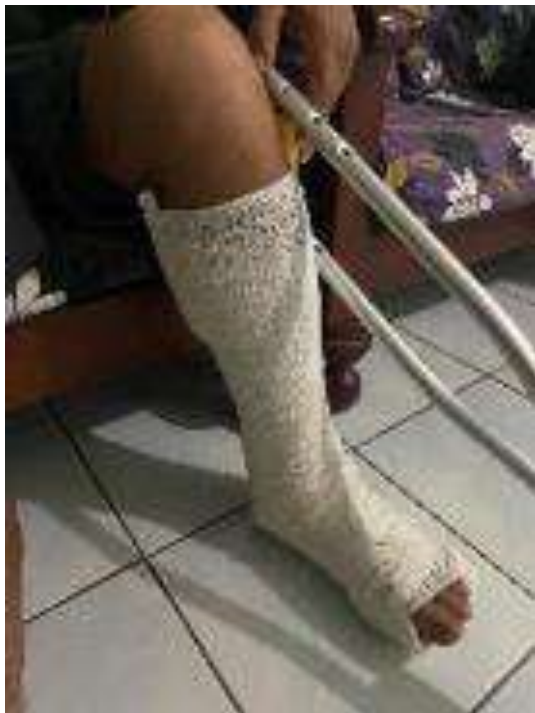
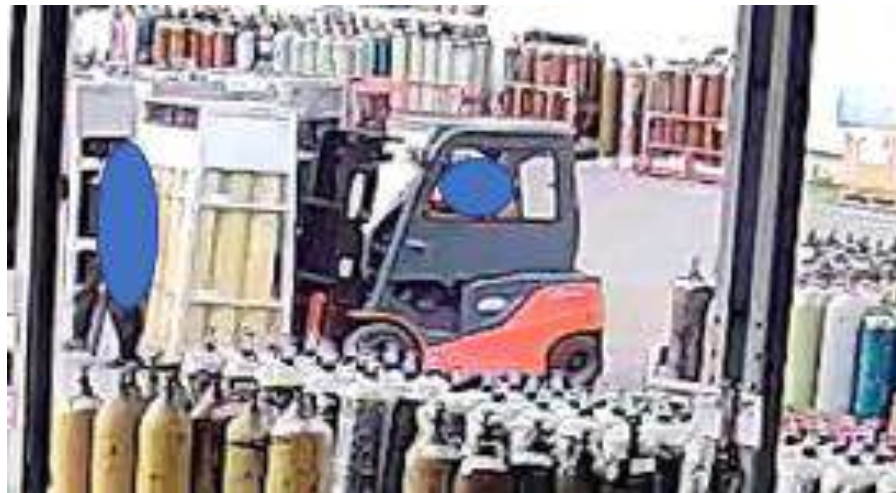
Consequences: Lost Time Injury of a Cylinder Truck Driver

- The operator was rolling two cylinders at the same time and performing other operations without ensuring that the cylinders were placed stably.
- Freestanding Cylinders were not properly secured. Also when the cylinder was tumbling, the operator tried to stop it.
- It is strictly forbidden to roll two cylinders at the same time, do not try to catch tumbling cylinders, and ensure that the cylinder is firmly secured during operation.

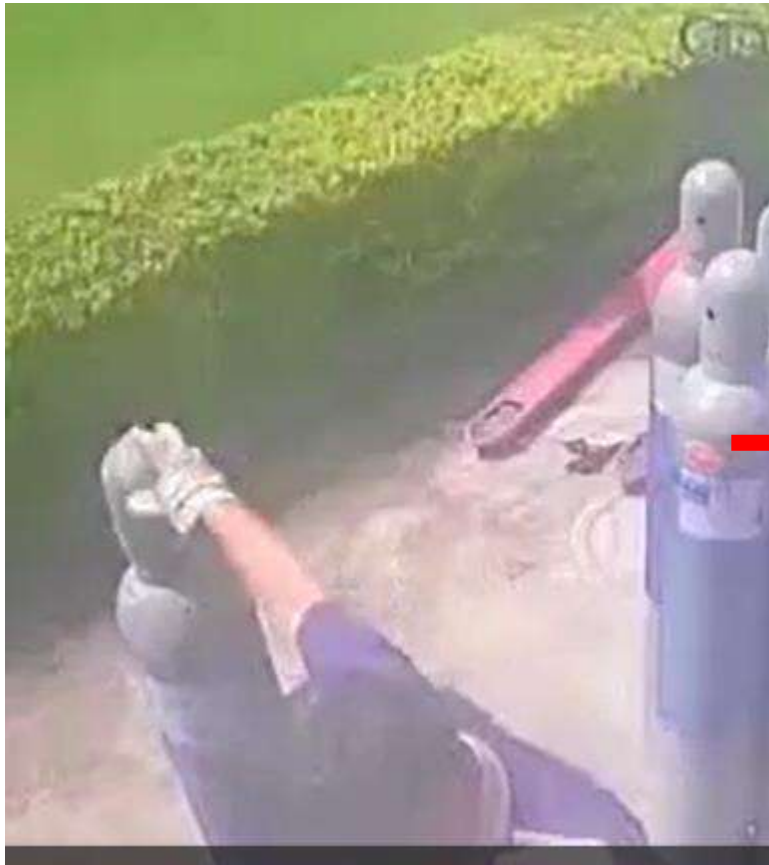
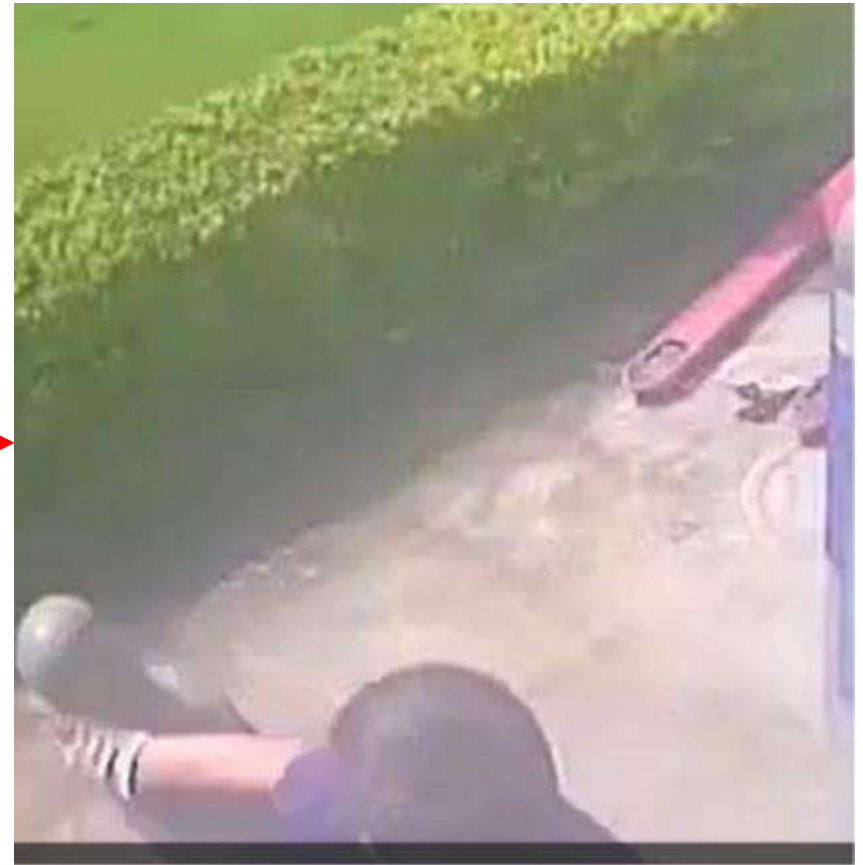
Consequences: Lost Time Injury of a Driver

- Conduct MOC for design safety reviews
- Revise and improve procedure
- Conduct job observations and engage team

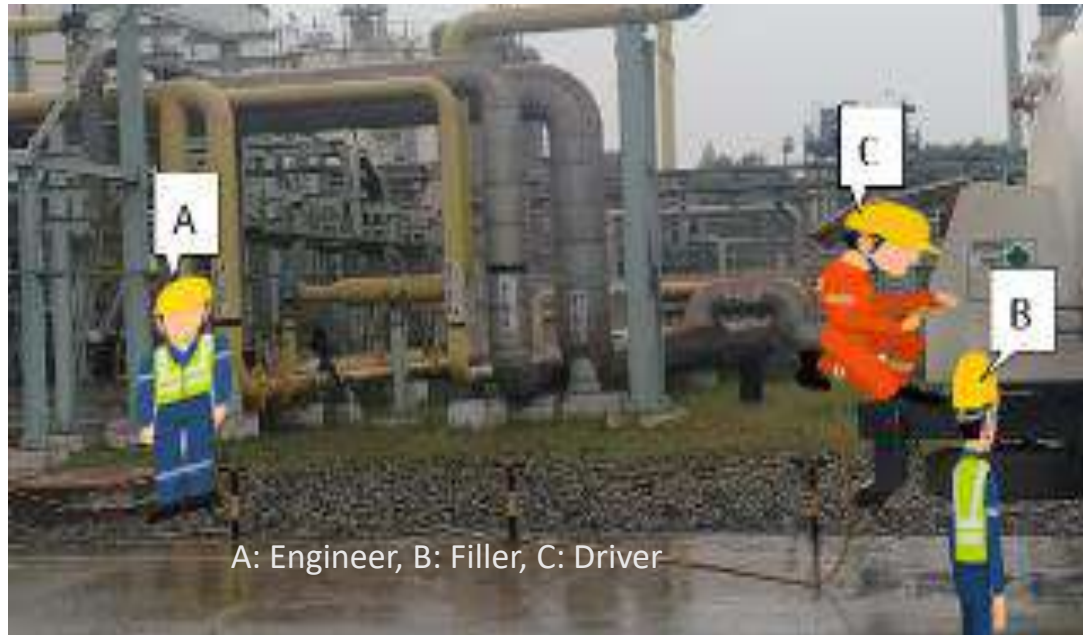
Laceration on eye lid

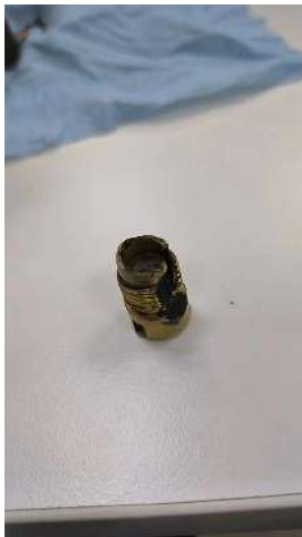
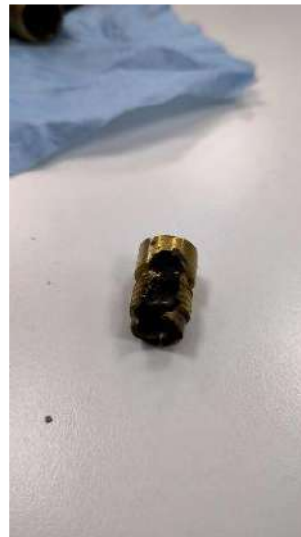
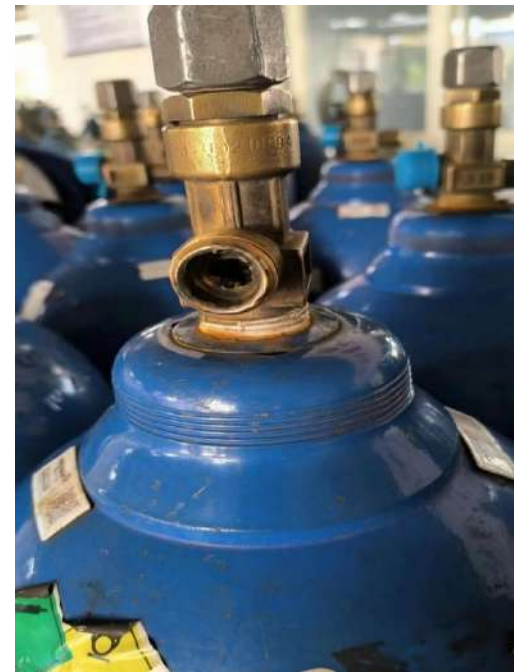
Pic3

Consequences: O2 filling hose ruptured and fire
