# Recent (H2 of 2024) Safety Incidents in the Gases Industry in Asia

# Recent (H2 of Year 2024) Safety Incidents in the Gases Industry in Asia

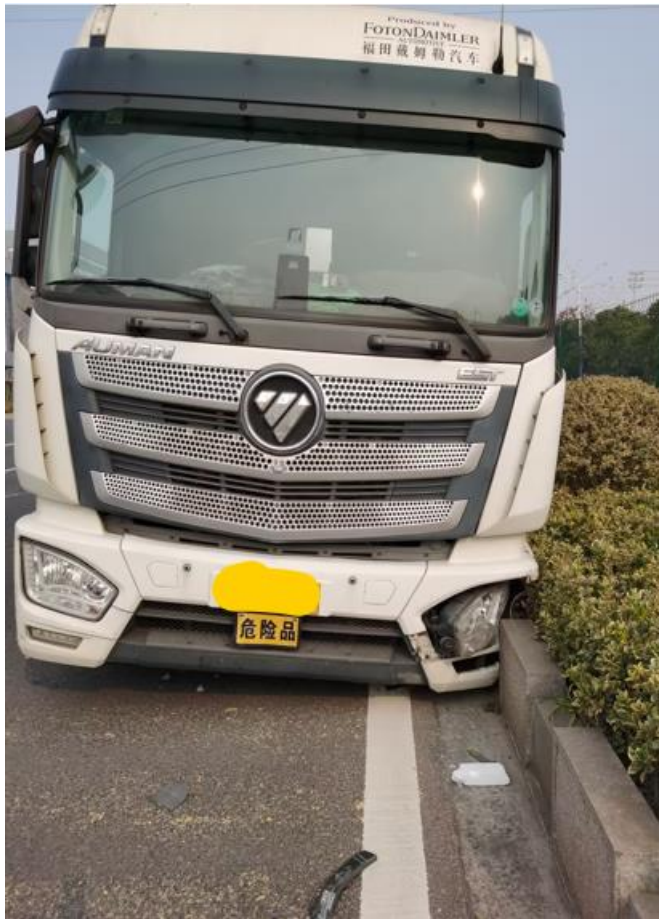
Product Vehicle

- Professional driver must be alert at all time and need to anticipate other drivers actions

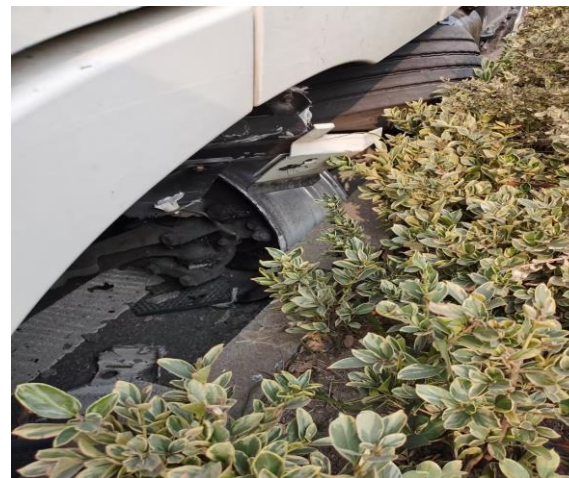
Rolled over 3<sup>rd</sup> party passenger car

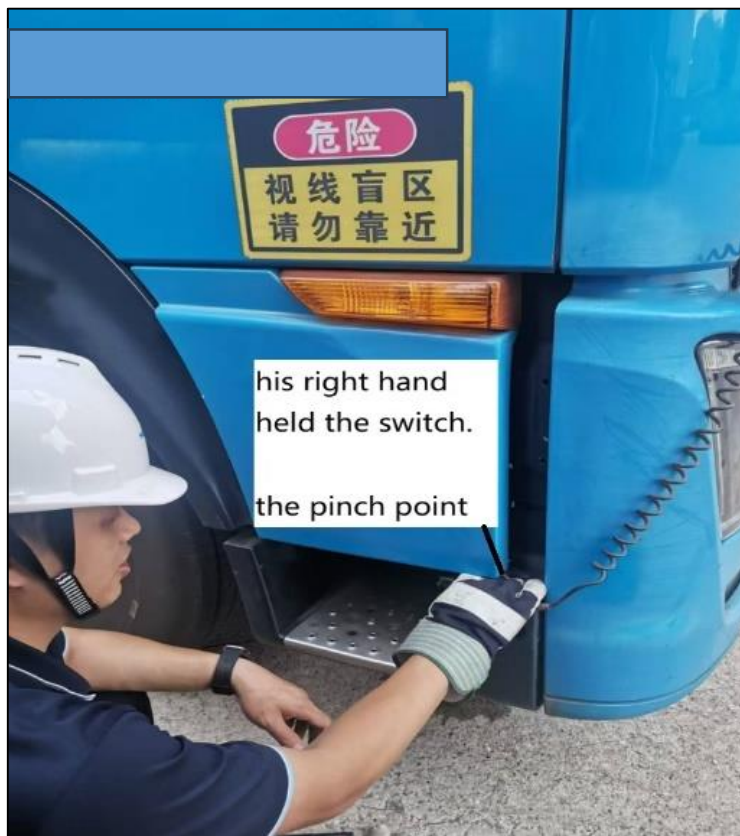
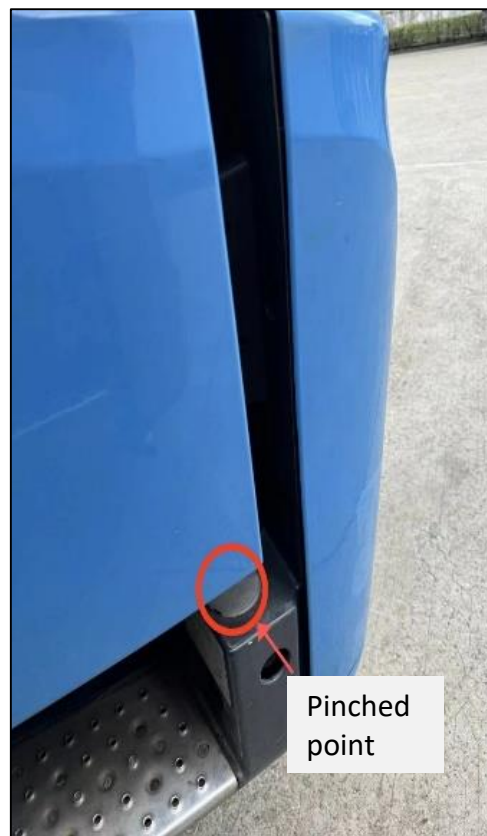
- Hand was in the LINE OF FIRE
- No Job Safety Analysis (JSA). Develop JSA for these kind of maintenance job and formulized the work instruction.

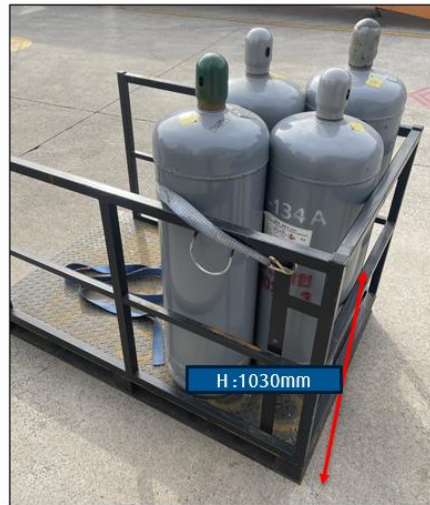
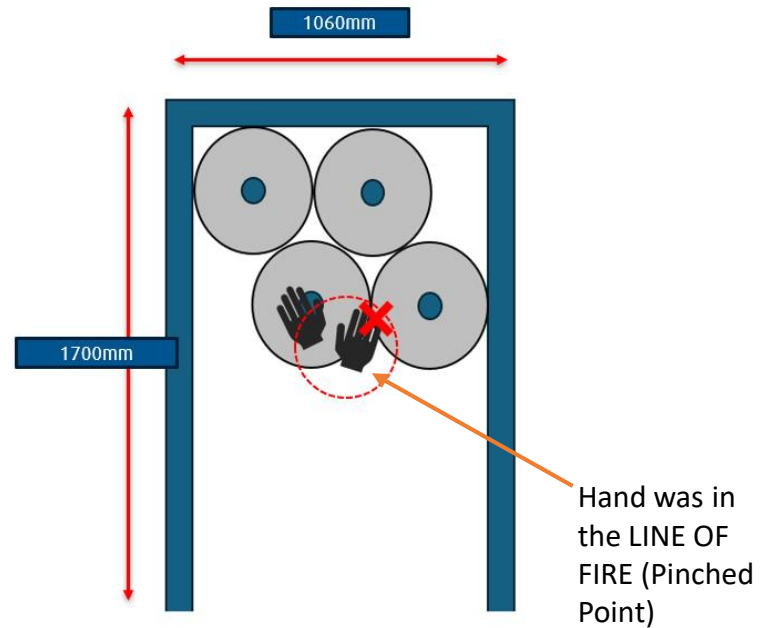
- Identify hazards and do not place hand into LINE OF FIRE (Pinched Point).
- Avoid distraction and look at hand movement when moving cylinders.

Cradle pallets used for loading trucks using forklifts

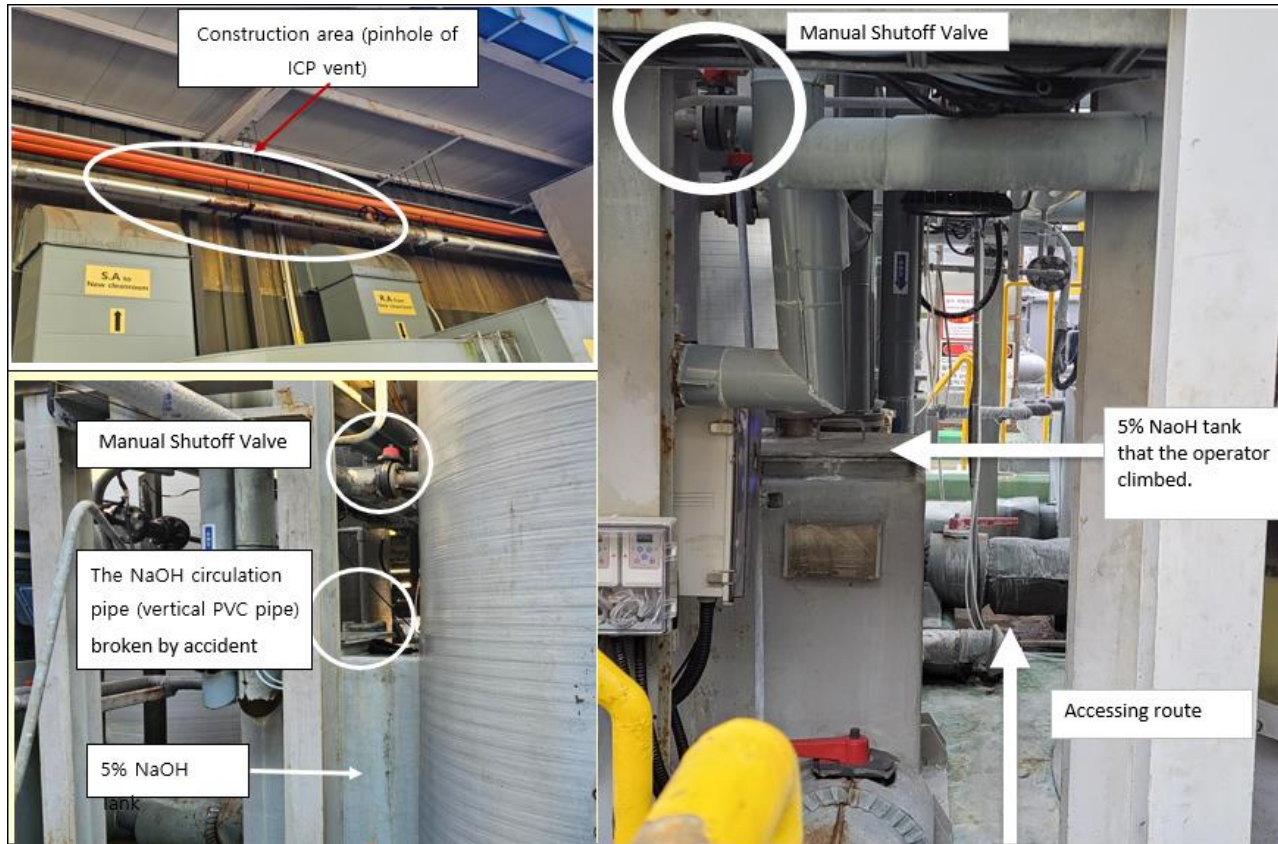
- The worker had to climb up to isolate the pipeline shut off valve and PVC pipe not well protected from climbing action. Relocate the shut off valve to a lower height.

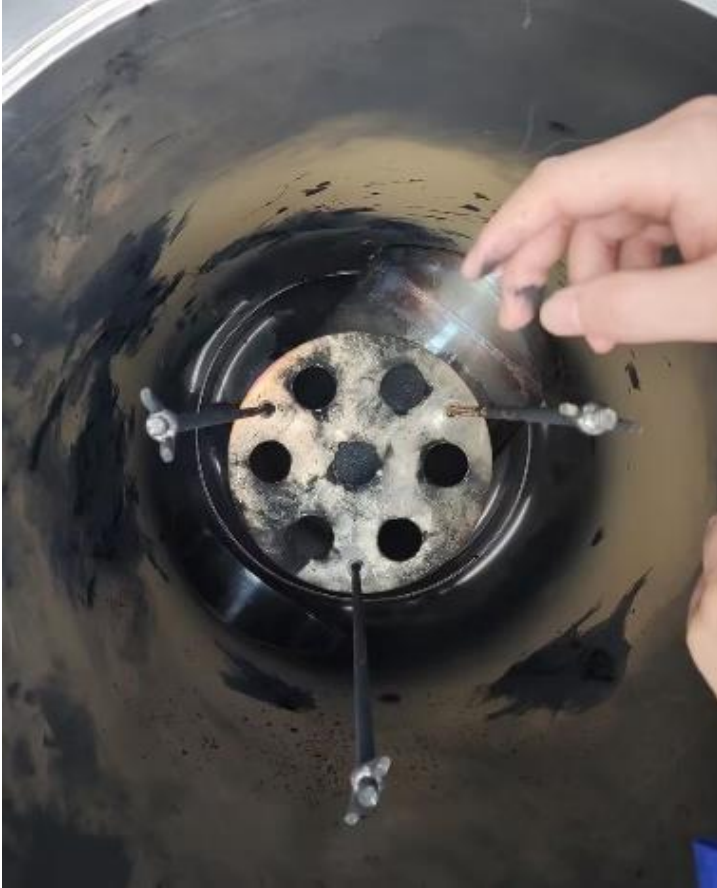
- Incompatible soft material for oxygen system
- Improve the control standards of oxygen-related non-metallic materials

Internal picture of the filter after the fire
