# **Recent (Year 2022) Safety Incidents in the Gases Industry in Asia**

# Agenda

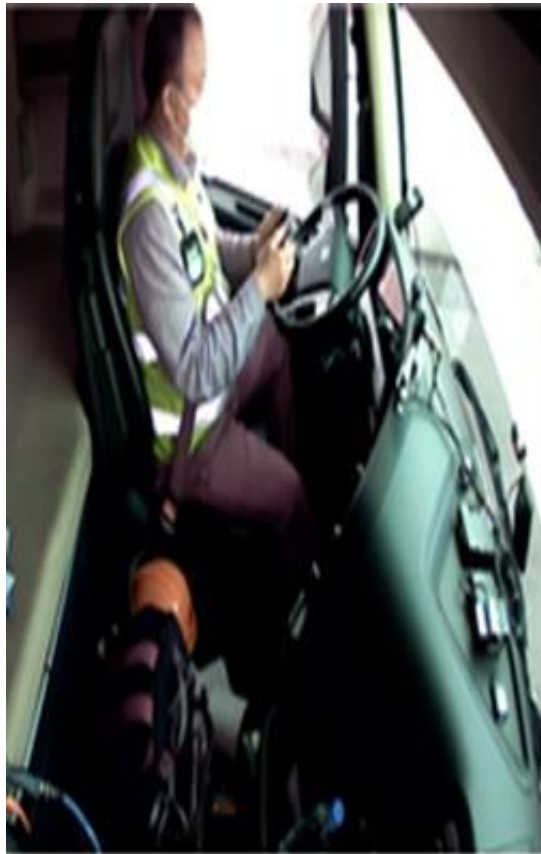
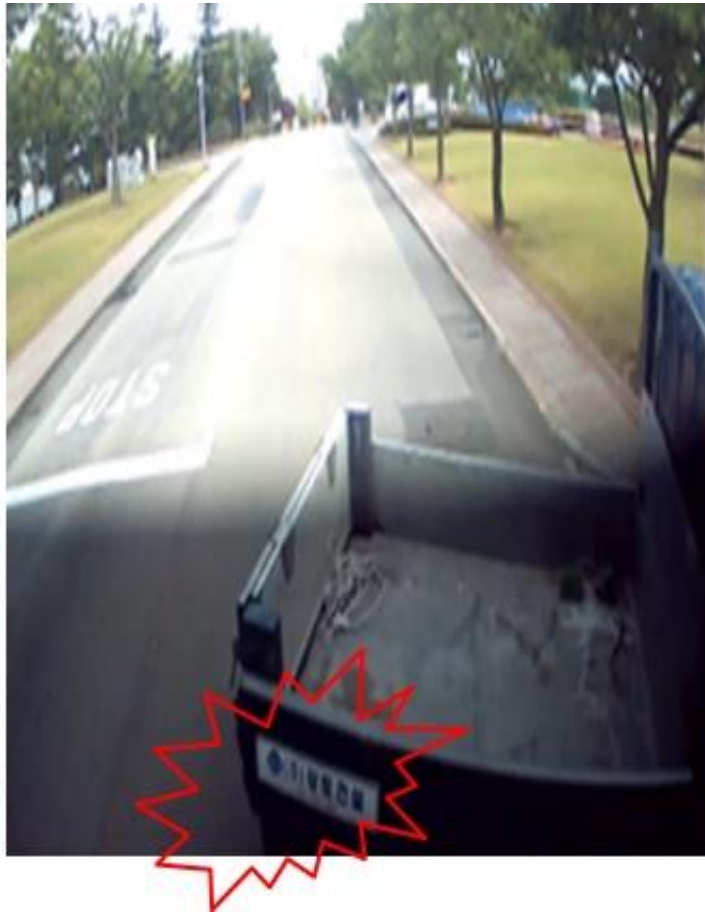
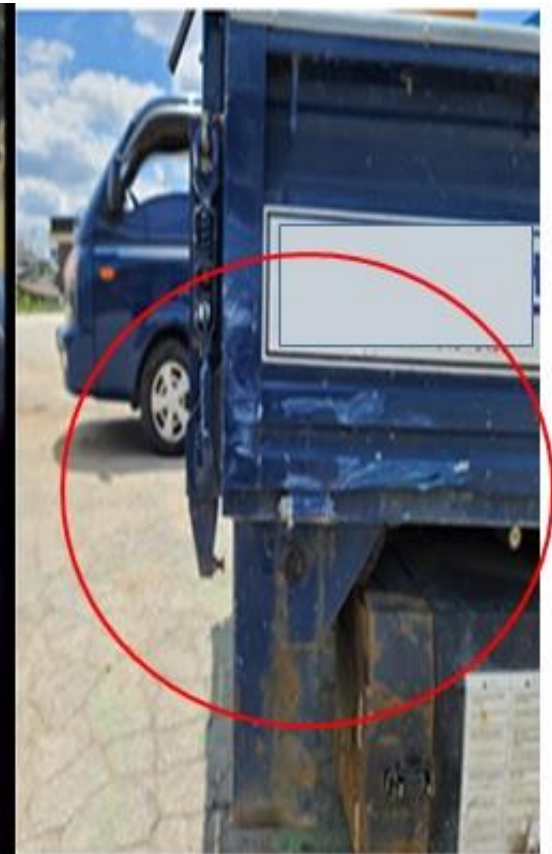
*Consequences: Single Vehicle Roll Over/ minor product release*

The driver received a hairline fracture on his spine. There was minor product release and significant damages on the tractor and trailer.

- Conduct refresher driver defensive driving and roll over training to all drivers.
- Measure the driver training effectiveness with road test.
- Conduct routine job safety observation and in cab footage review to rectify any unsafe behaviors.

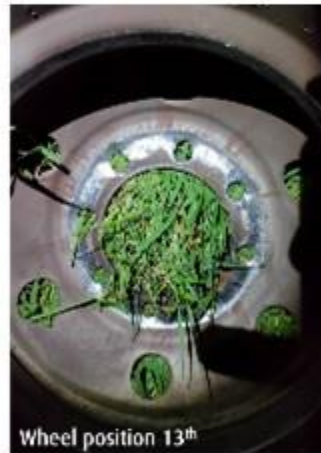
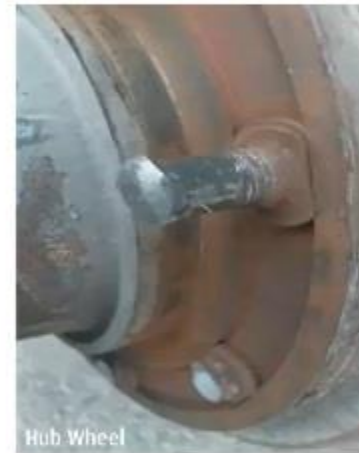
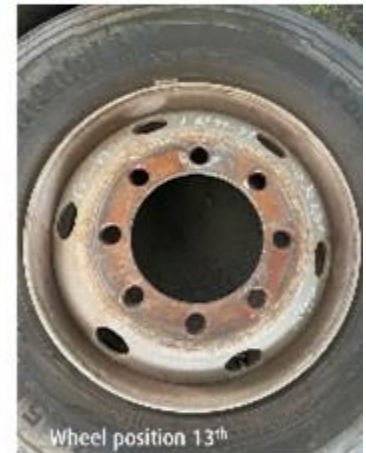
A driver completed pre-trip inspection process with no defect raised, and then started his journey. Approximately an hour later in the evening, the driver noticed on the right-side mirror that the wheel at front right trailer axle detached and rolled out from trailer. The driver immediately pulled over on the road shoulder, he found out the wheels at position no.13th and 14th disappeared, so he notified to supervisor. There was no third party involved.

Wheel moving away after separation from the truck

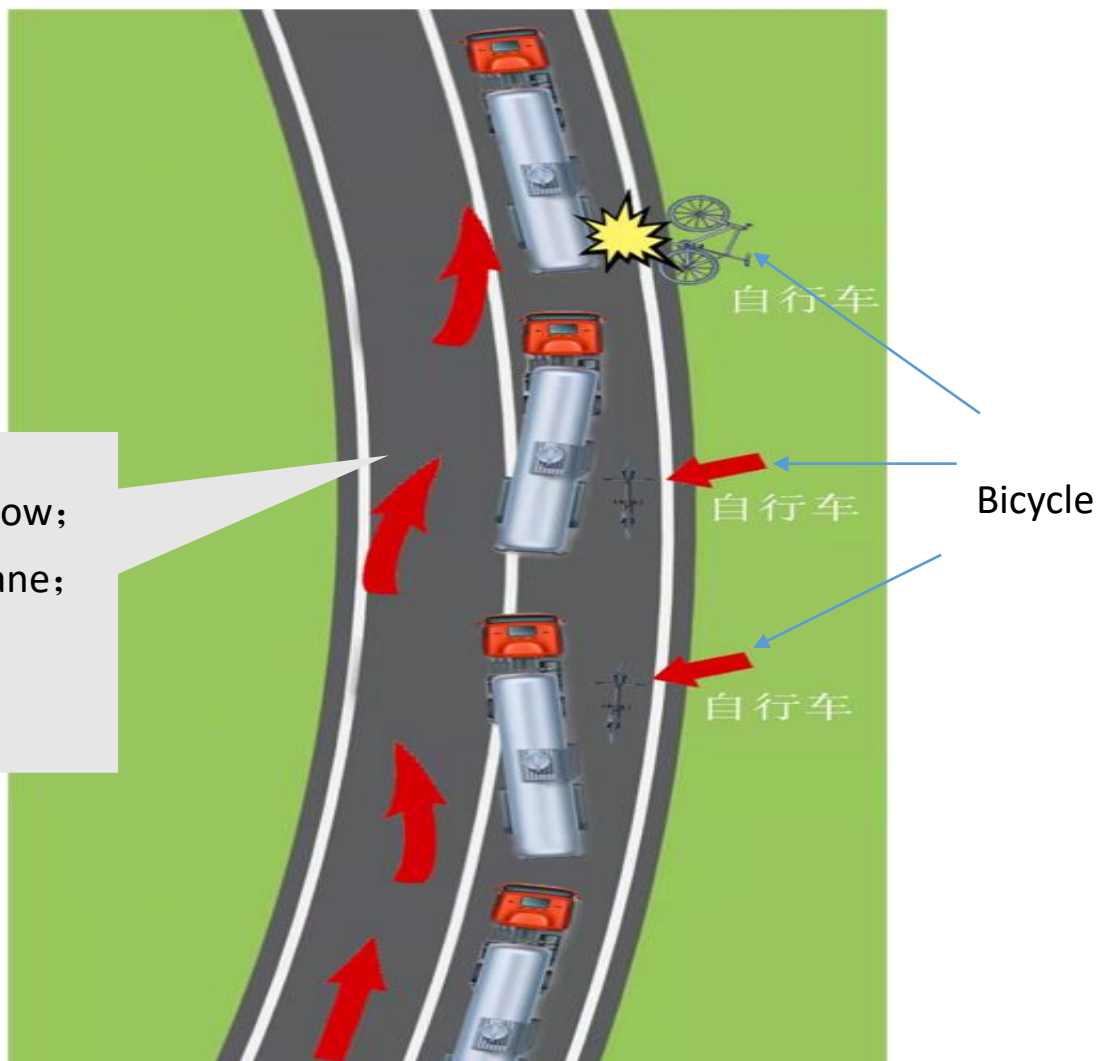
- Urban roads, large traffic flow;
- No dedicated non-motor lane;
- Speed 32km/h, the limit 40km/h

- Never take the to non-motor vehicle movement for granted;
- Remember they can easily lose control and hit the truck
- Do not trust your mirrors because a non-motor vehicle can be hidden in your blind spot;
- Never cut in too closely after overtaking a non-motor vehicle;
- Be courteous – signal your intentions well in advance – Make sure they see you;
- Avoid a non-motor vehicle on side by side of your vehicles because it can overtake and be in front of you any time;

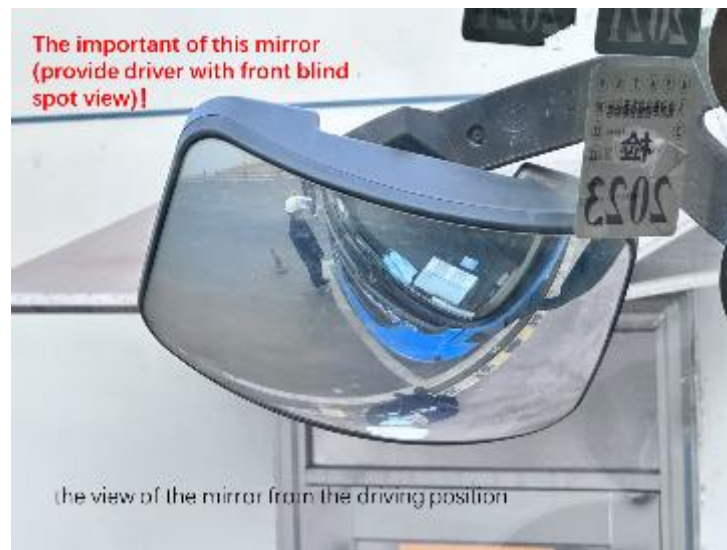
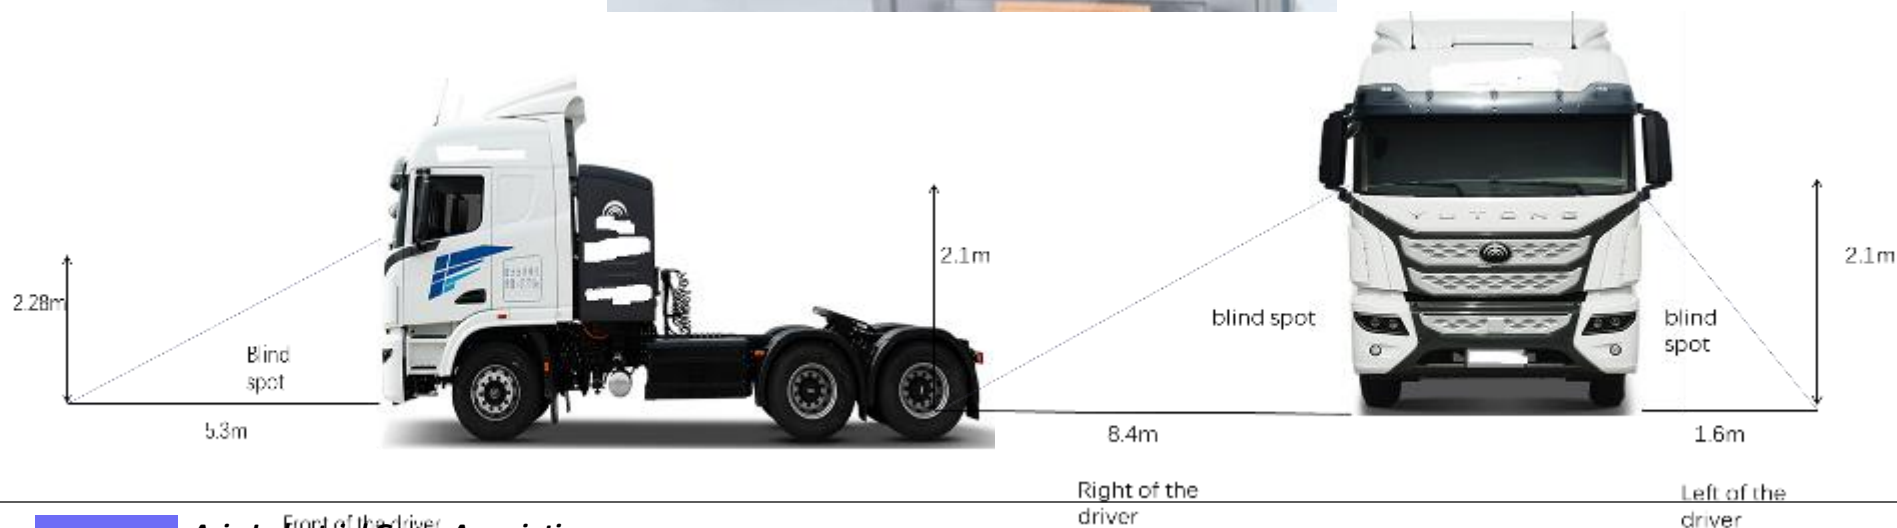
Traffic monitoring shows that the injured old lady was crossing the road from the right side of the road tanker, then she was walking along with the trailer and the truck as the red line shows. At last, she reached left front wheel of the truck (below the reflector) when the incident happened.

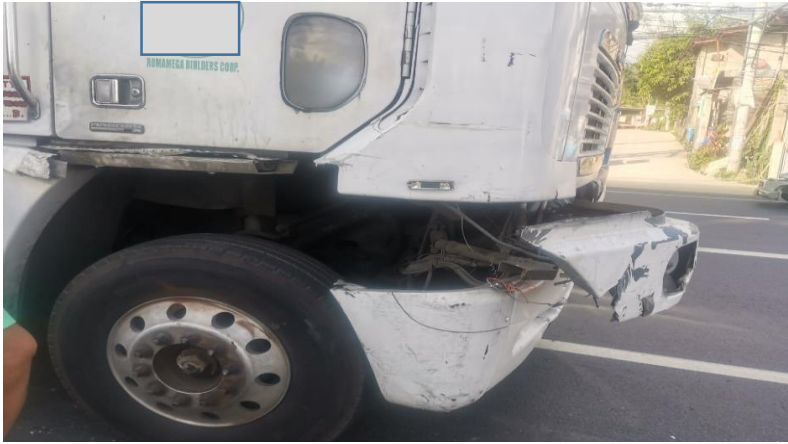
At 16:00hr, a Tractor was returning back to the production facility after product delivery. A red car in front of the tractor slowed down and signaled to turn left. The tractor driver in his effort to avoid collision with the car, tried to maneuver to the right. However a tanker carrying flammable goods was passing then and caused collision with the tractor. Left rear outer tire of the flammable tanker was hit by the tractor head causing the tire to burst while the front right bumper and fender of tractor head were damaged. No person reported injured in the accident.

Tractor Front Fender and Bumper

- Driver did not use defensive driving technique
- Reinforce defensive driving training for the driver.

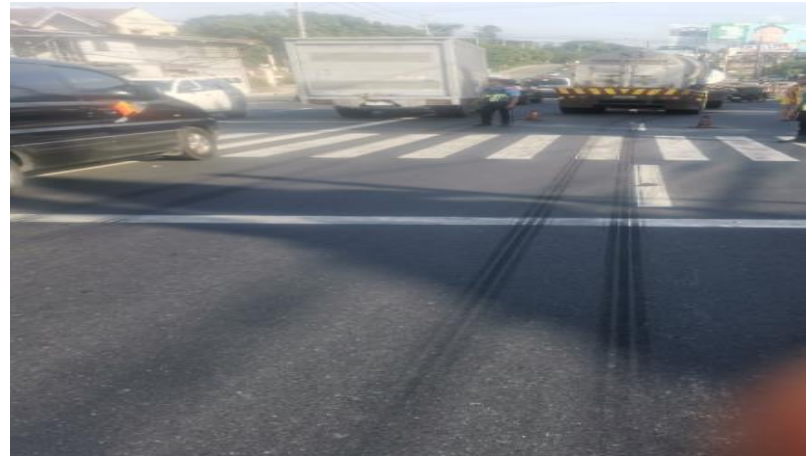
Tractor tyre skid mark

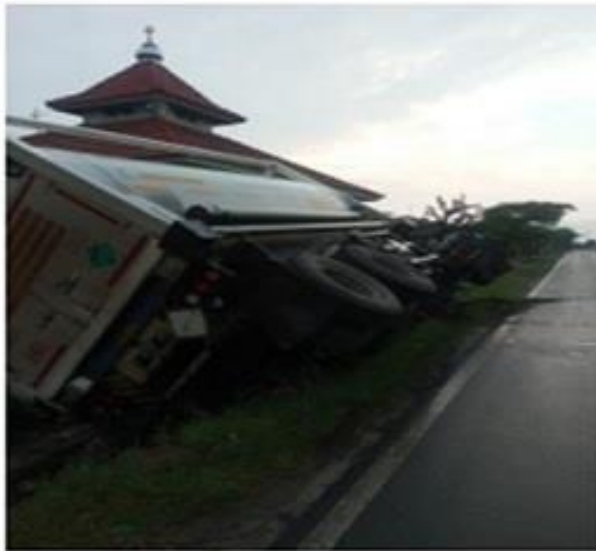
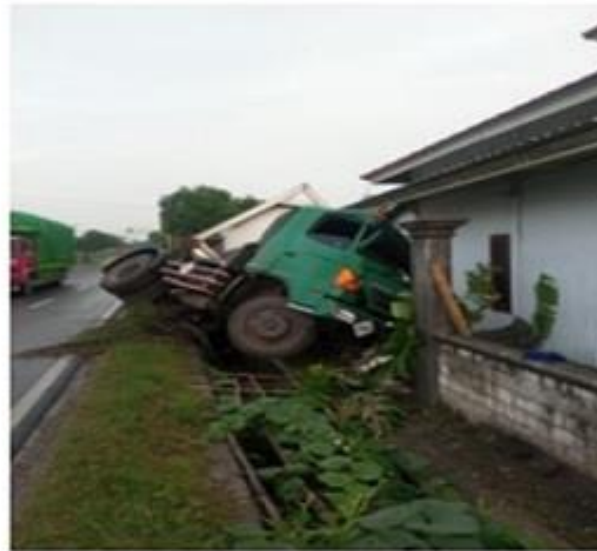
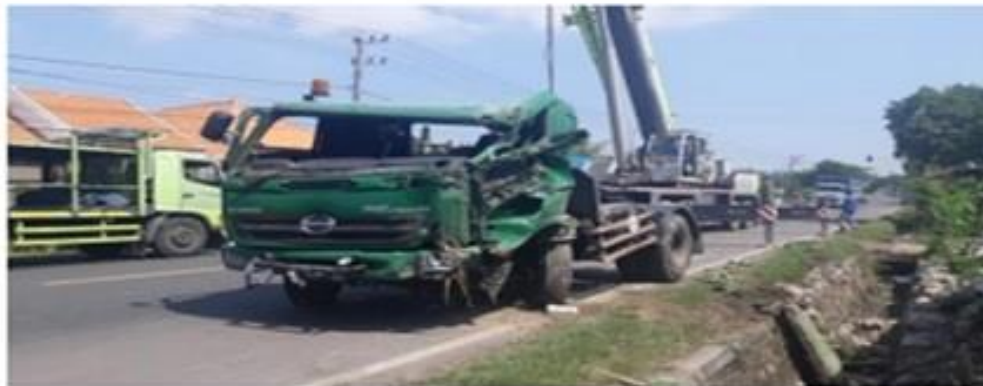
An ISO tank carrying LCO2 crashed against a road side prayer house building on left side of straight road after travelling 700Km of distance. The incident happened at around 7 40 am. This crash caused damage to the driver cabin and rollover of the ISO Tank. There was no injuries to anyone.

- Skill up the driver discipline and awareness by giving training on defensive driving continuously.
- Consider to install advanced safety features to reduce accident risk.
- To focus on fatigue management

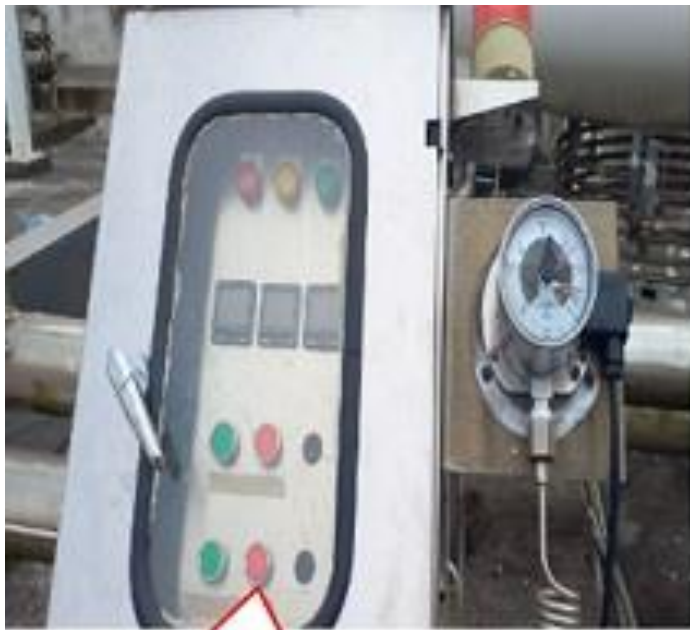
The filling station staff then informed the Maintenance Team about the situation. After investigations, the Pressure Switch was eventually replaced as it was found that the high pressure value set lever was broken.

**New Pressure Switch**

- Maintenance Strategy of equipment essential for safe and reliable operations needs to be established.
- To establish periodic visual inspections as a minimum for equipment with no periodic maintenance planned.

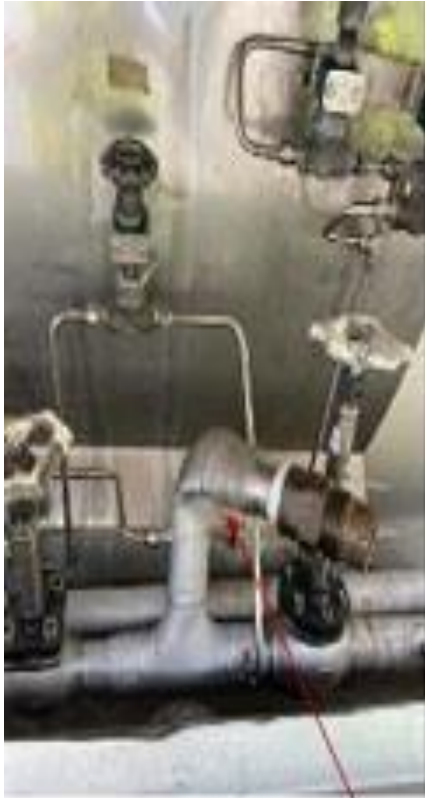
Bent filling port

- Be Aware of Your Surroundings - Check and ensure the truck is free from any connection
- Enforce ignition key control for all 3<sup>rd</sup> party trucks
- Install the break away coupling on the fill line

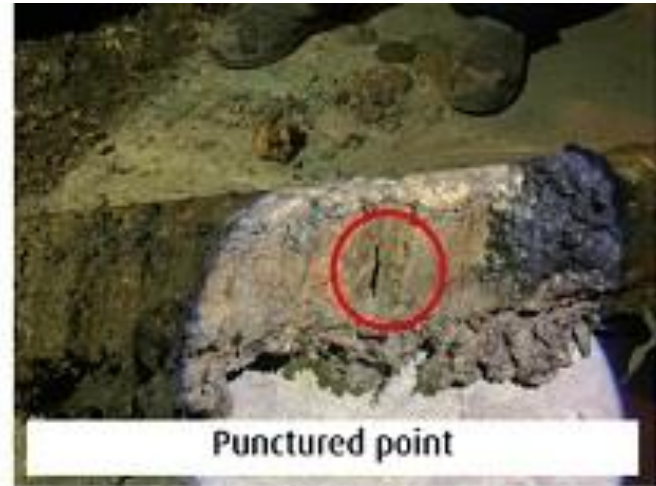
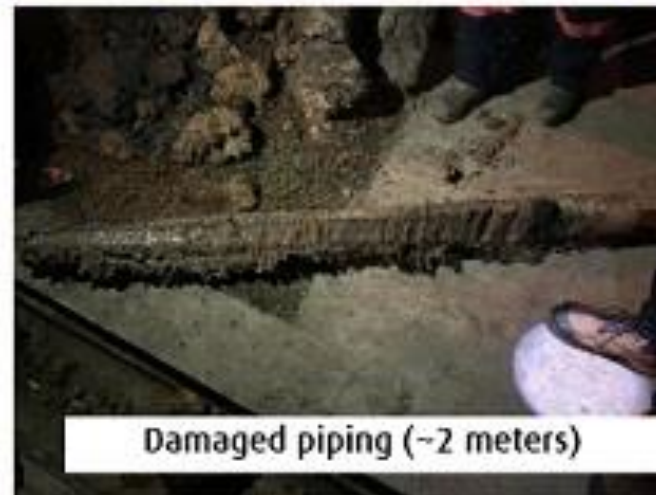
The nitrogen gas supply was isolated and approximately 2 meters length of nitrogen pipeline was damaged.

- Establish clear protocol on communication to utility contractors before any excavation works to occur near any gas pipeline.

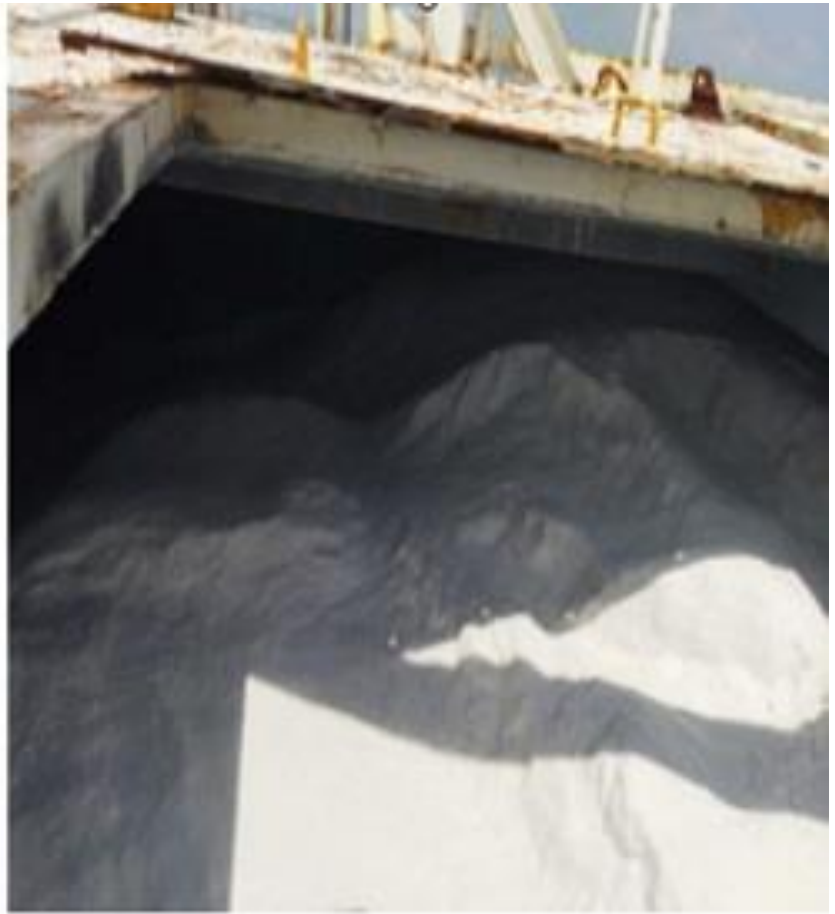
Around 1030am, a technician was performing weekly inspection of cold box when he found some perlite was released from corroded surface of a cold box top wall at 66 meters elevation. Approximately 2kg of perlite was released.

Cold box interior

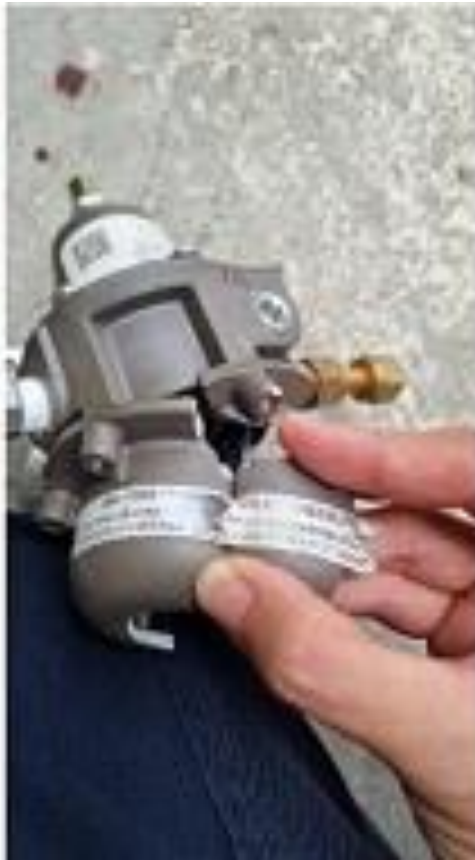
Incorrectly rated pressure regulator

- MOC to be raised for new work process
- WRA must be detailed to cover the entire scope of the process
- SWP Issuer and Receiver must communicate the detailed steps of the work activity

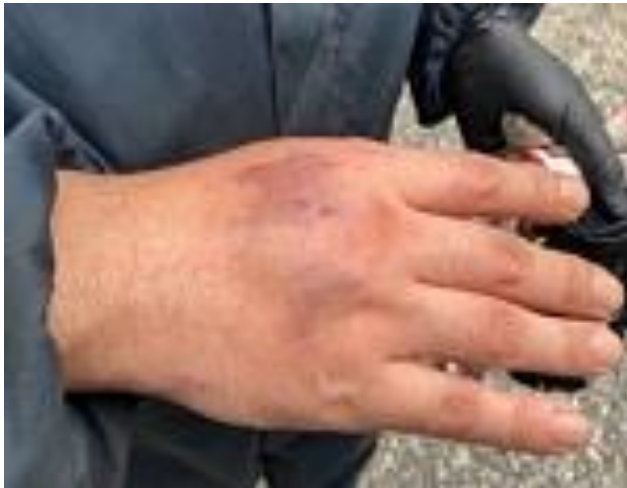
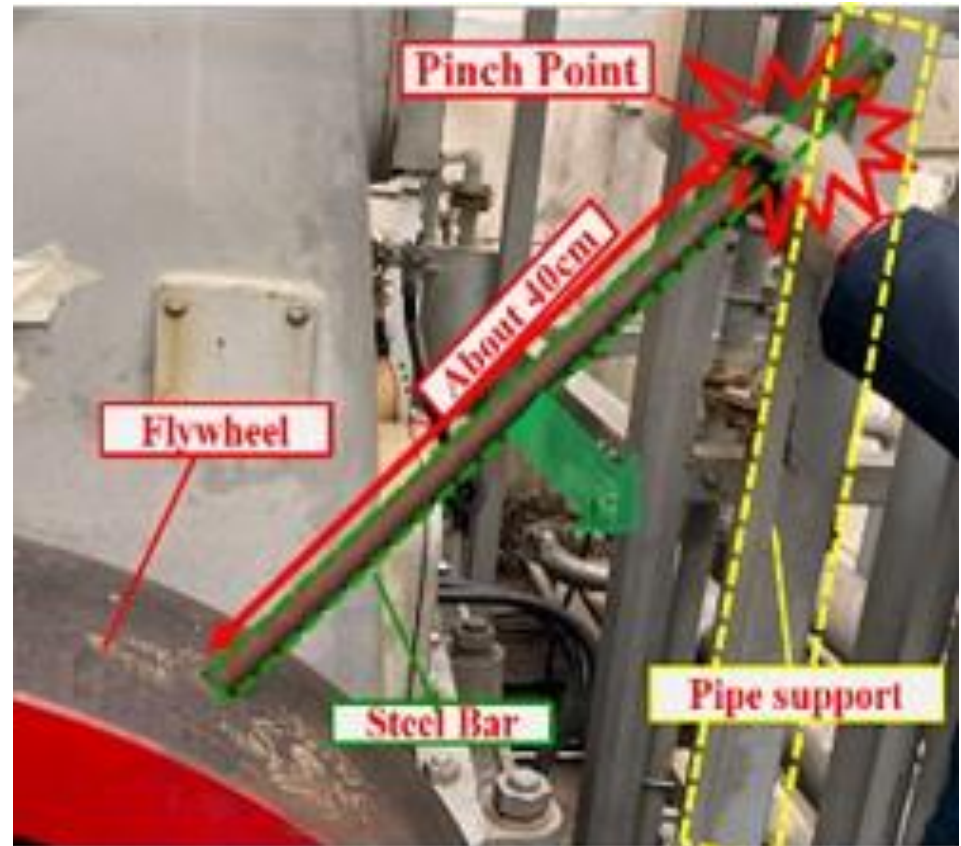
### *Consequences: Recordable Injury*

- Be aware of pinch point hazard
- Stay out of the Line of Fire
- Do not rush

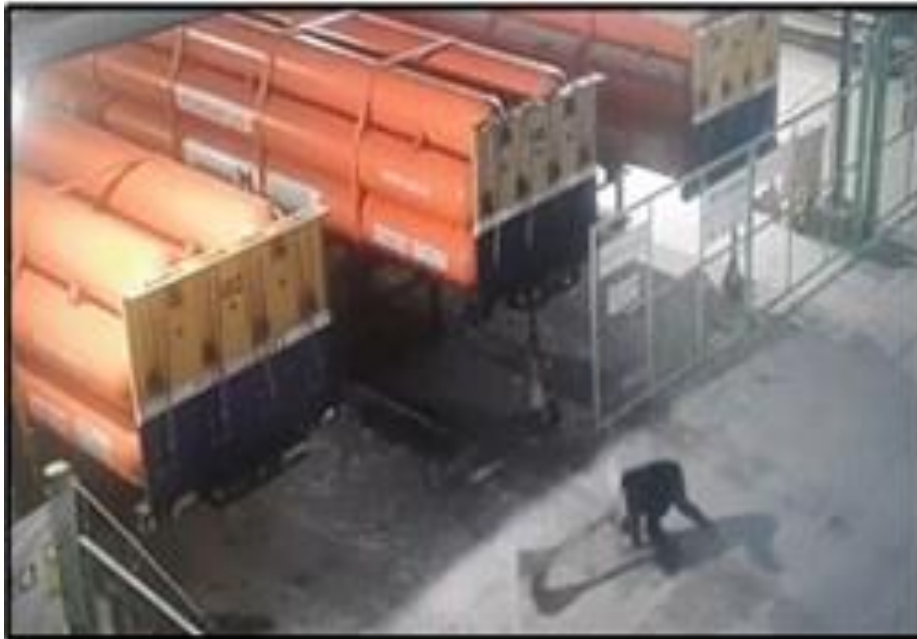
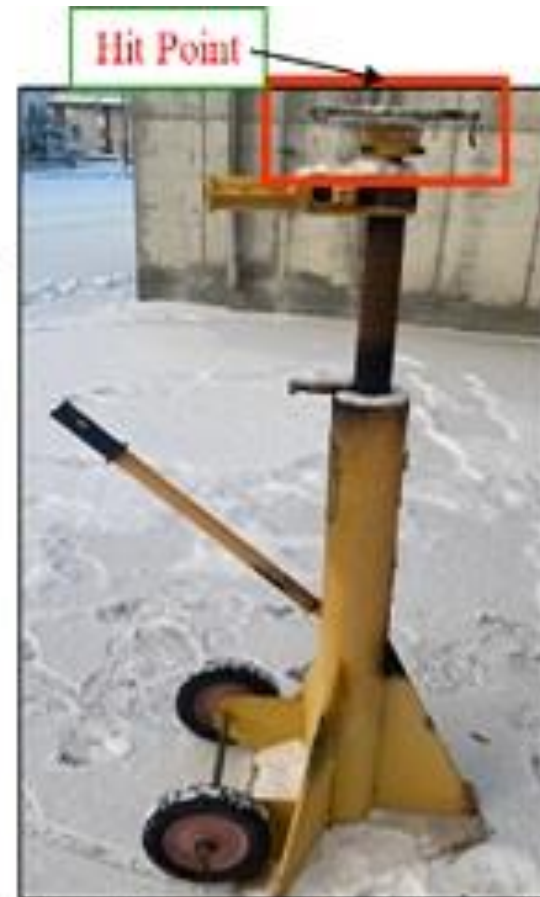
### ***Consequences: Recordable Injury***

- Remove ice and snow on the ground thoroughly
- Wear safety shoes with anti-slip aids

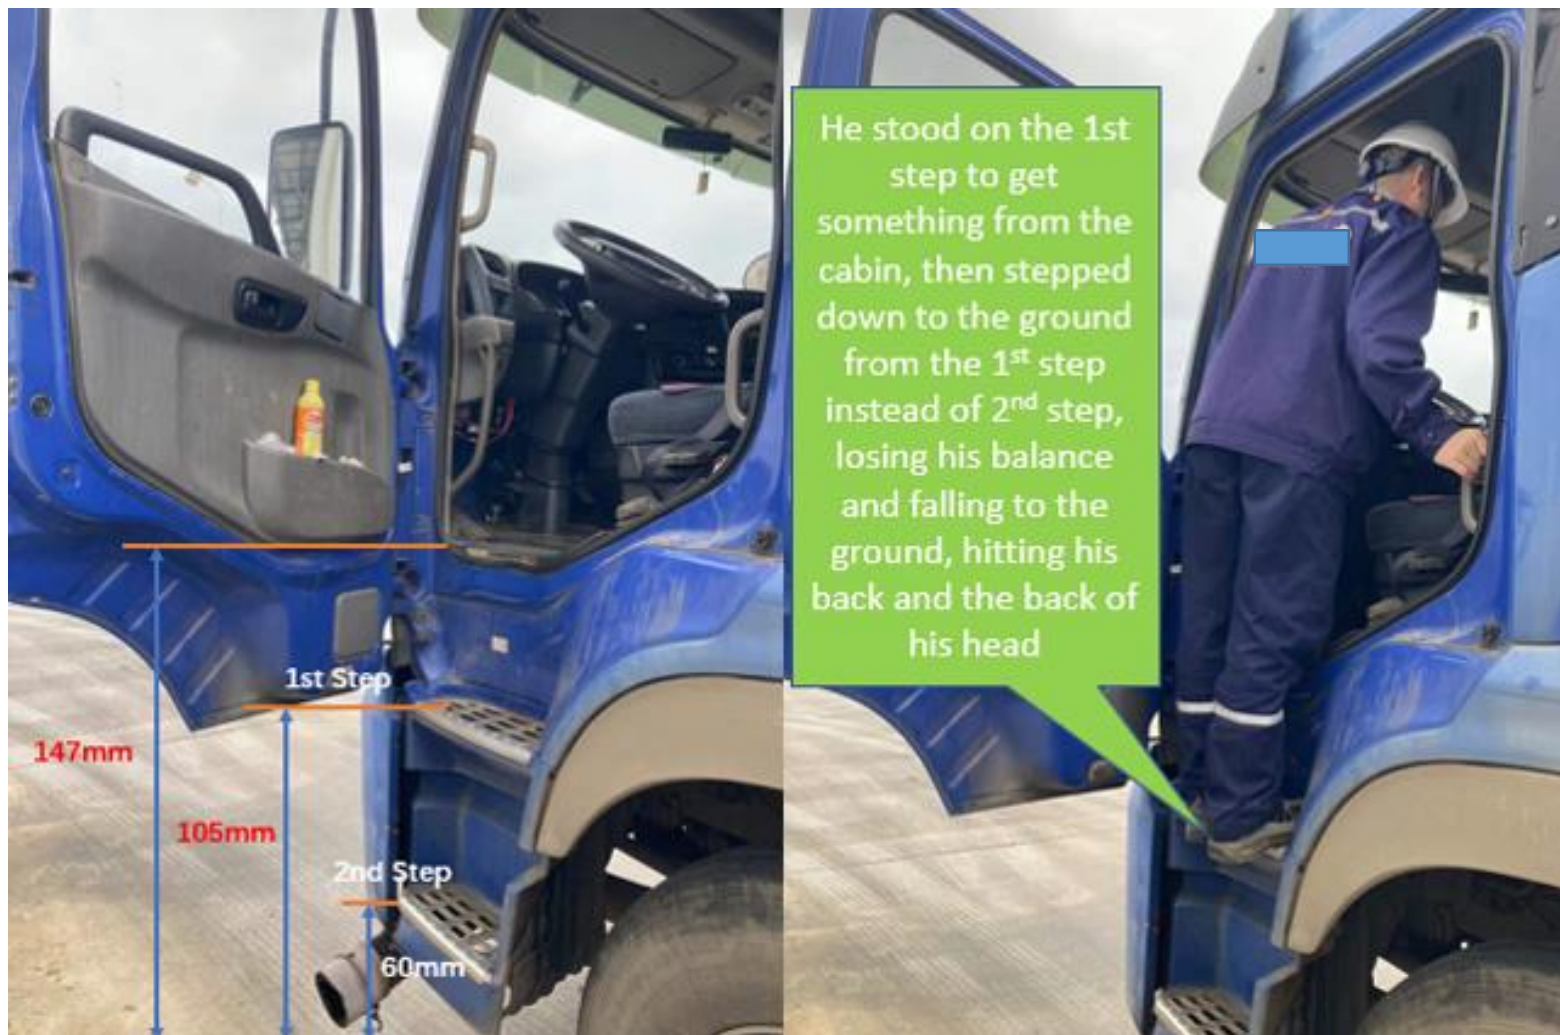
### ***Consequences: Lost Time Injury***

- Re-training Basic Safety Awareness regarding Prevention of Slips, Trips and Falls.
- Through video surveillance, regular spot check whether the up-down of the cabin behavior meets the requirements
