Training Package TP 09/12

Recent Incidents in the Gases Industry in Asia

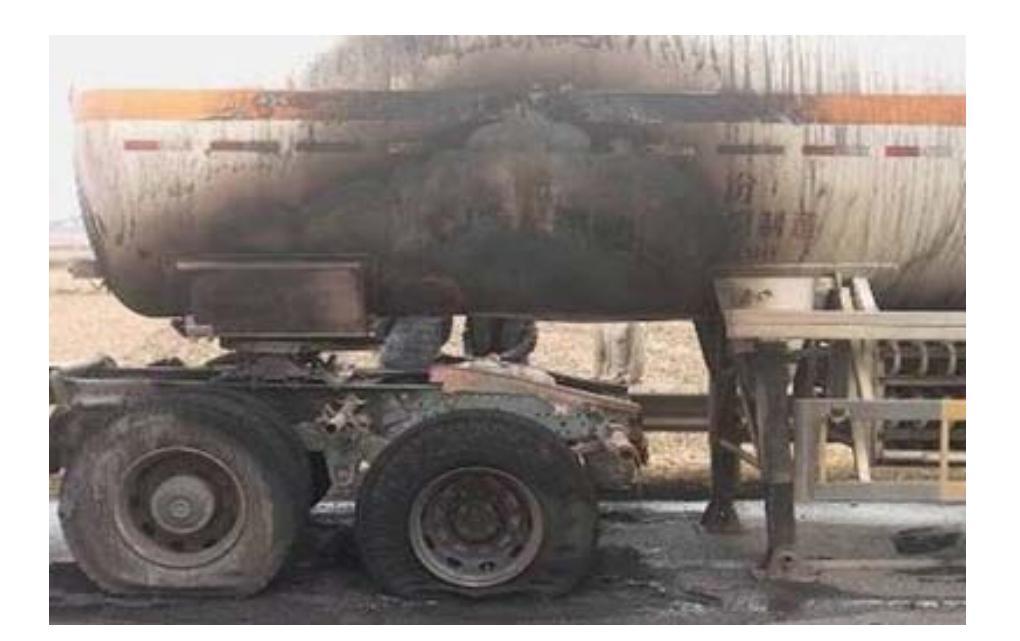
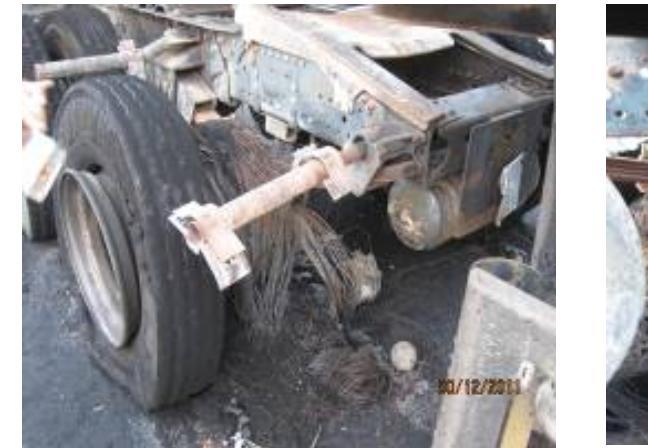
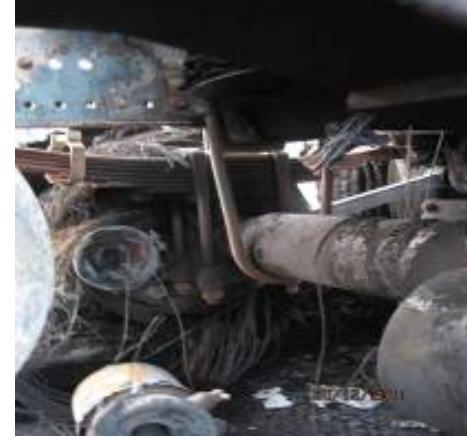
The fire occurred first at the inside rear tyre.

- Locked brake on trailer
- Convoluted electrical of wire system of trailer.
- Overheated tyres after a long trip on the road

Left tyres

Left brakes

Good maintenance of brakes, tyres and wheels, and proper tyre pressures will help prevent or reduce fire on tyres.

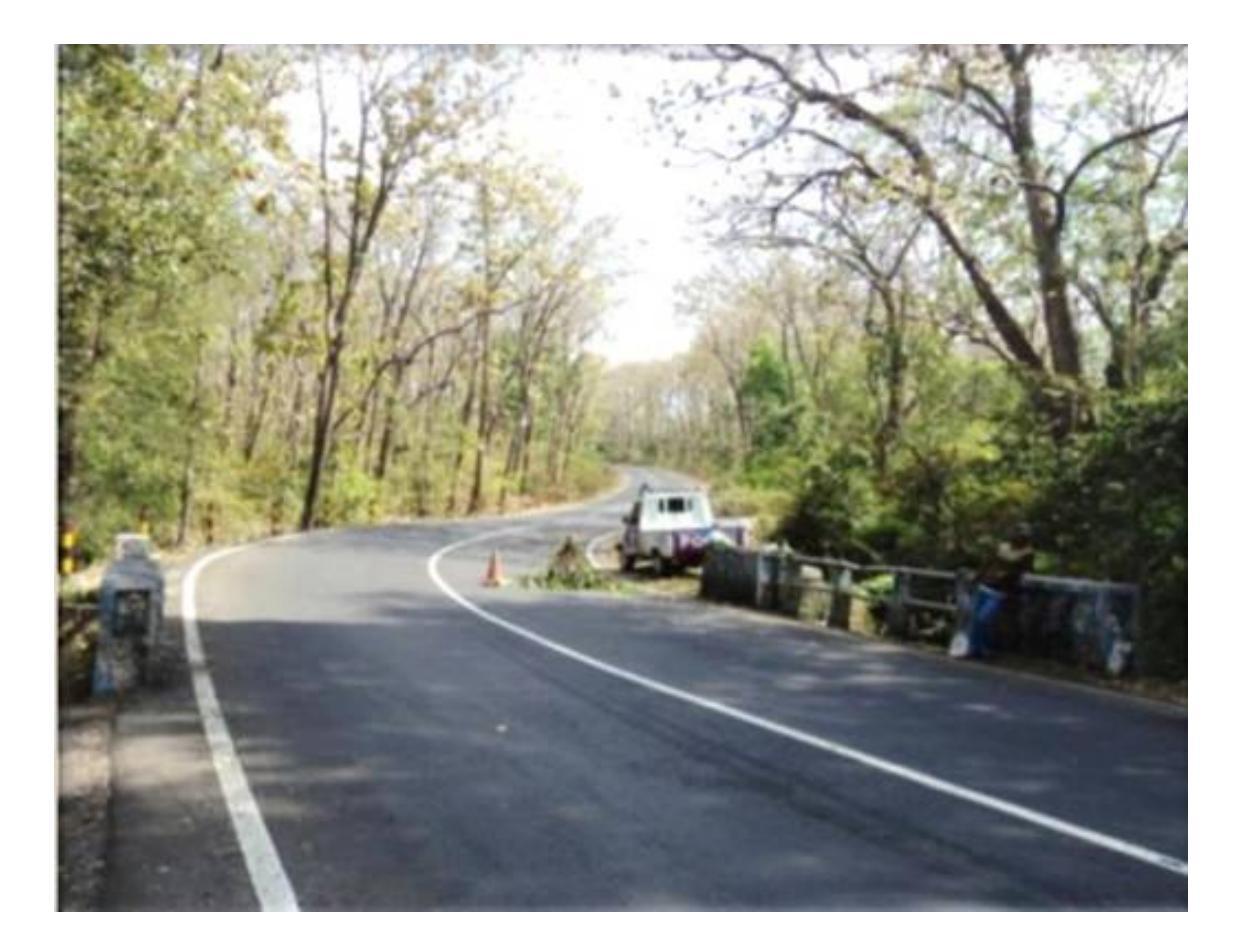
Approach direction of road

At approximately 7.45 am a cryogenic tanker transporting liquid nitrogen rolled over. The vehicle was travelling at about 40 km/hr on a downward slopping stretch of road when it failed to safely negotiate a left hand curve in the road.

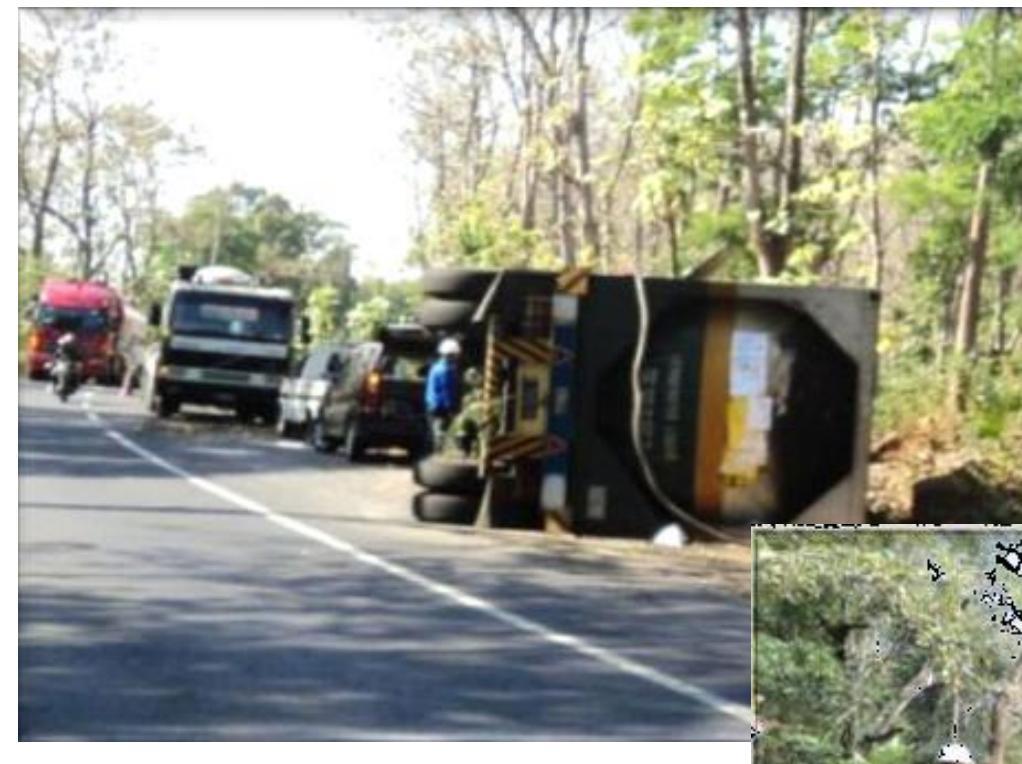
Truck rolled over and landed on the road

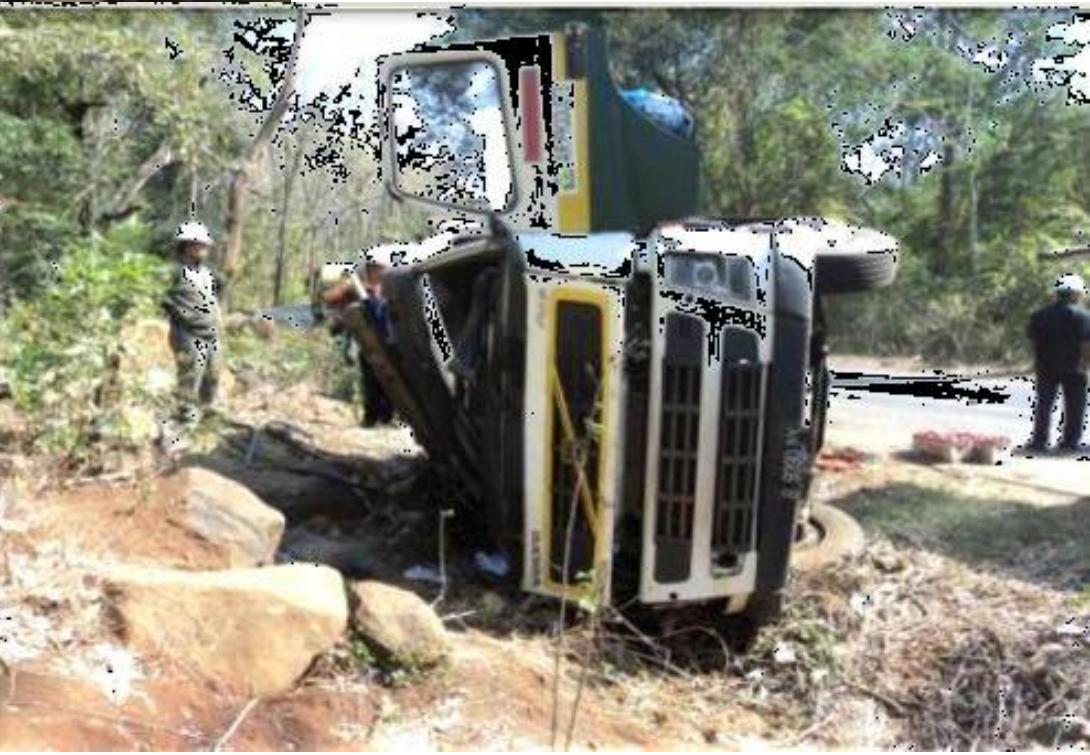
Drive side cabin crushed by the boulders

- Investigation revealed:
 - All truck systems were functioning properly
 - Driver was wearing his seat belt
 - Driver was not using his cell phone
 - Co-driver was in the sleeper berth (bunk) at the time of the incident
- Primary cause of the accident was driver fatigue or distraction/inattention.

• It is important to plan and monitor the schedules of the drivers to ensure that they have adequate rest.
